Channel-Floodplain Disconnection on the Stanislaus River: A Hydrologic and Geomorphic Perspective

ABSTRACT. The Stanislaus River, the northernmost major tributary to the San Joaquin River, has undergone profound alterations to its flow regime, channel form, and ecosystems. New Melones Dam (built in 1979) and over 30 smaller dams cumulatively impound 240% of average annual unimpaired runoff, reducing winter floods and spring snow melt runoff, and increasing summer base flows to supply irrigation demand. The frequency and extent of overbank flooding has consequently been reduced. Aerial photographs document reduced channel complexity and extensive encroachment of riparian vegetation into the formerly active channel from 1937 to 1998. Limited historical data and field evidence suggest the channel incised approximately 1-3 ft. since dam construction, so the discharge needed for overbank flows has approximately doubled, further isolating floodplains from the channel, and leading to the loss of important habitats. To reestablish overbank flooding and its attendant ecological benefits, both re-operating New Melones Dam to increase high flows in the river, and setting back or breaching le

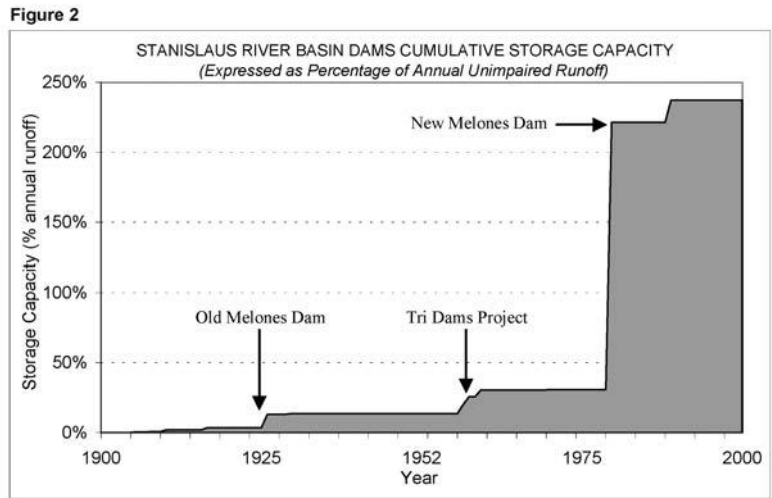
FIGURE 2. Stanislaus River Basin Dams Capacity. Increase in reservoir storage capacity in the Stanislaus River basin (32 dams) expressed as a percentage of mean annual runoff. Total reservoir capacity is nearly 2.85 maf, about 240% of the annual unimpaired runoff of 1.2 maf. (Source: California Department of Water Resources, 1993).

We analyzed changes in flow resulting from dam construction, notably Old Melones Dam (1926), the Tri-Dams Project (1957), and New Melones Dam (1979) (Figure 2). We developed and analyzed a composite record from several gauges near Knights Ferry that operated for different historical periods, and 1) plotted annual hydrographs (for extremely wet, wet, dry, and critically dry years); 2) conducted a flood frequency analysis; 3) conducted a flow duration analysis; and 4) plotted average monthly flows. We also summarized peak flows that occurred before 1934, and between the 1937, 1957, and 1997 aerial photographs we analyzed. Although the 1937 photographs did not represent "pre-impact" conditions on the Stanislaus, they were the earliest photographs available.

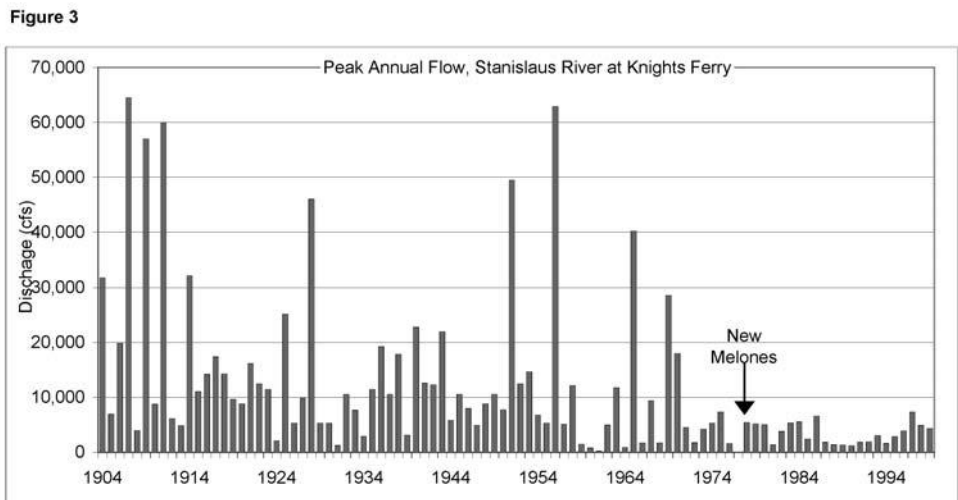
FIGURE 3. Annual Peak Flow, Stanislaus River at Knights Ferry, 1904-1999. Compiled using peak flow data from the gauges: Stan River near Knights Ferry (#11300000) 1904-1932; Melones Powerhouse (#11299500) 1933-1955; and Goodwin Dam near Knights Ferry (#1102000) 1956-1999. (Data source: US Geological Survey).

Since 1979, the annual peak flows of the Stanislaus River were distinctively smaller, with New Melones and upstream reservoirs absorbing winter and snowmelt flood flows (Figure 3), gradually releasing water down in the summer irrigation season. The floods with return intervals of 1-5 years (in many rivers considered the “channel forming” flows because they move the most sediment over time (Leopold et al., 1964)) were 3-4 times smaller since the construction of New Melones Dam (Table 1). A flow duration analysis for the pre-dam (1903-1926) and post-dam (1979-2000) periods shows essentially no change in median and smaller flows since dam construction, but large reductions in the bigger floods. Comparison of annual hydrographs shows that the flatter post-1979 hydrographs lack winter rainfall peaks, snowmelt peaks, and snowmelt recession limbs (Figure 4). Likewise, post-dam mean

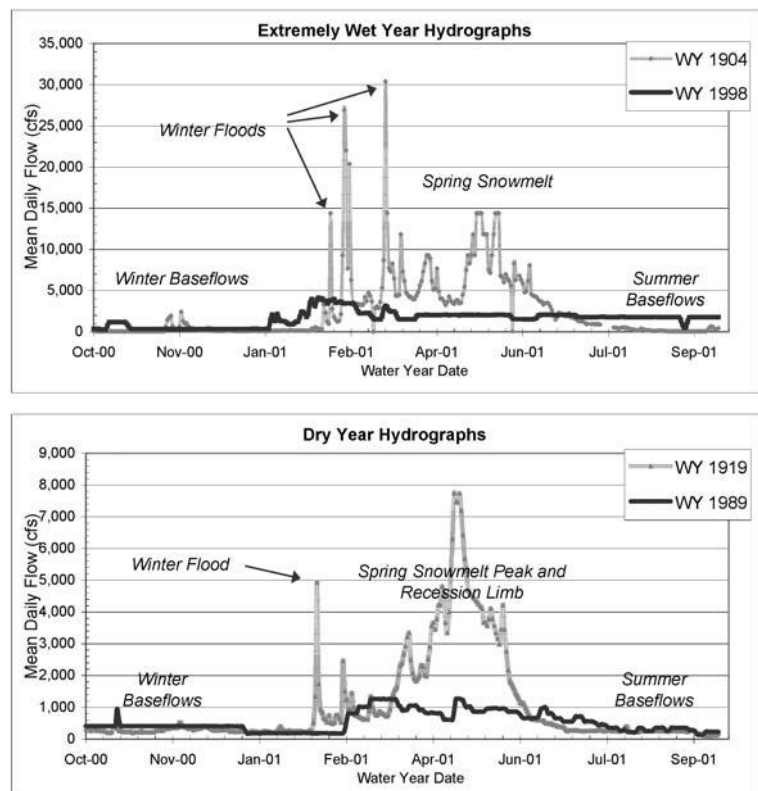
Figure 4

FIGURE 4. Annual Comparison of Extremely Wet and Dry Year Hydrographs. The 1904 pre-dam hydrograph showed high peak flows from rain-on snow, both winter and spring floods were reduced by New Melones reservoir. A dry year comparison of 1919 and 1989 shows post-dam reduction in early winter floods and late spring snowmelt peak flows. (Source: 1919 mean daily flow data: USGS gauge #11300000; 1904, 1989, and 1998: USGS gauge #11302000. Year type designations: DWR CDEC annual data (SNS, sensor #65) and McBain and Trush, 2000).

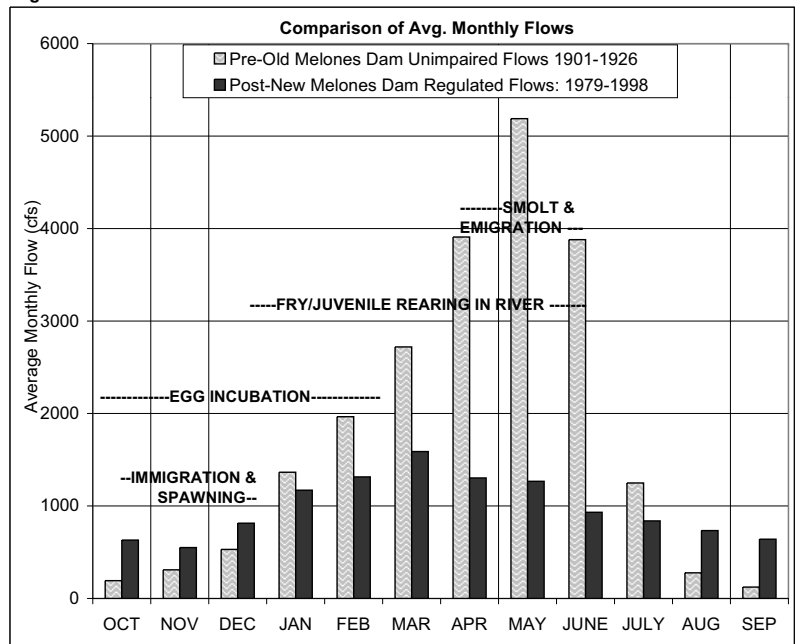
FIGURE 5. Comparison of Average Monthly Flows, Stanislaus River. Average monthly flows pre-Old Melones Dam (1901-1926) were highest in April, May, and June from snowmelt runoff. Post New Melones Dam (1979-1999) monthly flows are more even over the year with historical base flows in September, October and November increased up to five times. (Data Source: Unimpaired flows from "Full Natural Flow," USGS SNS gauge, <http://cdec.water.ca.gov>. Regulated flows from Indicators of Hydrologic Alteration Model (IHA) analysis of USGS mean daily flow data, Schneider, 2001).

monthly flows are lower in winter and spring, and higher in summer and fall (Figure 5).

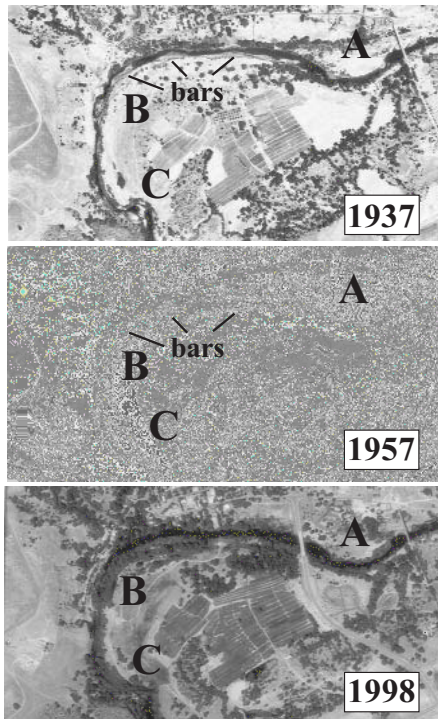
Figure 6 ▲ N 0 1,000 ft.

FIGURE 6. Sequential Aerial Photographs of the Stanislaus River near Knight's Ferry. A 1937 aerial photograph shows unvegetated alternative bar sequences adjacent to the river channel, suggesting frequent scour by high flows. In 1957, evidence of scour and deposition from the 1955 flood includes lack of vegetation development along the banks and bars, and deposition of sand and gravel on the bars and floodplains. In contrast, by 1998, open gravel bars had disappeared and were replaced by dense, riparian vegetation on the banks. A gravel pit (approximately 2,600 yd²) is visible at point D and was evidently partially refilled by deposition of bedload.

Knight's Ferry Reach (RM 54.7 to 53.1)

Sequential air photographs from 1937-1998 near Knights Ferry (RM 54.7 to RM 53.1) illustrate the nature of channel changes that have occurred on the Stanislaus River (Figure 6). In 1937, unvegetated alternating bar sequences adjacent to the river channel were visible, with discontinuous woody bank vegetation, and unvegetated point bar (A) on the left bank, and open gravel bars at B, C, and D suggesting frequent scour by high flows. The 1957 aerial photograph likewise showed an unvegetated active channel and apparently fresh deposition of sand and gravel on the bars and floodplains, presumably due to flood scour (including the effects of a peak flow of 62,900 cfs in December 1955).

By 1998, the unvegetated alternating bars had disappeared, and dense, riparian vegetation armored the banks, forming a continuous wall along the channel. The bar at point B was completely obscured by vegetation and the large bar at point C was fringed by a wall of vegetation. A gravel pit at point D appeared to be partially refilled by deposition of sediment.

Overall, air photos from 1937-1998 show extensive vegetation encroachment in the formerly active channel reflecting a reduction in frequency of flood

scour in the channel. Similarly, point bars and floodplain surfaces show less evidence of flood scour. The air photos also show substantial encroachment by urban and agricultural development, particularly orchards, in floodplain areas, thereby altering the natural river channel/floodplain connection.
