# Wasson Creek Watershed Restoration Plan

2022

Compiled by Alice Yeates (Stewardship Coordinator)  
Based on 2018 report by Coos Watershed Association and Advisory Team recommendations

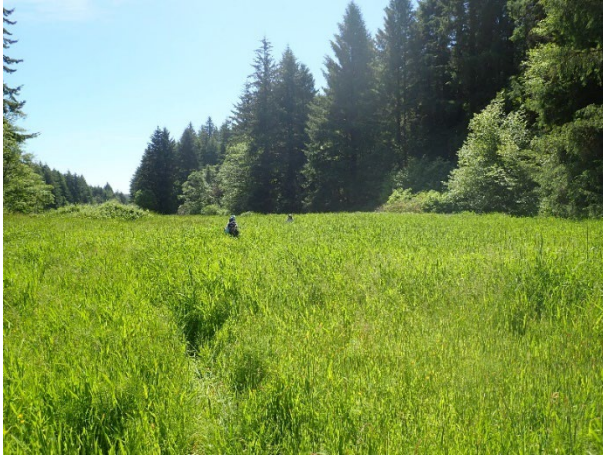
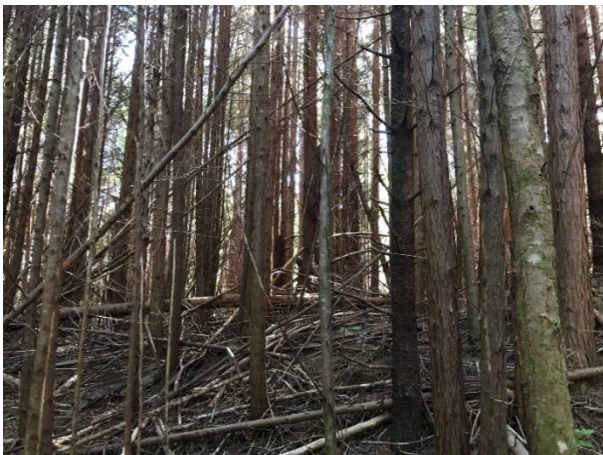
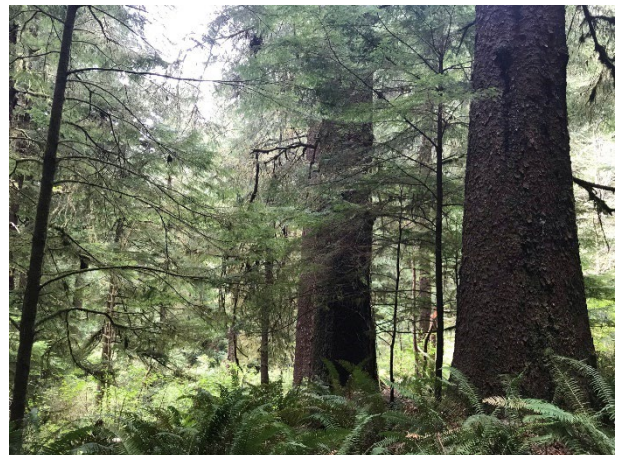
*Figure 3: Simplified habitats and in the Wasson Creek watershed. Images show a disconnected floodplain dominated by the invasive plant, reed canary grass (*Phalaris arundinacea*) (a), and a dense forest stand with poor branch development and sparse understory (c). Complex habitats at the Tom's Creek reference site in SSNERR (b) and Cummins Creek reference site (d) provide reference conditions.*

agricultural activities in the floodplain, resulted in fractured stream and floodplain connectivity, and resulted in diminished fish habitat. Also, the remnants of high-density tree planting without the recommended thinning in the uplands and simplified floodplain plant community resulted in degraded bird and wildlife habitats (Figure 3 & Attachment 1).

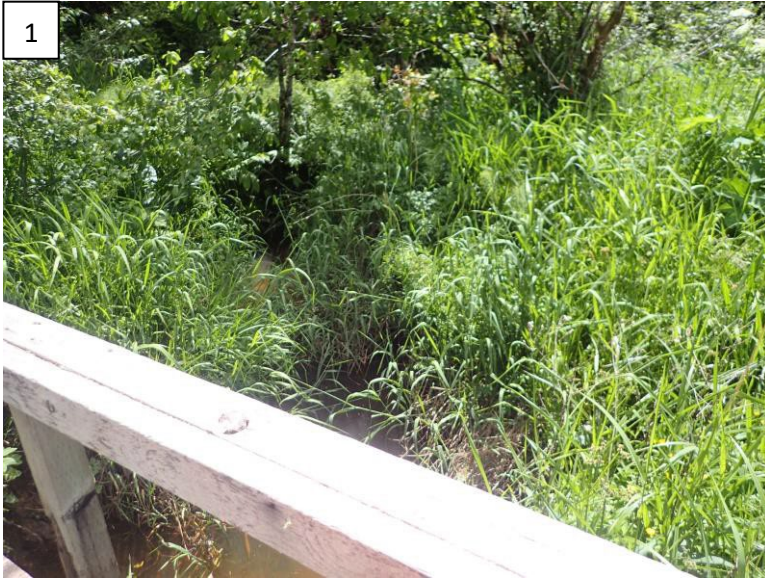
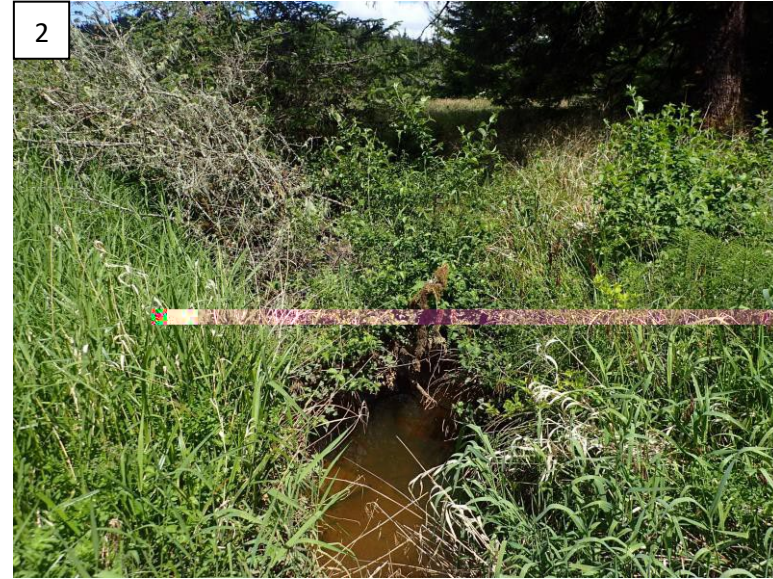
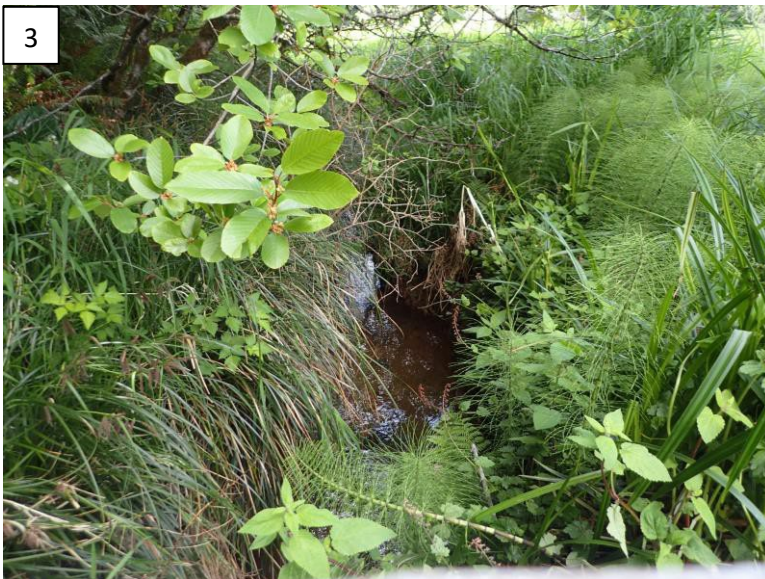
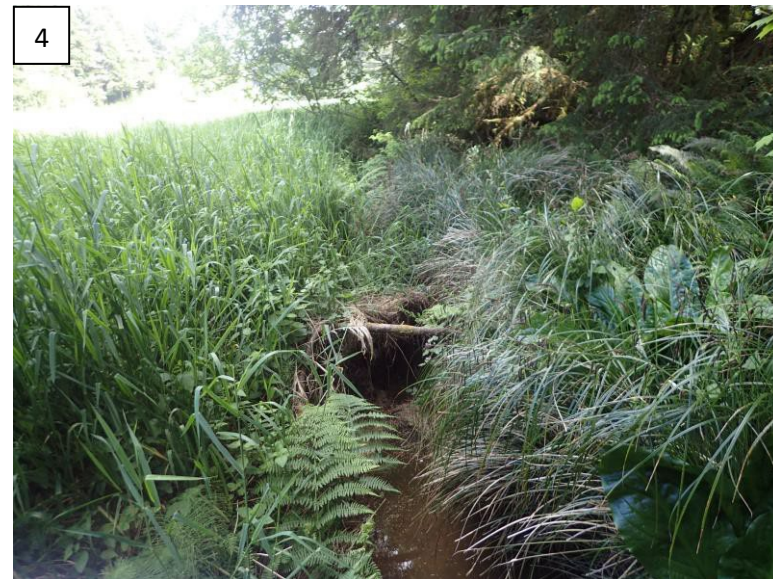
**Attachment 1.** Photoset 1. Photos of the ditched Wasson Creek. Photos 1 & 2 are at the lower end of the valley looking upstream and downstream respectively. Photos 3 & 4 are about a third up the valley, again looking upstream and downstream respectively.

- 1) **Constructed ditches.** Wasson Creek currently flows through an incised, historically constructed ditch that borders the south side of the valley, with a seasonally active ditch bordering the north side of the valley. The incised ditches still drain the floodplain, severely limiting wetland function and habitat complexity for fish and other aquatic species.
- 2) **Dense forests and few riparian zone trees.** The Wasson Creek subbasin includes

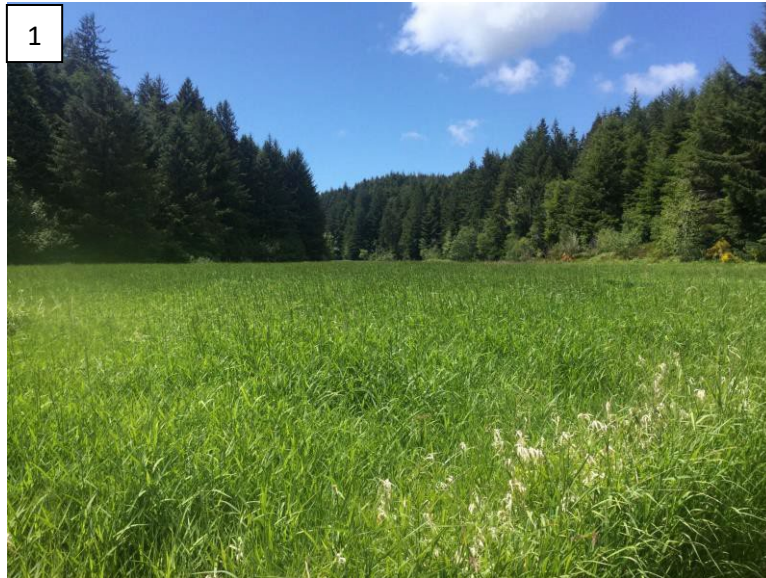
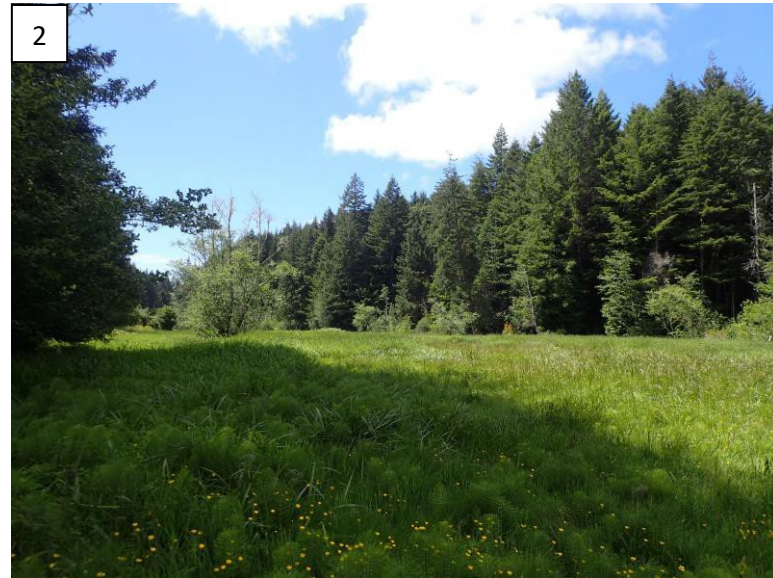
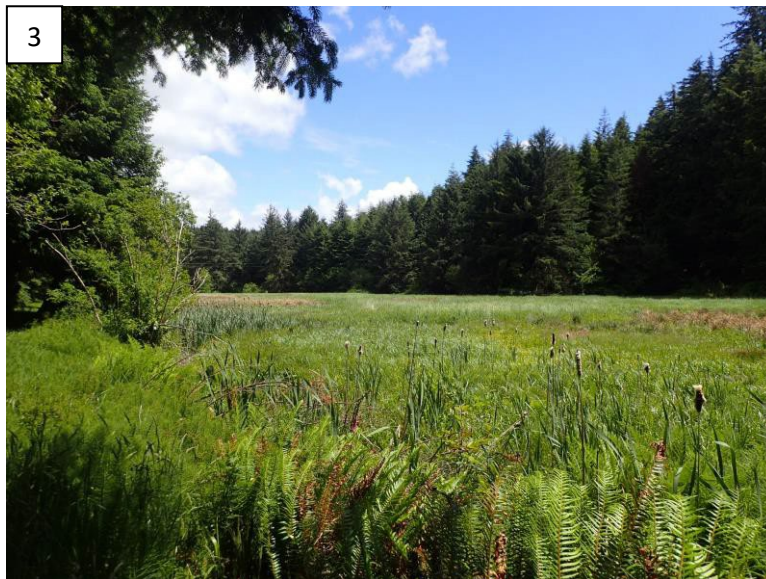
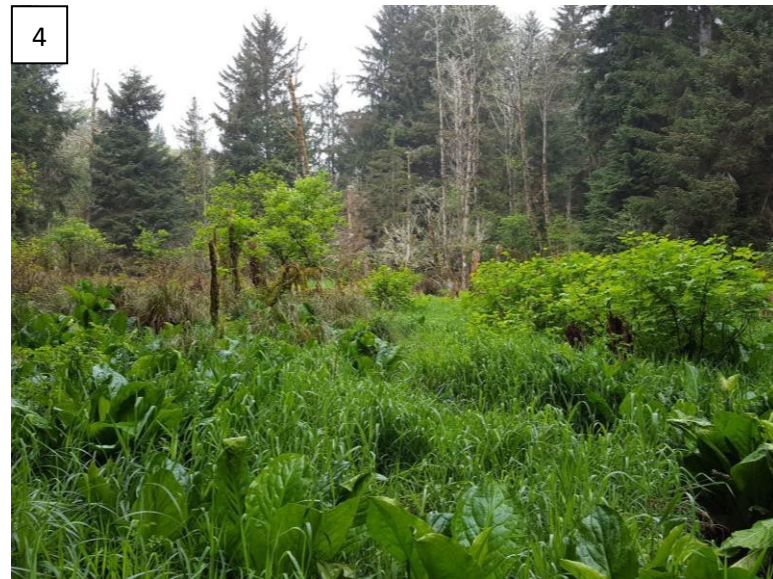
Photoset 2. Photos of the vast monoculture of reed canary grass within the Wasson valley with Photo 3 showing a section with a mix of native species and reed canary grass. Photo 4 is the more historic plant community just upstream of the geologic constriction.

- 5) **Invasive plant dominance.** Floodplain wetlands in the lower Wasson Creek drainage, that were once dominated with native sedge/bulrush/twinberry/crab apple plant communities, are now hydrologically disconnected from Wasson Creek and dominated by invasive reed canary grass (*Phalaris arundinacea*). The upland edge plant community is dominated by other non-native, invasive species including Himalayan blackberry (*Rubus armeniacus*), Scotch broom (*Cytisus scoparius*), Canadian thistle (*Cirsium arvense*), and cotoneaster (*Cotoneaster spp.*).

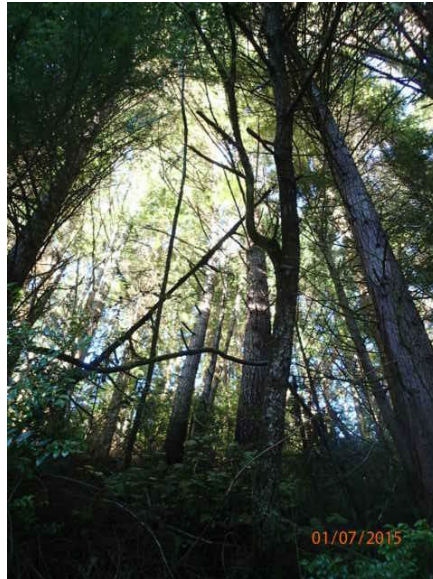
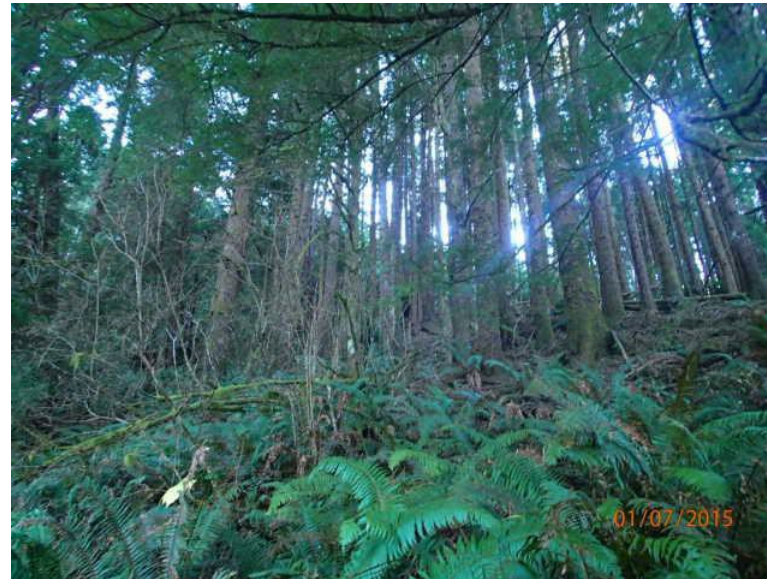
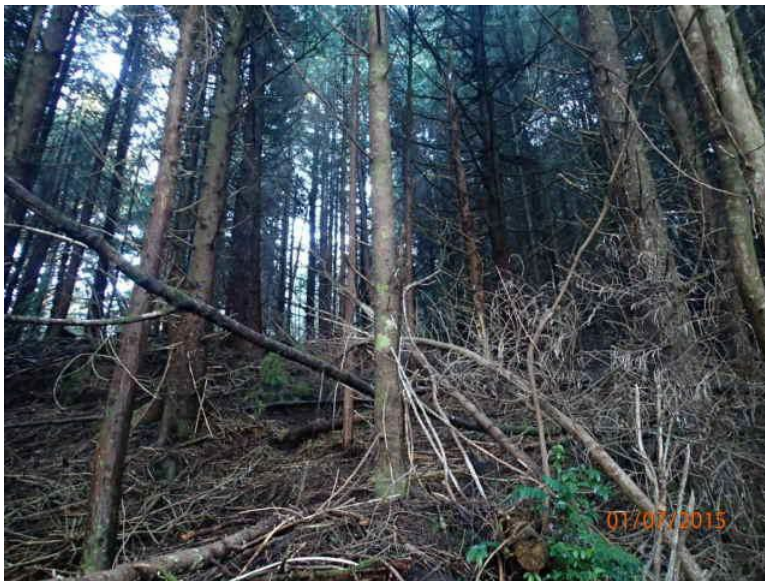
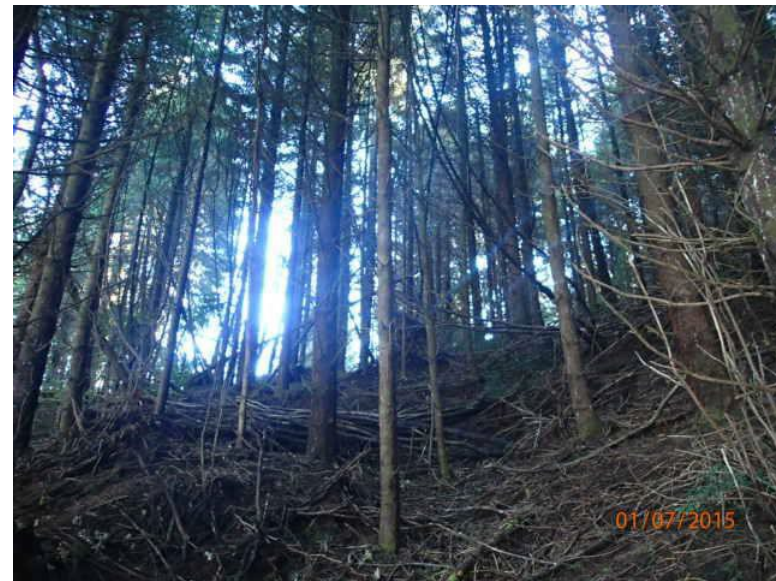
Photoset 3. Photos showing the overstocked, planted stands of Wasson's upland forests that are in dire need of restoration thinning to reintroduce heterogeneity, conserve biodiversity, and increase the overall ecological function of the basin.

- around 500-acres of forested upland, a majority of which has been harvested multiple times since the early 20<sup>th</sup> century. As a result, upland forest communities in the subbasin feature stands with overly crowded tree densities and repressed understory habitats. These conditions result in slow growing forests that are structurally simple, exhibiting few later successional or old growth characteristics. The absence of riparian zone trees or shrubs means limited opportunities for the natural recruitment of large woody debris to enhance the habitat complexity of the Wasson Creek floodplain.
