A Recommendation for an
ENHANCED FUJITA SCALE
(EF-Scale)

Submitted to
The National Weather Service
and
Other Interested Users

WIND SCIENCE AND ENGINEERING CENTER
Texas Tech University
Lubbock, Texas 79409-1023

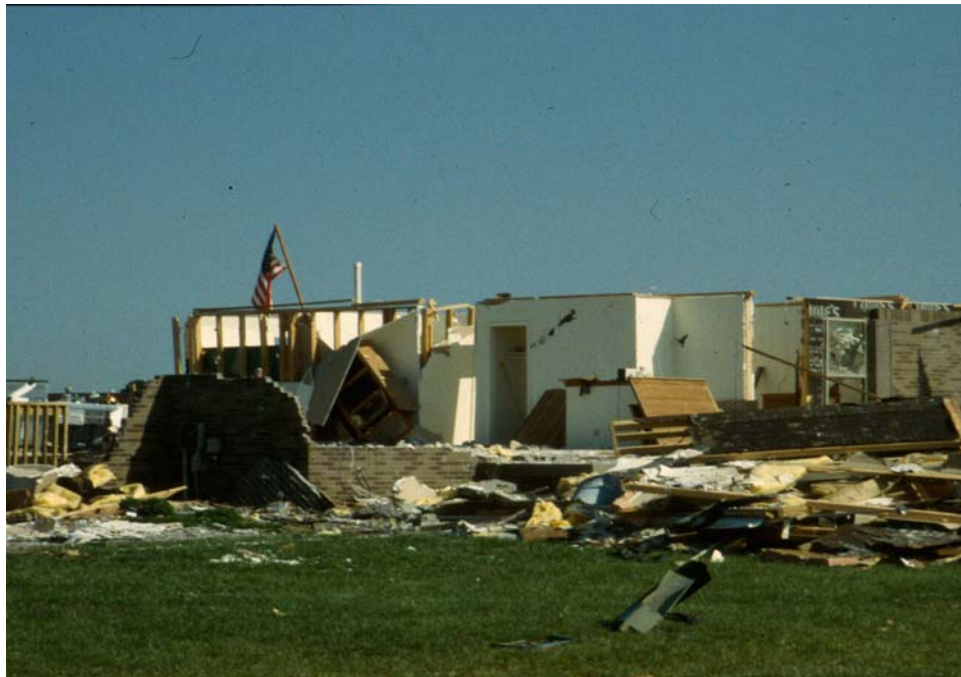
FR12: DOD 7: Top floor (First floor in this case) exterior walls collapsed

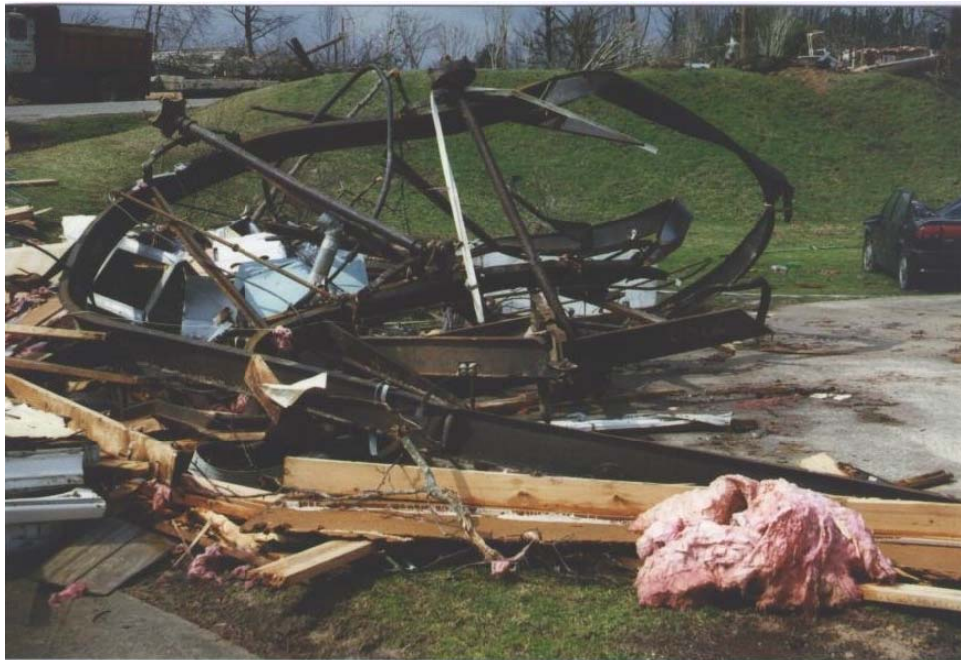
MHDW: DOD 11: Undercarriage separates from floor; rolls and tumbles, badly bent

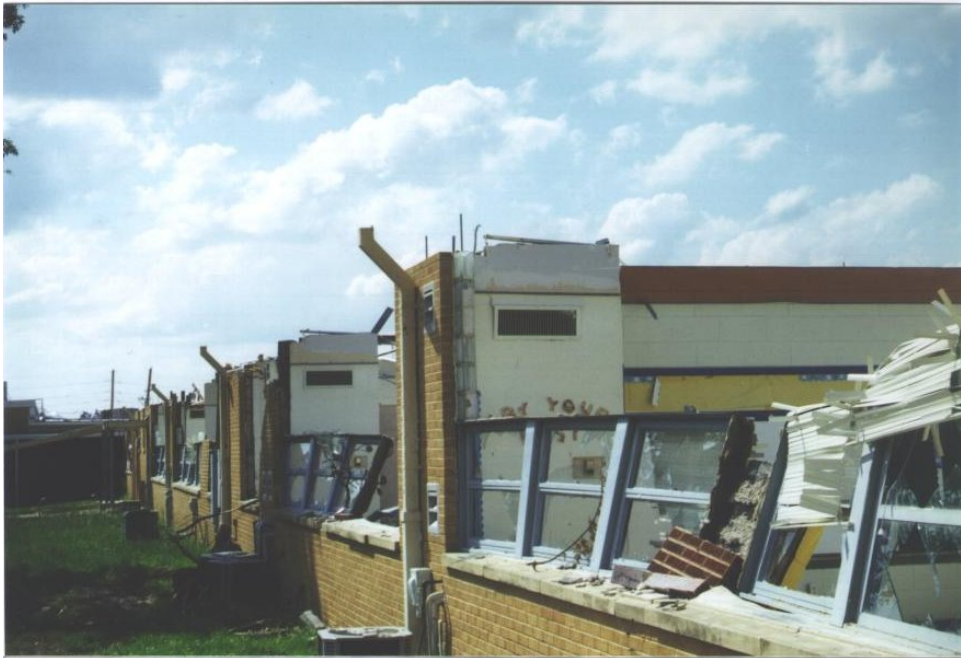
ES: DOD 7: Uplift of entire roof structure

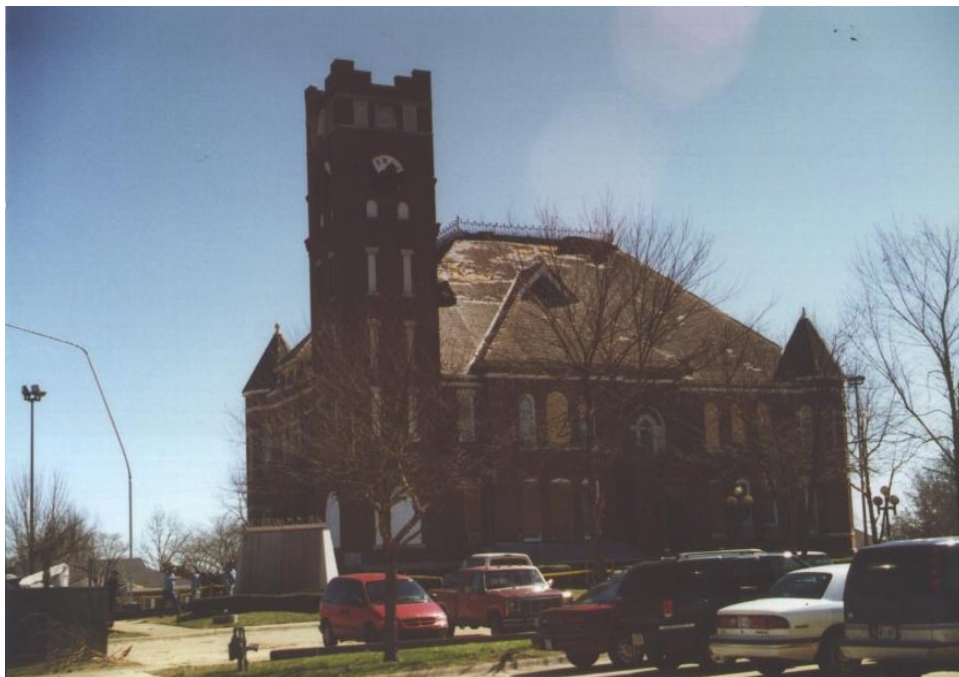
IB: DOD 6: Uplift of light-weight roof deck and insulation; significant loss of roofing material (>20%)
