**Alaska - Pacific
 River Forecast Center**
 6930 Sand Lake Road
 Anchorage, Alaska 99502-1845
<http://aprfc.arh.noaa.gov>
 800-847-1739

August Flooding in Southcentral Alaska

High Water Level Reference Levels by Larry Rundquist

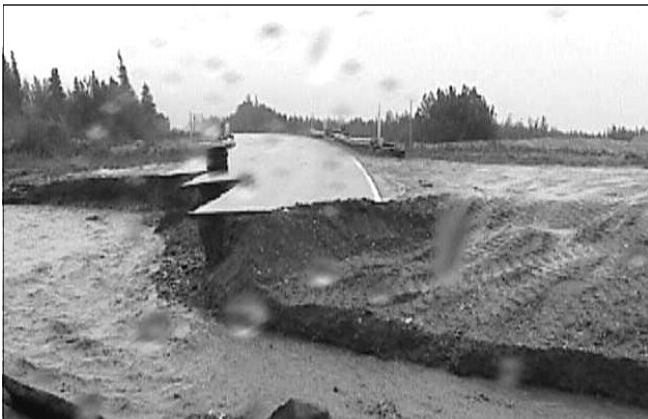
Richardson Hwy washed out south of Delta Junction

Several heavy rain events in the Alaska Range over the summer resulted in some significant flooding along the Richardson Highway. Over a three day period in mid-June, between 4 to 7 inches of rain fell from Delta Junction to Paxson. Flash flooding of small streams spread debris over the road and completely washed it out in several locations. More rain a few days later brought streams to bankfull again and pushed more water across the highway. More heavy rain in August resulted in another round of flooding and mudslides along the highway.

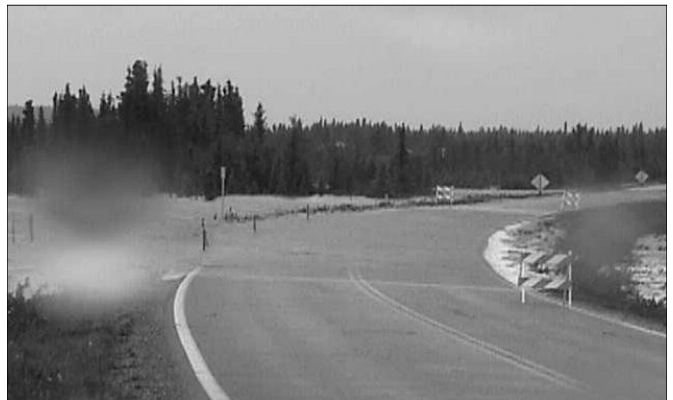
Water flows over the Richardson Hwy at Donnelly Creek State Recreation Site

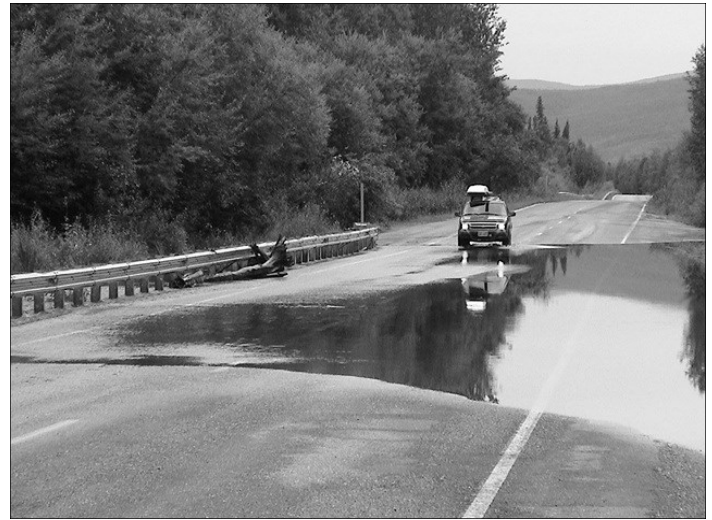
Minor flooding at Mile 31 of
Chena Hot Springs Road in Fairbanks
August 2003

Minor Flooding is defined to have minimal or no property damage, but possibly some public threat. In remote areas with few specific impacts, floods with 5-10 year recurrence interval would be assumed to be causing minor flooding on streams in the area. Examples of conditions that would be considered minor flooding include:

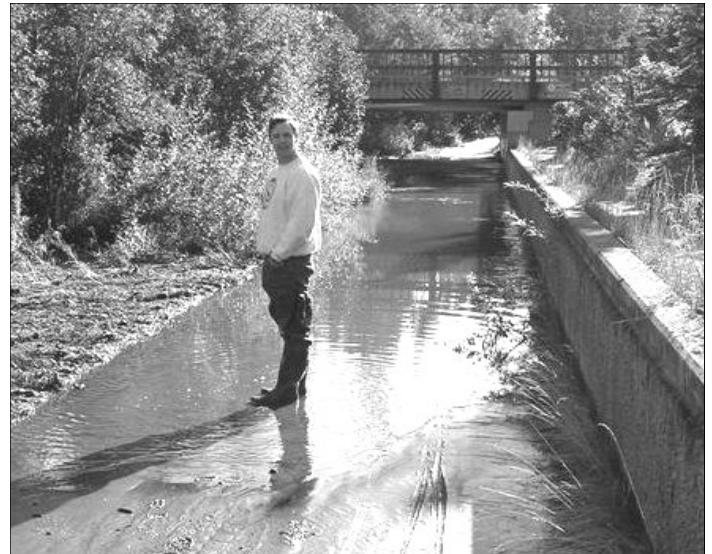
A few inches of water from Campbell Creek causes minor
flooding of the bike path at Old Seward Hwy
August 2006

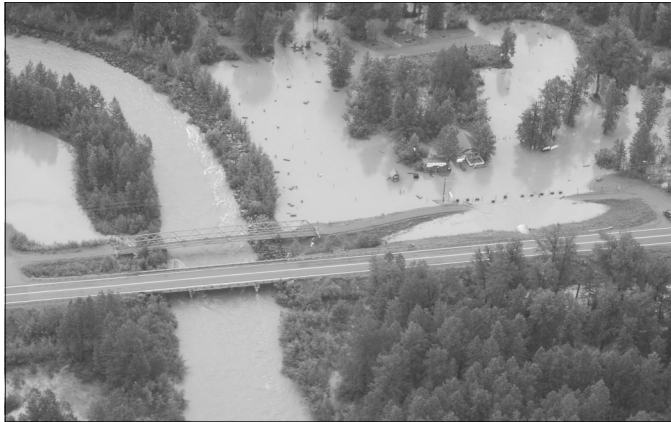
Water inundates the Montana Creek Campground located off the Parks Highway - an example of moderate flooding August 2006

Moderate Flooding is defined to have some inundation of structures and roads near the stream. Some evacuations of people and/or transfer of property to higher elevations may be necessary. In remote areas with few specific impacts, floods with 15-40 year recurrence interval would be assumed to be causing moderate flooding on streams in the area. Examples of conditions that would be considered moderate flooding include:

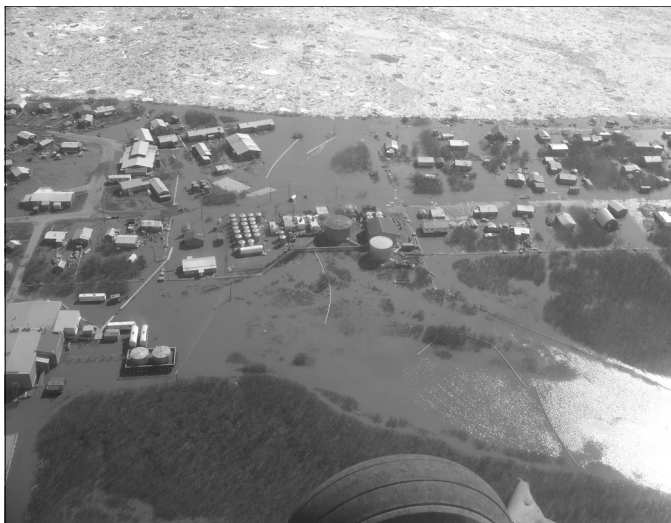
Moderate flooding in the village of Emmonak on the Yukon River May 2006

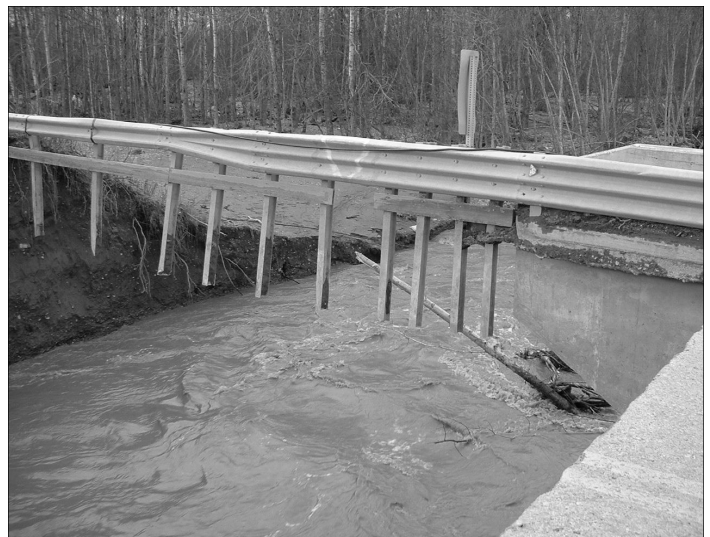
Bridge washed out over Deep Creek due to heavy rains October 2002

Major Flooding is defined to have extensive inundation of structures and roads. Significant evacuations of people and/or transfer of property to higher elevations are necessary. In remote areas with few specific impacts, floods with 50-100 year recurrence interval would be assumed to be causing major flooding on streams in the area. Examples of conditions that would be considered major flooding include:

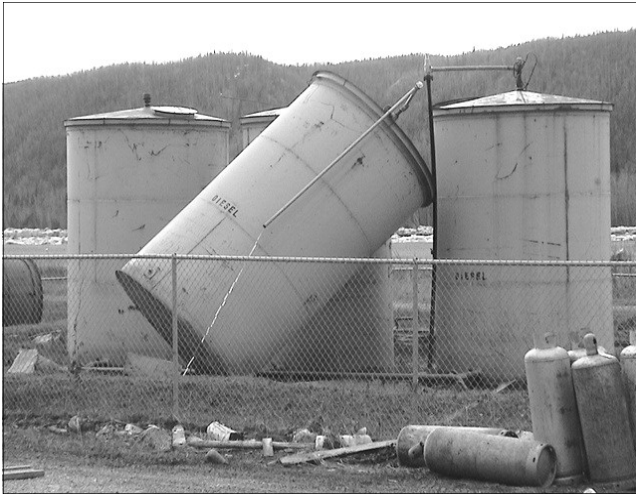
Fuel tank topples due to breakup related flooding in the village of Hughes on the Koyukuk River
May 2003

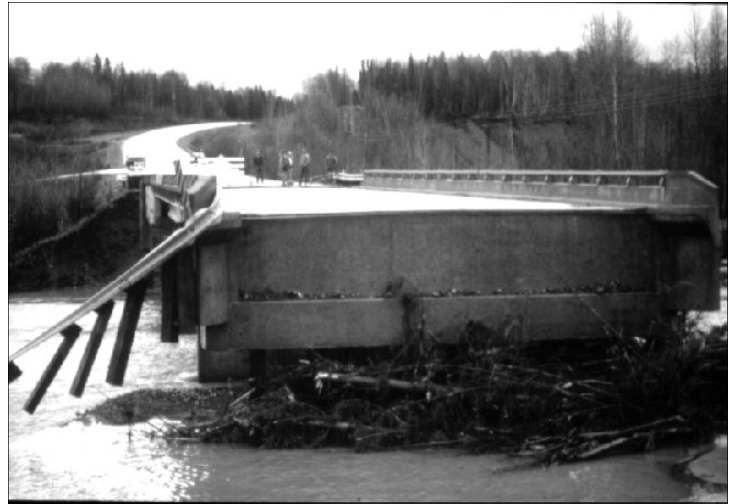
The approach to the bridge over Montana Creek on the Parks Highway washed out
October 1986
