Alaska - Pacific

River Forecast Center

Ice Breakup Flooding in May 2009

A Primer on Alaska River Gages

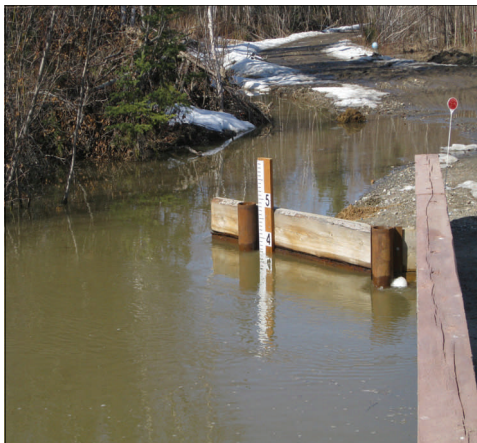
A new flood staff gage on Pile-driver Slough in Salcha helped emergency personnel and NWS forecasters respond to the 2009 spring breakup flooding.

Salcha, Alaska: this small community situated along the Tanana River about 30 miles southeast of Fairbanks has experienced chronic flooding in recent years. In 2008, the area was hit by significant ice jam flooding during breakup, and then again by heavy summer rains that brought near record flooding to the Tanana River. The complete lack of river gages on the Tanana River in Salcha has made it difficult to forecast, document, and compare the recurring floods. In the spring of 2009, the National Weather Service (NWS) in Fairbanks installed a handful of staff gages in the flood prone areas. Immediately after the installation, ice jams formed on the Tanana River, and Salcha was flooded once again. The usefulness of the new river gages became very obvious as the river began to rise. The gages served as an invaluable tool for monitoring the fluctuating flood waters by the NWS, emergency managers, Salcha Fire and Rescue, and local residents. The gages allowed many people to view and report changes in water levels from specific points within the community, which was extremely important for emergency response and evacuations. The addition of these gages will help to forecast and prepare for future floods in the Salcha area.

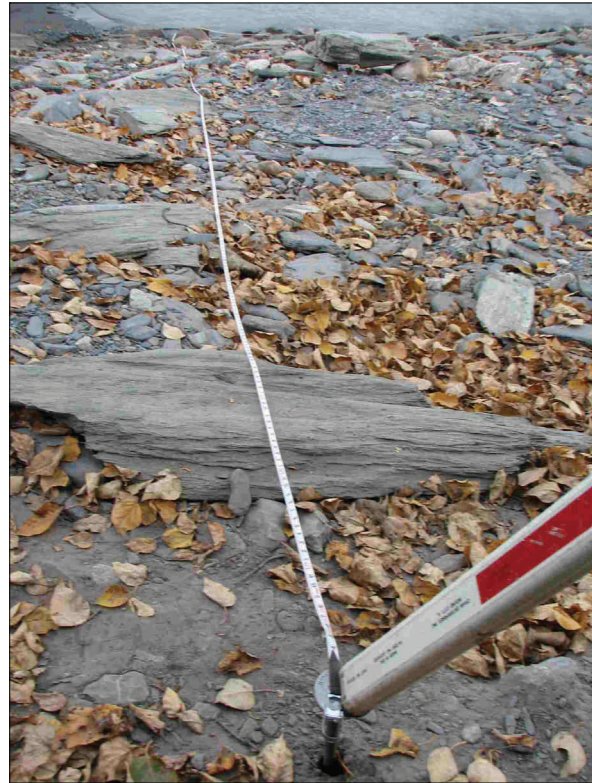
Slope Profile Gages

When there are no bridges and no good place to put a staff gage, we use geometry to determine the river level. We survey the river bank, install several markers and determine the elevation of those markers, and survey the slope of the bank as far down into the river as we can reach. Our observers measure the distance from the marker down to the river's edge, following the same path that was surveyed. We use our survey information to calculate the elevation of the bank at the edge of the water. This type of gage works well if the bank is stable, but if the bank is eroding, it will need to be resurveyed frequently or the gage may need to be moved to another location. Most of the remote sites in the state have this type of river gage.
