Alaska - Pacific  
River Forecast Center  
6930 Sand Lake Road  
Anchorage, Alaska 99502-1845  
<http://aprfc.arh.noaa.gov>  
800-847-1739

**Mendenhall Valley Jökulhlaup Flood Event  
by Aaron Jacobs**

## Susitna Hydroelectric Project by Celine van Breukelen

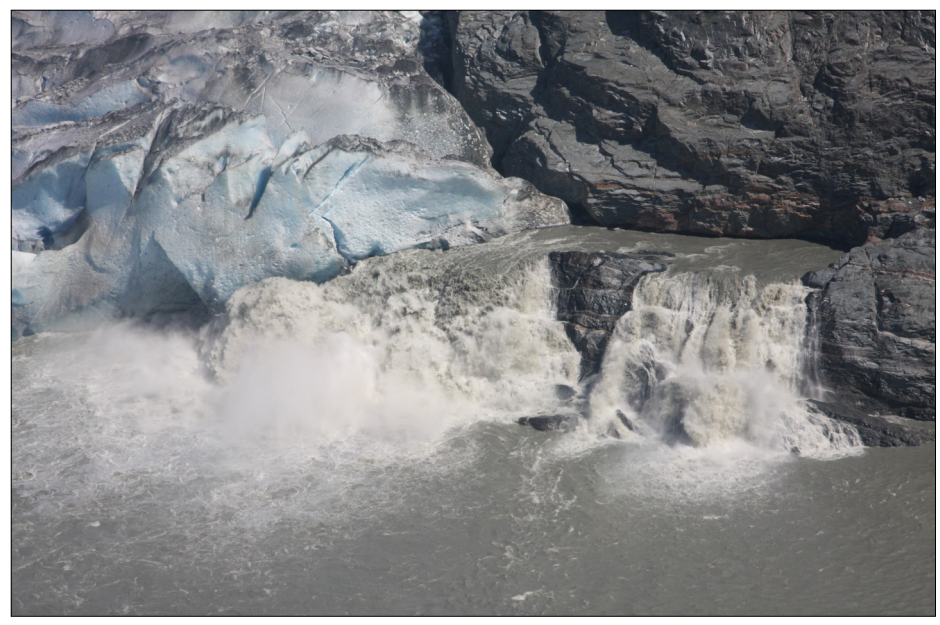
Flood waters flow underneath the Mendenhall Glacier. The flat rock the water is flowing over is approximately 75 feet wide.

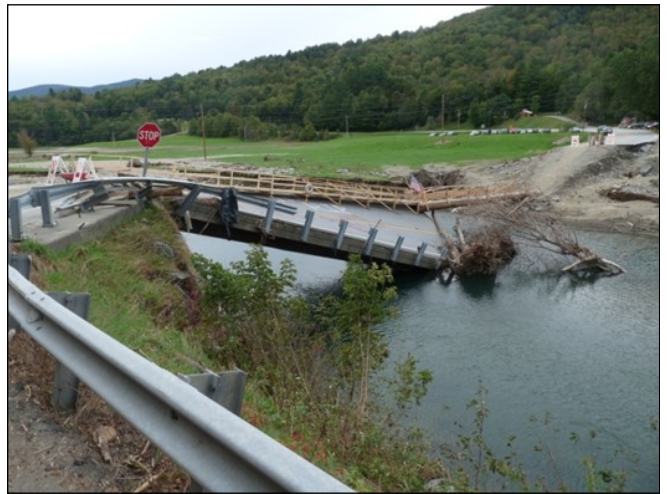
Bridge destroyed on Hwy 100 near Rochester, Vermont

Between 4 and 7 inches of rain fell within a few hours on August 27<sup>th</sup> and 28<sup>th</sup> in these areas, causing flash flooding as very small streams became raging rivers that took roads, bridges and homes downstream in many communities. Because the National Weather Service Office in Burlington, Vermont had highlighted the very dangerous nature of this storm, the governor of Vermont declared a state of emergency on Saturday, August 27 (which was a nice, sunny day), leading people to stay home and prepare on Sunday. This likely saved many lives, as only a couple of fatalities occurred during the event (compared to the previous flood of record in 1927, when 85 people died; 84 in Vermont). Although this was a very damaging and costly storm, the accuracy of the forecasts and the efforts of the NWS forecasters no doubt saved lives, and the local authorities had nothing but praise for their efforts. The final report on this event will be published sometime in early 2012. This report, along with service assessments from other weather disasters, can be found at:

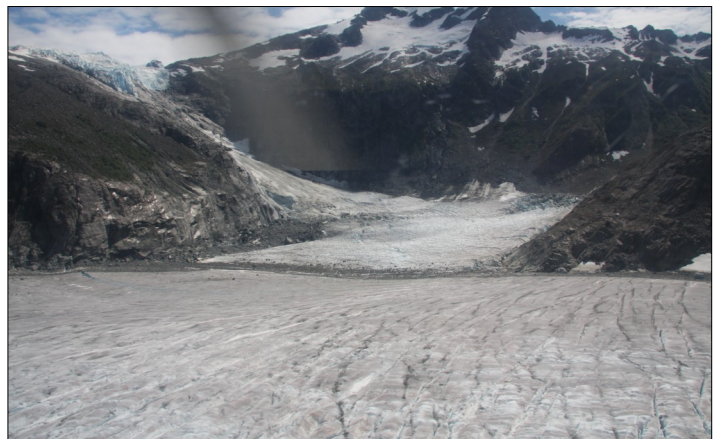
Suicide Basin after the lake drained

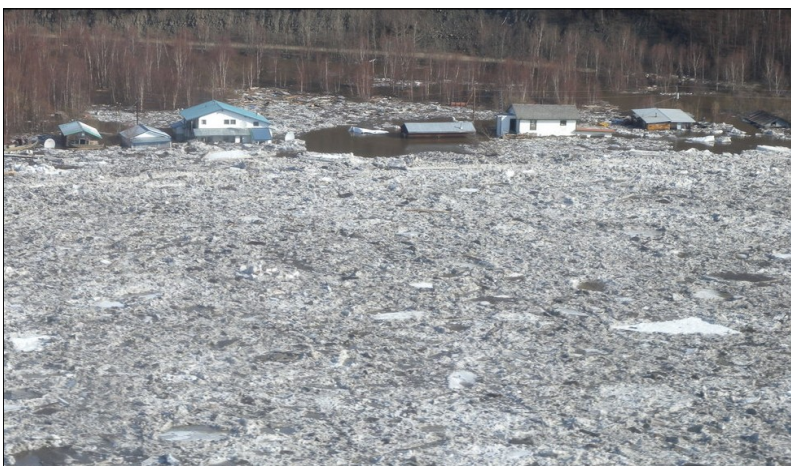
May 10, 2011 - Front Street in Crooked Creek on the Kuskokwim River

Major flooding occurred at Crooked Creek during breakup. An ice jam downstream of the village held for days before flooding began on May 8. Many homes were damaged or destroyed, and more than 50 residents were evacuated. The Governor declared a state disaster for the breakup flooding that damaged both Crooked Creek and Red Devil.

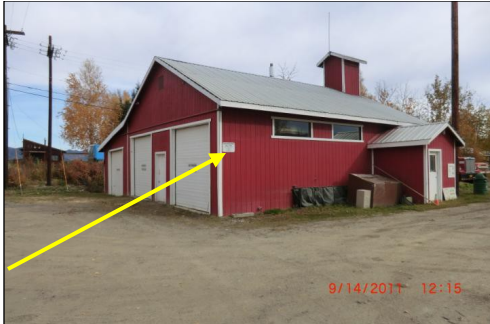
High Water Mark sign on the fire hall in Eagle to commemorate the devastating Yukon River ice jam flood in May 2009

The National Weather Service has teamed up with the US Army Corps of Engineers (COE) to install high water mark signs in several Alaska communities. These small placards identify the water depth and date of the record flood for the community. The signs are being placed in highly visible locations in order to bring awareness of flooding to the local residents and visitors. The first sign was installed at Crooked Creek on the Kuskokwim River to observe the record breakup flood last spring on May 8, 2011. Signs were also hung on the fire hall and Laundromat in Eagle to commemorate the devastating Yukon River ice jam flood in May 2009. Additional signs will be placed in other communities in years to come.
