## June 9, 2010 Heavy Rainfall Event

A significant rainfall event during the late evening of June 8<sup>th</sup> and lasting into the afternoon hours of the June 9<sup>th</sup> caused massive flooding for portions for South Central Texas. Abundant tropical moisture coupled with a slow moving upper level low pressure system which moved northeast across the area, forming a large complex of showers and thunderstorms. The storm complex encompassed nearly the entire I-35 corridor from Atascosa and Wilson counties northward to Travis and Williamson counties. The storms were very slow moving to near stationary producing intense rainfall over the same area for numerous hours. Rainfall reports and Doppler radar estimates showed portions of Atascosa, Bexar, Wilson, Comal, Guadalupe, and Lee County receiving 7 to 12 inches over an 18 hour period. The Guadalupe River in New Braunfels breached its banks forcing residents to evacuate their homes to escape the flood waters. Flash flooding damaged numerous homes and businesses, campgrounds, and forced the closure of multiple roadways. Images of the damage as well as rainfall reports and Doppler radar precipitation estimates can be seen below.

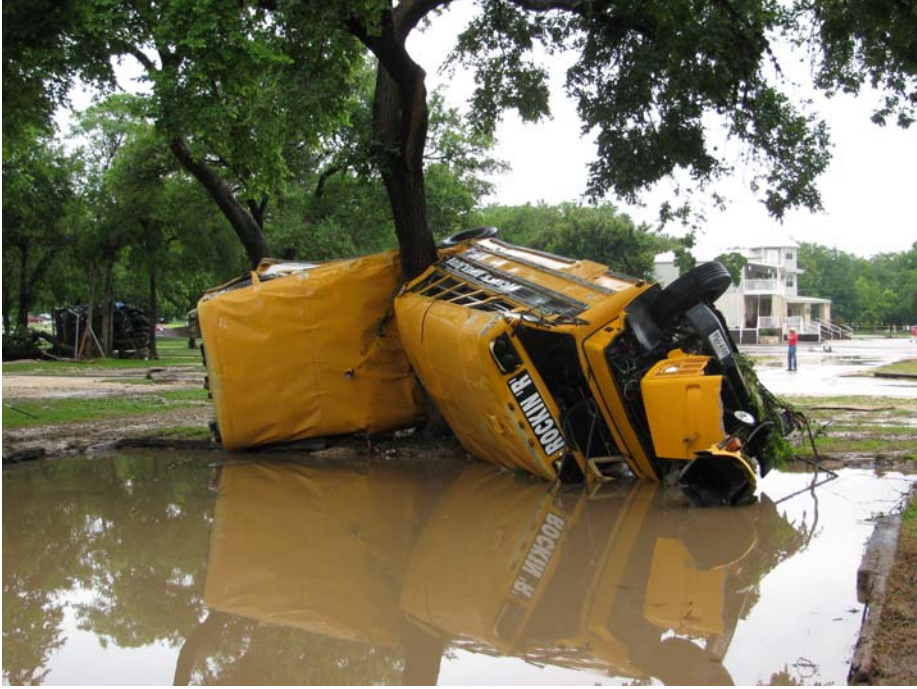
Photo 3, Tubing company bus pushed down river

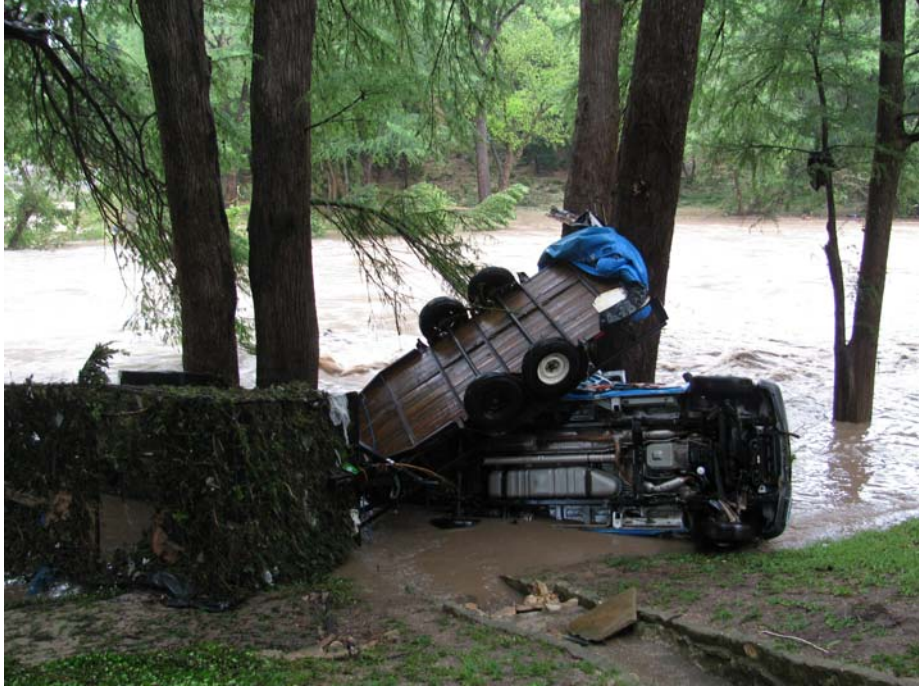
Photo 5, Cars and trailers littered along the Guadalupe River in Gruene

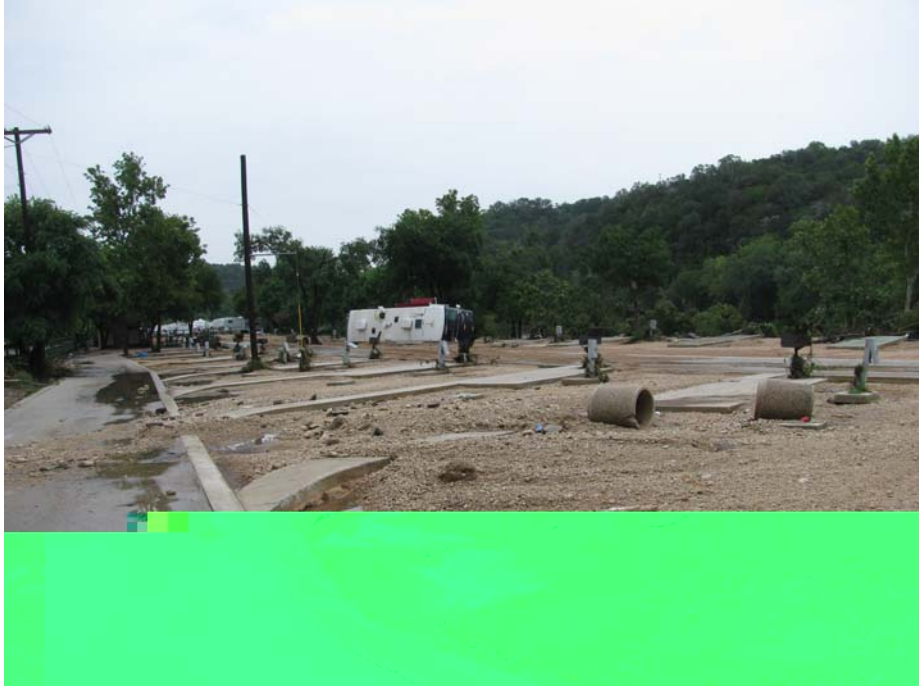
Photo 7, Remnants of a campground along River Road downstream from Crossing #1

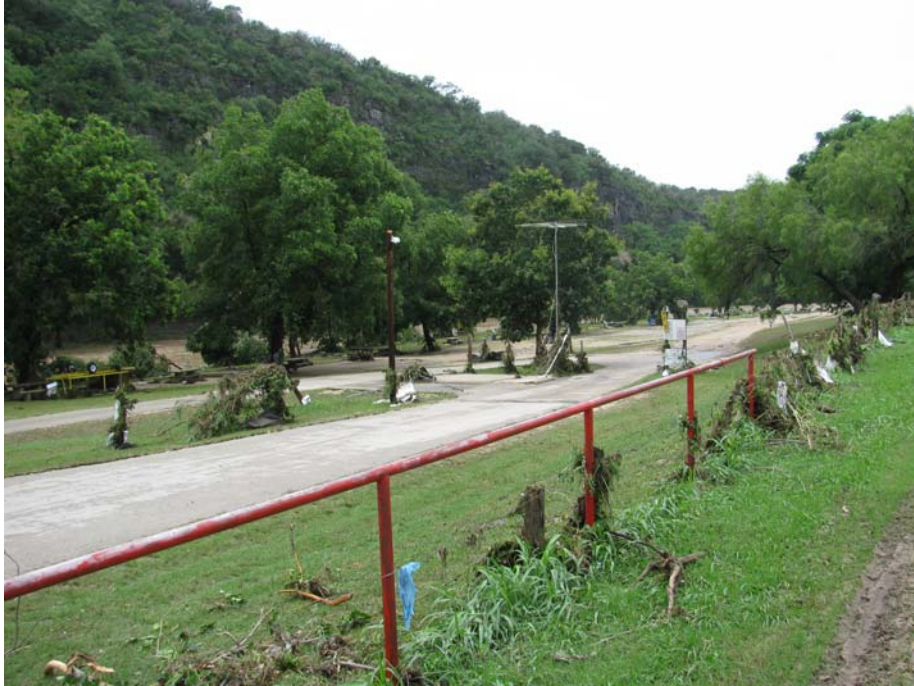
Photo 9, Campground along River Road between Crossing #1 and #2

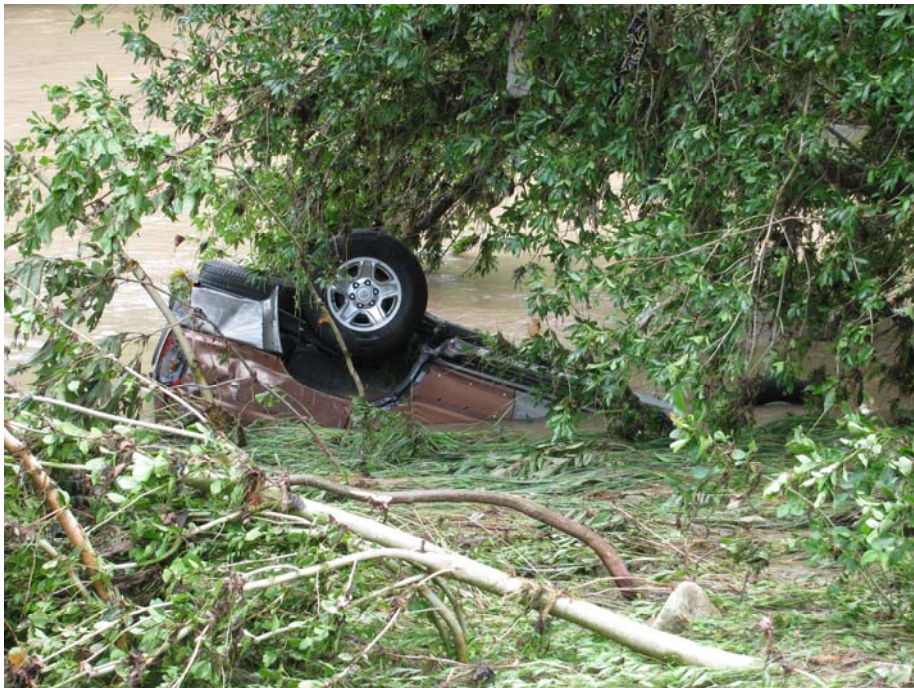
Photo 10, Submerged vehicle in the Guadalupe River

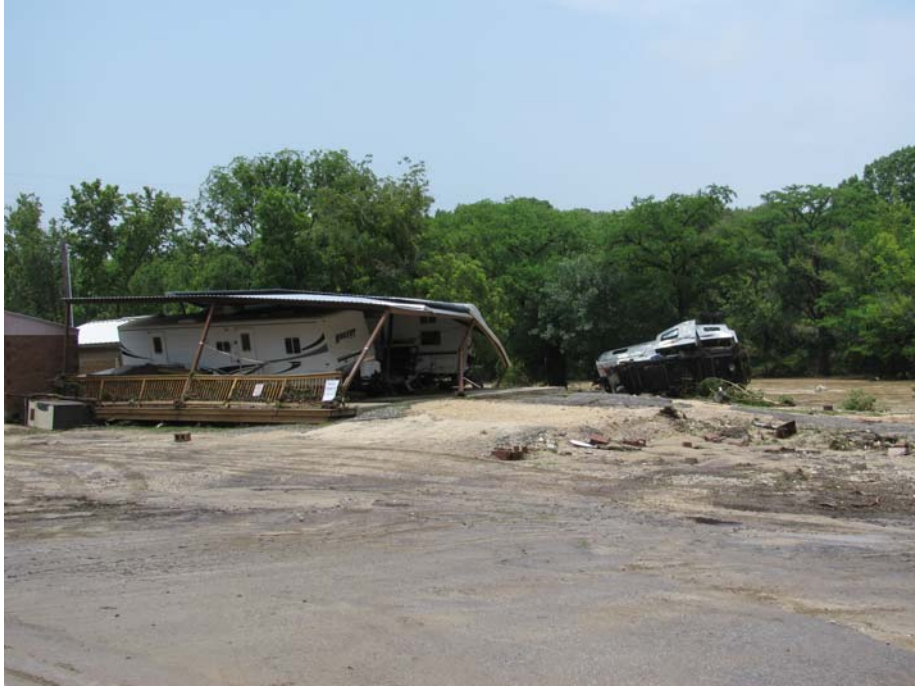
Photo 11, Camper trailers swept downstream from a campground

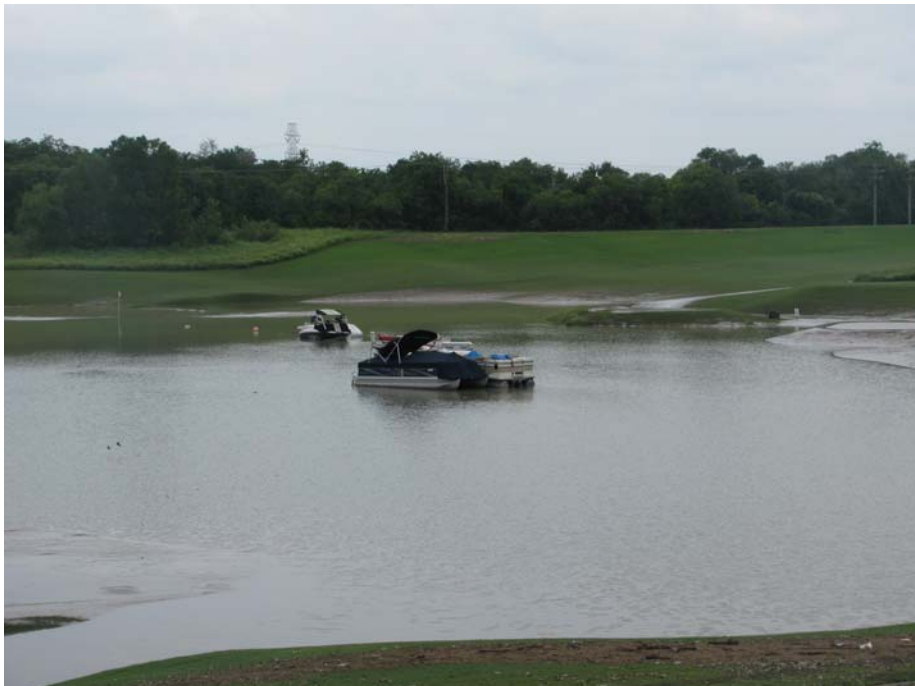
Photo 12, Bandit Golf Course

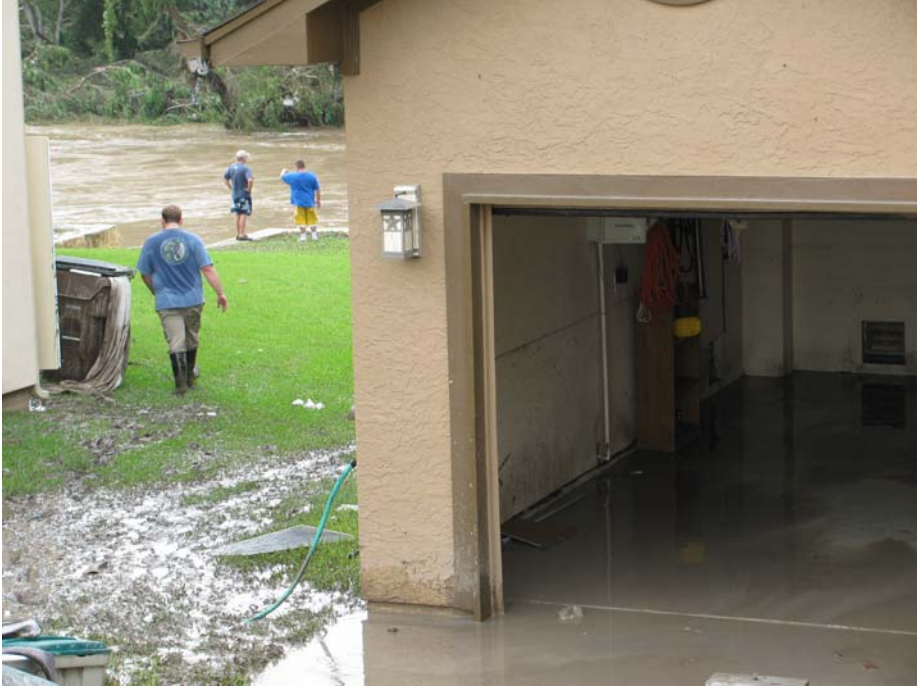
Photo 13, Water damage on the banks of the river

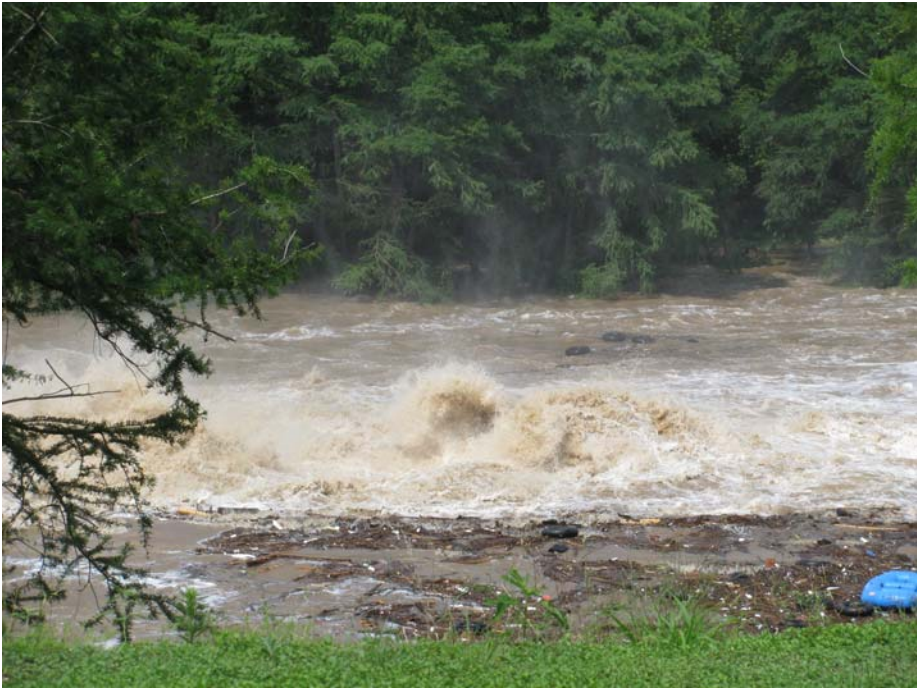
Photo 14, Debris just below Lake Dunlap

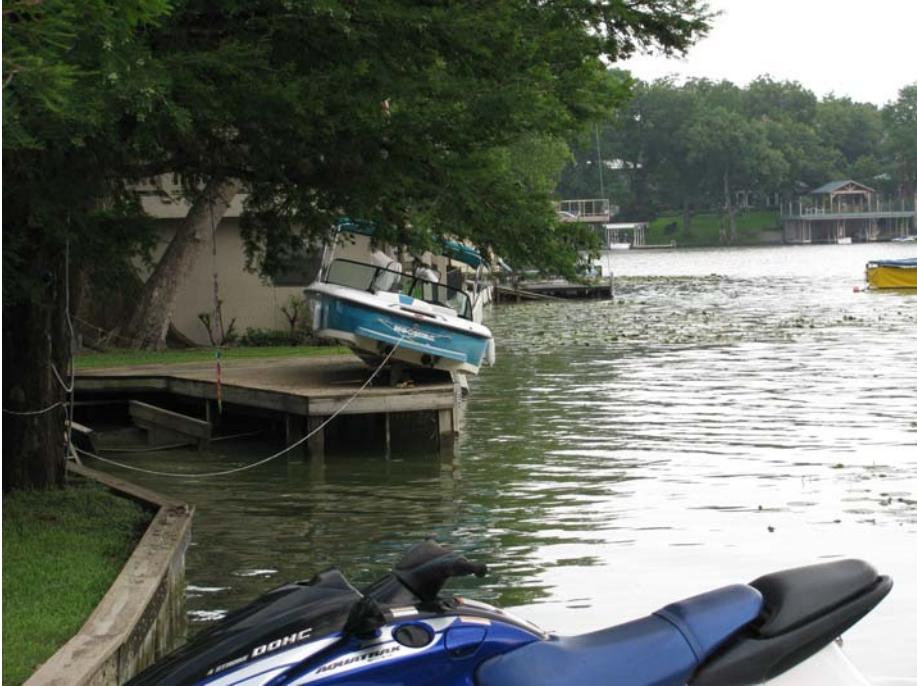
Photo 17, Many boats and homes were damaged on Treasure Island

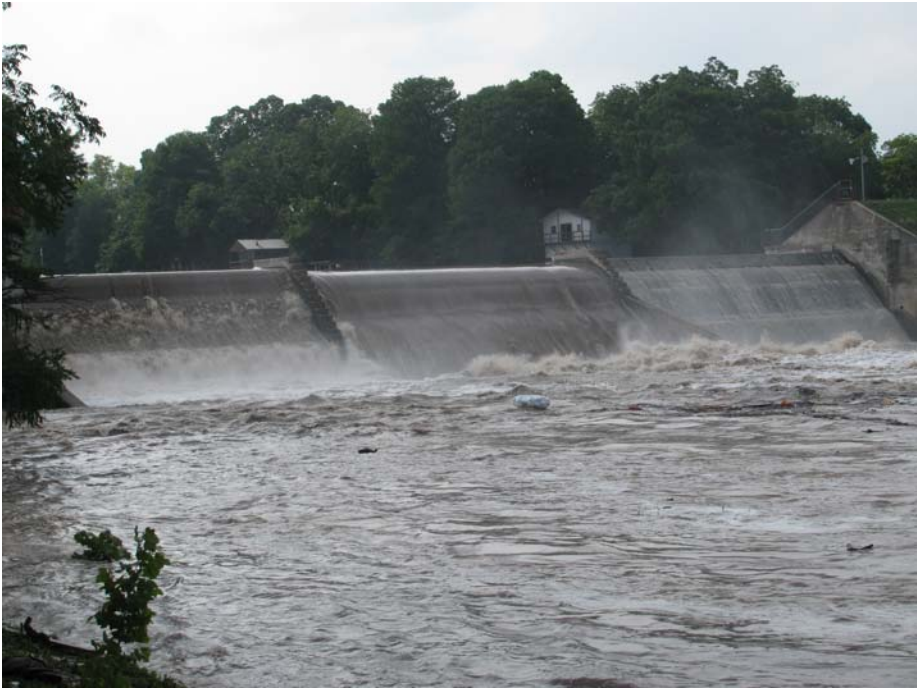
Photo 18, Dam on the Guadalupe at McQueeney
