National Weather Service Austin-San Antonio TX

Tornado hits San Antonio...South Central Texas Soaks Up Some Much Needed Rain

...UPDATE...EF1 TORNADO RATING FOR SAN ANTONIO TORNADO...

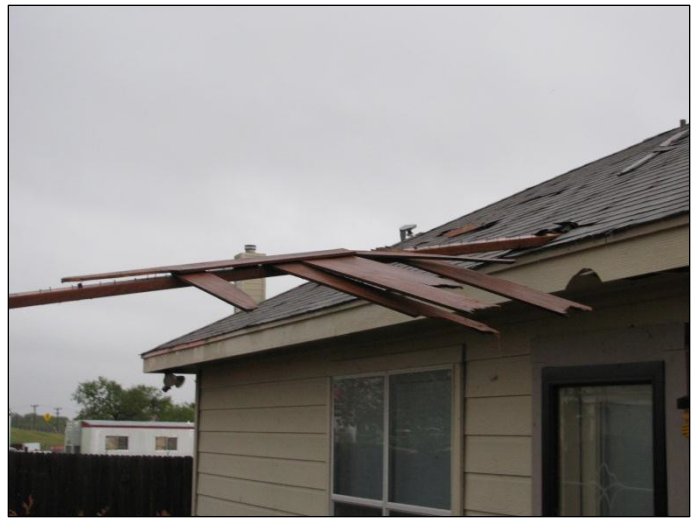
The tornado crossed Medina Base Road and headed north northwest into another neighborhood and affected residences along Heathers Cove. More roof and fence damage was observed. Here you can see the full force of flying debris with a section of fence skewered into a roof.

THE FIRST DAMAGE APPEARED IN THE RIDGESTONE SUBDIVISION WITH SEVERAL HOMES EXPERIENCING ROOF DAMAGE...BLOWN DOWN FENCES...LOST SHINGLES...AND THROWN OBJECTS SUCH AS TRAMPOLINES. THE TORNADO THEN MOVED NORTH NORTHWEST AND CROSSED MEDINA BASE ROAD WHERE MORE ROOF AND FENCE DAMAGE WAS NOTED ALONG HEATHERS COVE. THE TORNADO TRAVELED JUST TO THE EAST OF LOOP 410 ALONG PARALLEL DRIVE AND PRODUCED DAMAGE TO TREES...CARPORTS...ROOFS...AND VEHICLES. SOME OF THE DAMAGE WAS CAUSED BY FLYING DEBRIS.

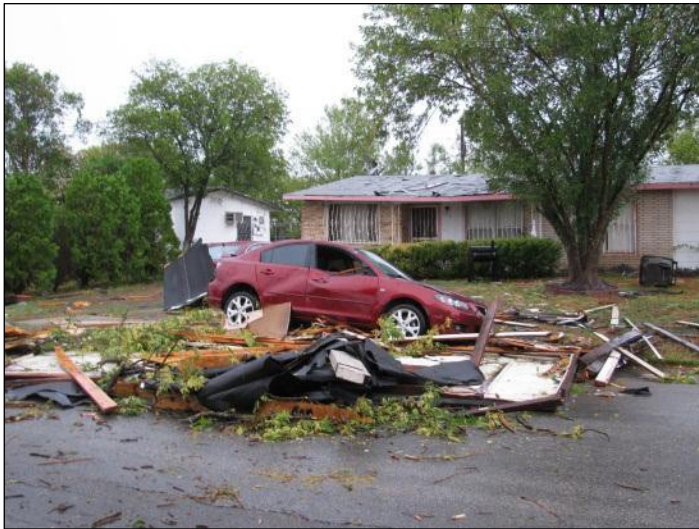
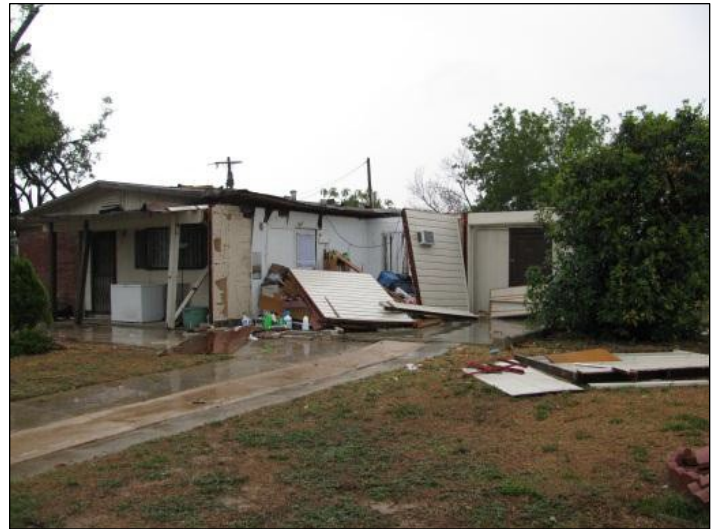
The tornado traveled up toward Valley Hi drive and caused additional damage along Parallel Road with several residences seeing damage to trees, carports, roofs, and vehicles. In one instance, a large section of roof was torn off a residence and thrown underneath a nearby car. The two pictures below were taken along Flair Drive.

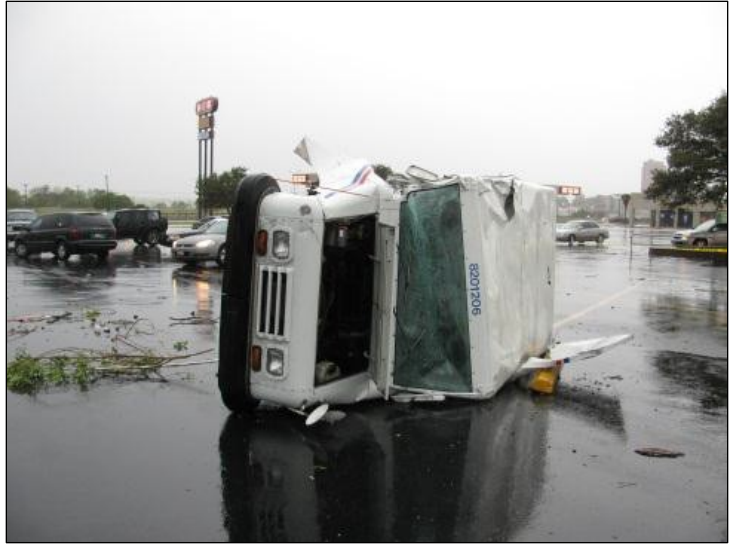
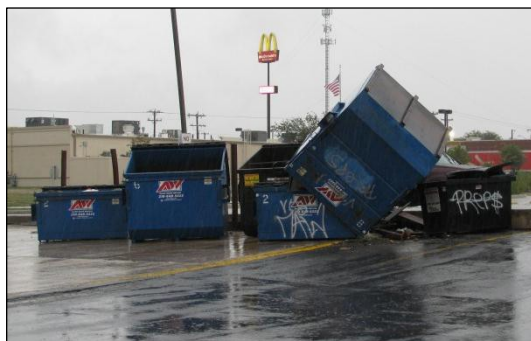
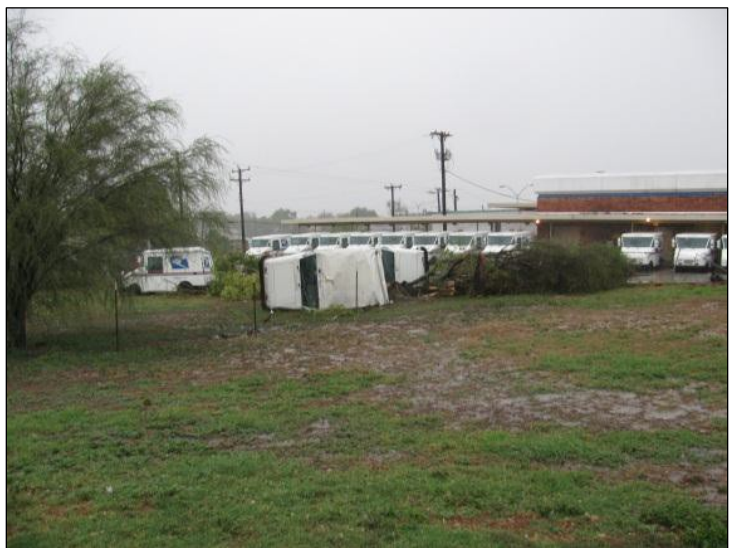
The tornado continued to head north, crossed Aldrich Drive and went behind the U.S. Post office (5510 SW Loop 410) near the corner of Loop 410 and Valley Hi Drive. This corner has several businesses along with an H.E.B. grocery store. Several eyewitnesses at H.E.B. saw the tornado move through the parking lot and cause subsequent damage to over 20 postal trucks that

were parked in the back of the Post Office. While several trucks were untouched, an entire row of vehicles were thrown up to 30 yards into another adjacent parking lot and grassy field. Fifteen postal trucks were a total loss. The postal building itself sustained little damage. The postal trucks weigh 2200 pounds each, showing the strength of wind associated with the tornado. This is where the tornado likely reached its peak intensity. The assessment of wind speed is still part of the ongoing investigation with this tornado track.

THE TORNADO CONTINUED NORTH NORTHWEST AND HIT NEAR THE US POST OFFICE (5510 SW LOOP 410) POSTAL TRUCKS WERE TOSSED FROM THE PARKING LOT BEHIND THE POST OFFICE. 22 TRUCKS WERE DAMAGE AT THE FACILITY WITH 15 OF THE TRUCKS BEING A TOTAL LOSS. THIS DAMAGE IS AN INDICATOR OF WHERE THE TORNADO LIKELY REACHED ITS PEAK INTENSITY. THERE WERE SEVERAL WITNESSES TO THE TORNADO INCLUDING EMPLOYEES AT THE NEARBY HEB GROCERY STORE...ALONG WITH SAN ANTONIO FIRE DEPARTMENT.

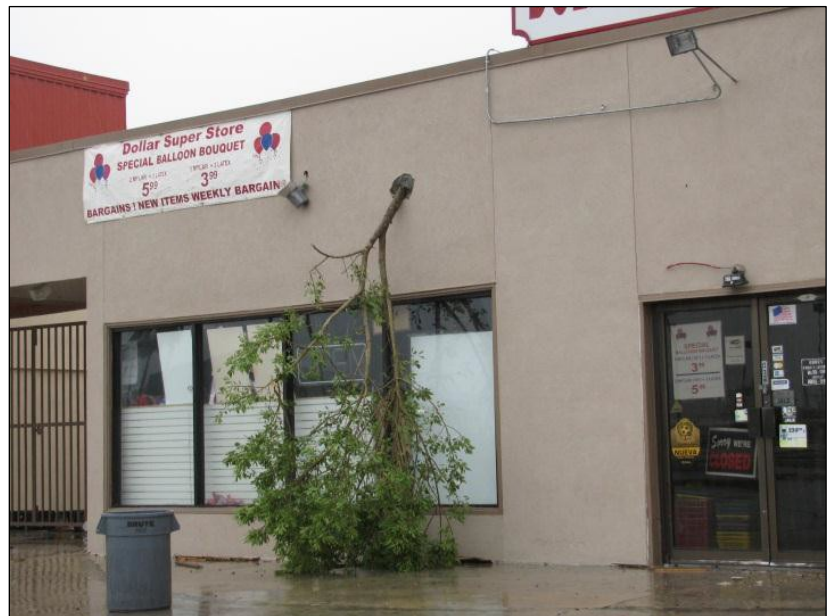
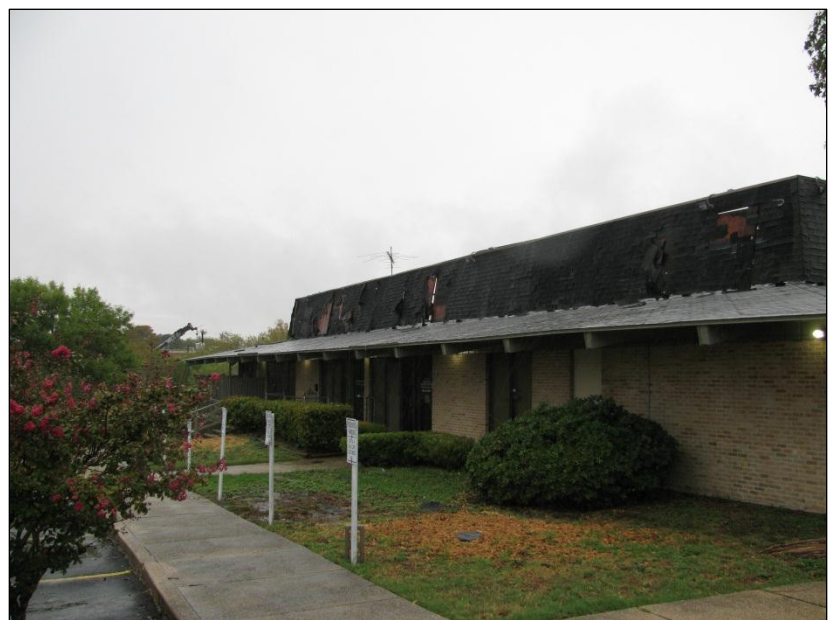
The tornado crossed Valley Hi Drive where it produced mainly shingle and roof damage to two office buildings before moving over or very near the Sam Rayburn Middle School. While the school itself only suffered minor roof damage, there was damage to the construction site where a new school addition was being built.

Roof damage at a business along Valley Hi Drive

THE TORNADO CROSSED VALLEY HI DRIVE WHERE IT DID SOME DAMAGE TO TWO OFFICE BUILDINGS ALONG VALLEY HI DRIVE BEFORE MOVING OVER OR VERY NEAR THE SAM RAYBURN MIDDLE SCHOOL. THE SCHOOL ITSELF SUFFERED ONLY MINOR ROOF DAMAGE...WITH MORE DAMAGE BEING SEEN BEHIND THE SCHOOL WHERE A NEW SCHOOL BUILDING IS UNDER CONSTRUCTION. JUST NORTH OF THE SCHOOL...A HOME LOST A SECTION OF ROOF AT THE CORNER OF CEDARHURST AND GAGE DRIVES. THE TORNADO APPEARS TO HAVE THEN SHIFTED A LITTLE MORE TO THE RIGHT AS IT TRAVELED ANOTHER ONE HALF MILE THROUGH A NEIGHBORHOOD WITH ADDITIONAL TREE DAMAGE AND DAMAGE TO PORTABLE BUILDINGS AND ROOFS. THE TORNADO APPEARS TO HAVE LIFTED OR DISSIPATED NEAR THE INTERSECTION OF SPRINGVALE DRIVE AND ALLENHURST DRIVE.
