# June 14-15, 2013 Flash Flood Event

A very moist atmosphere combined with a weak upper level low pressure system resulted in very heavy rainfall and significant flooding across portions of the Rio Grande Plains on June 14 and 15. From late Friday morning through Saturday, an incredible 17.05" of rain fell in Eagle Pass, Texas.

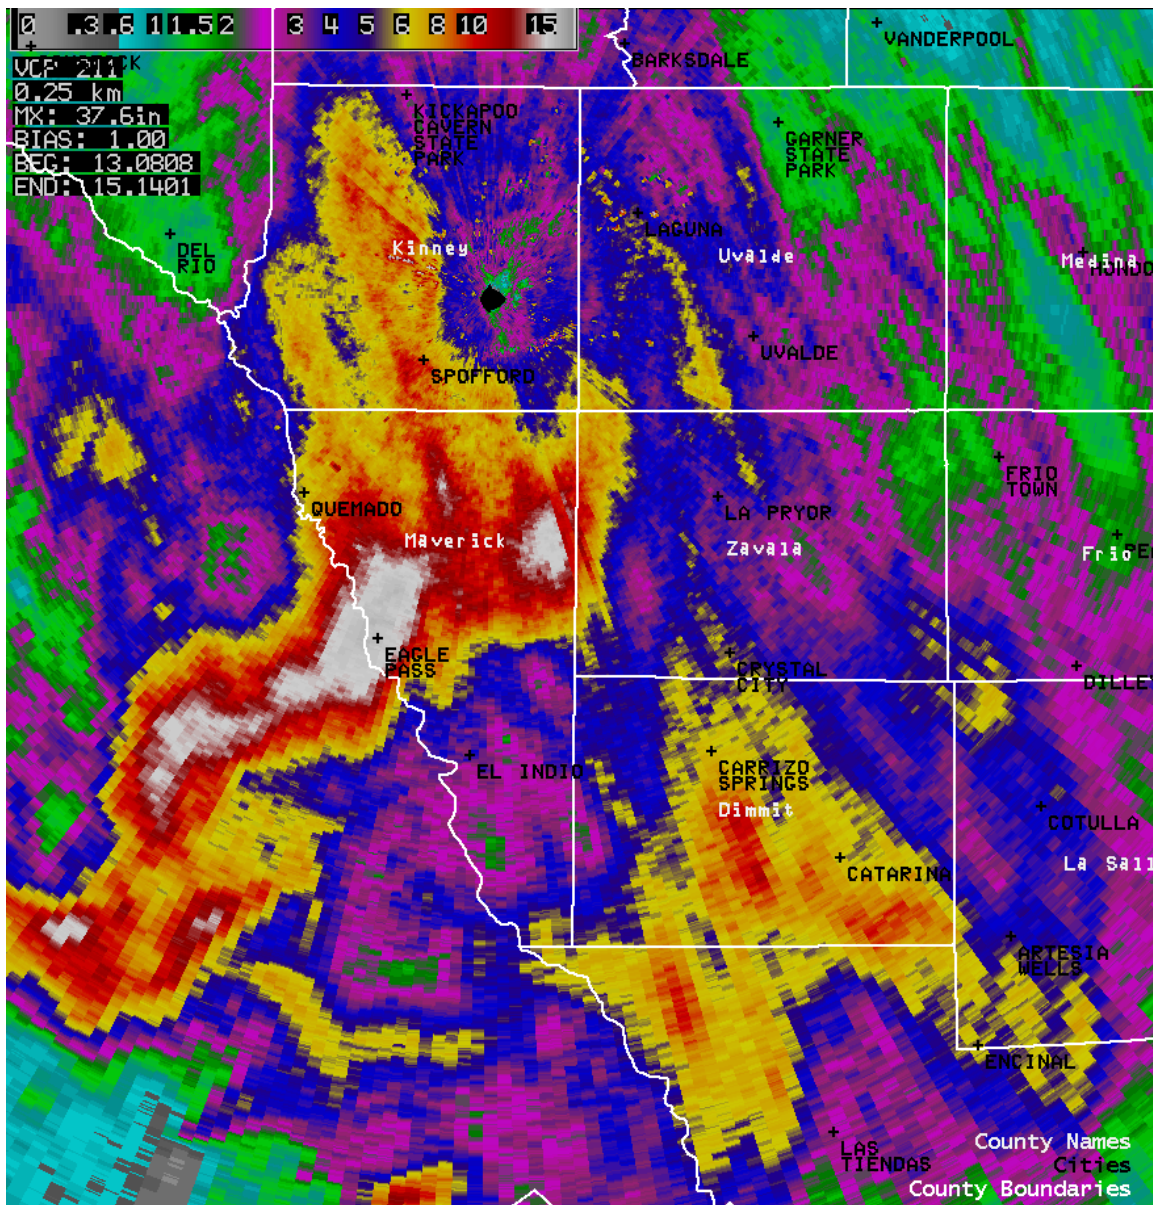
The image above shows radar estimated precipitation amounts across the Rio Grande Plains on June 14 and 15, 2013. Radar estimates show widespread 6 to 10" rainfall totals across the northern half of Maverick County. Significant rains also fell across the western half of Kinney County as well as much of Dimmit County.

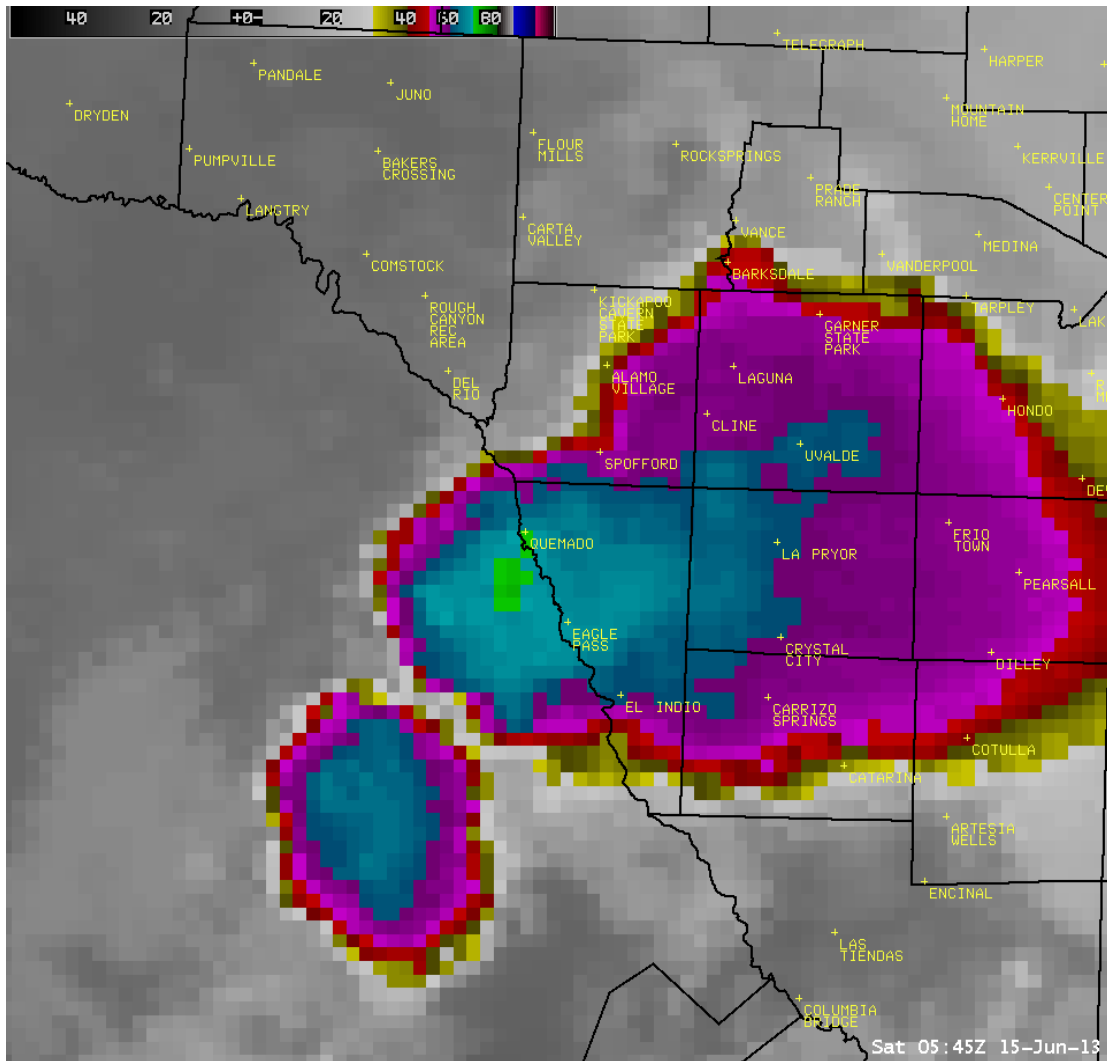
**The image above shows an area of thunderstorms along the Rio Grande during the early morning hours on June 15, 2013. The brighter blue and green colors indicate stronger thunderstorms and more intense rainfall rates. This image was taken at 12:45 AM on Saturday, June 15. At the time of this image, these thunderstorms extended to roughly 50,000 feet above ground and were producing rainfall rates near 3” per hour in Eagle Pass, TX.**

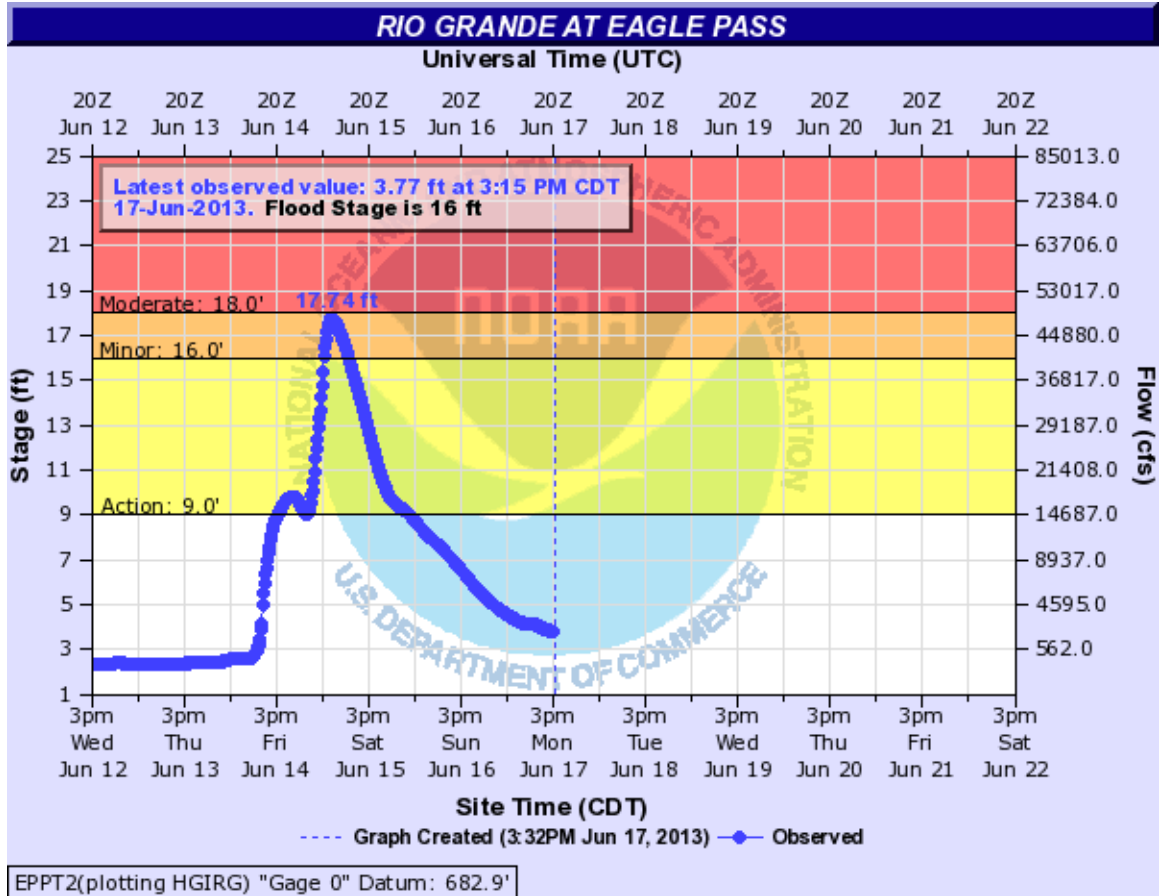
This graph above shows the rise in river levels at the gauge located near Eagle Pass, Texas.

The heavy rains also brought significant river rises to the Rio Grande at Eagle Pass.

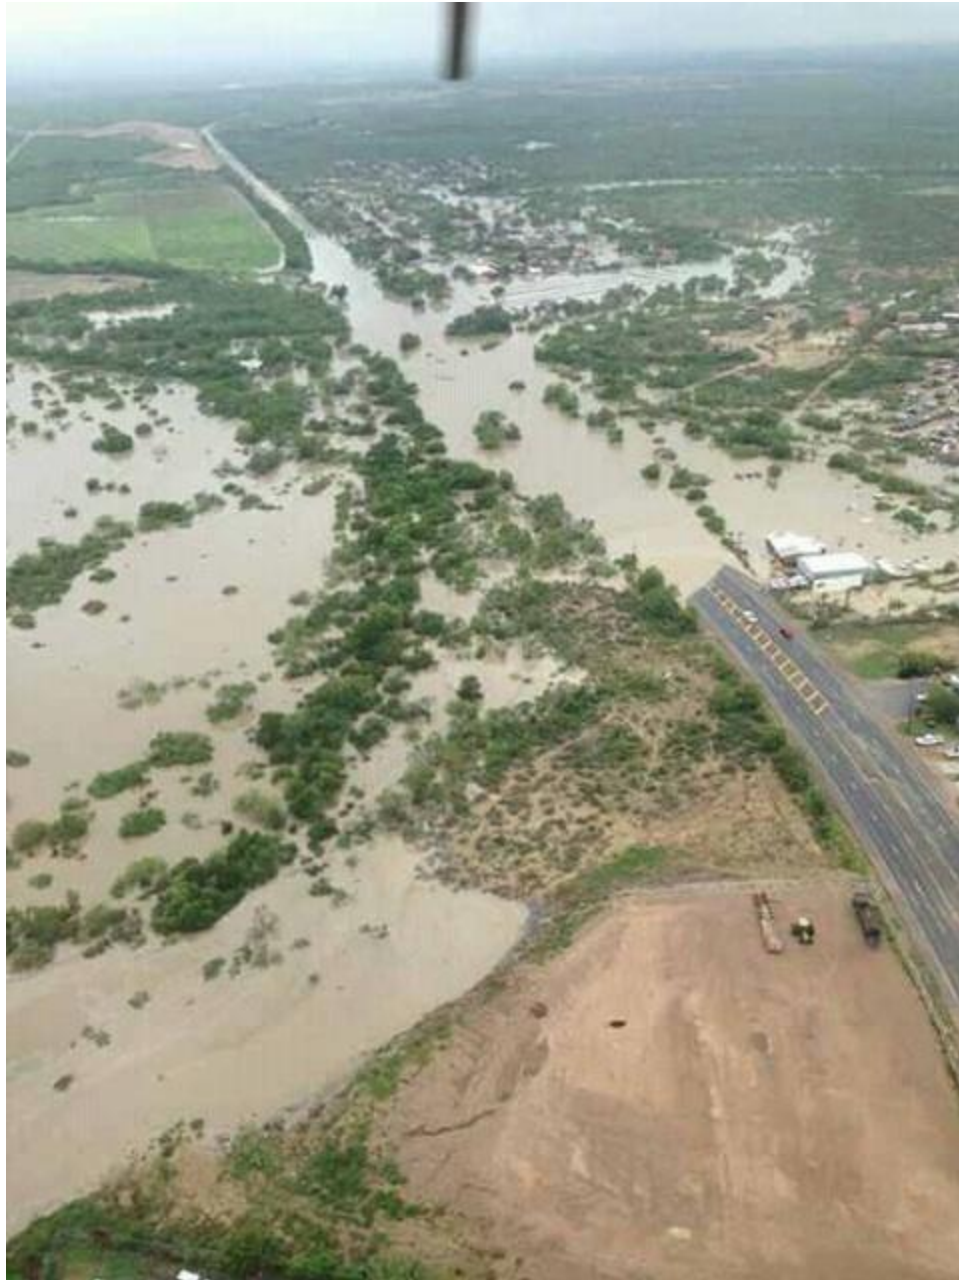
**The photo above shows flooding along U.S. Highway 277 and Elm Creek. This photo is courtesy of the Eagle Pass Daily News.**

The first round of heavy rainfall started Friday morning, June 14 around 8 AM and continued until Noon. The automated river gauge on the Rio Grande at Eagle Pass recorded just over 4" of rain during this time period. As a result of this initial round of rainfall, Highway 277 between Quemado and Eagle Pass was closed due to flooding. In addition, water began entering homes located near flooded irrigation canals.

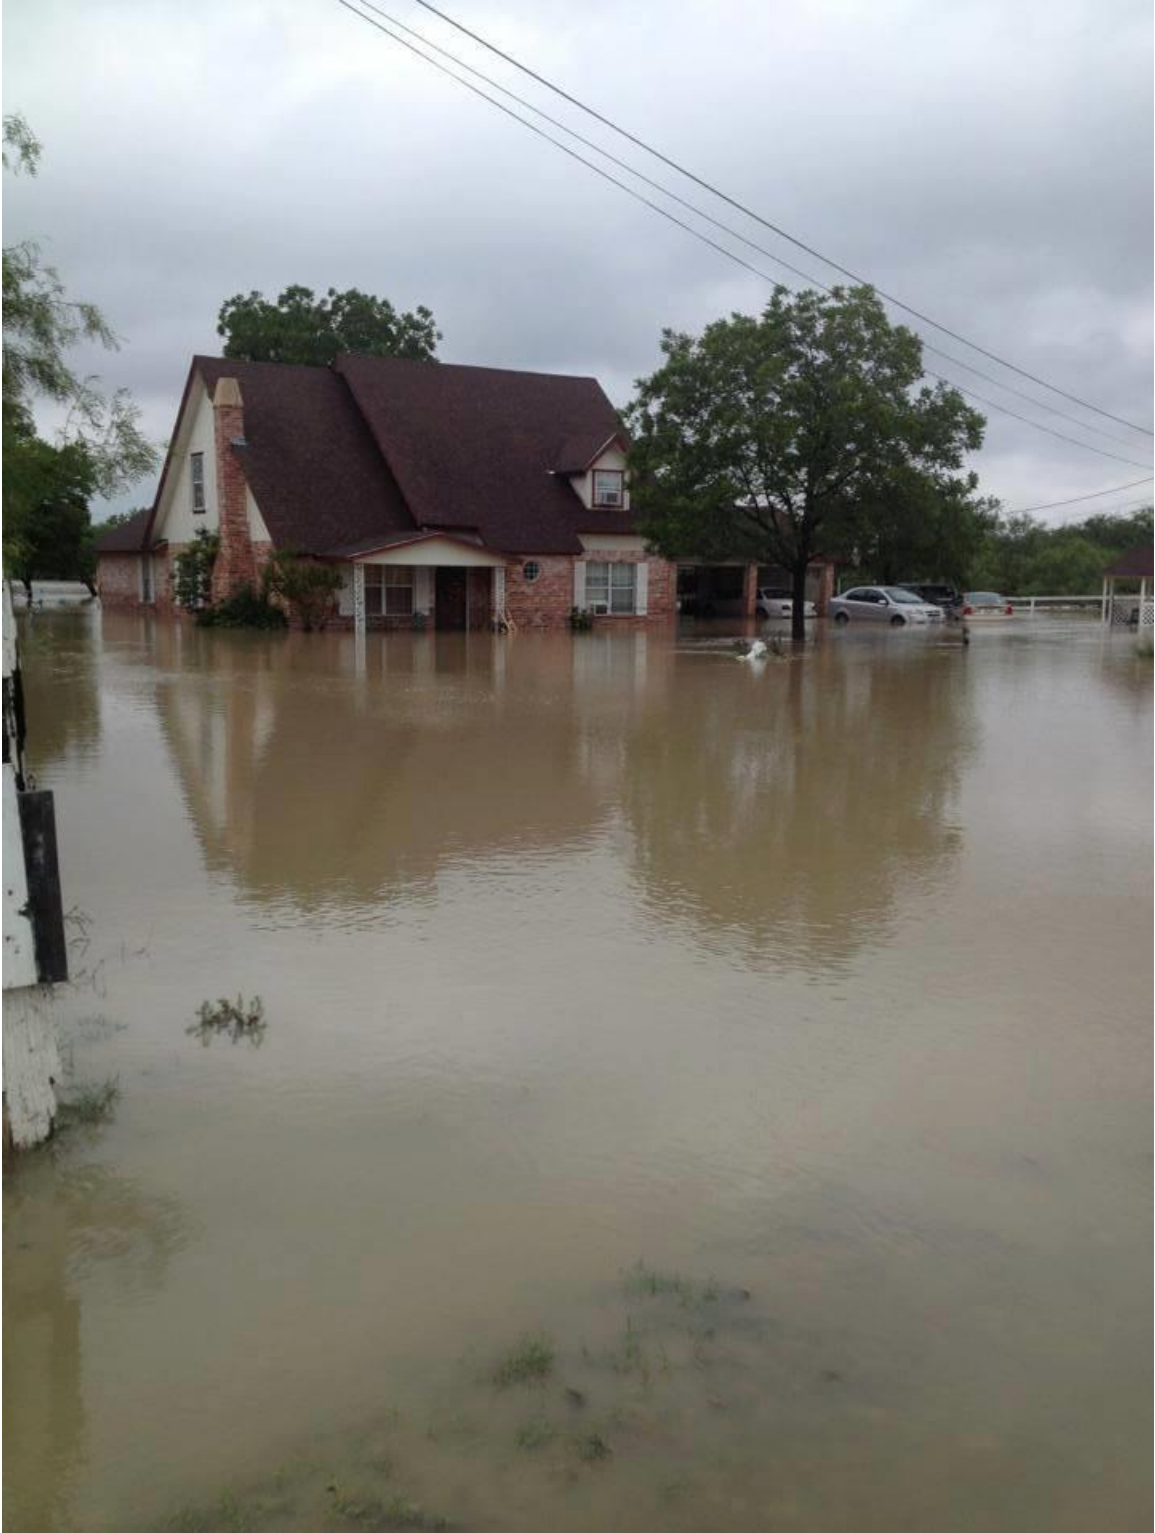
**A flooded home in Eagle Pass, Texas. This photo is courtesy of the Eagle Pass Daily News.**
