National Weather Service Melbourne, Florida

NWS Melbourne staff conducted a storm survey in Martin County on Sunday, October 30. The survey confirmed that storm damage in the Hobe Sound area occurring the morning of October 29, 2011 was due to an EF-0 tornado. A recently obtained video confirms a second EF-0 tornado occurred farther northeast, between Gomez Road and the Intracoastal Waterway, and continued over Peck Lake as a waterspout.

Tornado #1: Hobe Sound in Martin County, FL

Tornado #2: Hobe Sound/Loblolly Bay in Martin County, FL

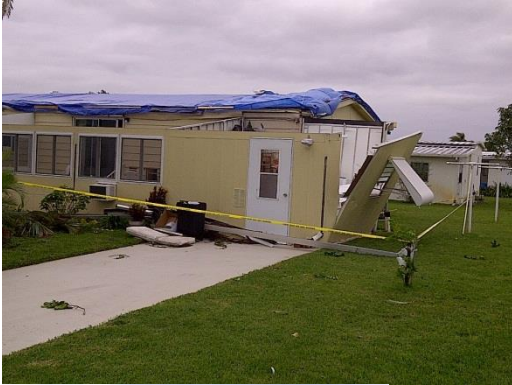
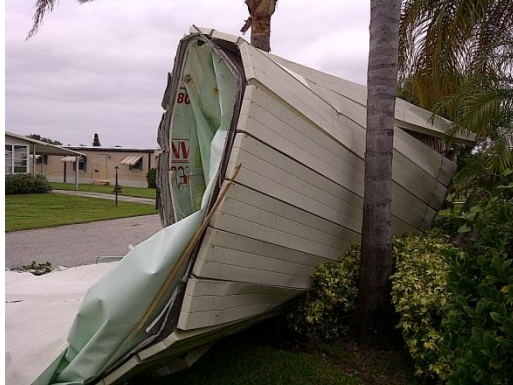
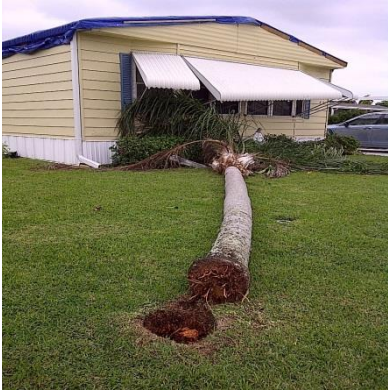
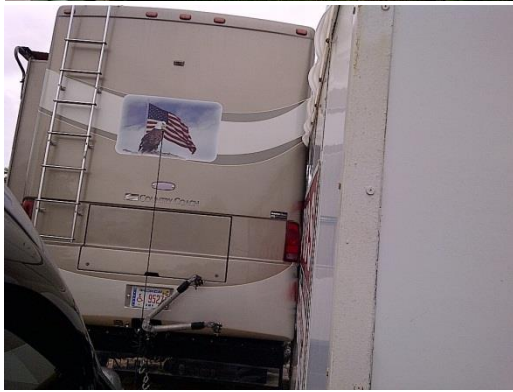
Damage Photos from the NWS Storm Survey:

at multiple levels on the TPBI TDWR. At 910 am, a second Tornado Warning was issued for east central Martin County as the cell began to track more northward. This second Tornado Warning also extended eastward to the coast, and included locations farther north through Port Salerno. Both Tornado Warnings covered portions of Hobe Sound, where damage to 42 mobile homes occurred at approximately 916 am. The tornado lifted the roof off one mobile home, and peeled back small portions of three other mobile home metal roofs. The remaining homes experienced mostly (minor) awning and carport damage. Three large palm trees were uprooted or toppled, and numerous smaller trees sustained damage. Two vehicles were also damaged.

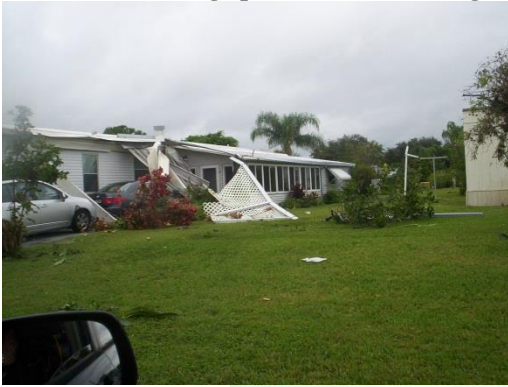
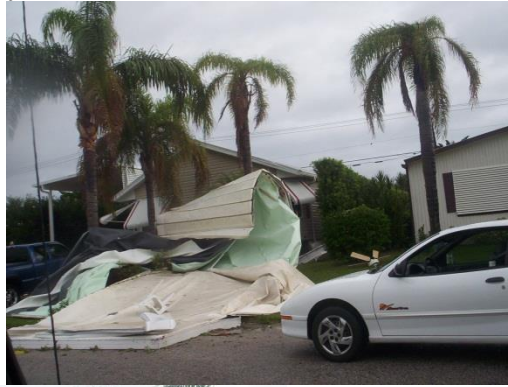
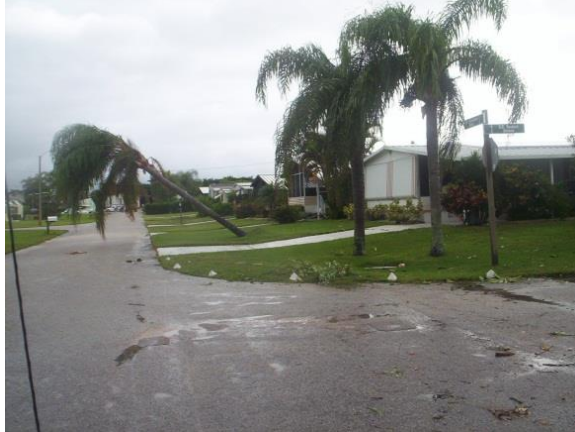
A few damage photos from the Ridgeway Mobile Home Park (courtesy of WPTV):
