**Iowa FACE Report:** Farmer and his employee died after collapse and attempted rescue in manure storage pit

**Case ID:** 2005 IA 024 / 2005 IA 025

**Date:** 4 August 2014

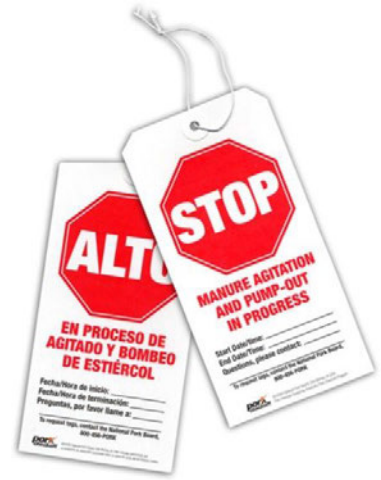
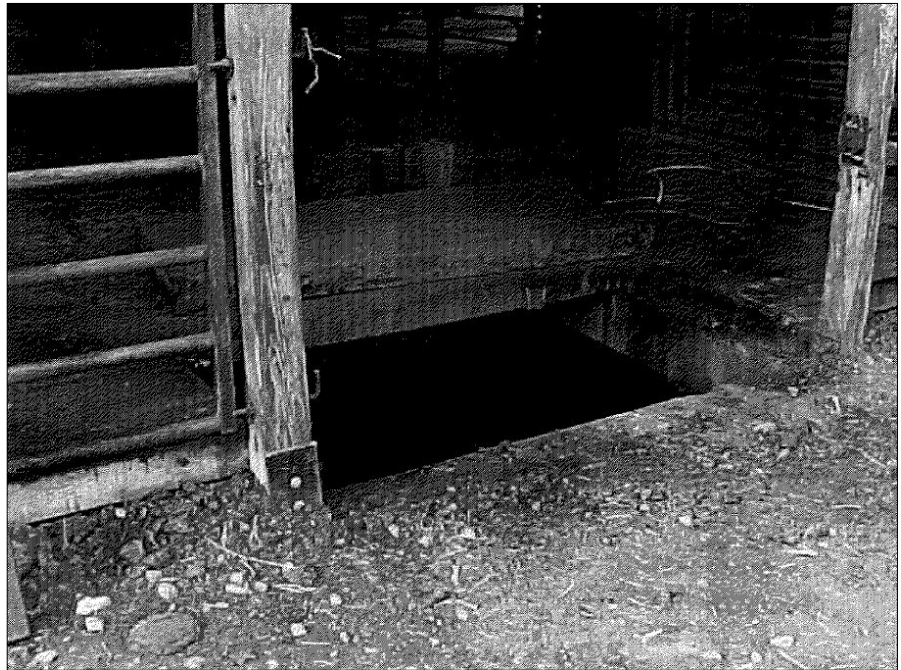
**B. North side of shed with manure spreader tank outside building**  
**Windows with white panel covers were added after the fatalities**  
(2014 photo)

The 200' x 60' cattle shed was constructed in 1975. It was enclosed on three sides with sliding doors on the east and west ends and three sliding-panel windows on the north wall (Exhibit B). The south side of the shed was completely open; it had steel gate partitions that opened to the adjacent lot (Exhibit C). The capacity of the building was 300 head.

The pit under this cattle shed (and many other livestock facilities still in use) was not configured with mechanical ventilation. While the above-ground area in the shed was completely open on the south side, and all windows and doors were open on the other sides, natural ventilation was not adequate in diluting gases that had settled below the flooring. Following the incident, the family added four additional windows to the north side of the building to improve ventilation (Exhibit B).

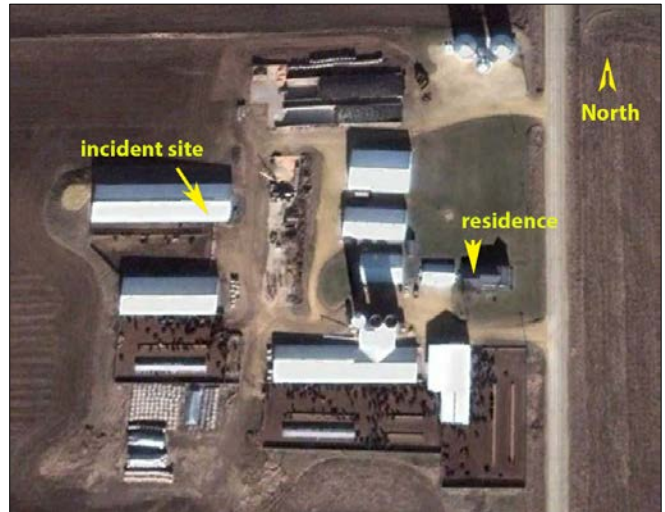
**A. Farmstead** (2006 Google Earth image)

The incident occurred at a cattle shed at the northwest area of the farmstead where the farmer and his wife resided. The farm was located 0.4 miles from the nearest town with a volunteer fire department and ambulance service and 12 miles from the county seat municipality with a regional hospital and ambulance service.

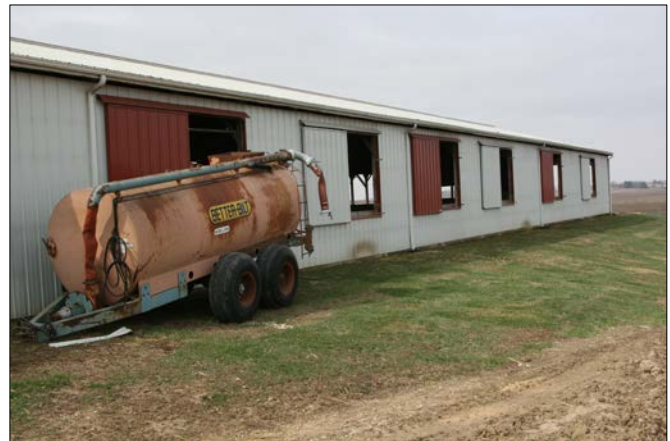
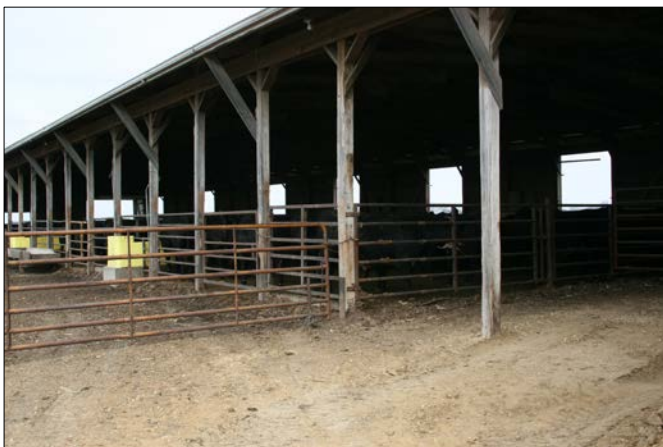
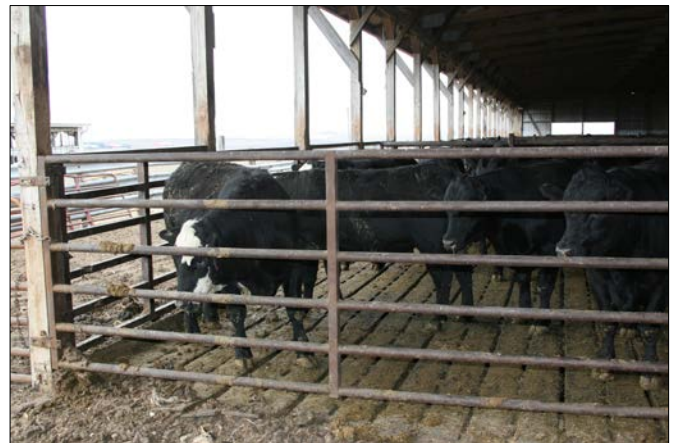
**C. South side of shed** (2014 photos)

A deep manure storage pit measuring 200' x 40' x 8' deep ran under sections of concrete slat flooring on the south side of the building. The pit was sectioned into five compartments and had no mechanical or natural means of ventilation. The incident occurred at the east end of the pit, after the last compartment had been pumped.

At the time the building was constructed, the flooring consisted of individual concrete slats over the manure pit. Over time, the slats would periodically break and fall into the pit. In the 1980s, the farmer replaced the individual slats with 4' x 8' sections of slatted concrete.

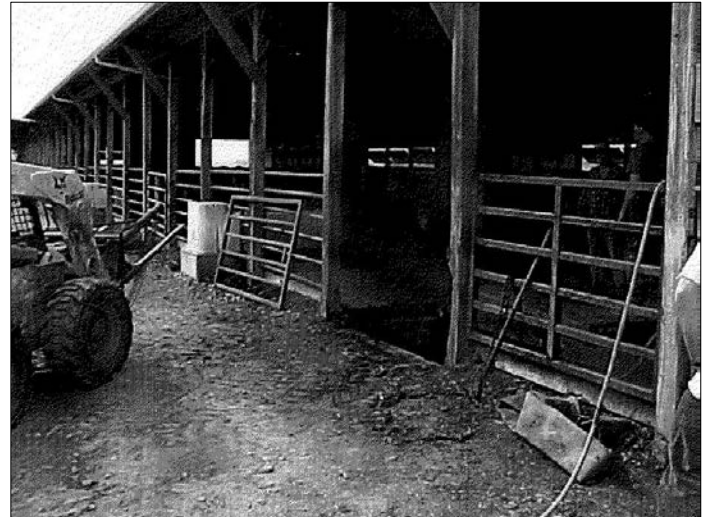
**E. South side of building showing open section gate and flooring where pump was used**

In preparation to empty the pit, a section of livestock gate was removed from the south side of the building, and a skid loader was brought in to remove a 4' x 8' section of concrete flooring (Exhibit E). The tractor was then backed to the opening, and the vertical pump was lowered into the pit.

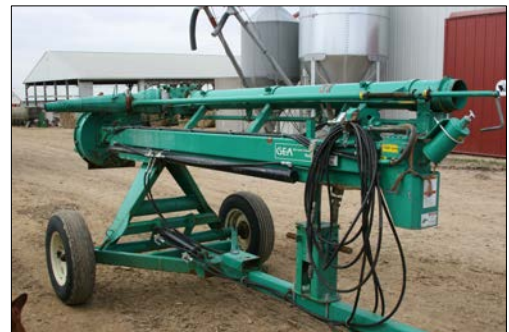
#### **J. Pump used at the farm in 2014**

It was not known what safety decals were on the manure pump that was used at the time of the fatalities. The family had traded for a new pump at some point following the fatalities (Exhibit J). Signage on the new pump includes a decal noting "*DANGER! Manure produces toxic gases that can cause a loss of consciousness, asphyxia, or death in a few seconds. Manure agitation can produce toxic gases in buildings built above the pit. Toxic gases can also emanate in buildings situated by the pit and /or connected to the pit by an evacuation line.*"

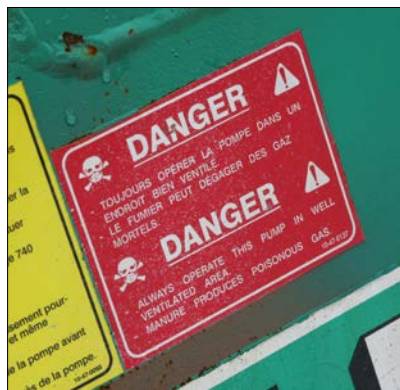
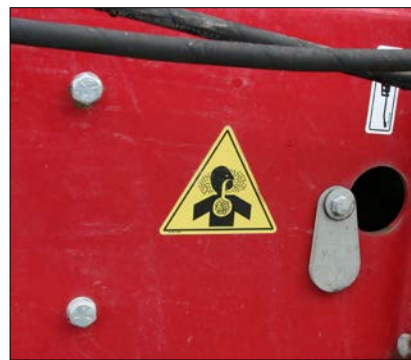
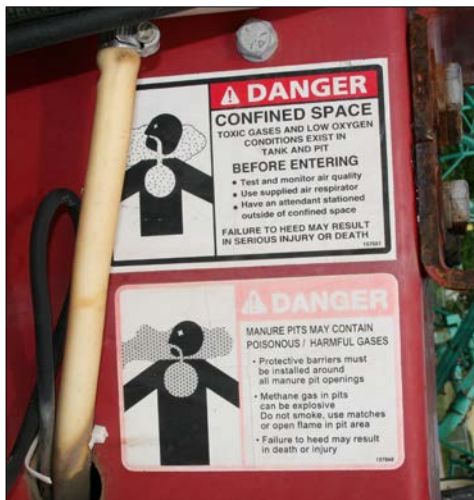
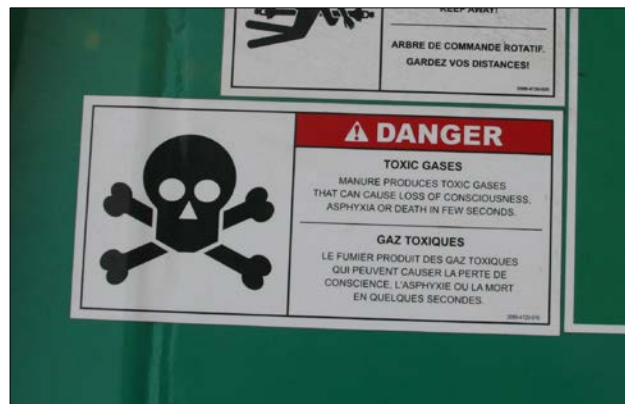
**K. Examples of manure gas warning signage on old and new equipment**

In follow up to this investigation, Iowa FACE visited a local implement dealership that sold new and reconditioned manure pumps. Various safety decals pertinent to manure gas hazards were present on older pumps, including one which had only a graphic depiction (Exhibit K). Not all safety decals were intact on some older pumps that had been traded and were awaiting reconditioning.<sup>3</sup> It is important that owners maintain safety decals on equipment and replace those that are missing, torn, or corroded. New decals are typically available through dealerships that condition equipment for resale.

None of the pumps at the local dealership had signage warning against “climbing down the pump” as a means to enter the pit. This hazard was not identified or addressed in operator manuals for new pumps at the dealership, although operator manuals did prescribe following confined space entry procedures. Climbing down pumps may not be an uncommon practice to access pits, as it has also been described in a prior FACE investigation report involving a manure gas fatality (94MN057). Equipment manufacturers should consider incorporating a warning decal and instructions advising against using the pump as a ladder to access the pit.
