Stockton Creek Watershed Plan

Stockton Creek/Town Branch Watershed Plan

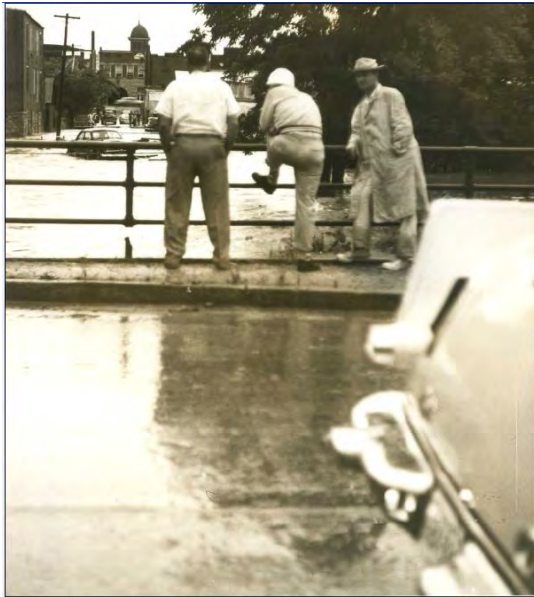
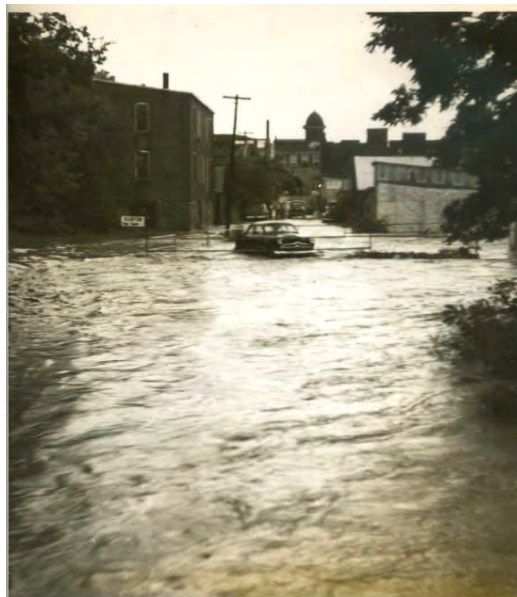
Figures 2.4 and 2.5 Photos from the 1956 flood in Flemingsburg (Flemingsburg Gazette, 1956).
