Chestnut Creek Watershed Based Plan

Marshall County, Kentucky

Revision 2, February 2016

Produced by:

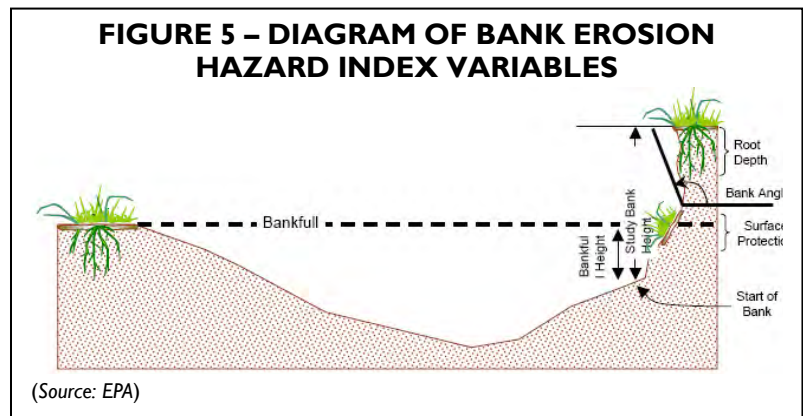
The streams were visually assessed in order to identify severe erosional areas. These areas can be large contributors to sediment pollution and often need to be addressed by best management practices. Not all areas of erosion were documented, only severe areas or areas above normal levels for the region. For each erosion area encountered, the length and height were measured and the bank erosion hazard index (BEHI) and near-bank stress (NBS) ratings were assessed. Figure 5 illustrates the measurements for the BEHI. Together, these measurements

indicate a rough approximation of the amount of sediment loading associated with bank erosion.

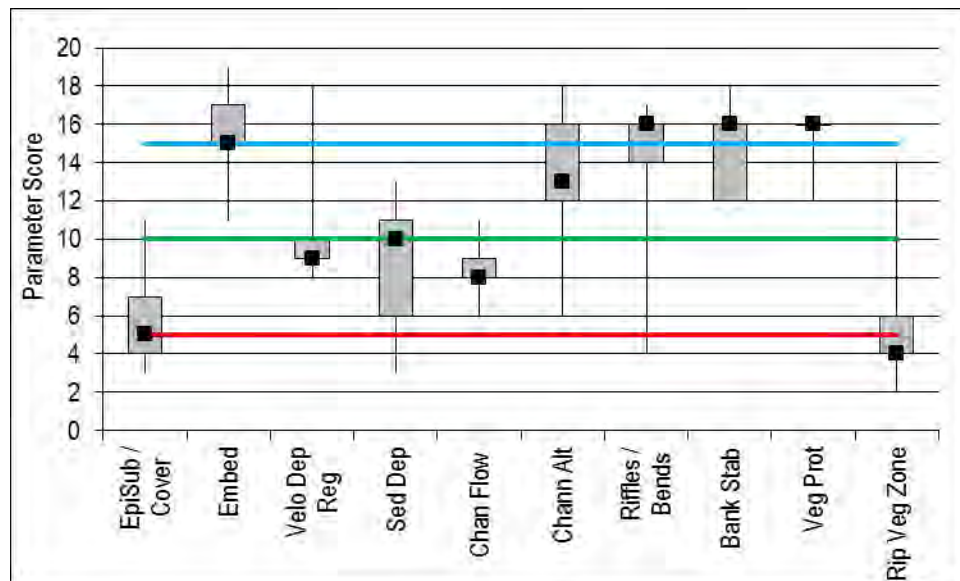
FIGURE 6 – CHESTNUT CREEK WATERSHED HABITAT SUMMARY

Note: Lines indicate the maximum and minimum results. Boxes indicate the middle 50% of results. Values above blue line are “Optimal”, above the green line are “Suboptimal”, above the red line are “Marginal”, and below the red line are “Poor”.

The gravelly, unstable substrate in most streams of the watershed do not provide for good substrate cover for macroinvertebrate species. Restoration efforts to provide increased instream niche habitat should aide in the recovery of macroinvertebrate community. Similarly, narrow riparian corridors are a problem in some areas of the watershed and should be expanded with no-mow zones and native plantings. Some sediment accumulation is occurring, which is linked to the bank erosion noted in other surveys.

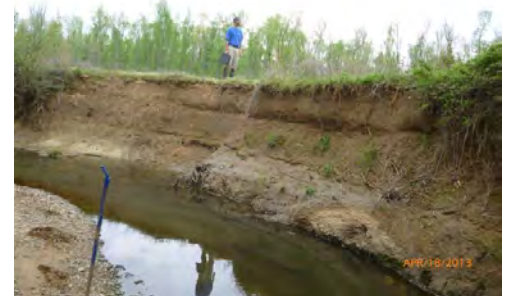
Extreme Rating (ER-19):

Bank erosion hazard index ratings of “extreme”, “very high”, and “high” in Chestnut Creek Watershed. For scale, the field technician pictured is 6’7” tall.

The banks had average height of seven feet, but the bankfull height was much lower indicating that all streams were deeply channelized and entrenched. On average, only 30% of the banks with severe erosion had root growth to aid in the stabilization of the bank. The bank angle ranged from 60 degrees to 95 degrees, indicating moderate to very high susceptibility to mass erosion. On average, only 22 percent of the banks had protection from sod mats, woody debris, or plant material.

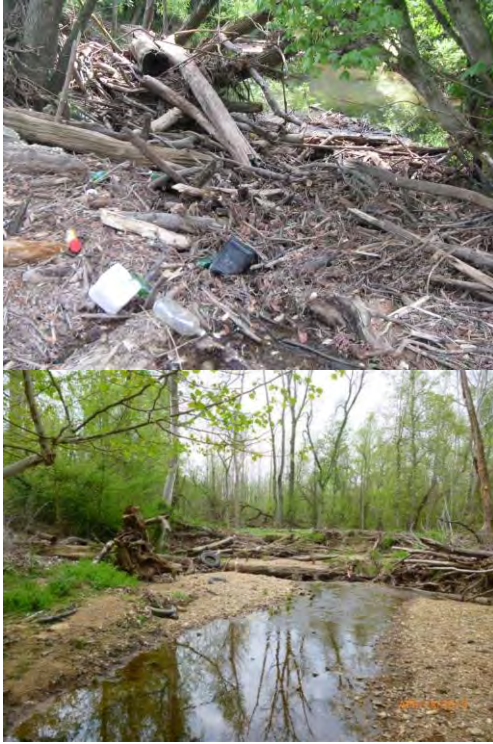
FIGURE 8 – DEBRIS BLOCKAGES OF CHESTNUT CREEK DUE TO CHANNELIZATION AND EROSION

Not only does the channelization and erosion contribute to sedimentation in the watershed, but it also increases the rate of flooding. As stream banks erode, trees located along the banks fall into the stream. As shown in Figure 8, additional debris accumulates behind these trees causing large flooding to occur since water cannot pass these blockages. When the velocity of the water is sufficient to break through the blockage, this debris is released downstream where it causes more erosion and accumulates in a similar location downstream.

The channelization also causes the lowering of the groundwater levels, which are a contributor to the impairment of the macroinvertebrate community in the watershed.
