Bacon Creek Watershed Plan

Kentucky Waterways Alliance & Kentucky Division of Water

Funding for this project was provided in part by a grant from the U.S. Environmental Protection Agency through the Kentucky Division of Water, Nonpoint Source Section and the Kentucky Division of Conservation Kentucky Waterways Alliance as authorized by the Clean Water Act Amendments of 1987, Section 319(h) Nonpoint Source Grant #C-9994861-10.

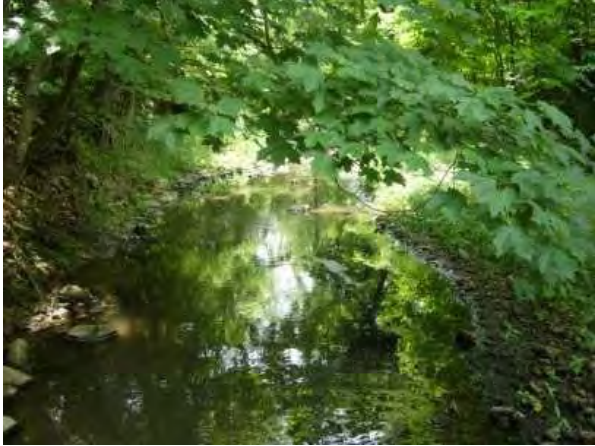
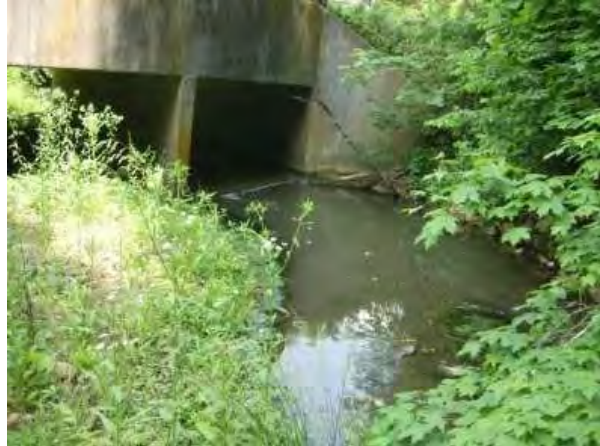
Site 1Ba is located most upstream Bacon Creek, on the middle fork of Upper Bacon Creek, near a roadway and downstream of agricultural land. Field technicians have reported livestock drinking from the stream at this site. Tire tracks, litter, and other signs of human activity were observed by field technicians.

Figure 3.2 – Site 1Ba Downstream

Figure 3.3 – Site 1Ba Upstream

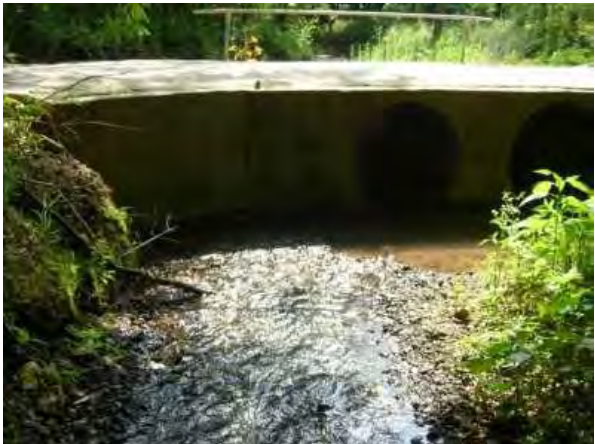
Site 1Bb is on private property along a tributary that feeds into Bacon Creek. It is on the east fork of Upper Bacon Creek. A large algae bloom was noted by field technicians at this site in December 2012. In April 2013, juvenile crayfish, dragonfly larvae molt, and fly larva were all observed in the water.

Figure 3.4 – Site 1Bb Downstream

Figure 3.5 – Site 1Bb Upstream

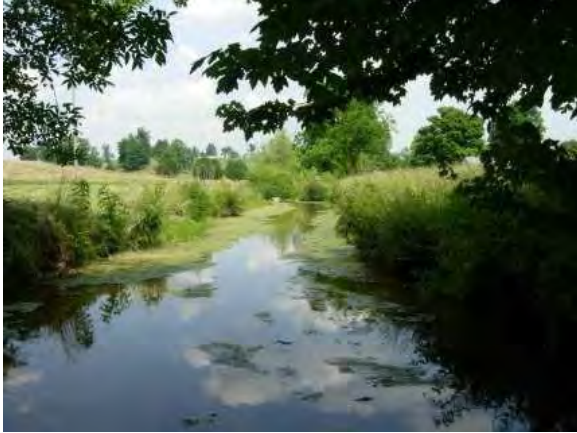
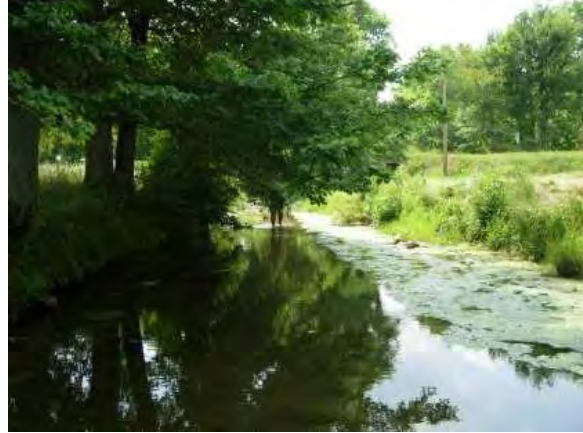
Site 1A also feeds into Bacon Creek, but is between private property and a roadway where sparse riparian zones protect the creek from nearby human activity. It is on the north fork of Upper Bacon Creek. Tire tracks, litter, and other signs of human activity have also been observed by field technicians at this site.

Figure 3.6 – Site 1A Downstream

Figure 3.7 – Site 1A Upstream

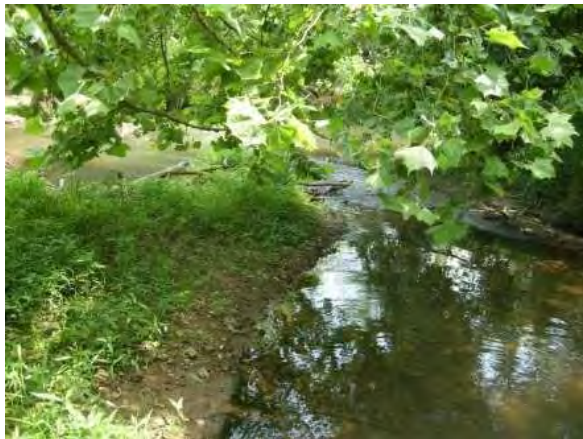
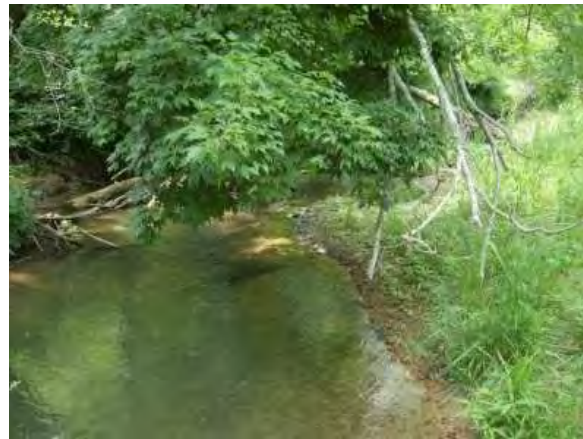
Site 1 is at the mouth of the Upper Bacon Creek sub-watershed. It is located directly on Bacon Creek behind a large agricultural field on private property where human activity has been noticed in and around the creek. It has a significant year round flow. Field technicians noted on the January 29, 2013 site visit that the site had flooded recently, and the riparian zone had been partially bulldozed and cleared.

Figure 3.8 – Site 1 Downstream

Figure 3.9 – Site 1 Upstream

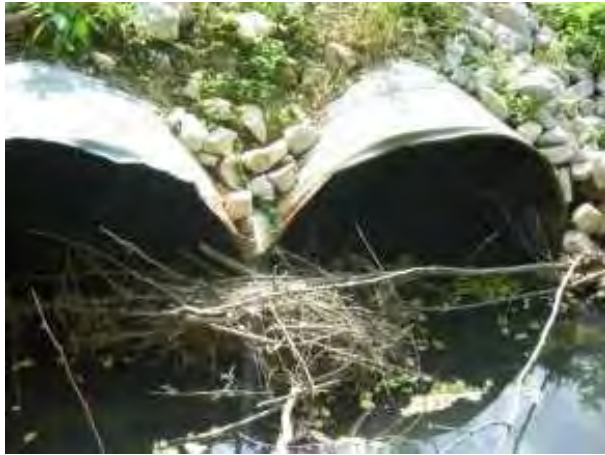
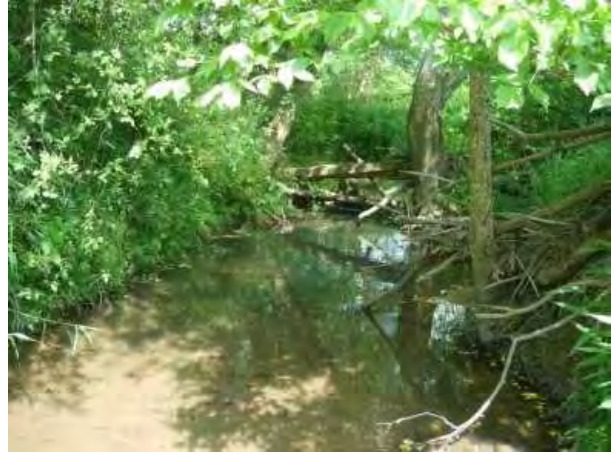
Site 2 is located at the mouth of the Tampa Branch sub-watershed, and appears to have the least riparian zone protecting the creek, as it is located near a roadway where field technicians found large amounts of litter. Field technicians noted that on October 12, 2012, significant clearing had been done 50ft upstream on both banks with no erosion control. They also noted in November 2012, vegetation from bank was removed, there were fewer trees, and bare dirt on both sides.

Figure 3.10 – Site 2 Downstream

Figure 3.11 – Site 2 Upstream

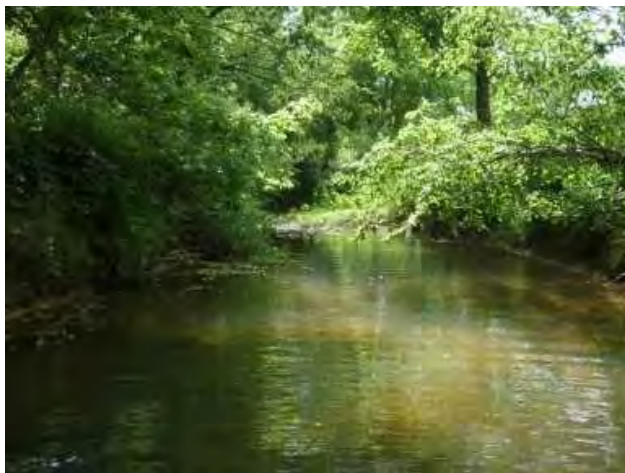
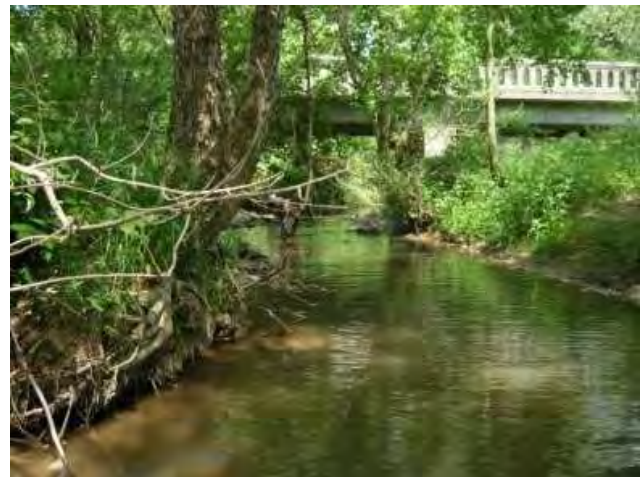
Site 3 on the Lower Martis Branch sub-watershed is along a roadway where oil has been observed leaking into the creek.

Figure 3.12 – Site 3 Downstream

Figure 3.13 – Site 3 Upstream

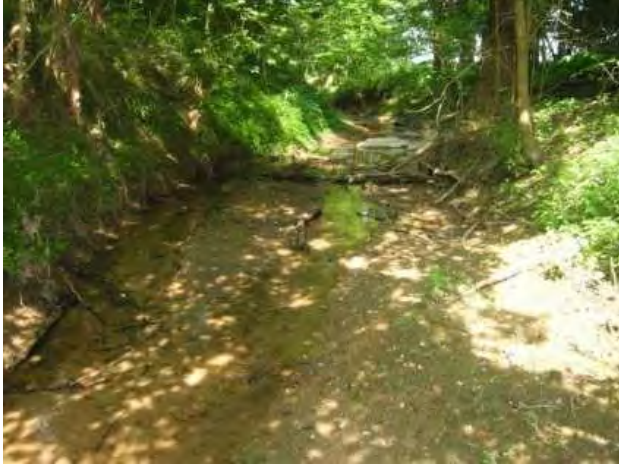
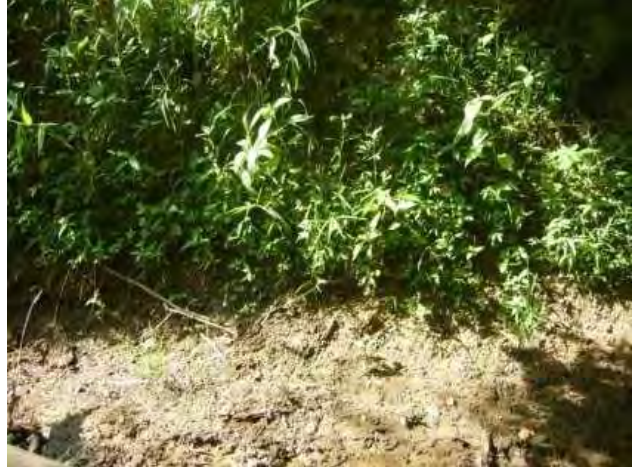
Site 5 is at the mouth of the Honey Run sub-watershed. Site 5 was noted as having a strong riparian zone, diverse biological activity, and few odors. Sites 5 and 6 are in close proximity, but are located in separate sub-watersheds.

Figure 3.14 – Site 5 Downstream

Figure 3.15 – Site 5 Upstream

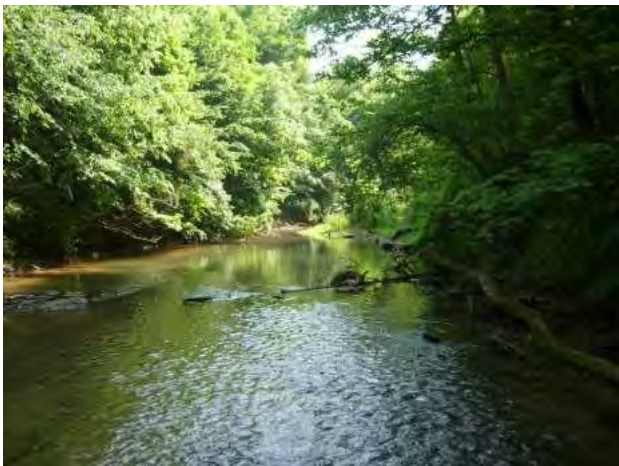
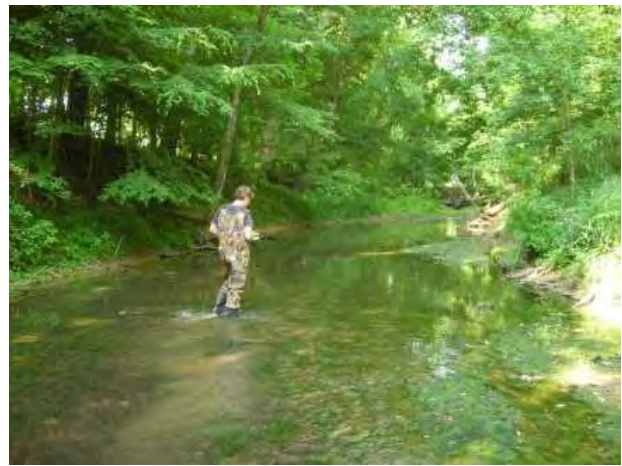
Site 6 is at the mouth of the Middle Bacon Creek sub-watershed, on the main stem of Bacon Creek, furthest downstream of all eight sampling sites. Thus, it receives flow from all of the upstream sub-watersheds and has the highest flow of all the sites. Site 6 was also noted as having a strong riparian zone, diverse biological activity, and few odors.

Figure 3.16 – Site 6 Downstream

Figure 3.17 – Site 6 Upstream

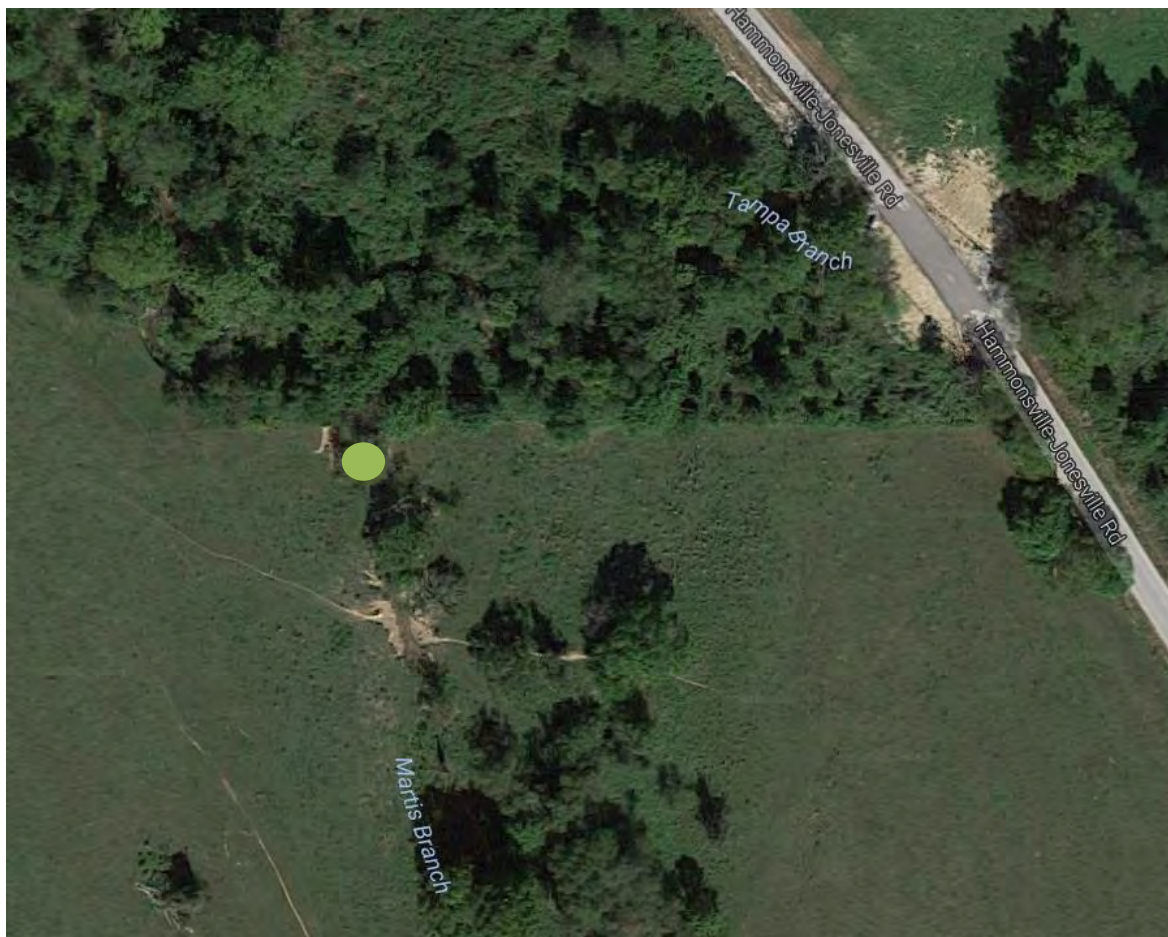
Figure 3.18 – Sampling Location for Upper Martis Branch Sub-watershed, sampled in 2016

In 2016 the Kentucky Division of Water sampled Upper Martis before it merges with Tampa Branch. After reviewing the data previously collected for this watershed, KDOW determined more samples needed to be taken for the Upper Martis sub-watershed in order to establish baseline data, list that section of stream and determine loading for that sub-watershed. The site selected for Upper Martis Branch was located off of Hammonsville-Jonesville Rd and was accessed by walking along Tampa Branch until it met Martis Branch. The Sample was taken just upstream on Martis Branch. This sampling site was located on a farm where cattle had access to the stream and a riparian zone was not present. On more than one sampling days, a strong manure smell was present. This site is labeled as point 7 on Figure 3.18.

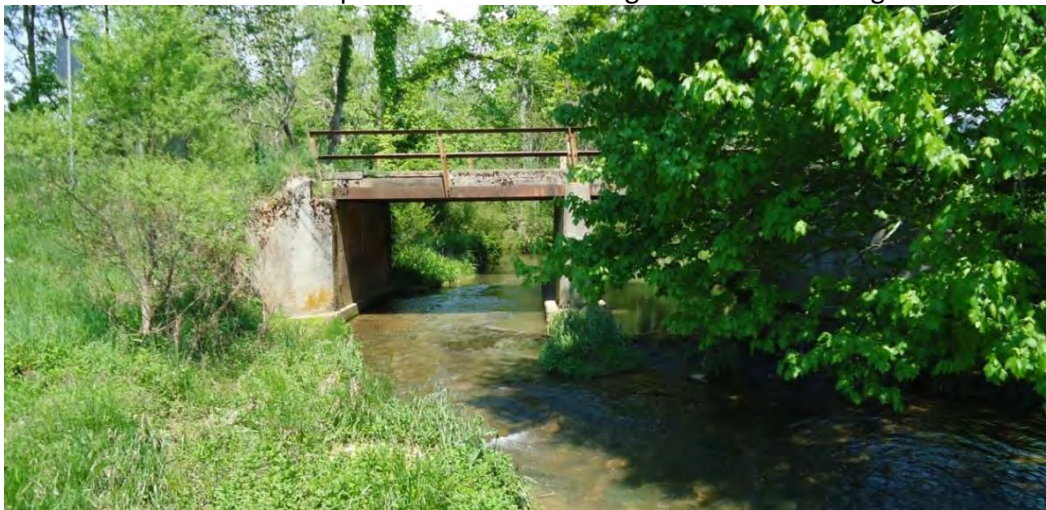
Field scientists were instructed to take notes and make observations about the watershed and surrounding areas during their sampling events. In these field notes, all sample sites indicated some debris either upstream or downstream of the sample site. Riparian zones are essential for preventing watershed pollution, however very few of the sample sites have effective riparian zones. Some of these riparian zones were limited to small bridge guardrails (see Figure 4.1), while those with more effective protection had thick vegetation surrounding the stream.

Figure 4.1 Riparian Zone

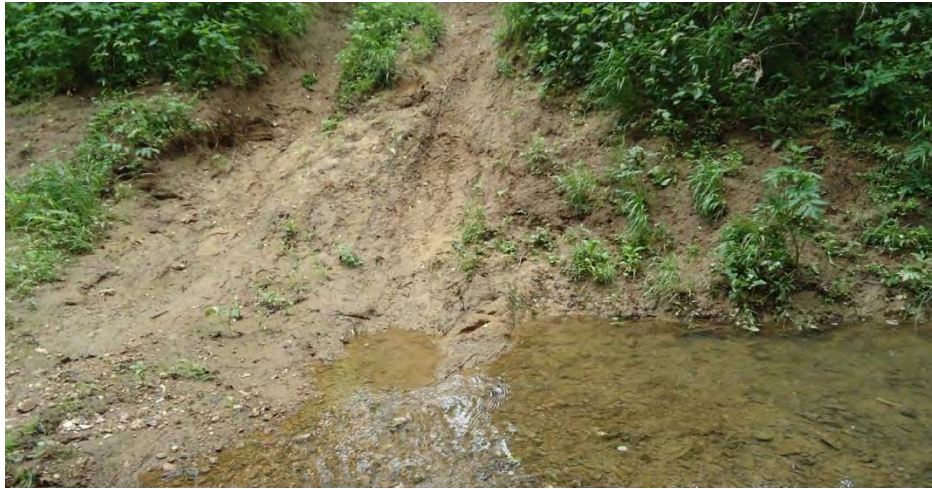
Often times field scientists would find man-made pollutants, such as tires, in or around the stream with no effective riparian zone. Few sites demonstrated an effective riparian zone, with several trees and thick vegetation protecting the stream, however human activity easily penetrates riparian zones (see Figure 4.2).

Figure 4.2 Creek Condition

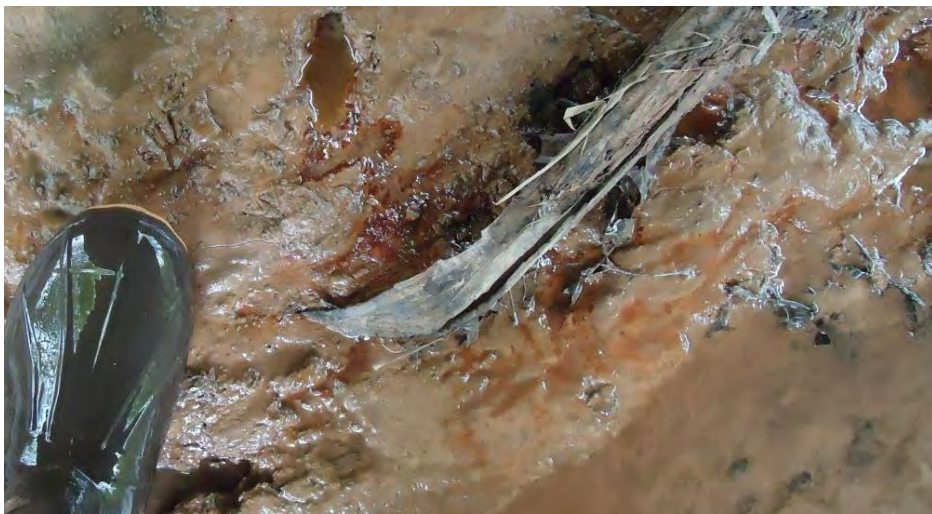
Figure 4.3 Creek Conditions

Sites where there are signs of automobile traffic often produced evidence of oil & grease in the watershed (see Figure 4.3). Even small concentrations of oil in the watershed can have devastating effects on wildlife and biological activity.

In most cases, even with riparian zones, there will be some trace of nearby waste being flushed into the watershed.

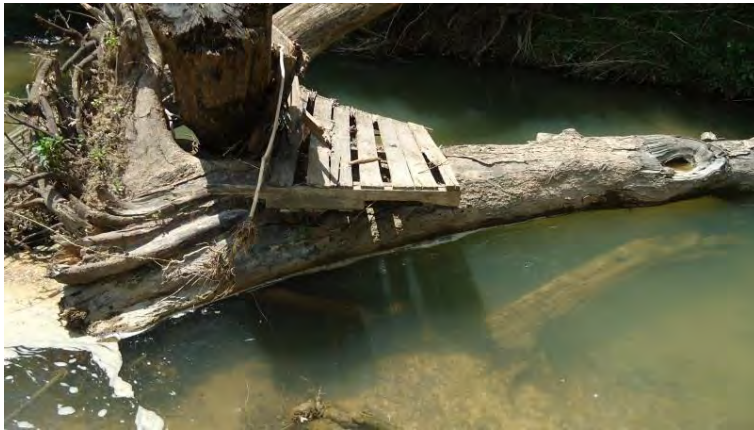
Figure 4.4: Human activity in the watershed

However, pollutant sources can be managed by human activity and proper waste disposal. Pollution in the waterways can have serious biological and chemical effects by depleting the water of dissolved oxygen as the waste decomposes.

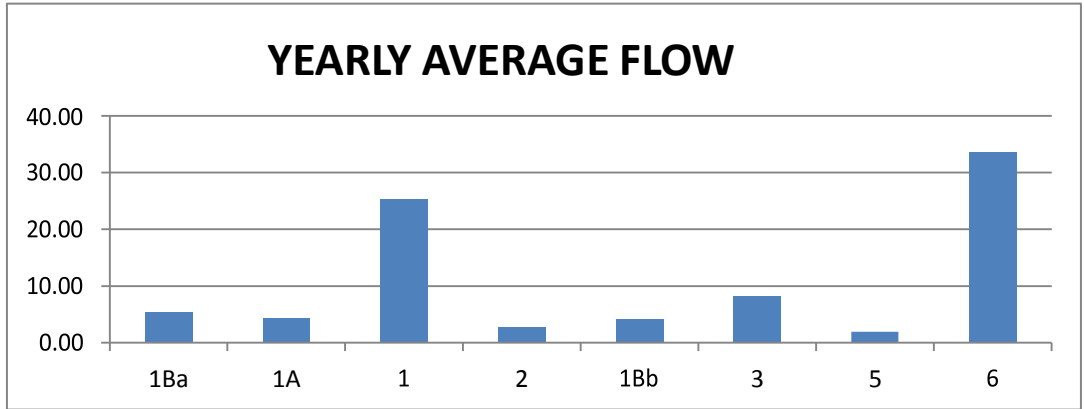
Figure 4.10 Mean annual flow for each site (ft³/s)

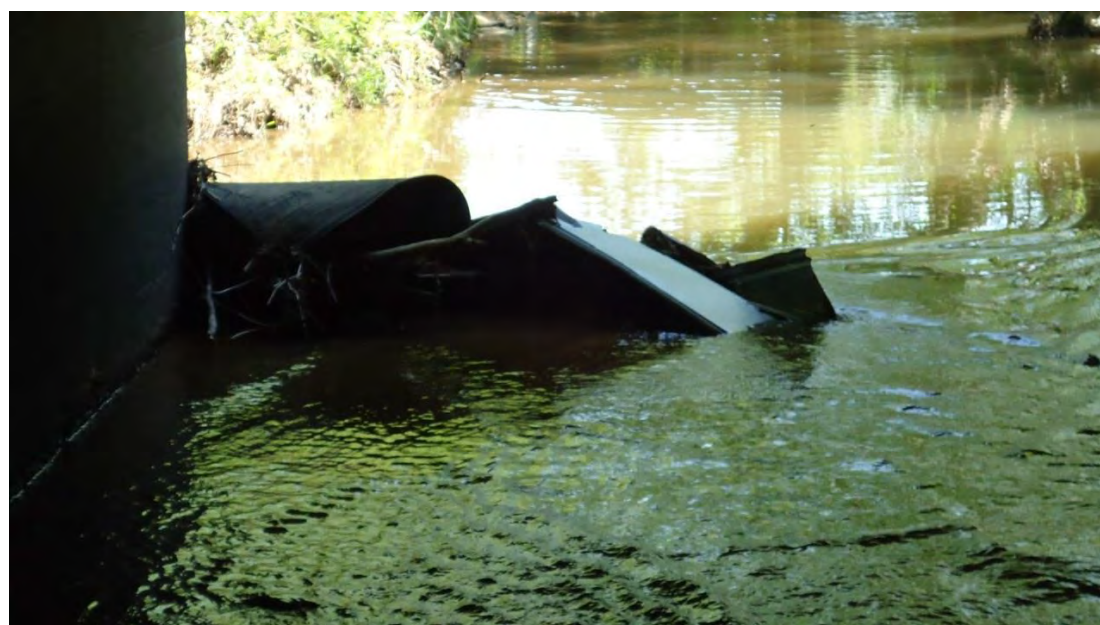
Figure 4.12 Litter at Site 1Ba.

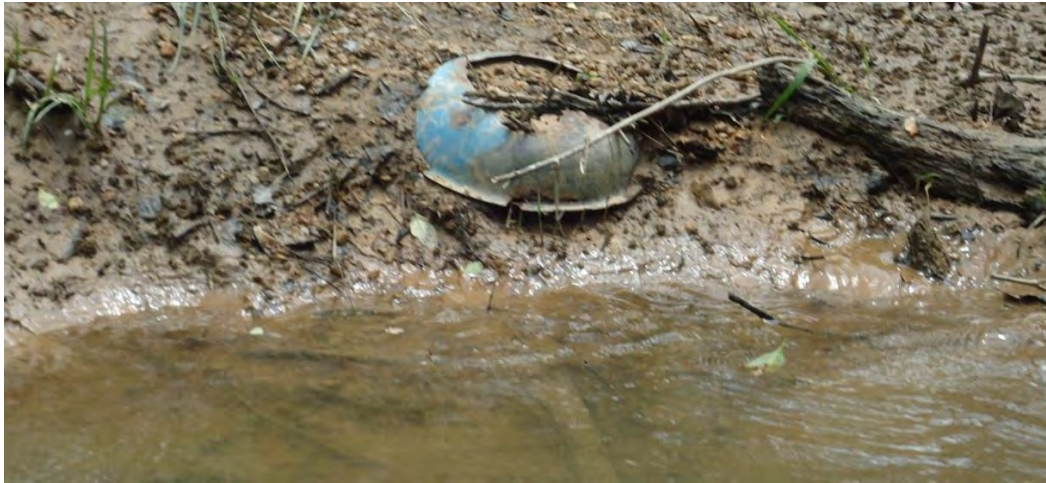
Field scientists noted any pollutants, riparian zones, biological activity, and unusual odors near the sample sites. Sites 5 and 6 were noted as having strong riparian zones, diverse biological activity, and few odors. Upstream from these sites, however, tire tracks, litter, and other signs of human activity were discovered. The heavy flow of Bacon Creek upstream from site 6 carries pollutants to the sample sites. Laboratory test results show high concentrations of *E. coli* and TSS for site 6, especially during the summer months. The annual pollutant loads are nearly thirty times the benchmark value for *E. coli*, and triple the benchmark value for TSS at site 6.

Figure 4.13 Human Activity at Site 6

Sites 1 and 1A have the heaviest annual pollutant loads for *E. coli* and TSS, however both sites were noted as having vegetation riparian zones, but show signs of human activity near or in the streams (see Figure 4.13). Some biological activity was noted at these sites, such as darter fish or small aquatic invertebrates.

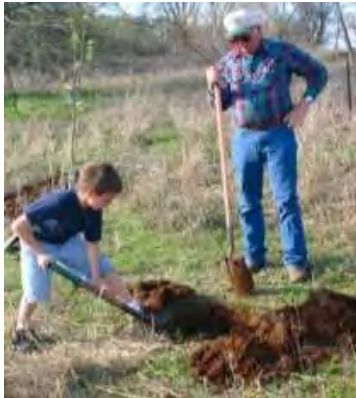
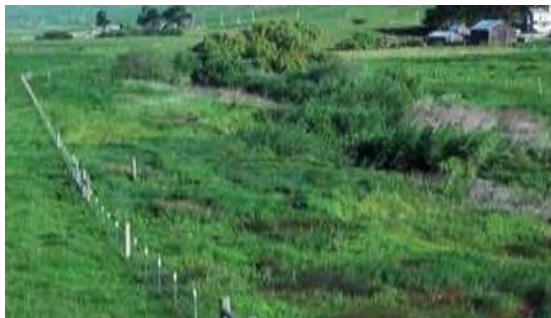
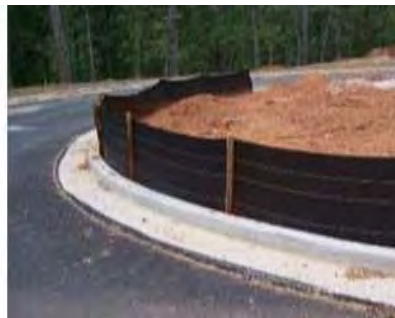
Figure 5.1: Best Management Practices: Planting native trees, shrubs, and grasses; riparian stream buffers; and silt fences (counter clockwise from the top).
