# Wolf Run Watershed Based Plan

Final, March 1, 2013

## Wolf Run Watershed Based Plan

Third Rock Consultants, LLC  
Steve Evans, Chelsey Olson, Jennifer Shelby  
2526 Regency Road, Suite 180  
Lexington, Kentucky 40503  
859-977-2000

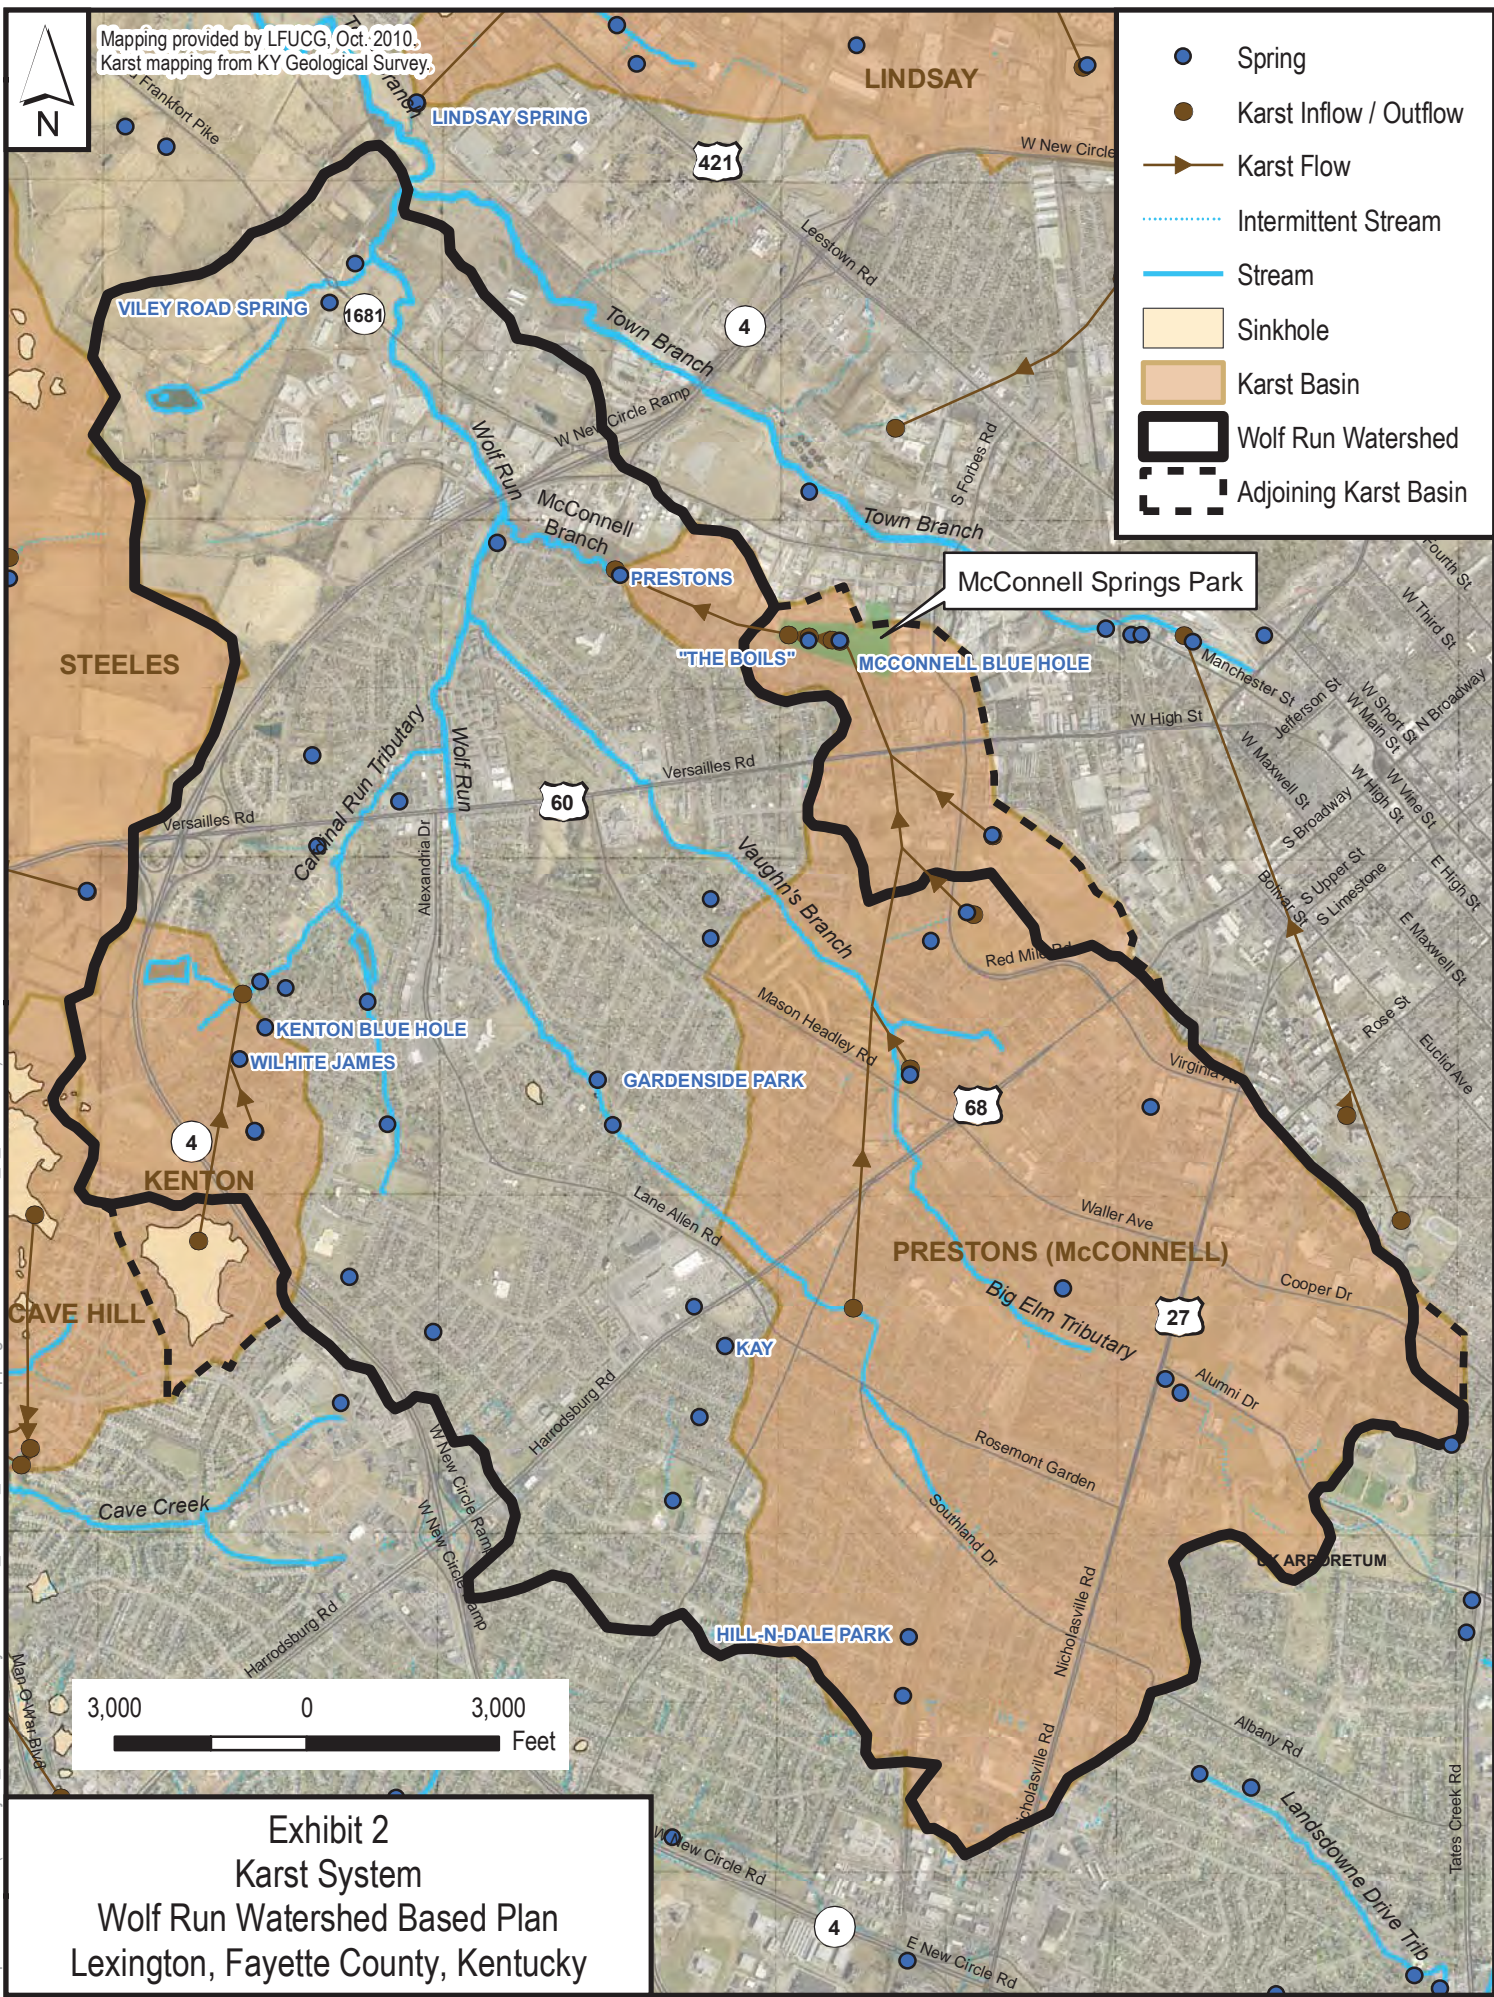
**Exhibit 2**  
**Karst System**  
**Wolf Run Watershed Based Plan**  
**Lexington, Fayette County, Kentucky**

- Spring
- Karst Inflow / Outflow
- Karst Flow
- ⋯ Intermittent Stream
- Stream
- Sinkhole
- Karst Basin
- Wolf Run Watershed
- Adjoining Karst Basin

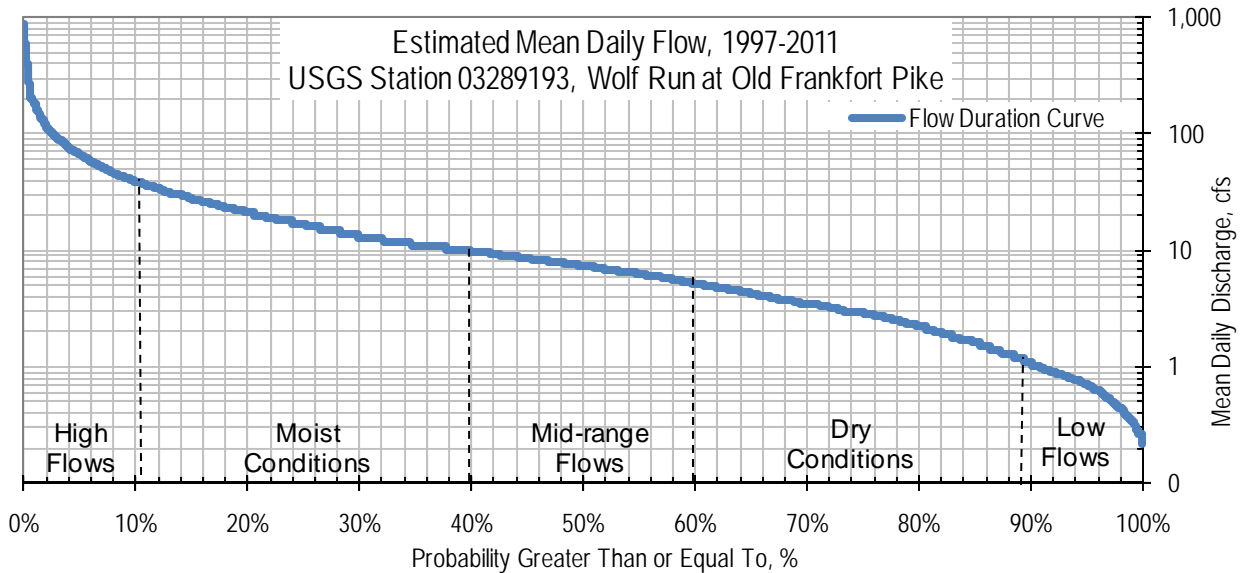
**FIGURE 1 – WOLF RUN AT OLD FRANKFORT PIKE, MEAN FLOW STATISTICS**

A United States Geological Survey gaging station was established on Wolf Run near Old Frankfort Pike in September 1997. Basic statistics on the discharge at this station are provided in Figure 1. These statistics indicate that Wolf Run discharges approximately 0.1 to one cubic foot per second (cfs) under low flows, one to four cfs in dry conditions, four to 10 cfs in mid-range conditions, 10 to 30 cfs under moist conditions, and 30 to 893 cfs in high flows.

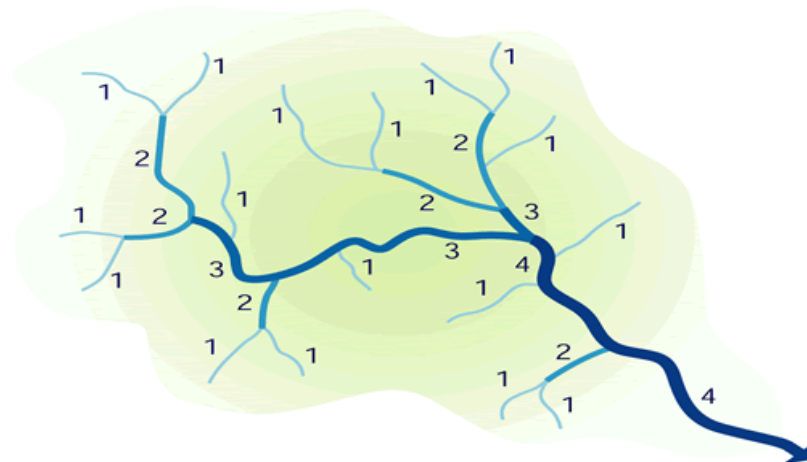
**FIGURE 2 – STREAM ORDER DIAGRAM**

From FISRWG, 1998

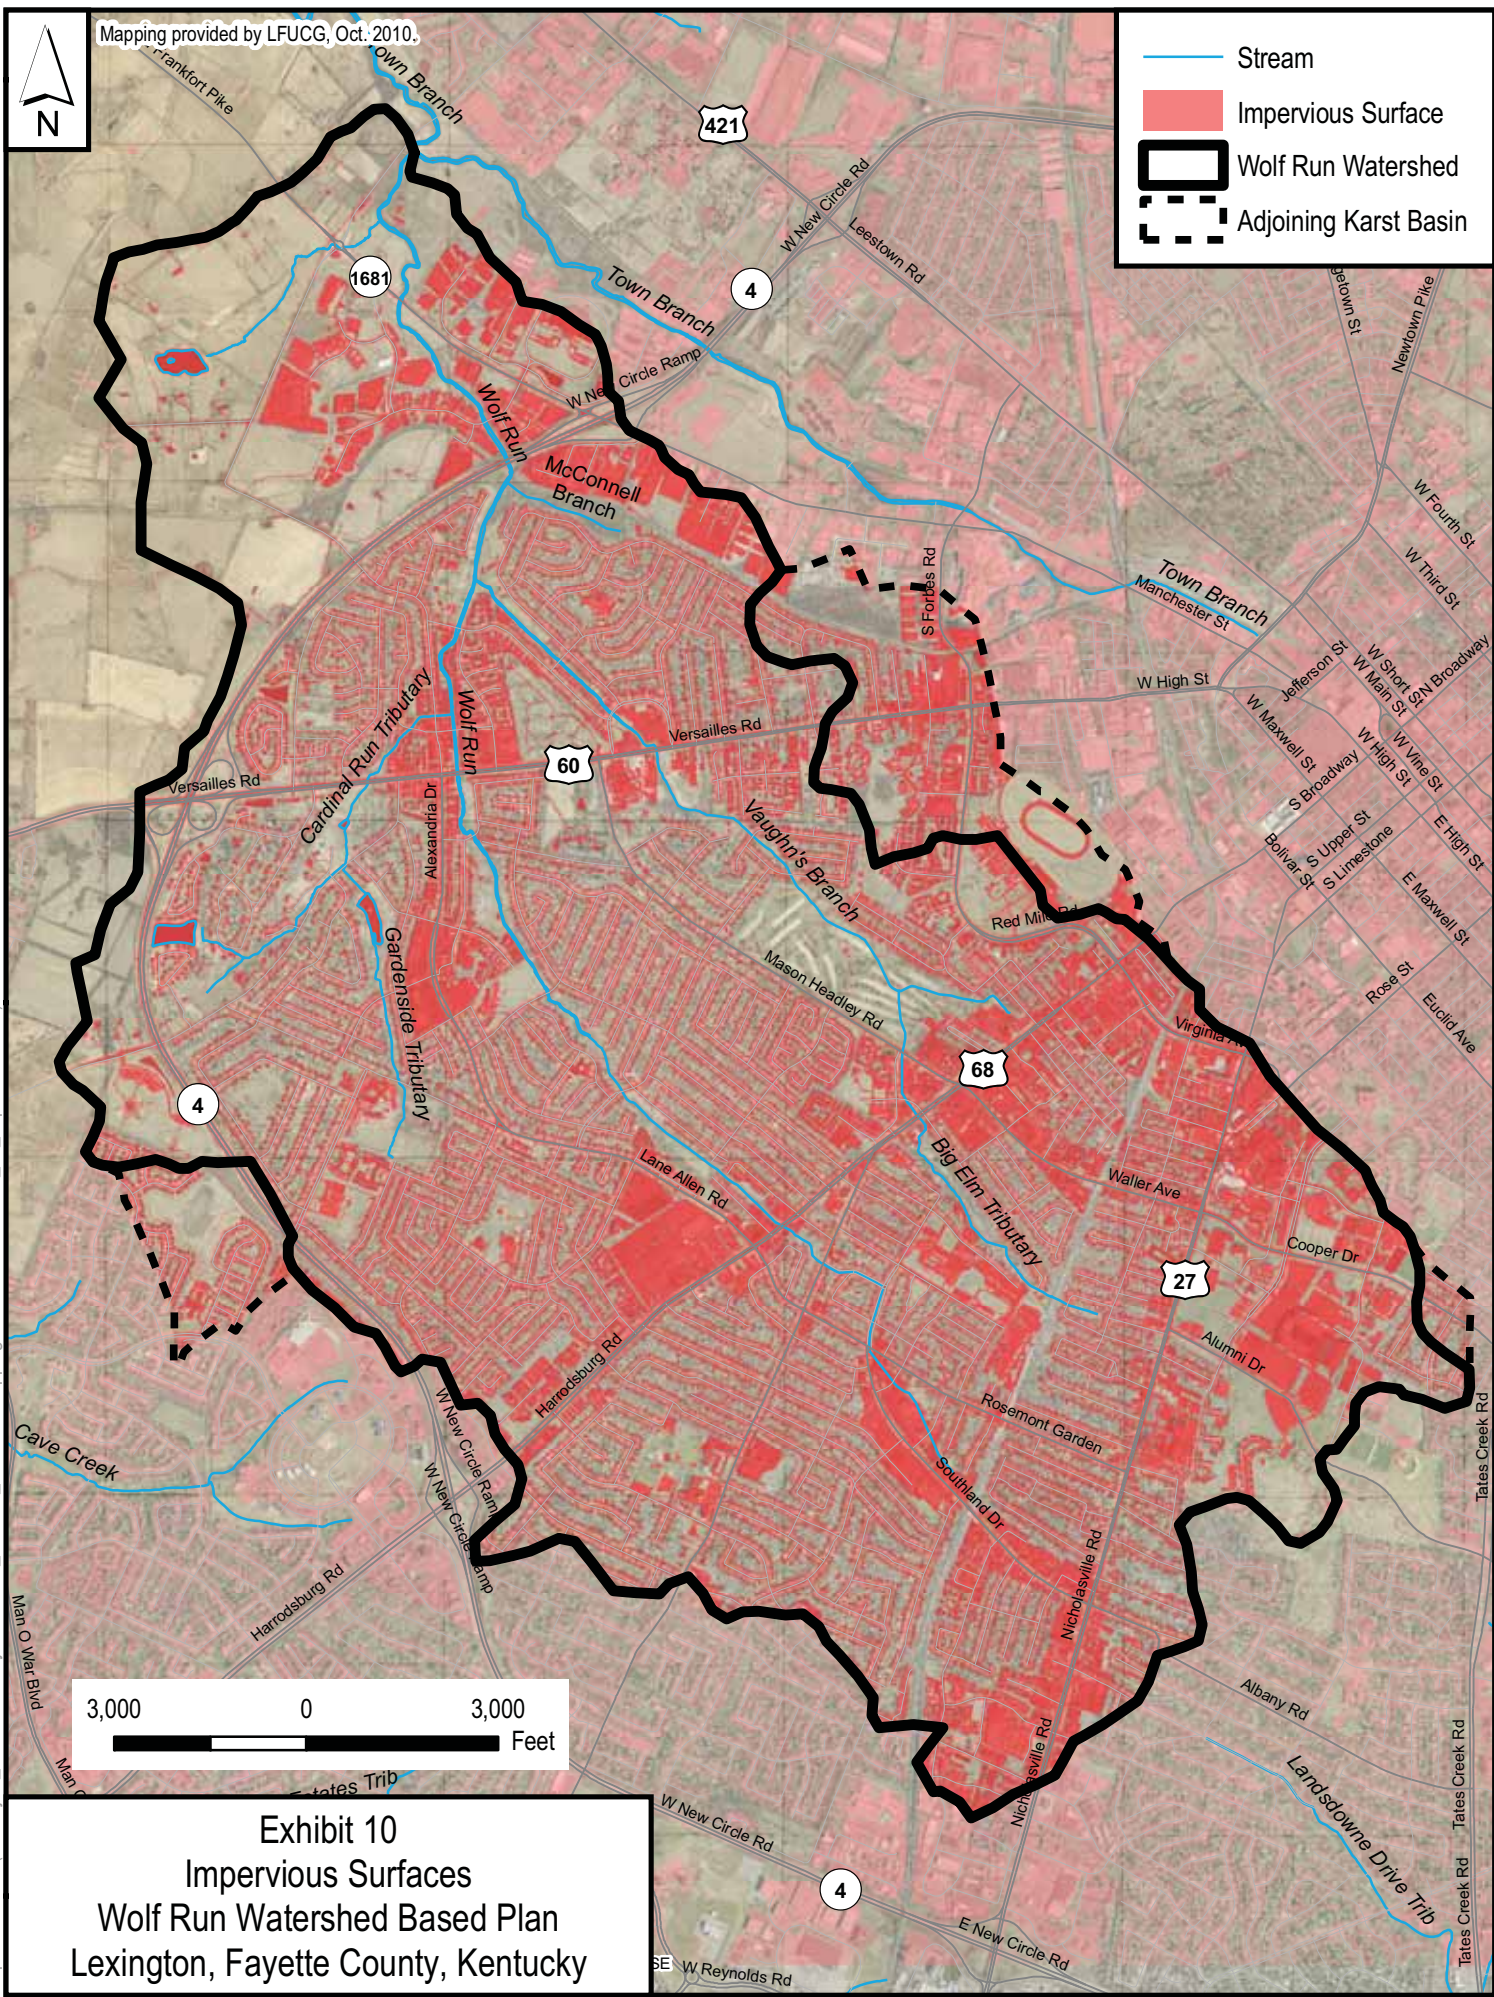
**Exhibit 10**  
**Impervious Surfaces**  
**Wolf Run Watershed Based Plan**  
**Lexington, Fayette County, Kentucky**

Impervious surfaces in Wolf Run account for 40 percent of the watershed area as shown in Table 7, page II-23, and Exhibit 10, page II-24. Impervious surfaces, such as roadways and rooftops, are surfaces which water cannot penetrate. As these surfaces are unable to infiltrate water, they subject streams to extraordinarily high flows during storm events, leading to erosion and further pollution. Impervious surfaces have been found to multiply discharge rates by two to five times for a given event. On impervious roadways, vehicles introduce numerous pollutants including oils, grease, rubber, and heavy metals (lead, zinc, copper). Some of these pollutants also accumulate when the vehicles are idle on parking lots, driveways, and other parking areas. Most heavy metals tend to accumulate and remain within vegetated ditches adjacent to the surface. Other roadway pollutants tend to be more mobile. Research indicates that the amount of pollutants in surface waters is proportional to the amount of average daily traffic. Also, in winter months, deicing salt transported through runoff can be a significant pollutant to surface waters. Roof runoff can also be high in certain metals and solids. In residential areas, lawn fertilization and pesticide applications, carried to streams through the storm sewer system, can also contribute to nonpoint source

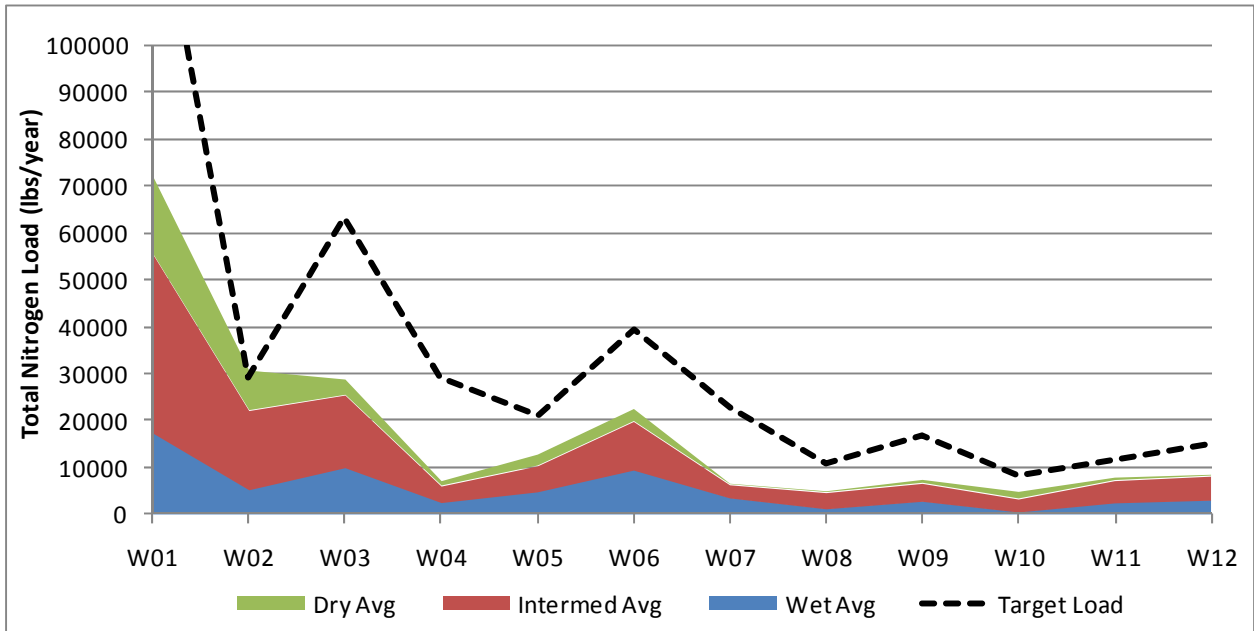
FIGURE 7 – ANNUAL TOTAL NITROGEN LOADING CONTRIBUTIONS BY EVENT TYPE

\*Target load based on 3.0 mg/L non-regulatory reference point.

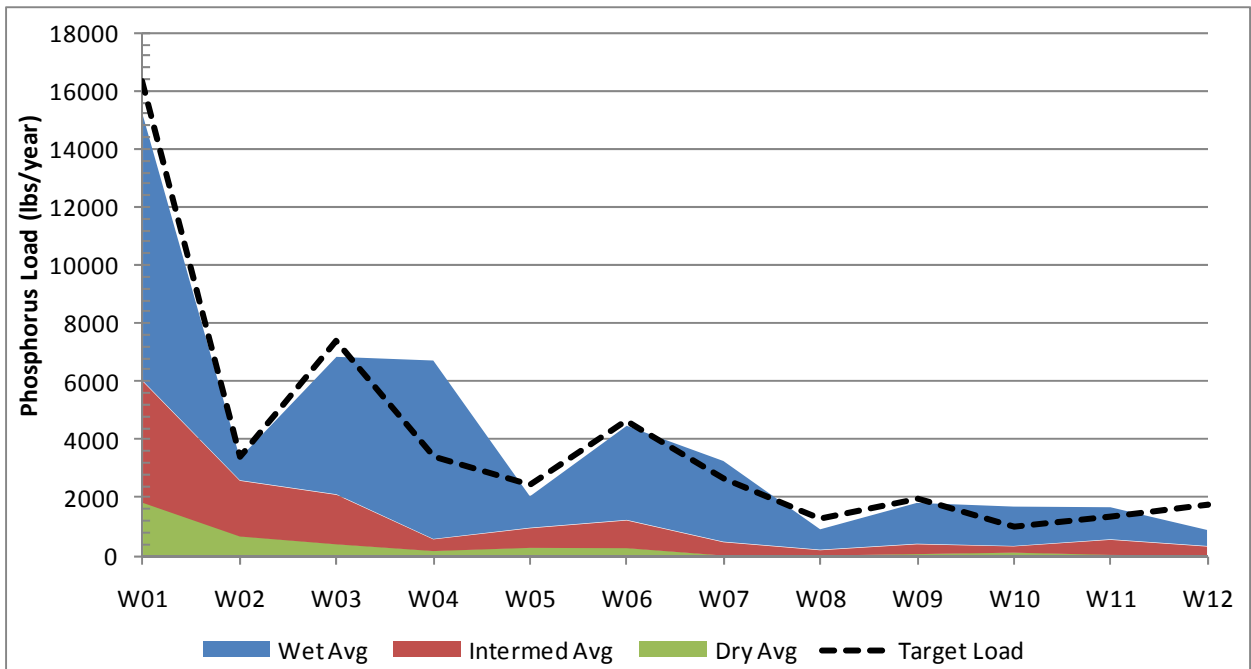
**FIGURE 8 – ANNUAL TOTAL PHOSPHORUS LOADING CONTRIBUTIONS BY EVENT TYPE**

\*Target load based on 0.35 mg/L non-regulatory reference point.

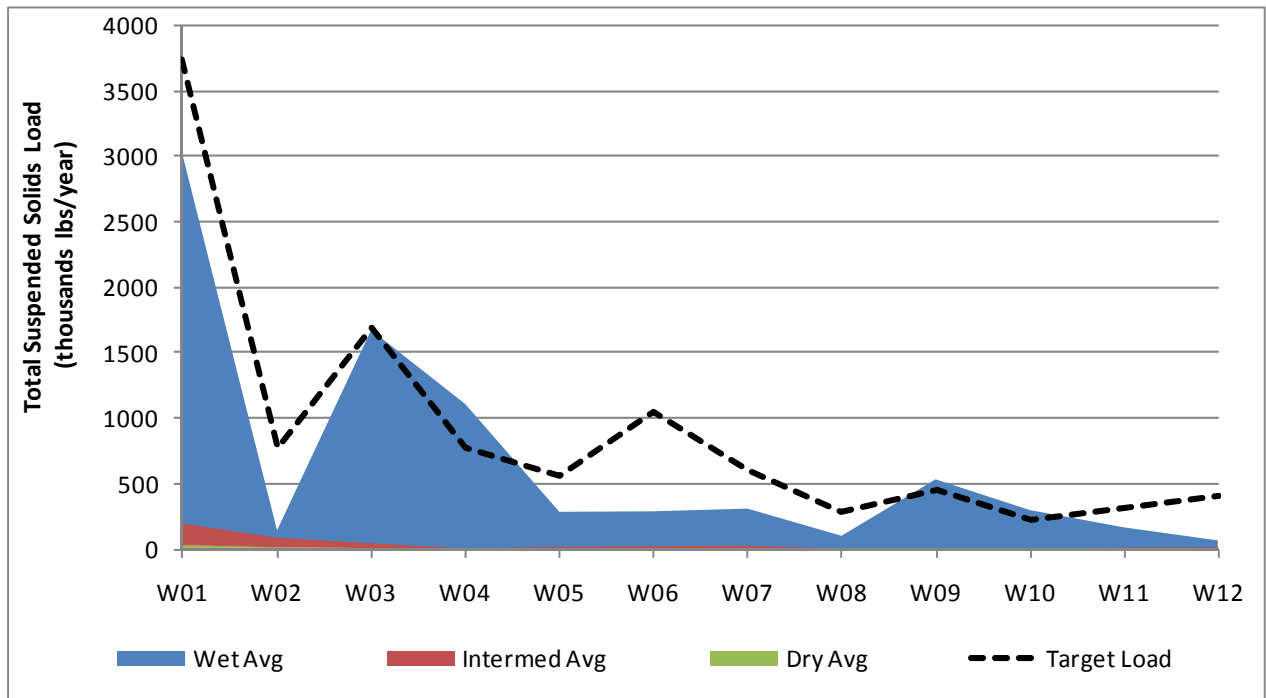
FIGURE 9 – ANNUAL TOTAL SUSPENDED SOLIDS LOADING CONTRIBUTIONS BY EVENT TYPE

\*Target load based on 80 mg/L non-regulatory reference point.

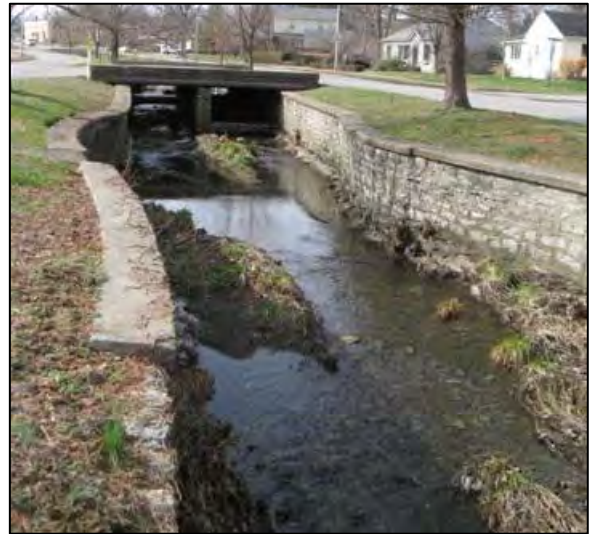
The encroachment of development into the floodplain and riparian zone of some streams within the Wolf Run Watershed have rendered restoration of certain reaches unfeasible due to the high cost involved with the acquisition of property and stream and floodplain restoration. Specifically, over 4,300 feet of Wolf Run upstream of Clays Mill Road is either located within a concrete channel or has stone armored banks. Much of this reach is also located between roadways or shopping centers. These urban constraints limit the restoration options for these reaches and make restoration very difficult; thus, stream restoration is considered unfeasible for these reaches. Green infrastructure to contain stormwater onsite and reduce runoff volumes is considered a more feasible BMP in this area.

*Armored Banks on Wolf Run at Lafayette Parkway*

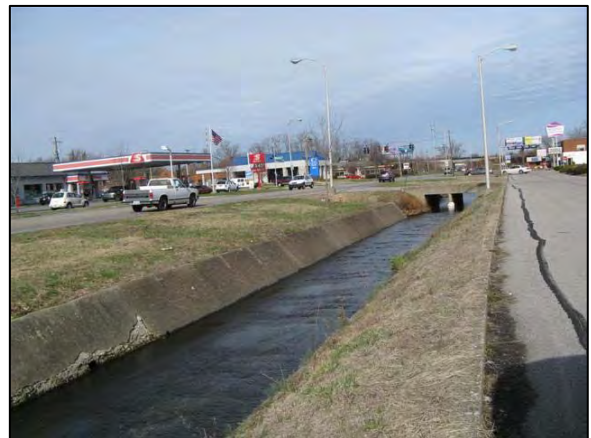
The ownership of property was considered when determining the feasibility of BMPs. Publicly-owned lands were given priority for BMP installation, particularly for stream restoration, due to the ease in procuring funding and coordination and avoidance of some of the challenges of obtaining landowner permission and participation. When projects are located on properties owned by multiple landowners, the coordination process is often slow and can fail after considerable expense has gone towards conceptual development and planning. Therefore, projects with public ownership or single property ownership were preferred.

*Wolf Run, Concrete Channel Beside Southland Drive*
