Hancock Creek Watershed Plan

The Hancock Creek Watershed Plan (WP) outlines all point and nonpoint pollution sources in the watershed, quantifies the pollution coming from each source, and makes recommendations for Best Management Practices (BMPs) to improve water quality in Hancock Creek.

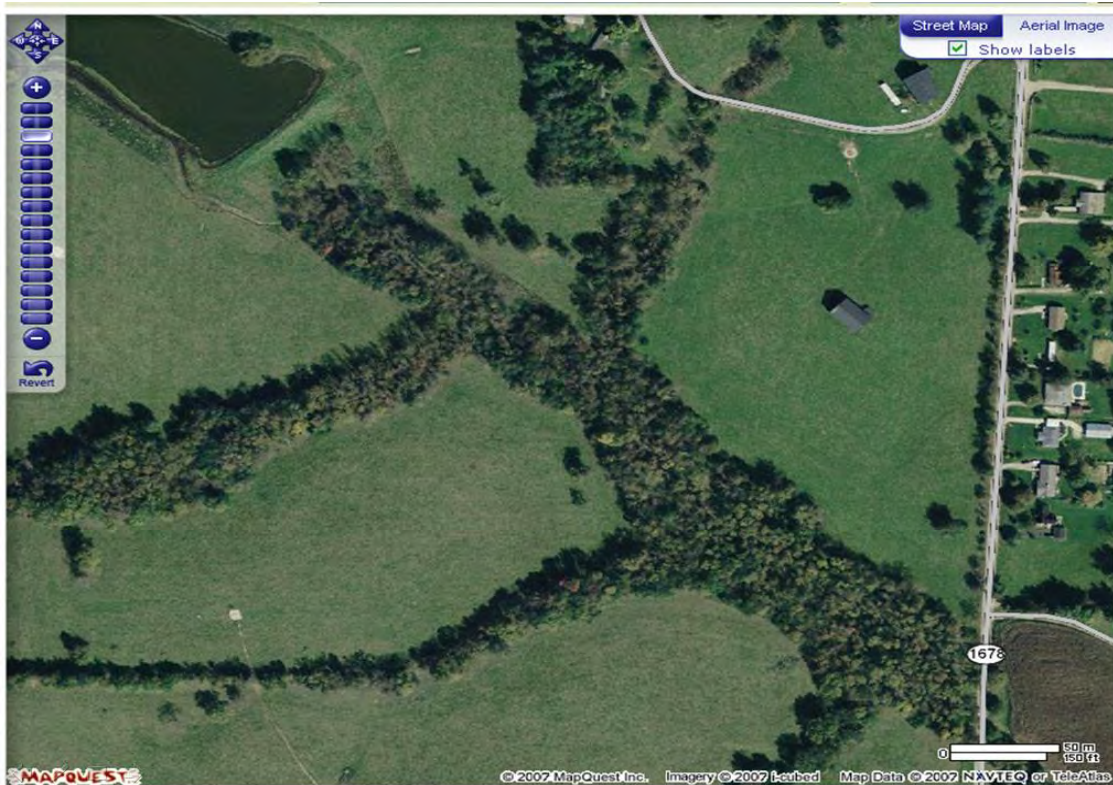
Figure 2.8. Upland tributary of Hancock Creek, north of I-64 at the Fayette County line, with intact riparian tree canopy. Source: Tetra Tech, 2008.

In terms of stream channel issues, it should be noted that the mainstem of Hancock Creek is fenced off from cattle and fairly vegetated for most of its length. Small sections – especially along the tributaries and the lowermost portion of the creek at the confluence with Strodes Creek – do remain unfenced with degraded streambeds. It is believed that the lack of riparian vegetative and tree canopy cover, unrestricted livestock access to the stream network, and heavy grazing of riparian and upland pastures by mostly cattle on some sections of Hancock Creek and most of its tributaries contribute to increased runoff, higher stream flows, elevated loadings of bacteria and sediment, and lowered dissolved oxygen during low summertime flows. While there are some reaches of the creek that display excellent riparian vegetative cover, many areas are relatively devoid of all vegetation except grasses (see Figures 2.5-2.8 below).

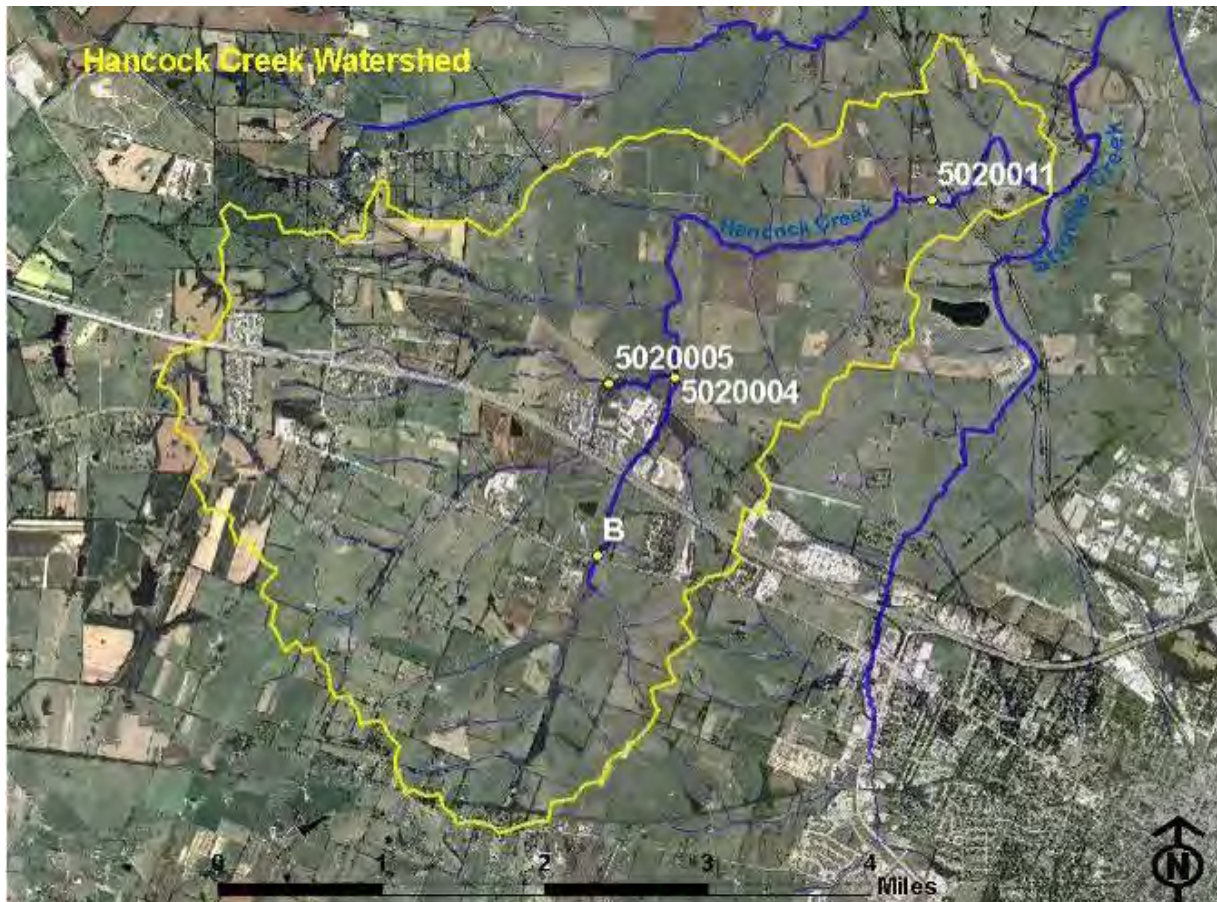
Figure 3.1: Location of Hancock Creek Monitoring Sites. Source: Tetra Tech, 2008.

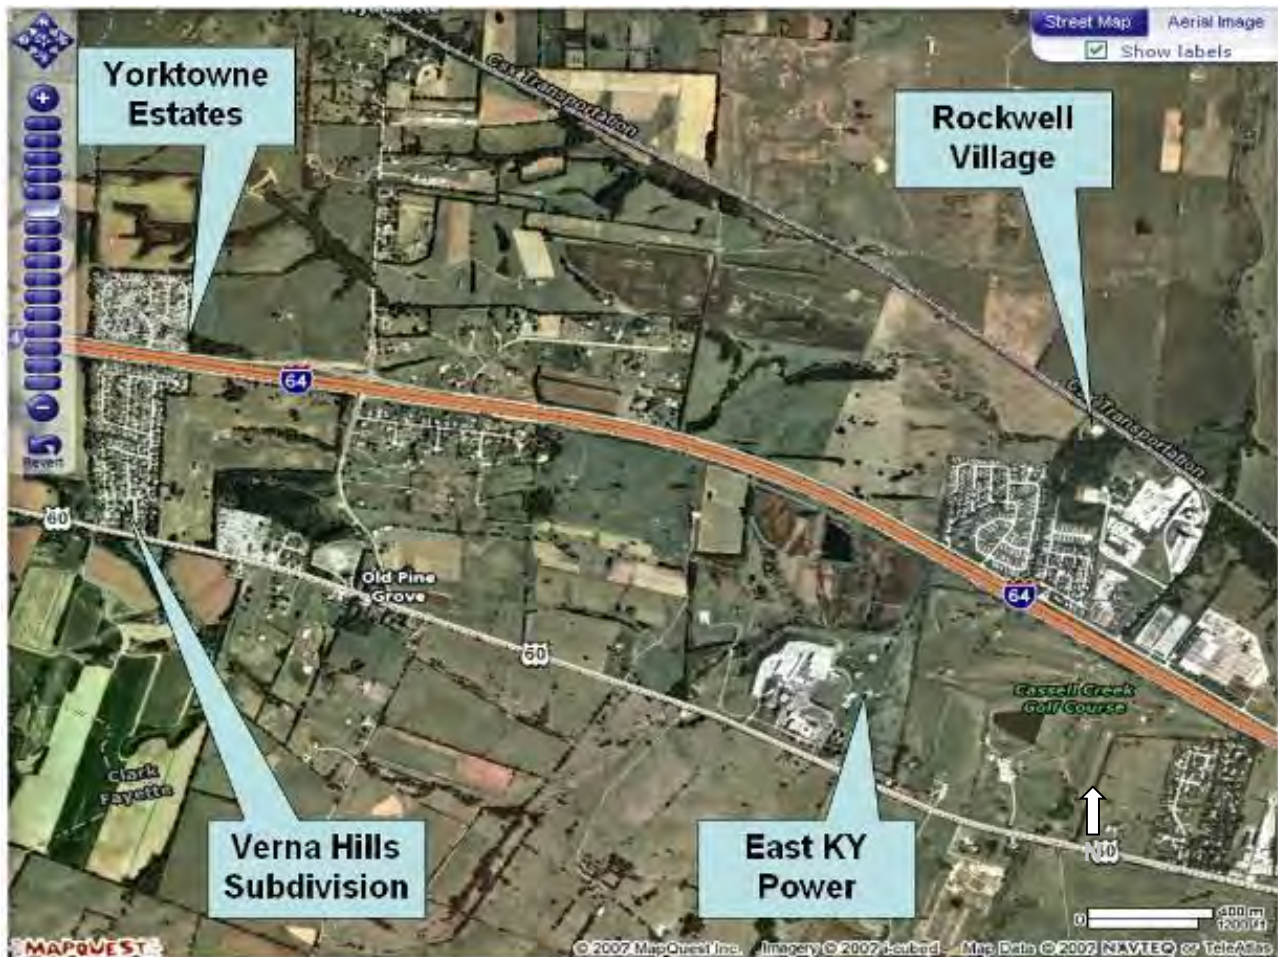
Figure 3.41: Locations of the wastewater treatment plants that discharge into Hancock Creek. Source: Tetra Tech, 2009.

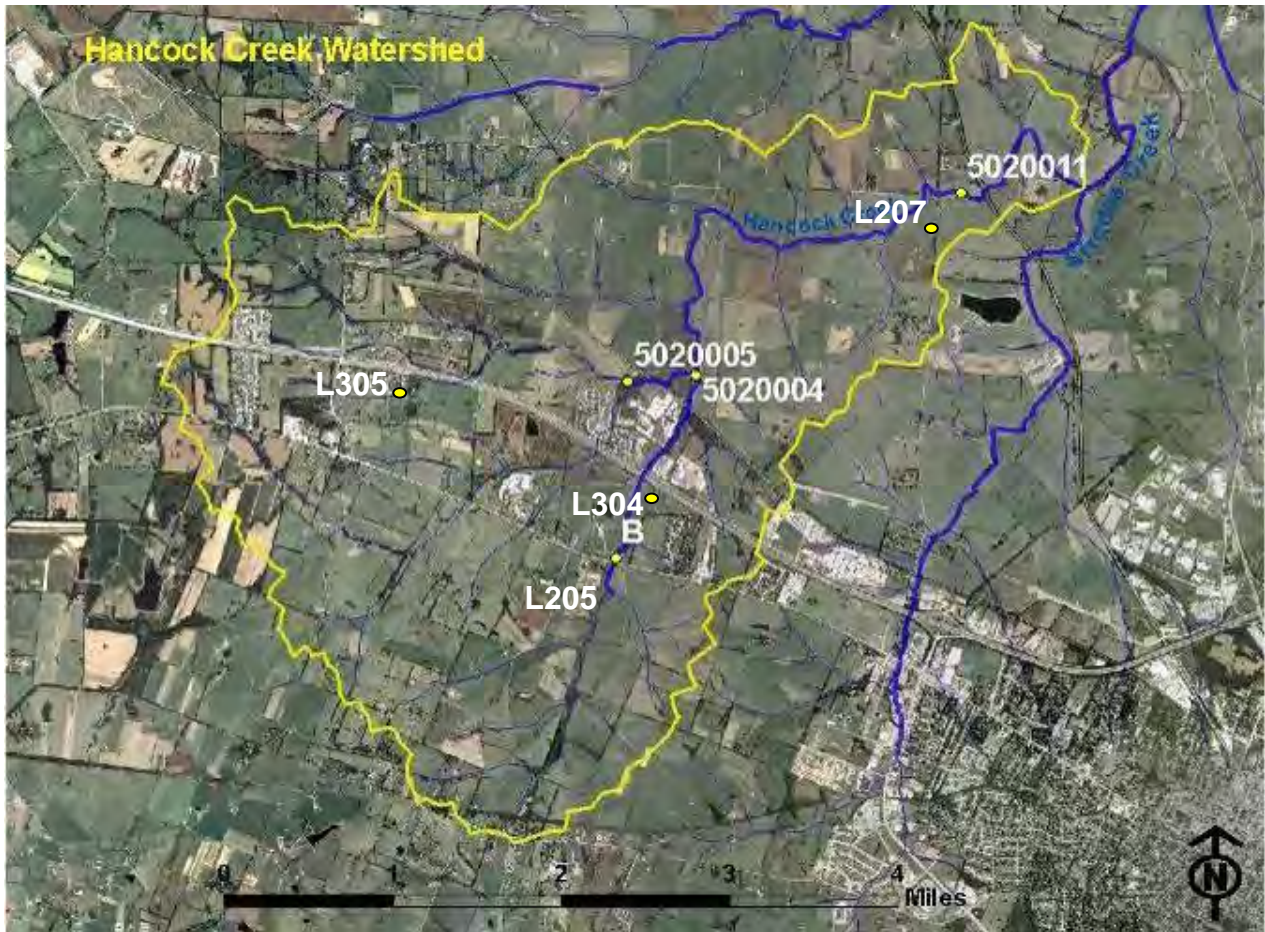
Figure 3.42: Location of Hancock Creek water quality monitoring sites. Source: Tetra Tech, 2008.

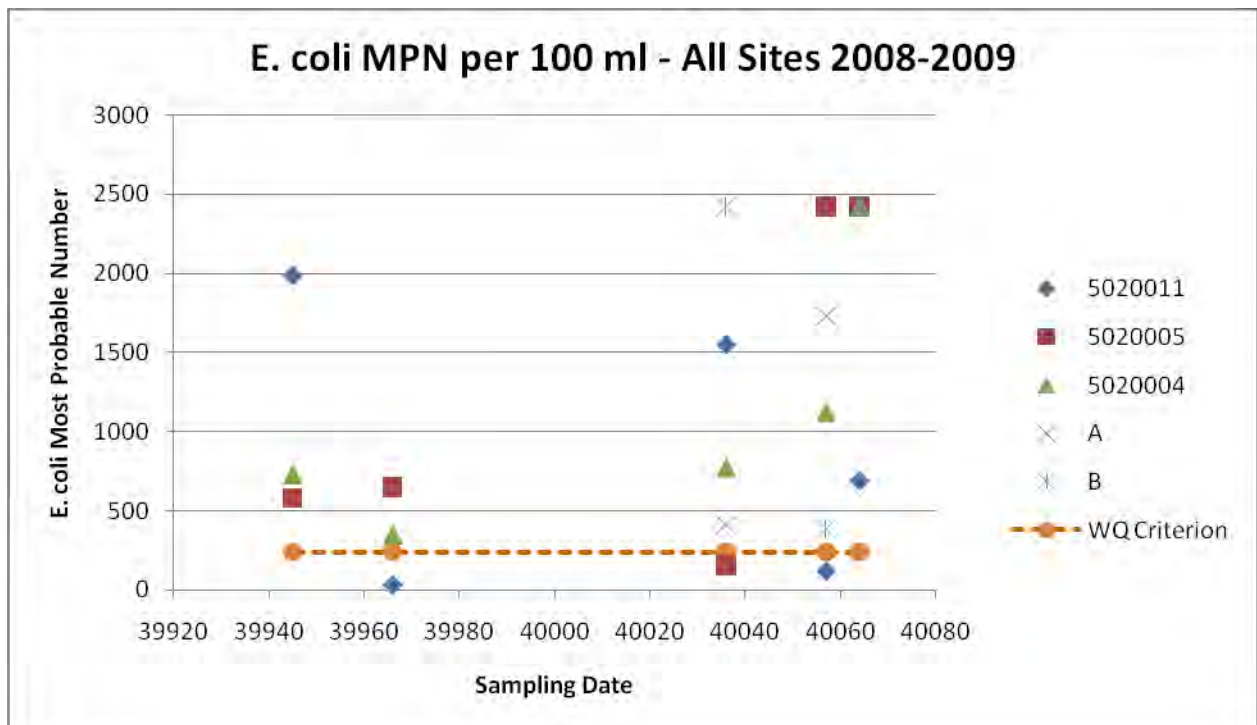
Figure 3.51: *E. coli* data for Hancock Creek sampling sites during late 2008 – 2009. Source: Tetra Tech, 2009.

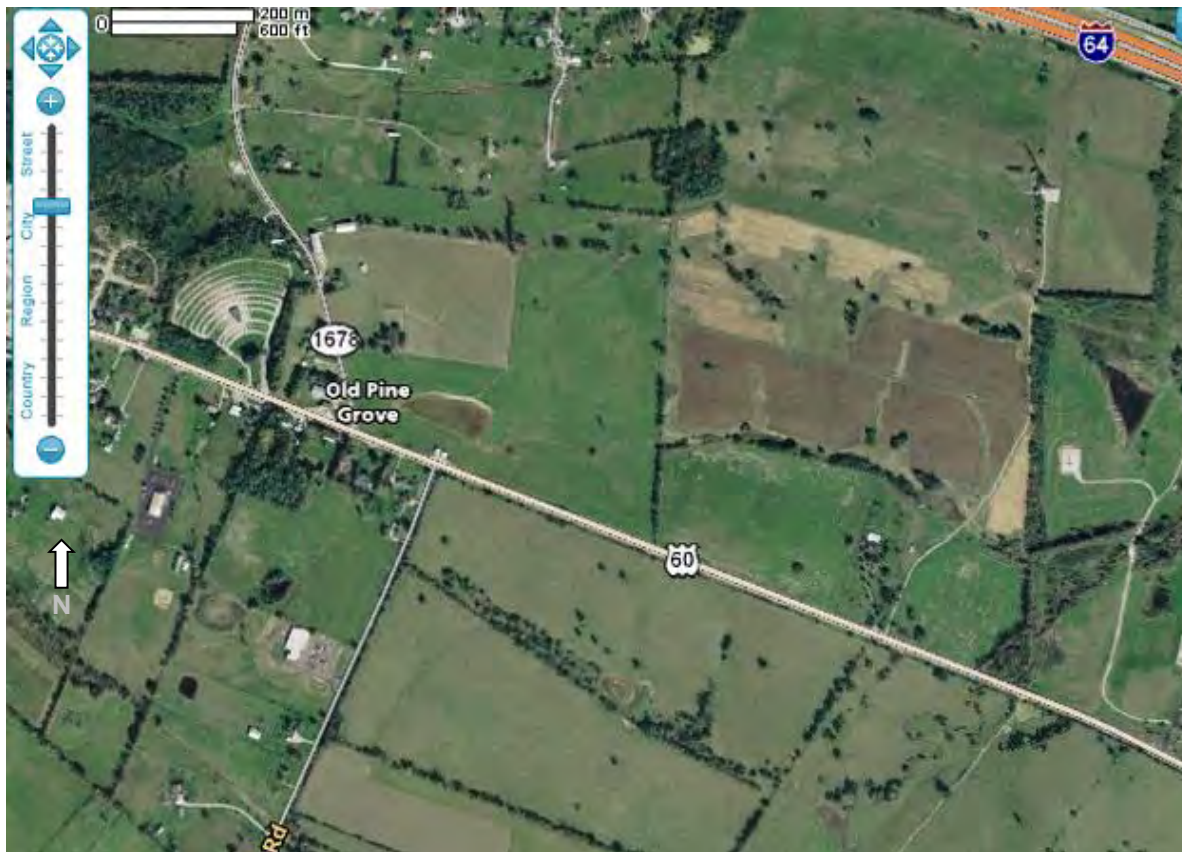
Figure 3.55: Upper Hancock Creek watershed aerial photo, showing variable pasture quality. Source: Tetra Tech, 2009.
