**Red Bird River Watershed Restoration Project  
Draft Watershed Plan**

**April 2016**

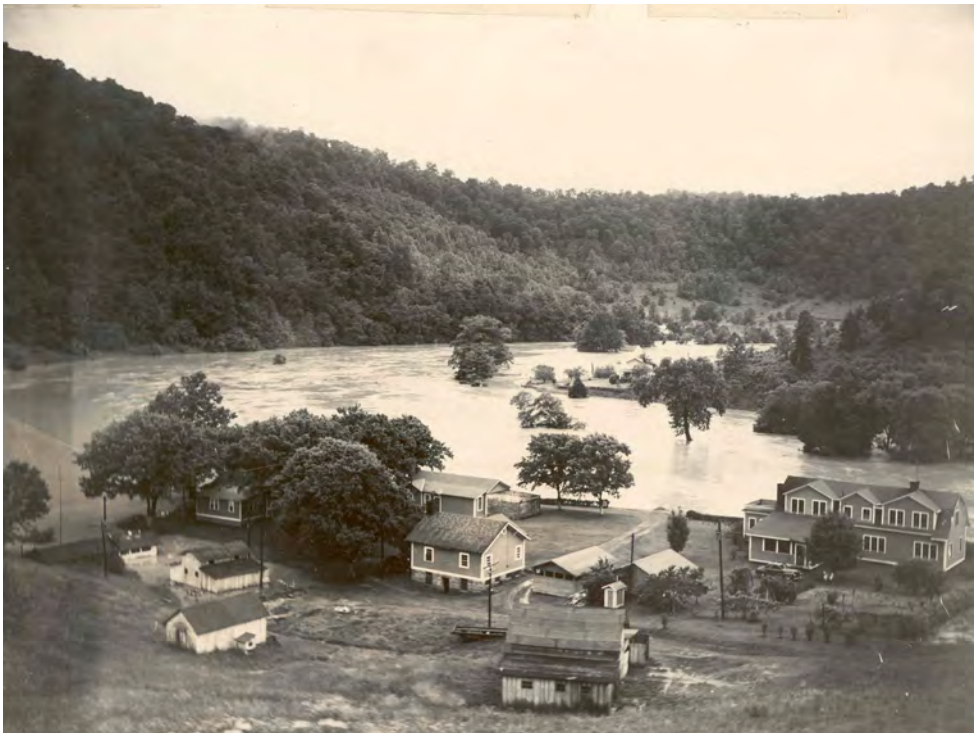
**Figure 2.4:** The June 28, 1947 Red Bird River flood as seen from the USFS office in Peabody, KY.

Two of the largest floods in the Red Bird River Watershed were in 1947 and 1957. The heaviest damage occurred in built up areas where a higher percentage of homes were built in the flood plain than homes in less developed areas. Figure 2.3 shows the Ranger Station in the Peabody area in 1940, before the 1947 flood. Figure 2.4 shows the same area during the 1947 flood.

In addition to the unusually heavy rain fall, a convergence of other events that diminished the area of forest cover and reduced forest health across the landscape may have contributed to the severity of flooding in the 1947 and 1957 floods. These factors include:

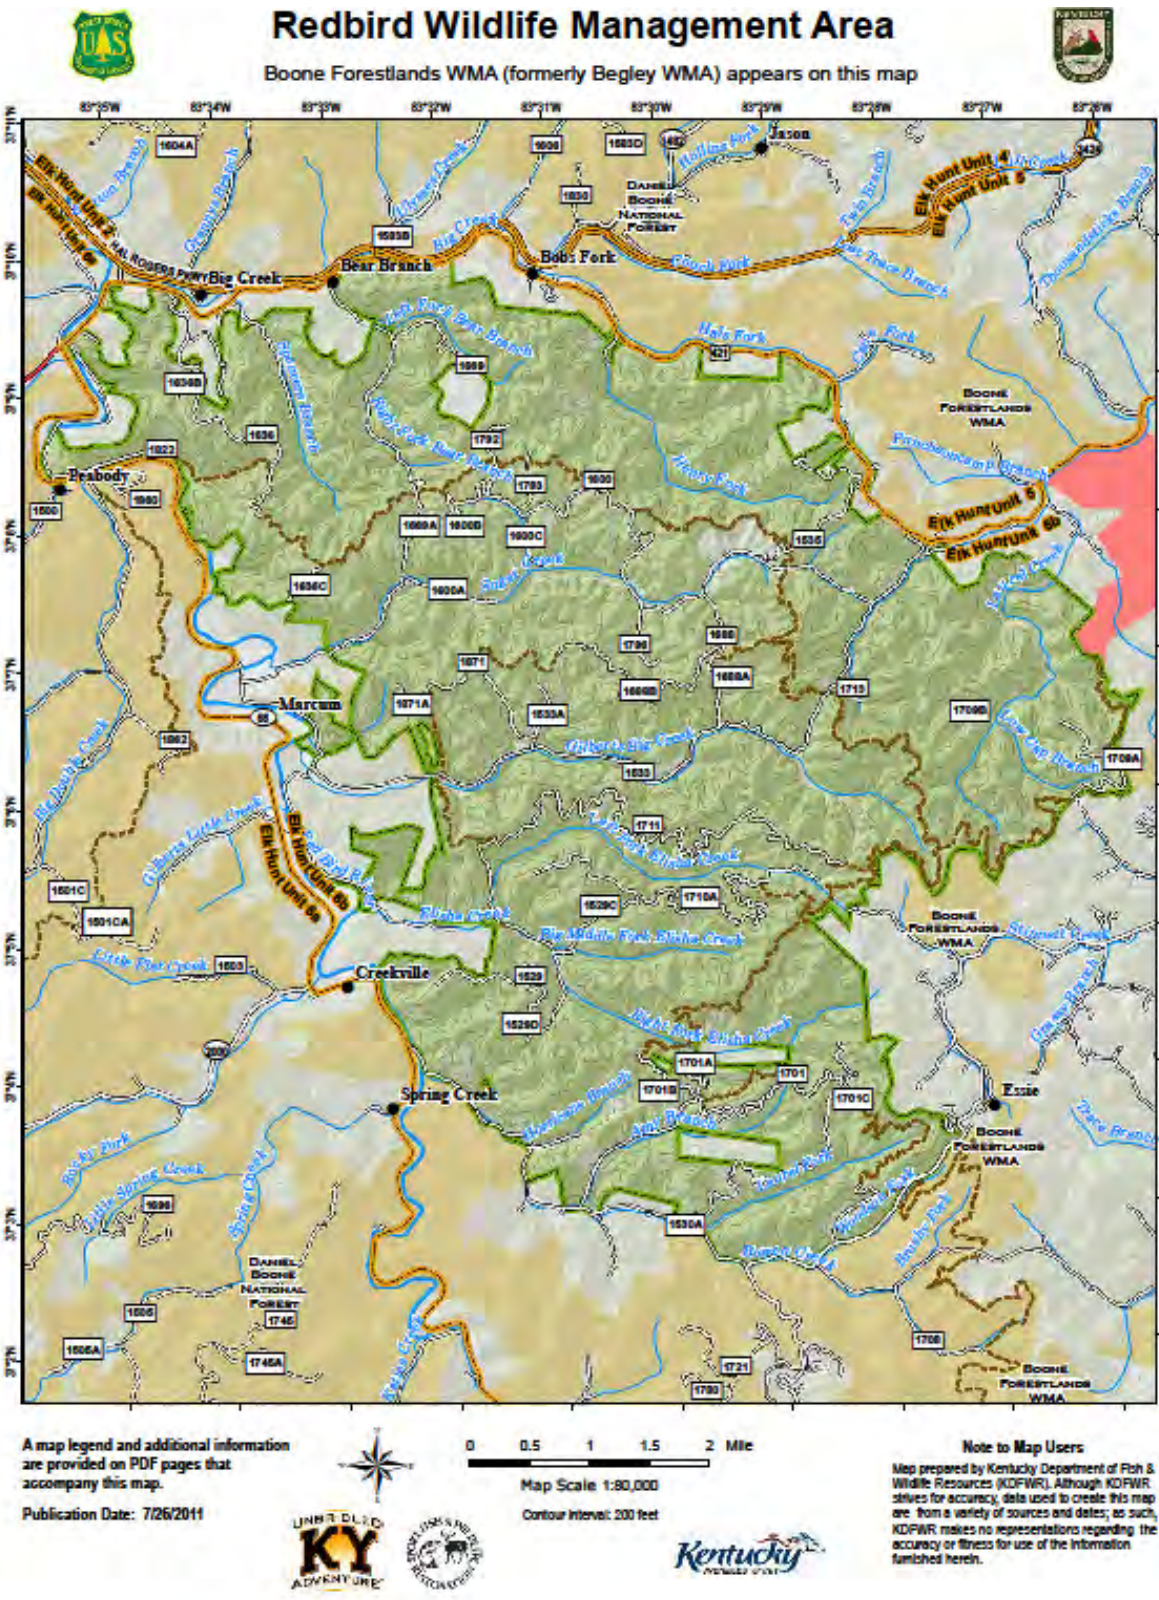
Figure 2.13: The Redbird Wildlife Management Area Map (KY State 2012).

There are two wildlife management areas located within the watershed (Figure 2.13). One of them, the Redbird Wildlife Management Area, accounts for a large portion of the watershed. The other, the Elk Forest Wildlife Management Area, is a small portion of the southern tip of the watershed. Information taken directly from each area's website is included here. For more information, contact the Management area directly.

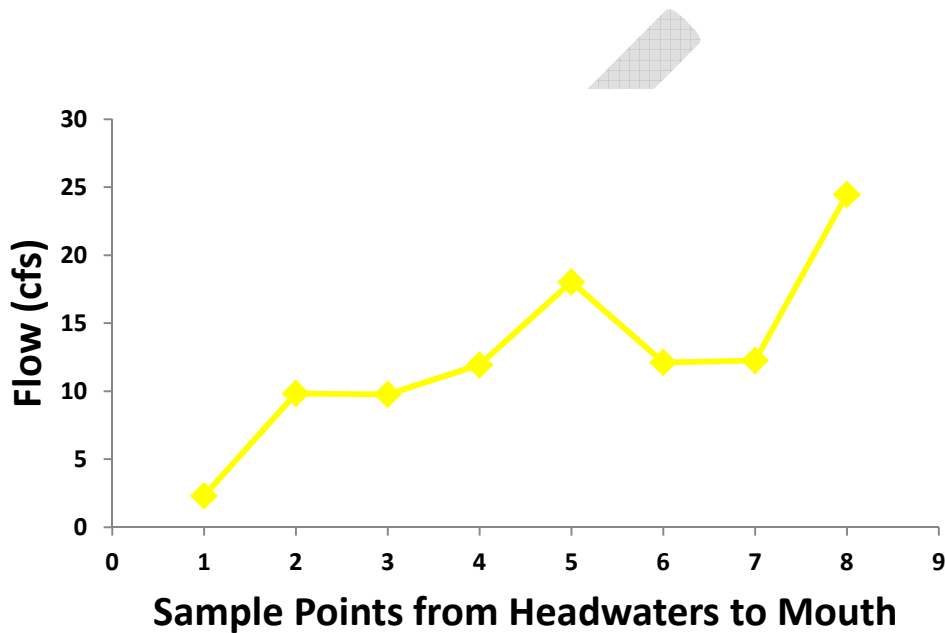
**Figure 4.4:** Flow, measured in cubic feet per second, in the Red Bird River from the headwaters (Sample point 1) to the mouth (Sample point 8).

The following figures (Figures 4.4 through 4.13) depict water quality measurements taken during the sampling event that occurred between August 29 and September 1, 2011. All water quality parameters, except *E. coli*, were sampled one time during this sampling event. The amount of the measured parameter is on the vertical axis, and the sample point/location is on the horizontal axis (see mapped location of sample points on Figures 4.1 and 4.2). Data was graphed this way so that one may compare the differences in amounts of a specific parameter, such as flow, at different locations in the watershed, from the headwaters to the mouth.

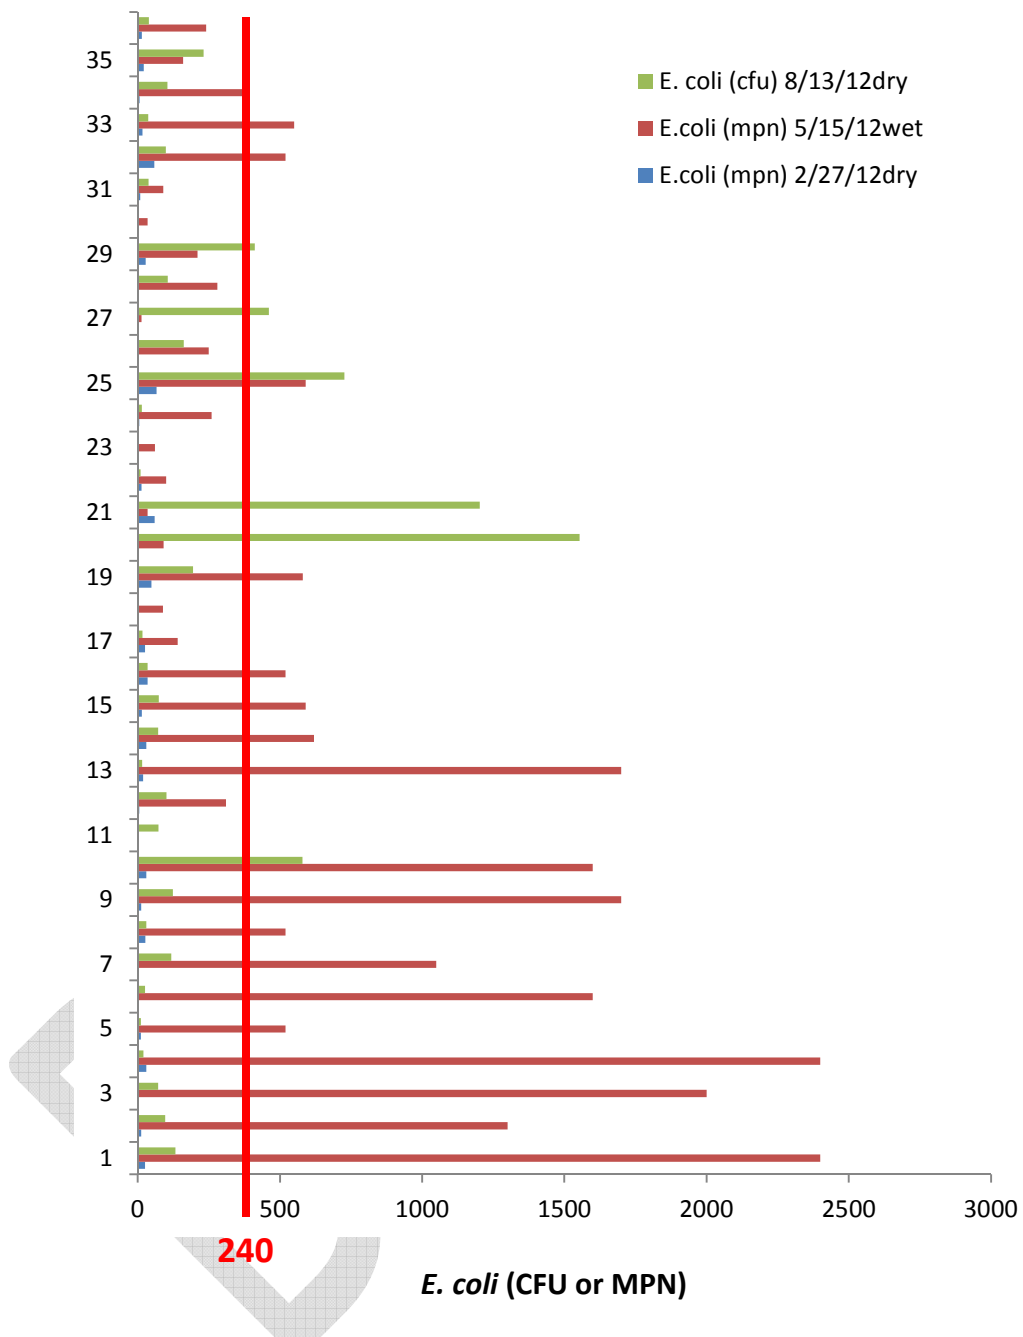
**Figure 4.23:** *E. coli* concentrations at all 36 sampling points on the Red Bird River, arranged spatially from the headwaters (point 1) to the mouth (point 36), for three sampling events. The water quality standard of 240 CFU is shown.

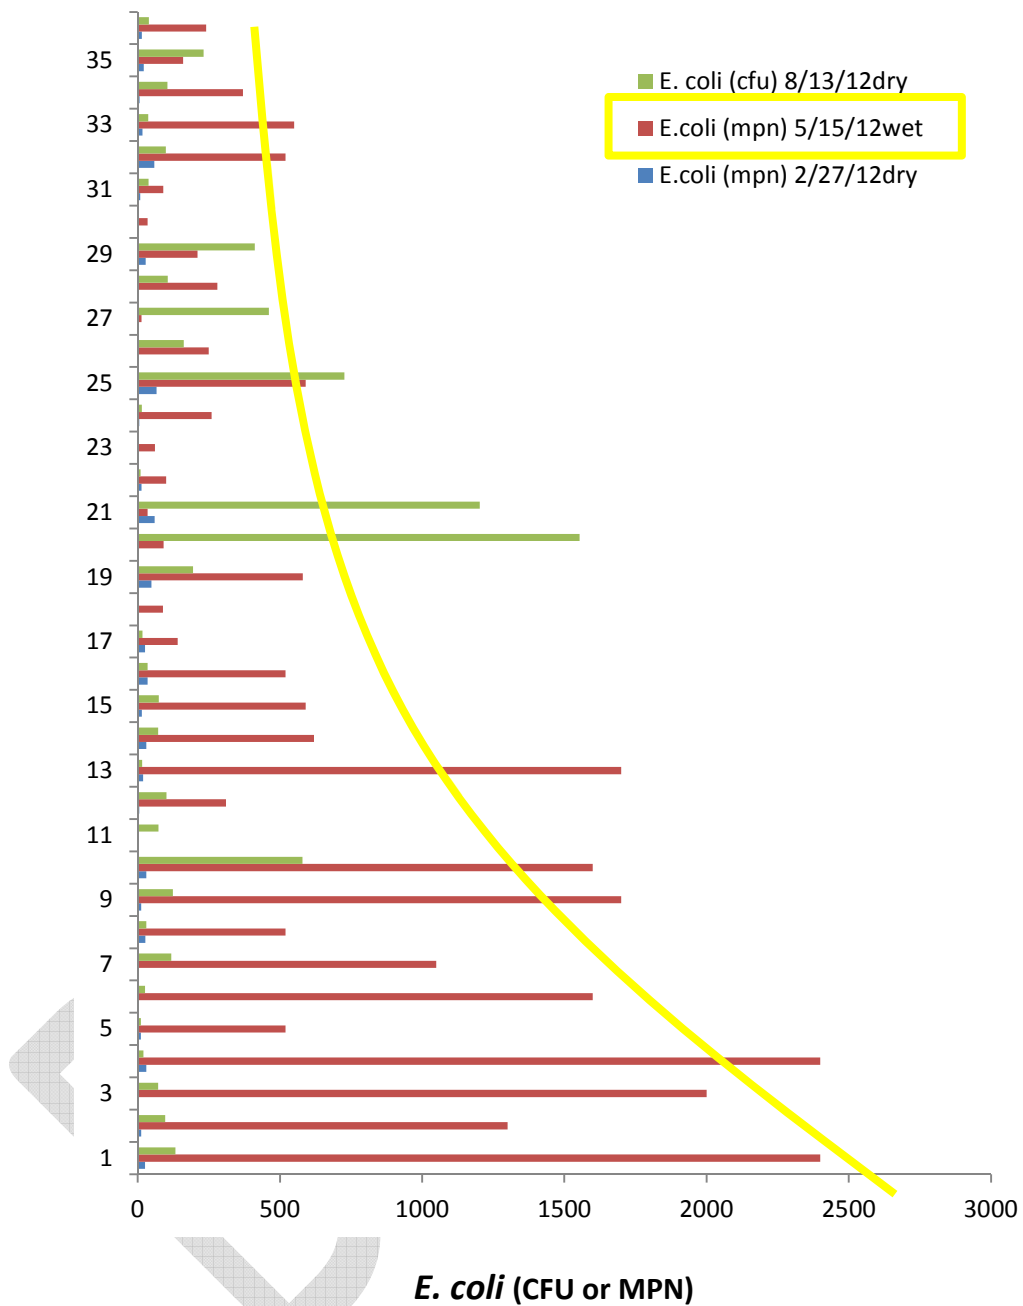
**Figure 4.24:** *E. coli* concentrations at 36 sampling points from the Red Bird River. The yellow line illustrates the pattern of decreasing concentration from the headwaters (point 1) to the mouth (point 36) of the Red Bird River for the 5/15-16/2012 sampling event.

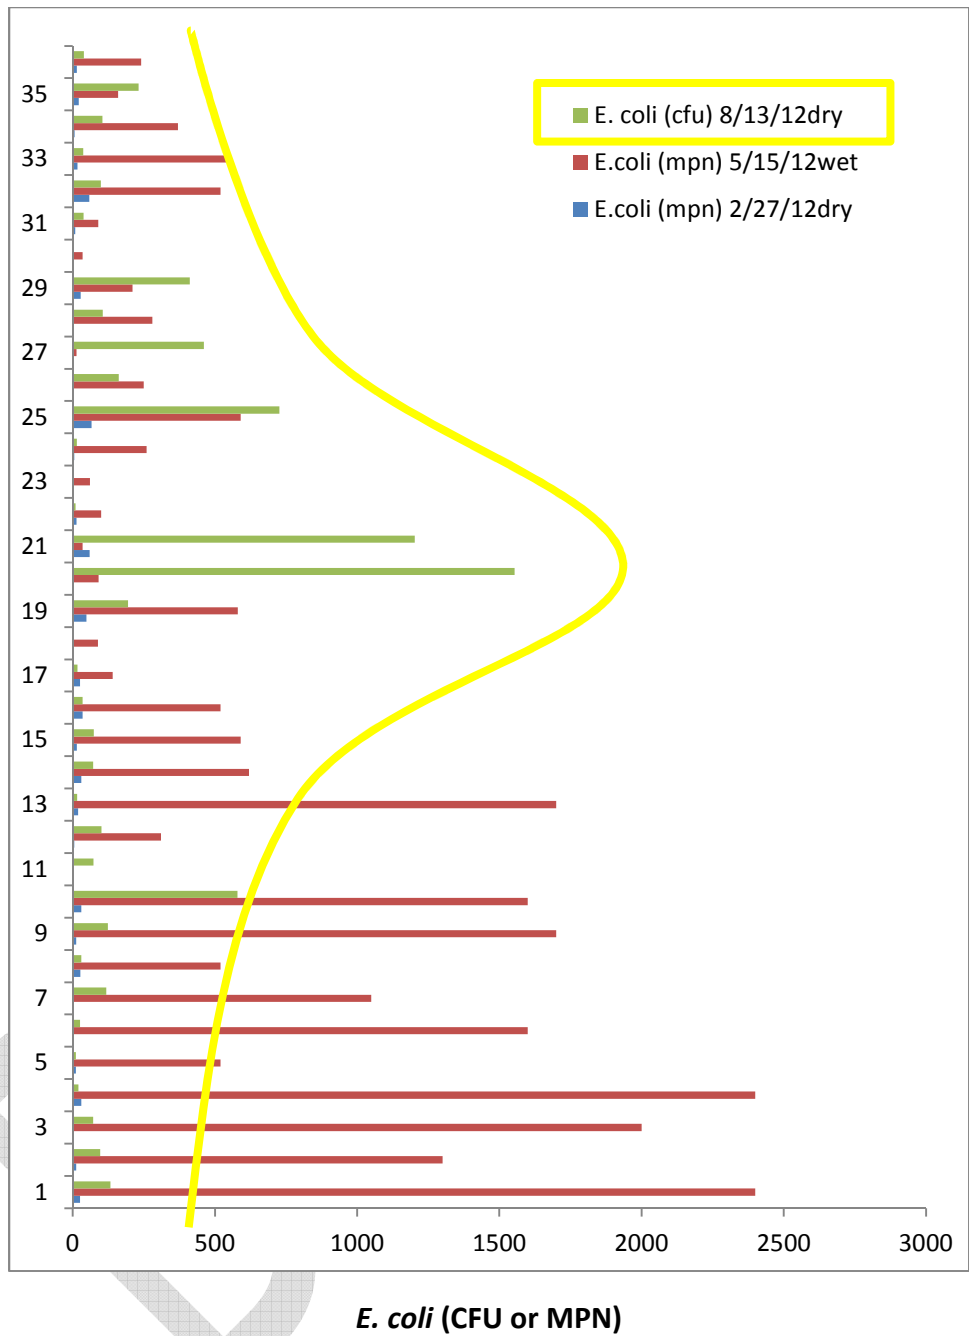
**Figure 4.25:** *E. coli* concentrations at 36 sampling points in the Red Bird River Watershed arranged from the headwaters (point 1) to the mouth (point 36). The sampling event of 8/13/12 is highlighted, showing a spike in concentration in the middle of the Red Bird River Watershed.

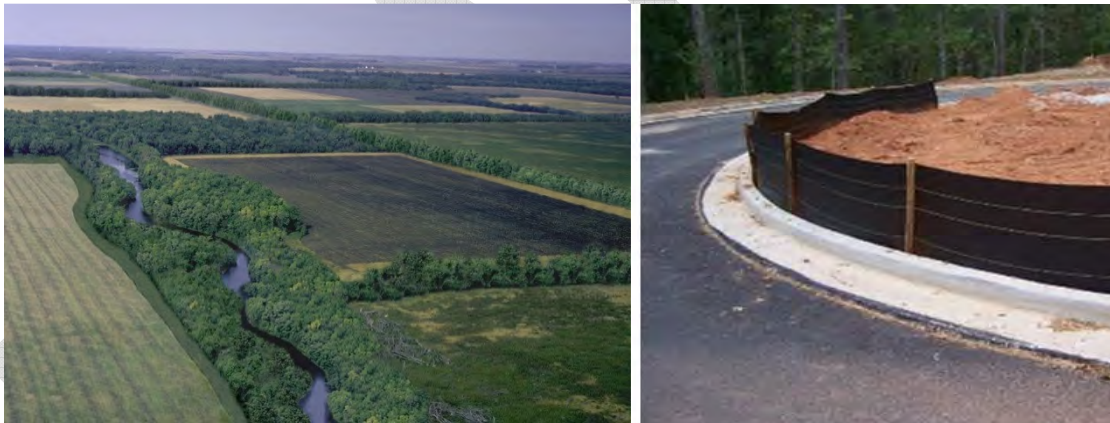
**Figure 5.1:** Riparian stream buffers and silt fences are structural BMPs that help protect water quality.

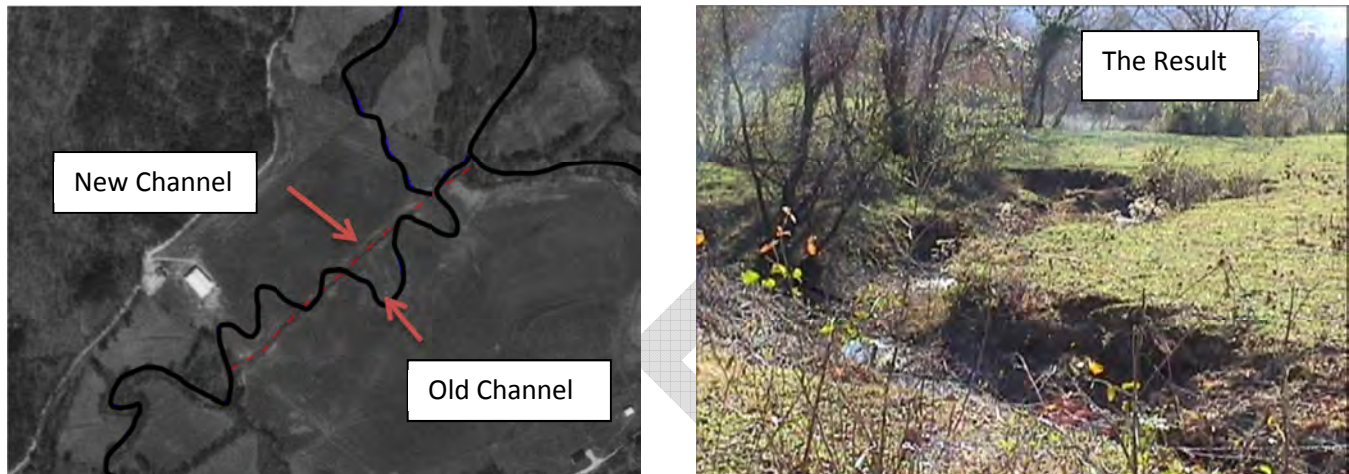
**Figure 5.2:** Stream channelization and the resulting bank erosion.
