Watershed Based Plan

Clarks Run Watershed Boyle County, Kentucky

Prepared for
Kentucky Division of Water
200 Fair Oaks Lane
Frankfort, KY 40601

Prepared by
Third Rock Consultants, LLC
2526 Regency Road, Suite 180
Lexington, KY 40503
859.977.2000

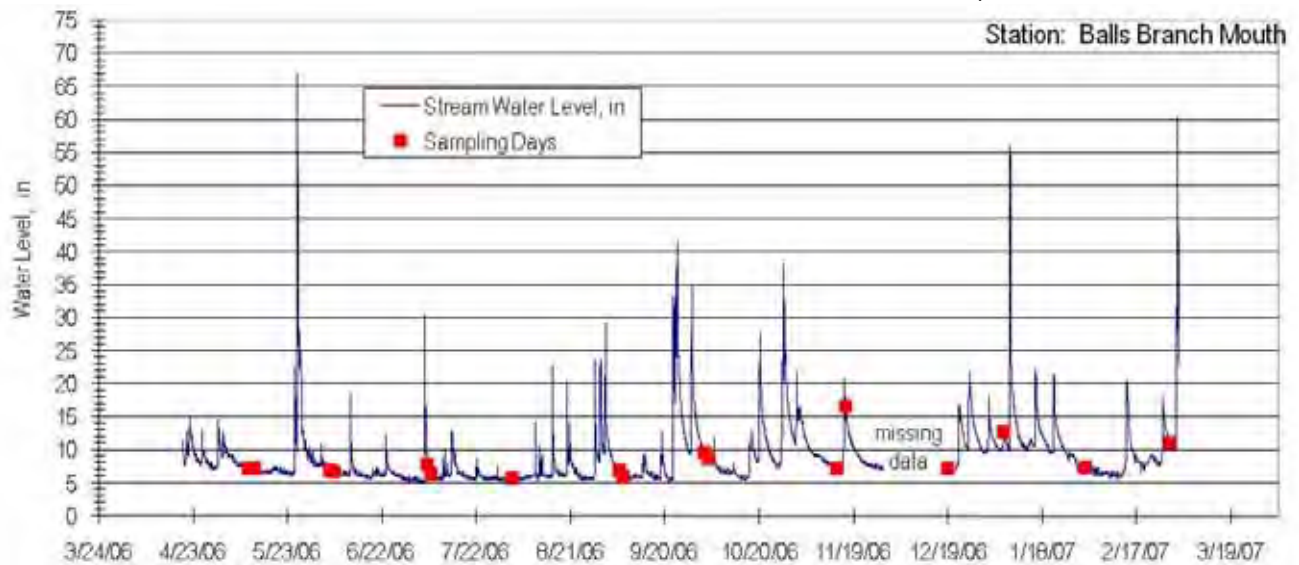
FIGURE 1 – WATER LEVEL AT BALLS BRANCH MOUTH, 2006-2007

Cumulatively, Figures 1 and 2 indicate that the water levels in the stream show wide variance, increasing over 5 feet at the mouth of Balls Branch and as much as 4.5 feet at Clarks Run at US 127 Bypass. The hydrographs show that the streams exhibit a flashy response to storm events, quickly rising and falling in response to the runoff and groundwater influx. As shown in these figures, the water quality sampling conducted concurrently with these water level readings were usually measured during the lowering of the water level to base flow conditions subsequent to a storm, although several events did capture rising stream conditions. The water quality study is discussed further in Section 2.1.8 of this document.

As part of a yearlong water quality monitoring study in Clarks Run, two water level data loggers were utilized to evaluate the relationship between the daily stream water depth and the flow data captured. These data loggers captured daily changes in the water level at the mouth of Balls Branch and at the US 127 overpass of Clarks Run. Figures 1 and 2 (pages 6 and 7, respectively) graphically illustrate the results of this study.

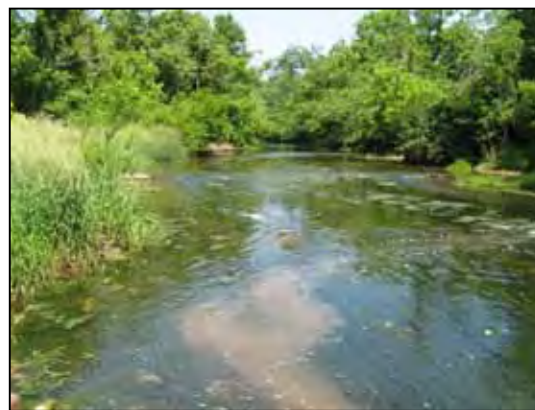
Algal Bloom at Goggin Lane During Un-ionized Ammonia Exceedance

Algal blooms were observed throughout the watershed, but were especially dense at Goggin Lane, where they clogged the entire stream. Algal blooms also occurred at KY 52, but shading of the stream by the tree canopy minimized the severity of these blooms. No dissolved oxygen problems were detected in Clarks Run, most likely due to frequent aeration at riffles in the shallow streams.

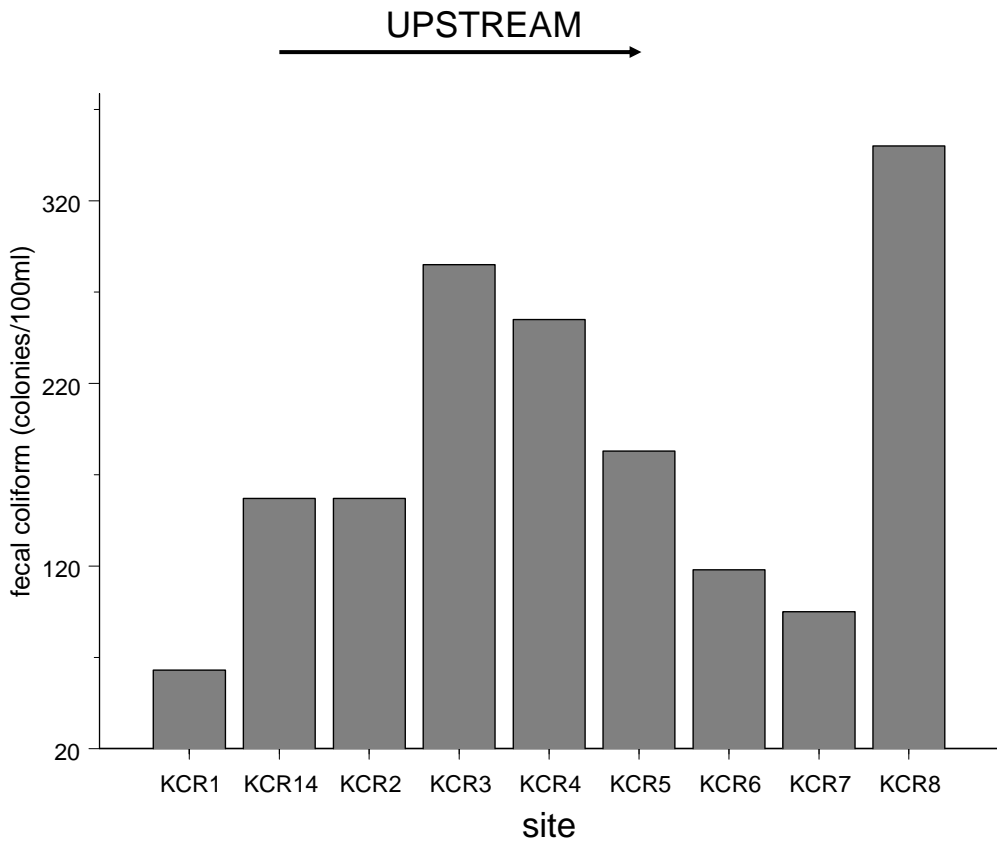
Figure 2. Fecal Coliform data for October 2003

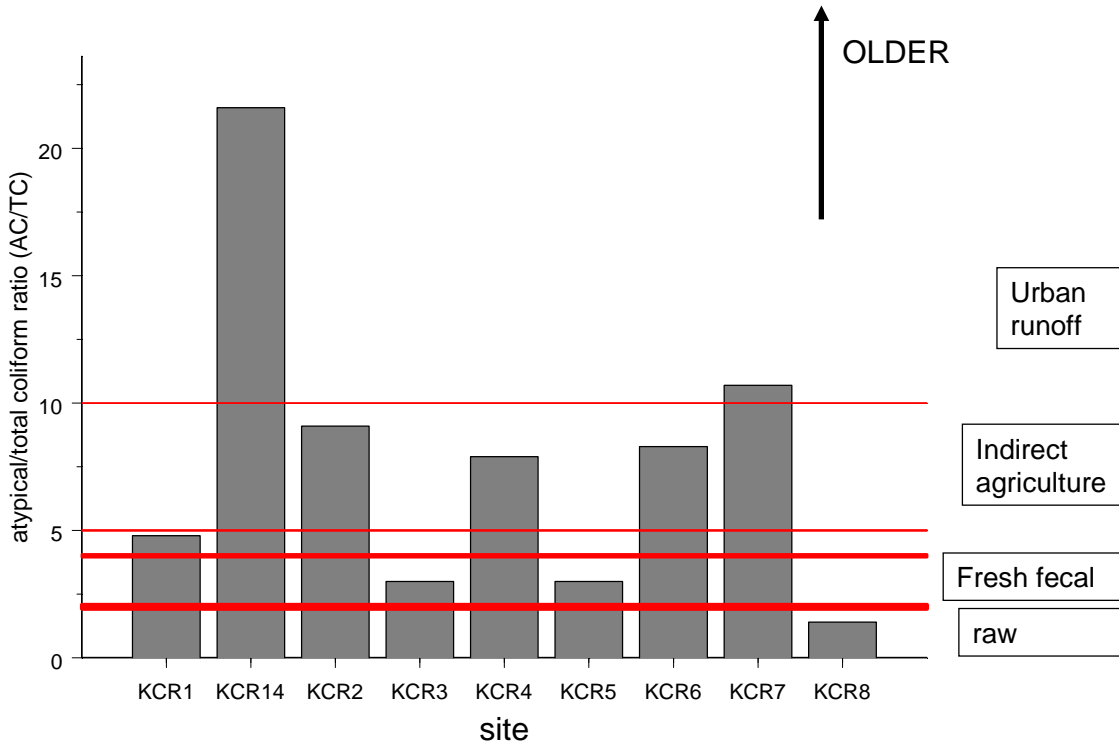
Figure 3. Atypical colony analysis for October 2003

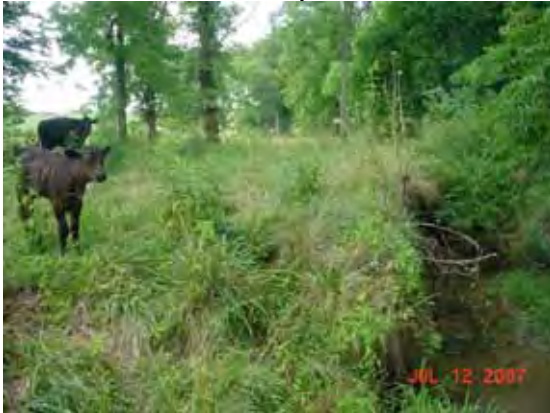
Cattle along BB6

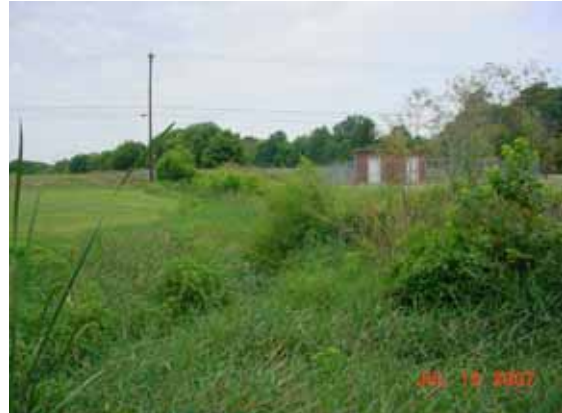
Pump station upstream of BB7

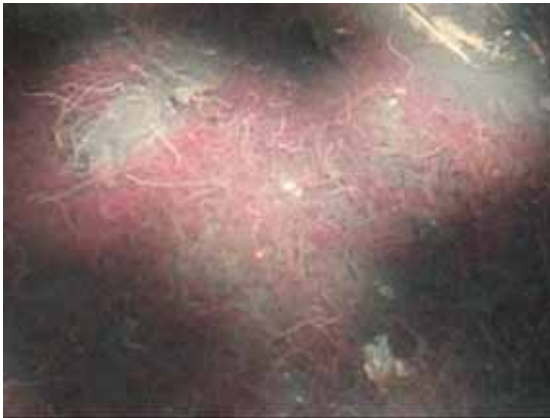
Nematodes as indicator of sewage overflow upstream of CR08
