# Brushy Creek Watershed Plan

Upper Cumberland Basin, Kentucky

May 2017

University of Louisville Stream Institute

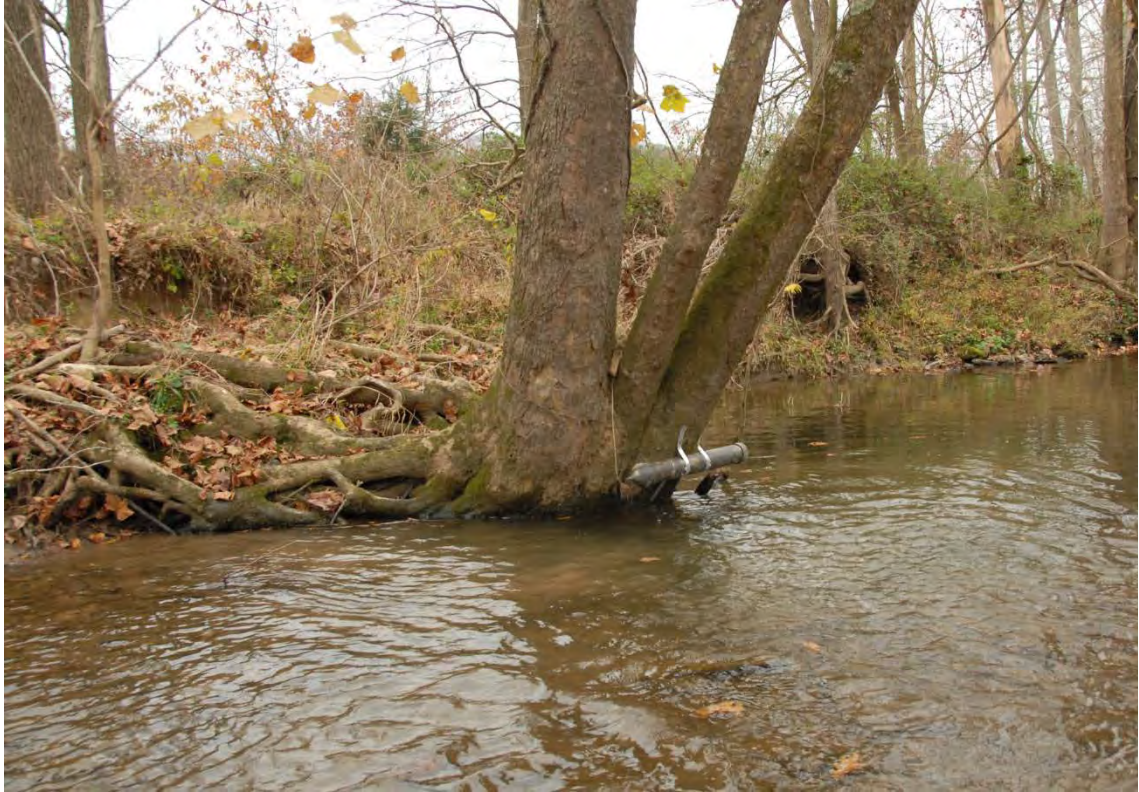
**Figure 3.2** Passive sediment samplers were used to collect suspended sediment during flood events.

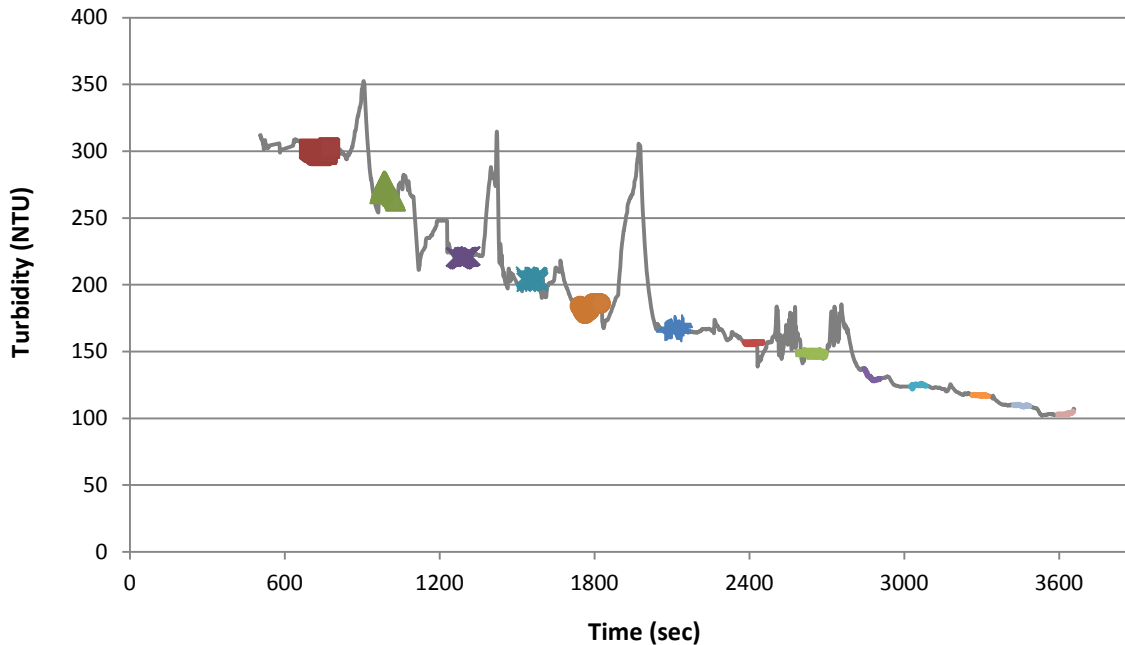
**Figure 3.6** Bucket test outputs (time and turbidity).

To generate the SSC–turbidity relationship, the outputs from the bucket tests (time and turbidity in NTU) were entered into an Excel spreadsheet and plotted (Fig. 3.6). The times of the dilutions also were entered. Periods of 40 to 80 readings (20 to 40 seconds) were identified for each dilution. Spikes in the dataset representing more than 10 NTU between subsequent readings were removed.

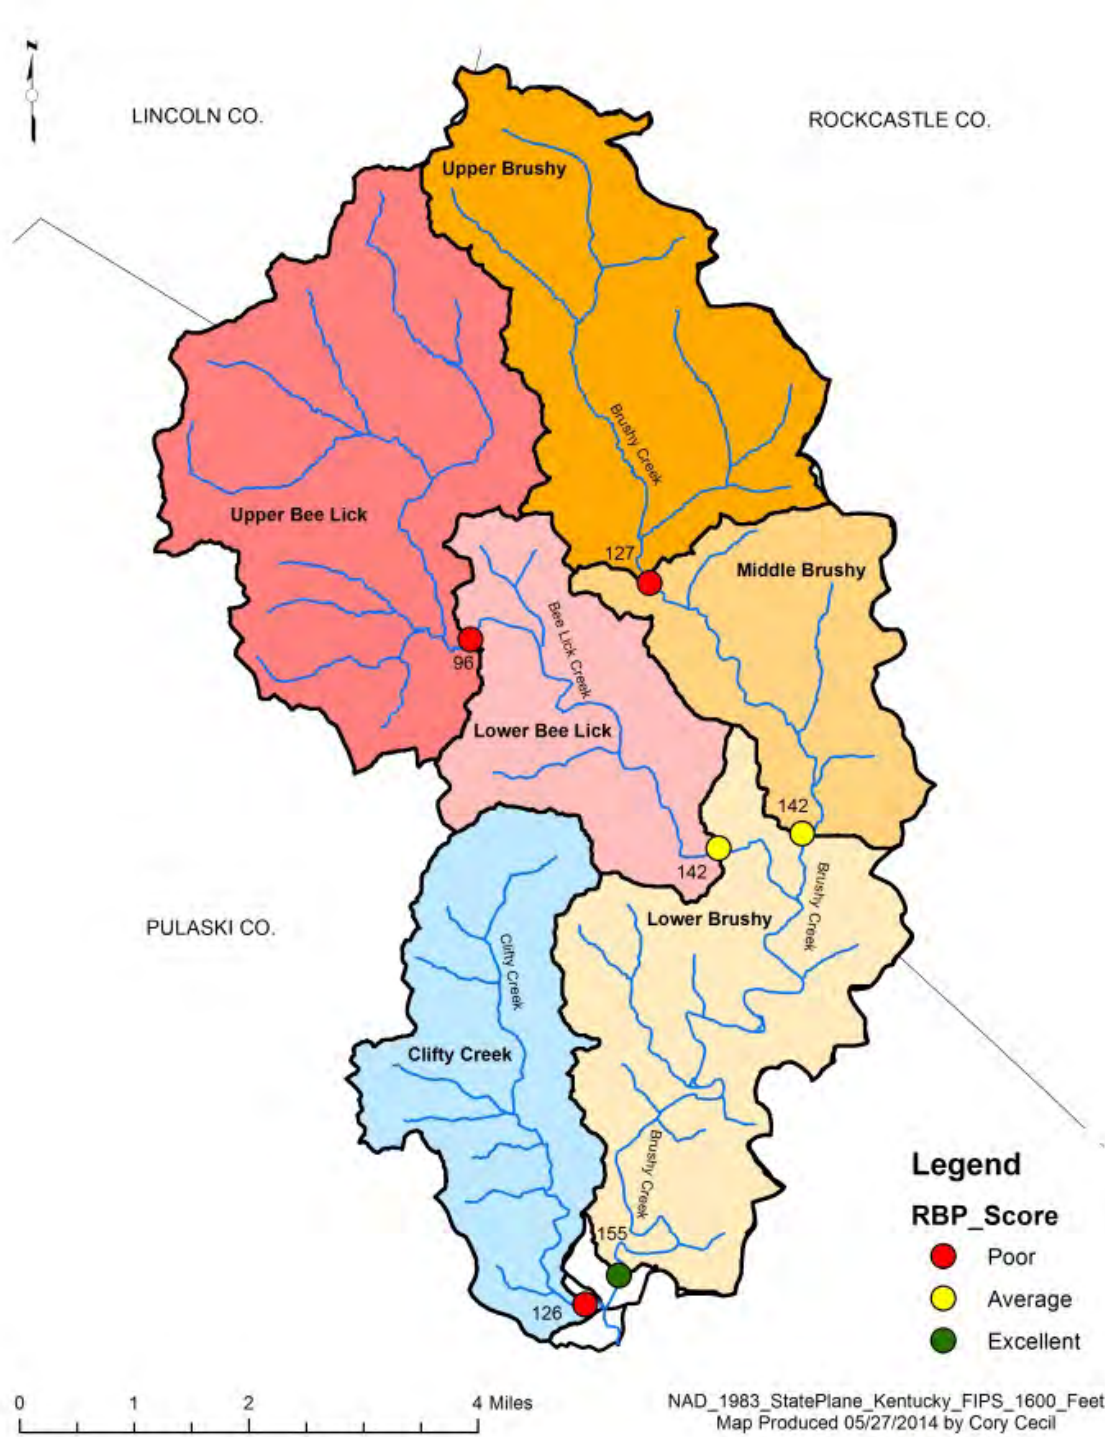
Figure 4.1 Phase 1 reach-scale RBP scores and ratings.

The most common cause of habitat impairment was incision and entrenchment of the channel. Although these parameters are not measured directly in the RBP, they are reflected in the stability of epifaunal substrate, the velocity/depth regime, the frequency of riffles, and the stability of banks. At BR3, the incision of the channel was to bedrock with very infrequent pools and few riffles. Local sediment supply of gravel/cobble at CLI and sand at BL2 was sufficient that the stream had not scoured to bedrock. The majority of riffles at CLI, however, were mobilized to some degree during the Phase 1 assessment, and the reach at BR2 was buried in sand. Both frequent mobilization of the bed and burial by sand could be expected to impair benthic macroinvertebrates (Allan and Castillo 2007). The embeddedness of riffles at BR2 was clearly related to local supply of sediment, so it was identified for Phase 2 investigation.

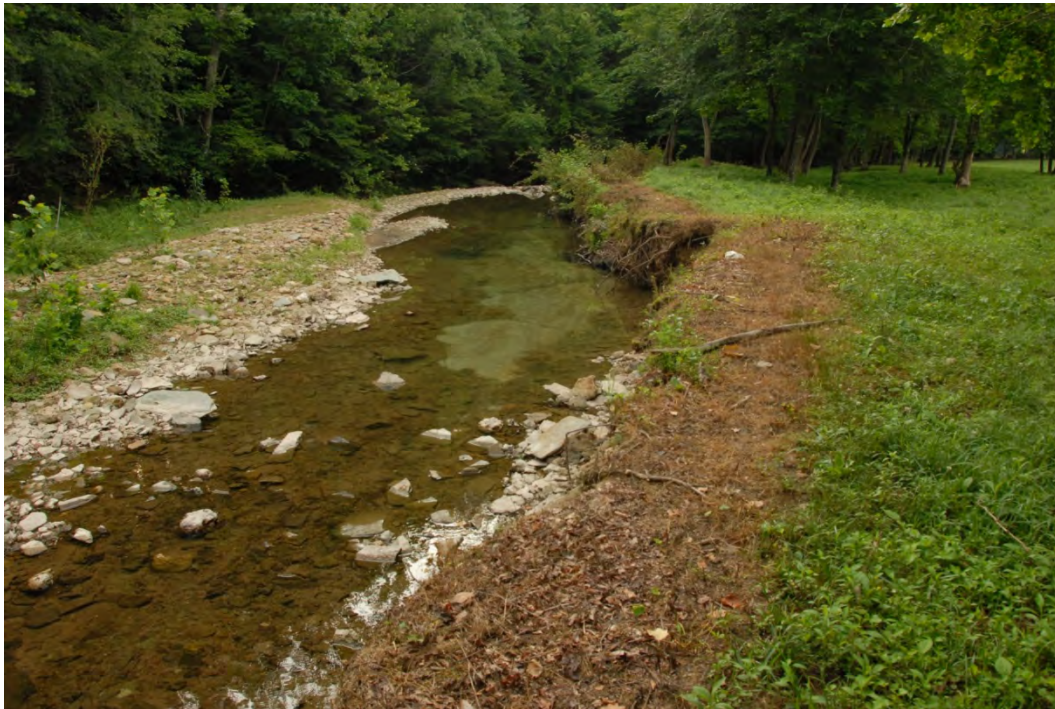
**Figure 4.2** Application of herbicide has impeded the re-establishment of riparian vegetation at CLI, a downstream reach of Clifty Creek.

The riparian vegetation at all sites was limited on one or both stream banks. Farming of the valley bottom for hay was the most common cause of lack of vegetation. None of the valley bottoms of the Phase 1 reaches had row crop agriculture (but see Phase 2 results). Herbicide spraying of streambank vegetation at Clifty (about 500 ft upstream of CLI sampling site) was observed and was clearly impeding the establishment of stabilizing vegetation (Fig. 4.2).
