The Banklick Watershed Action Plan

Kenton and Boone Counties, Kentucky

A Comprehensive Approach to Watershed Improvement

Publication Date: November 2005
First Printing

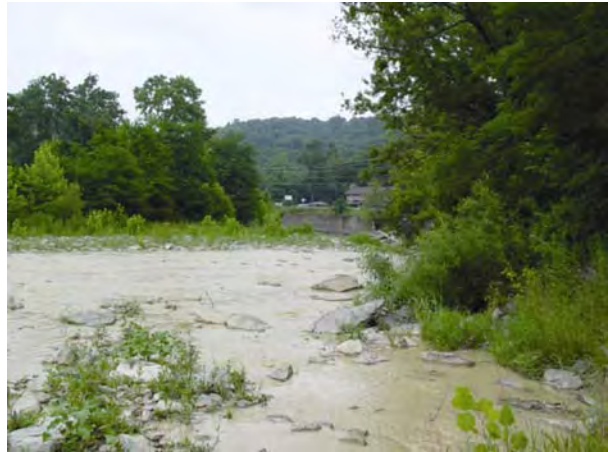
Banklick Creek along Madison Pike

Channelization at many locations in the watershed has only served to hasten the movement of water downstream, rather than prevent flooding. Within the past couple decades, development of the watershed's upland areas has accelerated and exacerbated flooding, endangering safety and private property. As with water quality problems, flooding in the Banklick watershed is a complex problem for which there is no "quick fix". Additional information on flooding is found in Chapter 2.
