Early warning system for ice collapses and river blockages in the Sedongpu Valley, southeastern Tibetan Plateau

Abstract. The Tibetan Plateau and its surroundings have recently experienced several catastrophic glacier-related disasters. It is of great scientific and practical significance to establish ground-based early warning systems (EWSs) to understand the processes and mechanisms of glacial disasters and warn against potential threats to downstream settlements and infrastructure. However, there are few sophisticated EWSs on the Tibetan Plateau. With the support of the Second Tibetan Plateau Scientific Expedition and Research Program (STPSE), an EWS was developed and implemented in the Sedongpu Valley, southeastern Tibetan Plateau, where repeated river blockages have occurred due to ice/rock collapse debris flow. The EWS collected datasets of optical/thermal videos/photos, geophone waveforms, water levels, and meteorological variables in this sparsely populated zone. It has successfully warned against three ice-rock collapse–debris flow–river blockage chain events, and seven small-scale ice-rock collapse–debris flow events. Meanwhile, it was found that the low-cost geophone ca

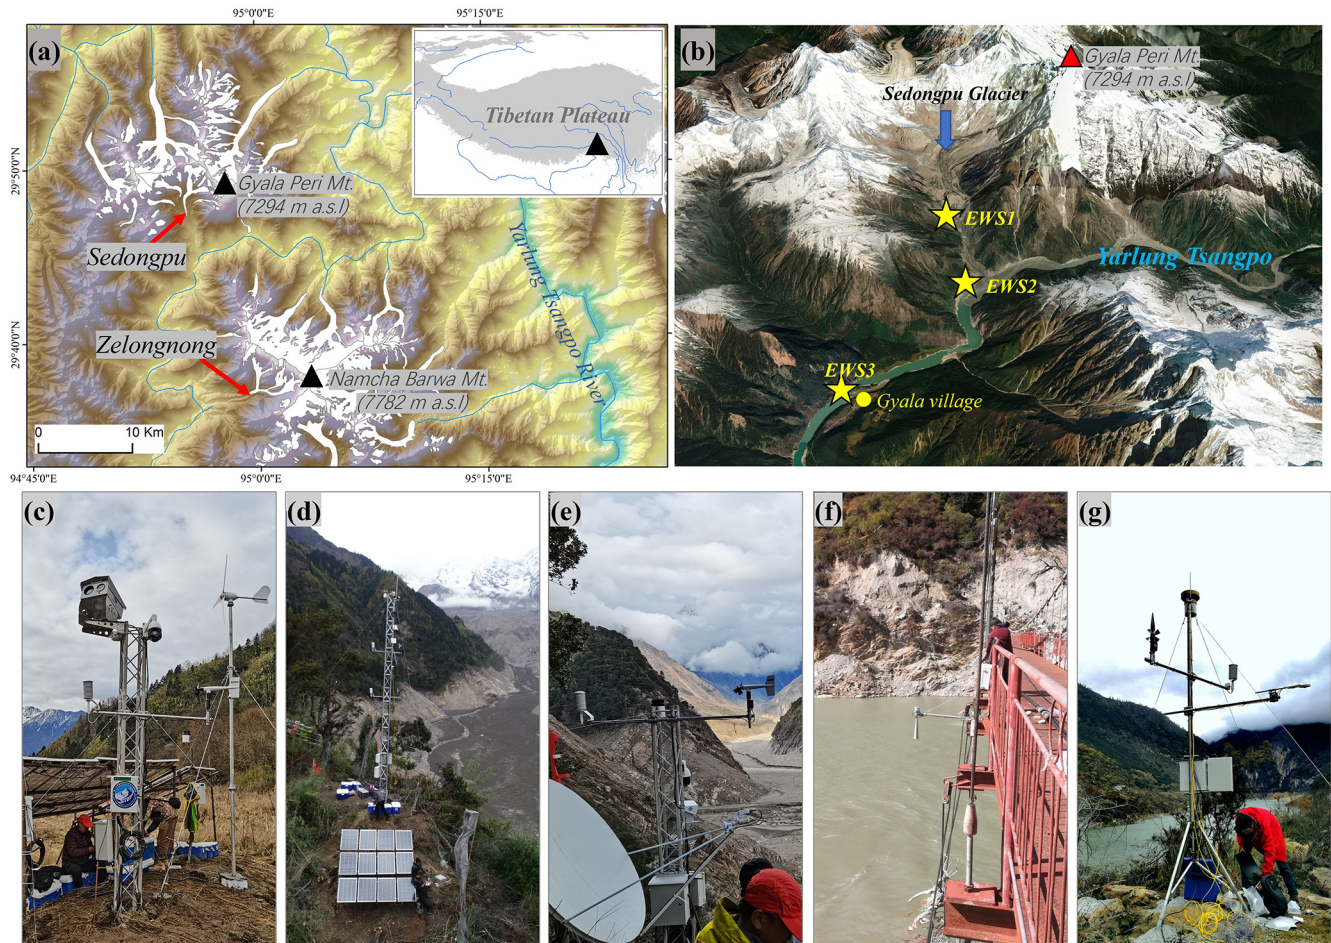
Figure 1. Study region and early warning systems. (a) Glacier distribution around the Mt. Namcha Barwa and the Mt. Gyala Peri in the southeastern Tibetan Plateau with the Sedongpu Glacier and Zelongnong Glacier; (b) @Google Earth image showing the 3D topography of the Sedongpu Valley and the locations of three early warning systems: EWS1–3 (yellow stars); (c) the EWS1 inside the Sedongpu Valley for ice collapse observations; (d) the EWS2 of the 10 m observation tower, which was installed near the Sedongpu Valley outlet but was destroyed by the massive ice-rock collapse on 22 March 2022; (e) the rebuilt EWS2 near the Sedongpu Valley outlet to warn the blockage of the Yarlung Tsangpo River; and (f, g) the EWS3 of the radar water level sensor and the automatic weather station (AWS) with pressure water level sensor near the Gyala village.

Since 2019, the EWSs have been progressively built along the Sedongpu Valley. The EWSs consist of three parts (EWS 1–3) with different monitoring instruments and scientific functions (Fig. 1c–g and Table 1).

In May 2022, a 4 m observation tower with various monitoring sensors was constructed on the right bank of the glacial terraces at 3308 m a.s.l. in the Sedongpu Valley (Fig. 1b and c). Owing to logistical inaccessibility, all instruments were transported by helicopters. The objective of EWS1 is to monitor the location, magnitude, and process of the ice-rock collapse inside the Sedongpu Valley. The overall monitoring system consists of the following five parts.

v. *Data transmission and power supply.* All datasets were transmitted via the Asia-Pacific satellite (Asiasat 7). Owing to the heavy monsoon cloud cover and less efficient solar power generation in this region, power is supplied by both solar panels and wind (Fig. 1c).

Ice-rock collapses generally produce debris flows that are deposited near the Sedongpu Valley outlet and then block the Yarlung Tsangpo River (Chen et al., 2020; Tong et al., 2019). The EWS2 was installed near the valley outlet to monitor the river blockage. In fact, a 10 m integrated observation tower, equipped with time-lapse optical and thermal cameras and various meteorological variables (wind speed/direction, air temperature, relative humidity, four components of radiation, rainfall, atmospheric pressure) was installed 150 m above the valley floor at the valley outlet in October 2019 (Fig. 1d). However, this EWS2 was destroyed by the collapse-induced

In May 2021, the EWS2 was re-established in the upstream region to avoid possible destruction by debris flows of similar magnitude as in March 2021 (Fig. 1e). Similar to the monitoring equipment at EWS1, EWS2 was equipped with optical and thermal cameras to monitor the status of the Sedongpu Valley outlet, a three-component SmartSolo geophone with a transmission threshold of 10 to indicate the power of debris flows and various meteorological sensors (Table 1). The video was stored locally on the hard disc, and hourly photos were transmitted to the service via satellite.

stream of the Sedongpu Basin. The water level will soon rise when the Yarlung Tsangpo River is partially or completely blocked by debris flow from the Sedongpu Valley. Therefore, the water level is a very important early warning indicator. Two different types of water level sensors were used to provide sufficient redundancy and to avoid possible sensor failures. A Campbell CS477 radar water-level sensor (10 min interval) and a Campbell CS451 pressure transducer (5 min interval) were installed separately in October 2019 and May 2021 to provide real-time records of the water level in case of river blockages (Fig. 1f).

Considering the relatively open topography near Gyala village, an automatic weather station was also installed (Fig. 1g) for long-term monitoring of the regional background of climate change by measuring air temperature; relative humidity; wind speed/direction; precipitation; four components of radiation including incoming shortwave radiation (S_{in}), reflected shortwave radiation (S_{out}), incoming longwave radiation (L_{in}), and outgoing longwave radiation (L_{out}) using a CNR4 net radiometer; and air pressure using a Vaisala PTB110 barometer (Table 1).

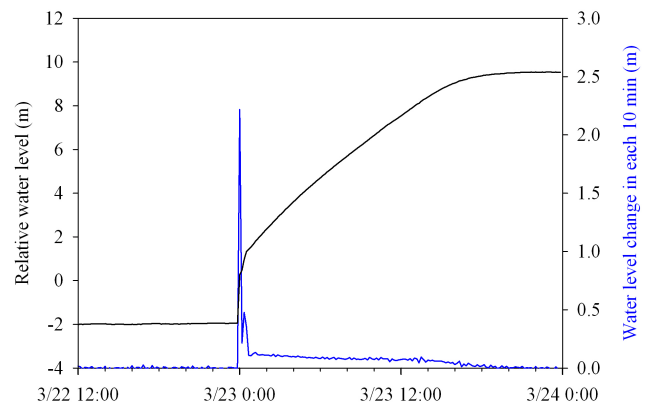
Figure 2. A total water level rise of 11 m (black line) caused by the damming of the Yarlung Tsangpo River on 22 March 2021, with the rate of water level rise every 10 min (blue line).

23 March (Fig. 2). The water level continued to rise at a rate of $0.6\text{--}0.8 \text{ m h}^{-1}$, rising by a total of 11 m before stabilizing at approximately 18:00 LT on 23 March 2021. This collapse turned into a highly mobile mass flow which destroyed the EWS2 installed near the Sedongpu Valley outlet (Fig. 1d). Unfortunately, the video of this chain disaster was not recorded.

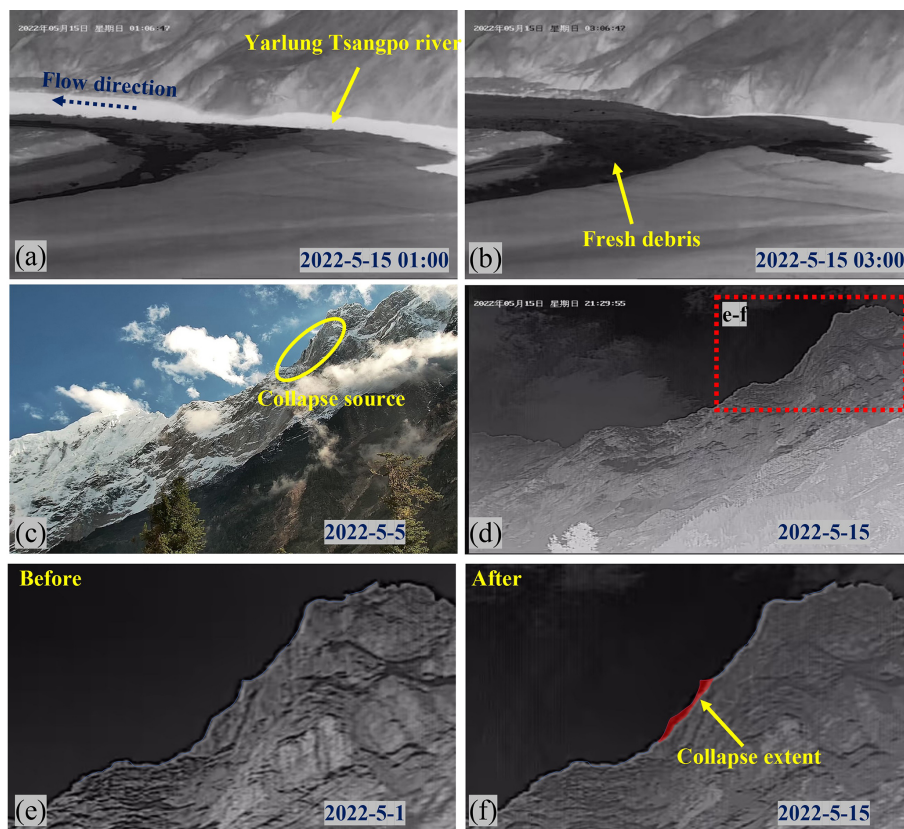
Figure 4. The debris-induced blockage of the Yarlung Tsangpo River (a, b) and the optical and thermal images showing the topographic conditions at the targeted monitoring of the collapsed area (c, d), with the zoomed region (red dashed rectangle) shown in panels (e) and (f), and the change of ridgeline before and after the repeated ice-rock collapses on 14 May 2022 and the extent of the collapse source outlined in transparent red.

On 14 May 2022, the geophone at EWS1 warned that repeated collapses occurred in the Sedongpu Valley (Fig. 3a). The most pronounced shaking occurred at approximately 10:00 and 12:00 LT, with both waveform amplitudes exceeding 20. However, both EWS2 near the Sedongpu Valley outlet and EWS3 near Gyala village did not show river blockage and water level rising before midnight on 14 May 2022. Between 23:50 LT on 14 May and 00:00 LT on 15 May, the water level sensor at EWS3 sent a warning message, and the water level rose by a total of 4 m before stabilizing at around 20:00 LT on 15 May 2022 (Fig. 3b). Infrared imagery at EWS2 showed that the Yarlung Tsangpo River was temporarily completely dammed and then released, consistent with the rapid rise and fall in the water level (Fig. 4a and b). The AWS at EWS1 recorded a total rainfall of 31.6 mm during the period from 14 to 17 May with intensive rainfall (7 mm) occurring between 01:00 and 04:00 LT on 15 May (Fig. 3b). Overall, the ice-rock collapse and intensive rainfall provided favourable conditions for the formation of a diluted debris flow, resulting in the temporary blockage of the Yarlung Tsangpo River (Fig. 4a and b).

A comparison of both optical and infrared photographs before and after the ice-rock collapse showed that repeated collapses occurred on the northern ridge of Mt. Gyala Peri (Fig. 4c–f), which is close to the locations of previous massive ice-rock collapses in 2017 (Käb et al., 2021) and 2021

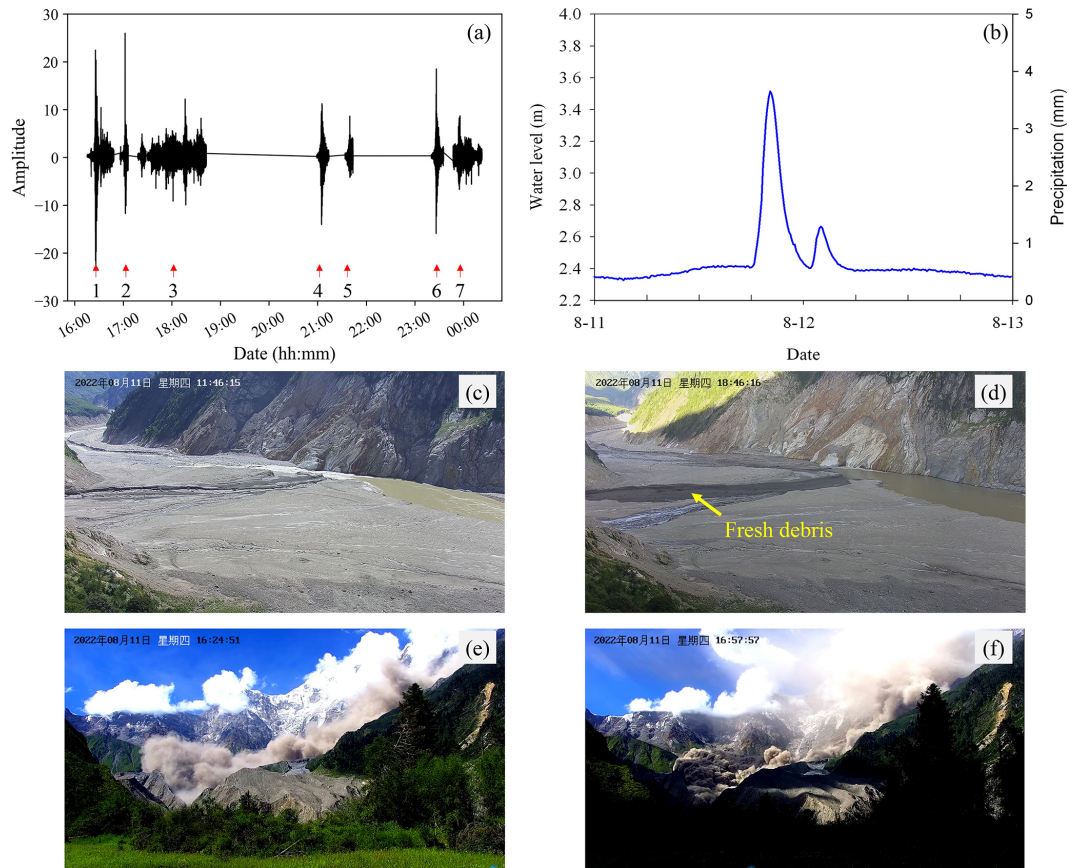
Figure 5. The recorded waveform of seven collapses on 11 August 2022 (a) and the water level rise by small-scale debris flow and precipitation condition (b), the photos taken before and after the occurrence of fresh debris flow into the Yarlung Tsangpo River (c, d), and video screenshots of two rock collapses at 16:24 and 16:57 LT on 11 August 2022.

On 11 August 2022, the geophone at EWS1 warned of repeated collapses in the Sedongpu Valley (Fig. 5a). The

first collapse occurred at 16:26 LT, with a waveform amplitude greater than 20, and lasted approximately 5–7 min. The following six repeated collapses occurred within the next 8 h. Among these seven repeated collapses, the waveform showed that the greatest energy was released by the first collapse, with a maximum amplitude greater than 25, and the longest collapse process lasted approximately 84 min during the third event (Fig. 5a).

The warning system at EWS3 indicated that the water level began to rise at around 18:30 LT, rose by 1.1 m at around 20:00 LT, and then started to fall back rapidly (Fig. 5b). Photographs of EWS2 also show that small-scale fresh debris flowed into the Yarlung Tsangpo River, causing partial river blockage (Fig. 5c and d). Comparison between the post- and pre-event optical and infrared imagery at EWS1 showed that the collapsed sources were different from previous ice-rock collapses (Fig. S1 in the Supplement). Two collapsed regions are mainly concentrated a few hundred metres below the mountain ridge, with a few glacier distributions. This evidence suggests that lower ice content within collapsed materials prevents the formation of highly mobile debris flows and thus limits the magnitude of river blockage.

Owing to the sunny weather conditions, the optical video system at EWS1 successfully captured the entire process of the two collapses that occurred during the daytime (Fig. 5e and f, Supplementary videos). Both videos of the two collapses showed that the highly mobile collapsed material resulted in dark yellow dust in the Sedongpu Valley. The colours of both collapses differed from the observed ice collapse recorded in October 2019 (Zhao et al., 2022). This indicates that the majority of the collapsed material on 11 August 2022 was composed of rock. Second, the combination of the video and geophone waveform showed that the size of the collapses was impressive when the amplitude of the geophone waveform at EWS1 was greater than 20. In addition, the onset and duration of the collapse recorded by the geophone were in agreement with the video recordings. These matches demonstrate that the geophone waveform at EWS1 can be used to reflect the onset and magnitude of repeated collapses in the Sedongpu Valley.

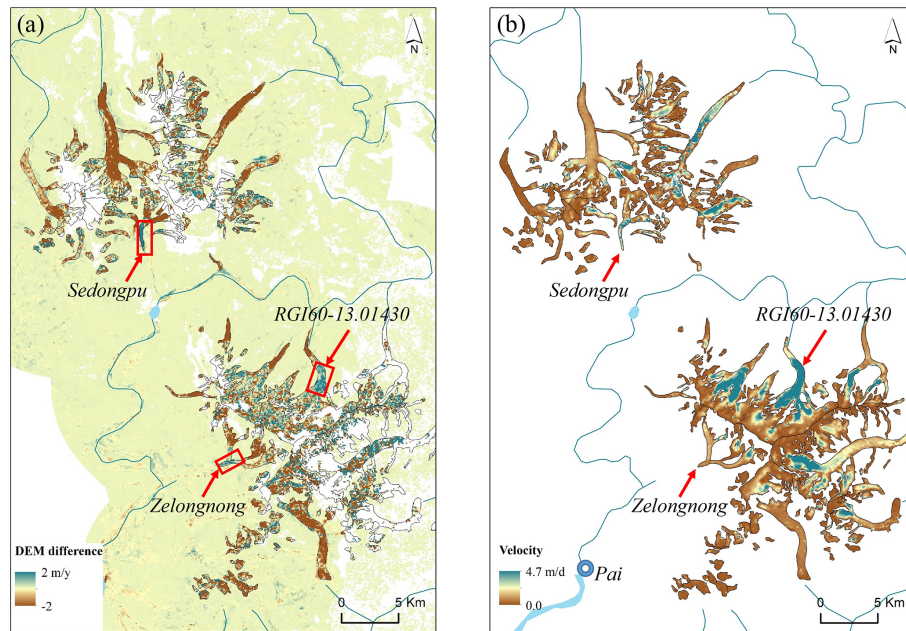
Figure 9. Spatial distribution of mean surface elevation change (m yr^{-1}) during 2010–2020 (Hugonnet et al., 2021) and annual surface velocity (m d^{-1}) in 2017 (Millan et al., 2022) and the locations of the three glaciers with abnormal surface thickening (the red rectangles) and the tower of Pai.

Based on the published datasets, including glacier elevation change during the period 2010–2020 (Hugonnet et al., 2021) and glacier surface velocity during the period 2017–2018 (Millan et al., 2022), it was found that apart from the detached Sedongpu Glacier, there are still two glaciers (Zelongnong Glacier and the glacier numbered RGI60-13.01430) with possible collapse risks in the study region (Fig. 9). As shown in Fig. 9a, the ablation zone of the Sedongpu Glacier has experienced an anomalous glacier thickening ($\sim +2.0 \text{ m yr}^{-1}$) over the last decade, which facilitated massive low-angle glacier detachment in October 2018 (Käab et al., 2021). A similar anomalous ice thickening near the ablation zone (the red rectangles in Fig. 8a) was also found at the Zelongnong Glacier ($\sim +0.35 \text{ m yr}^{-1}$) and RGI60-13.01430 Glacier ($\sim +0.37 \text{ m yr}^{-1}$). In addition, the spatial distribution of the surface velocity also indicated a high glacier displacement in the ablation zone with possible sliding risks on these glaciers (Fig. 9b).

It is therefore worth paying special attention to the dynamic changes of these glaciers by using high-resolution satellite data and ground-based EWS. Enhanced monitoring, particular the surface movement monitoring by using a Global Navigation Satellite System (GNSS), is critical for the accessible Zelongnong Glacier, which is very close to the town of Pai with a population of more than 3000, and for the proposed mega hydropower project nearby (Fig. 9b).
