# Landslides in the Western Columbia Gorge, Skamania County, Washington

By Thomas C. Pierson, Russell C. Everts, and Joseph A. Bard

Scientific Investigations Map 3358

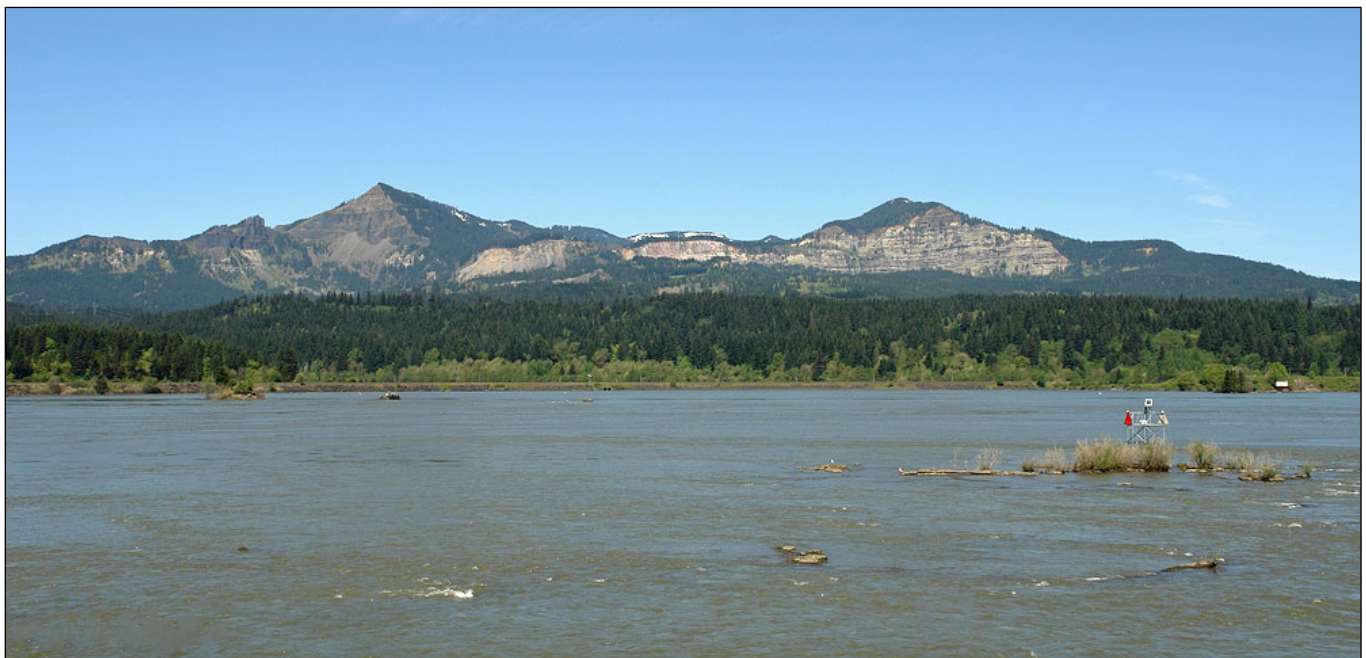
View northward from Cascade Locks, Oregon, of headscarp of the Red Bluffs landslide (most of the whitish cliff faces) and the slightly darker headscarp of the Bonneville landslide to the west (mostly below the sharp-peaked mountain on left, Table Mountain). Toe of Bonneville landslide and Columbia River in foreground. Photograph by Lyn Topinka (Copyright, 2011), published with permission.

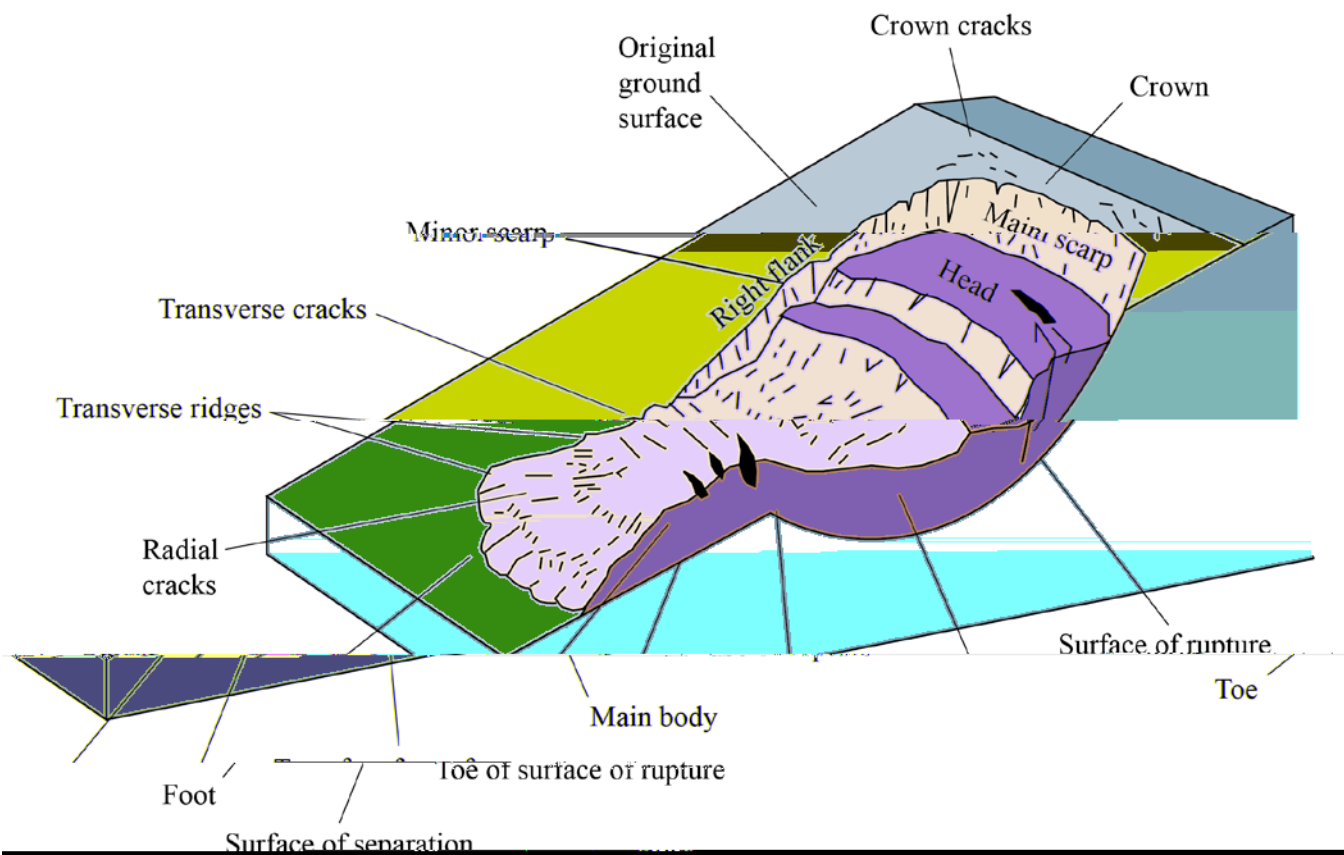
Figure 4. An idealized rotational landslide showing commonly used terms for various features. Figure from Highland (2004).

Landslides in this study have been mapped on the basis of geomorphic features characteristic of landslides (fig. 4) that are visible on 6-ft-resolution (1.83-m-resolution), bare-earth, shaded-relief, digital elevation models (DEMs) at the scale of 1:12,000 and derived from 2005 lidar imagery obtained from the Puget Sound Lidar Consortium (<http://pugetsoundlidar.ess.washington.edu/>). Readily identifiable landslide features on the lidar DEMs include headscarps, internal scarps, radial cracks and shear zones, concave slope depressions and grabens, back-rotated blocks, transverse cracks and ridges, and convex slope bulges and toes.
