# Utilization of satellite data in the recent volcanic disaster at Mt. Semeru, Indonesia

Yoshito Kikumori, Ph. D  
JICA Expert to BNPB

# Utilization of Satellite Data at Mt. Semeru Volcano Disasters(Dec, 2021)

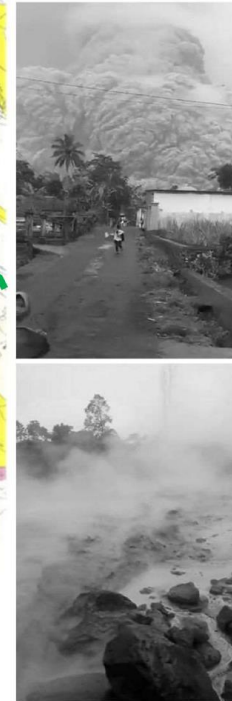
Hazard Map for Volcanic Disaster

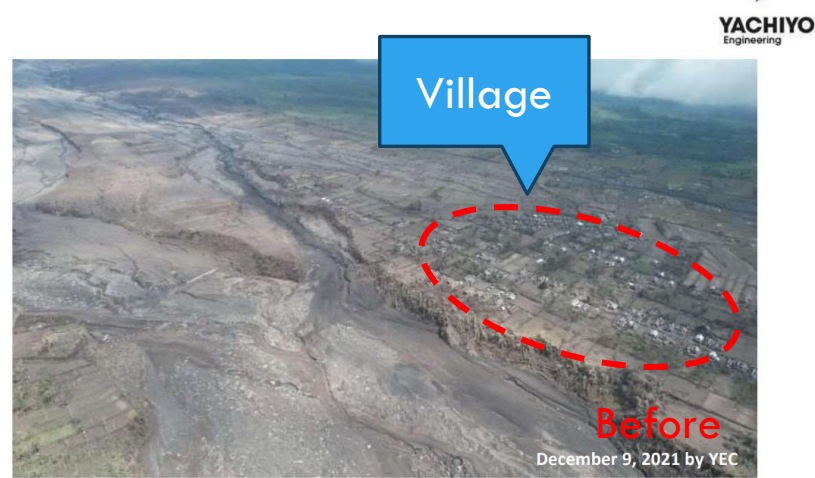
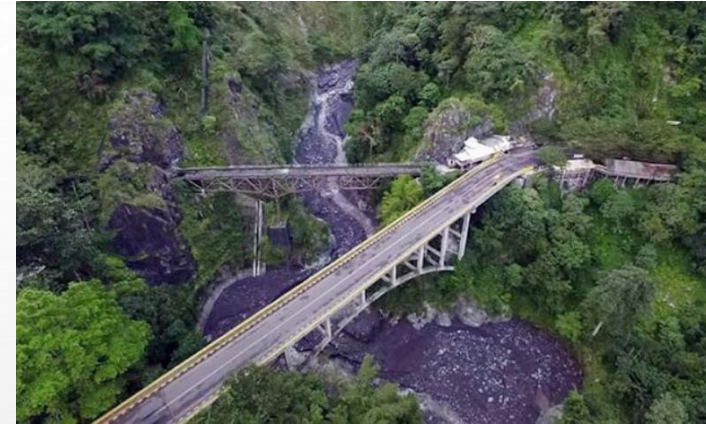
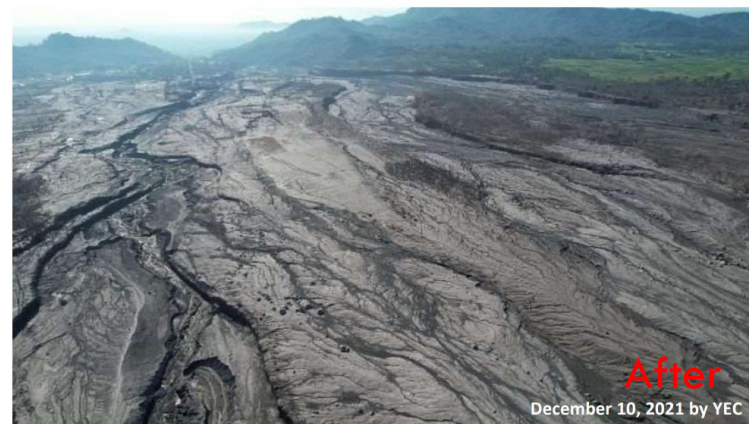
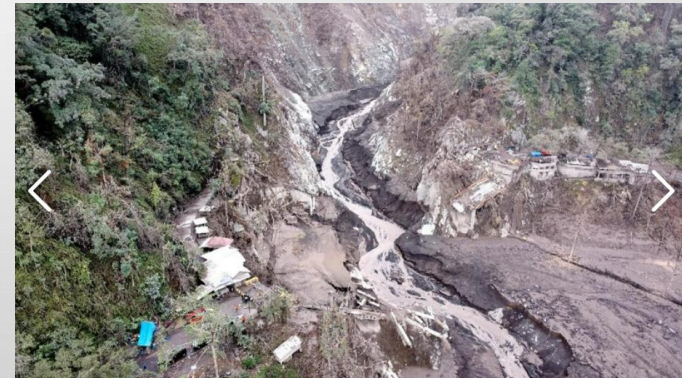
Along Rajali River 10km from the summit

Perak Bridge, Route No.3(12km from the summit)
