THE SECRETARY
OF THE INTERIOR'S
STANDARDS FOR
REHABILITATION &

GUIDELINES
ON FLOOD
ADAPTATION FOR
REHABILITATING
HISTORIC
BUILDINGS

U.S. Department of the Interior National Park Service Technical Preservation Services These Guidelines were previously issued as a text-only version in November 2019. This illustrated version was revised to include diagrams, photographs, and other changes and replaces the prior version.

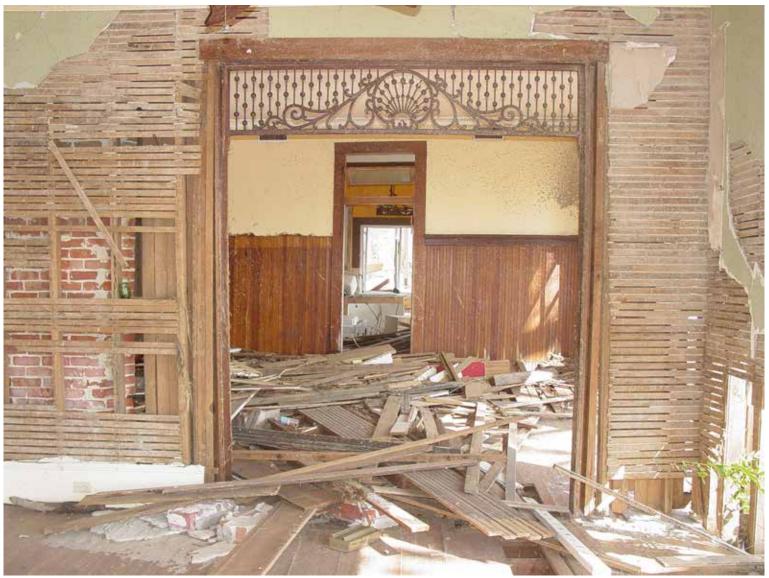
[6] Flood waters can also damage interior spaces. This historic home in Bay St. Louis, MS, was severely impacted by the storm surge from Hurricane Katrina. Even with such dramatic damage, it is crucial to properly assess the condition of historic materials and identify what remains and can be retained. In this case, most of the woodwork, the wood wainscot, upper sections of plaster in some rooms, and some areas of flooring were cleaned, dried, and repaired. Photo: Mississippi Department of Archives and History, Mississippi Historic Resources Inventory (HRI) Database. http://www.apps.mdah.ms.gov/Public

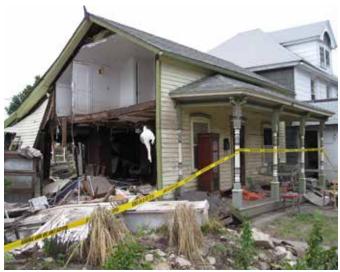
[8] Understanding the characteristics of a flood are critical to understanding property risk. Significant structural damage occurred to this building as a result of a riverine flood in Cedar Rapids, IA, in 2008. *Photo: Greg Januska*

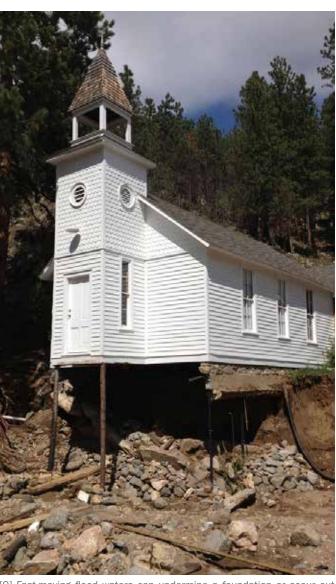
[9] Fast-moving flood waters can undermine a foundation or scour out land around a building. The Little Church of the Pines in Salina, CO, was left structurally compromised after heavy rains caused flooding in the Front Range of the Rocky Mountains in 2013. *Photo: Burton Construction burton-construction.com*

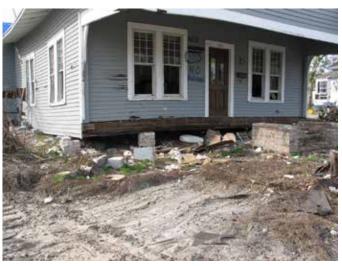
[11] Flood forces are powerful and can result in a building being shifted from its foundation. This historic property in Gulfport, MS, was knocked off of its piers by Hurricane Katrina in 2005. *Photo: Jennifer V.O. Baughn/Mississippi Department of Archives and History, January* 26, 2006

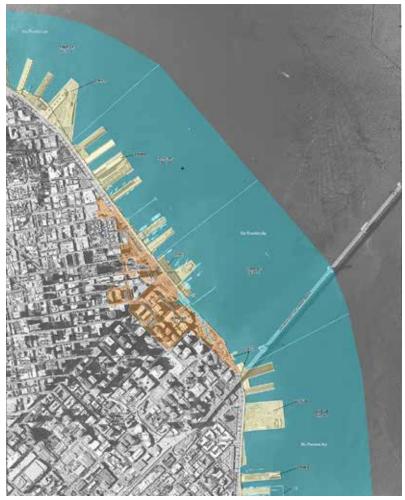
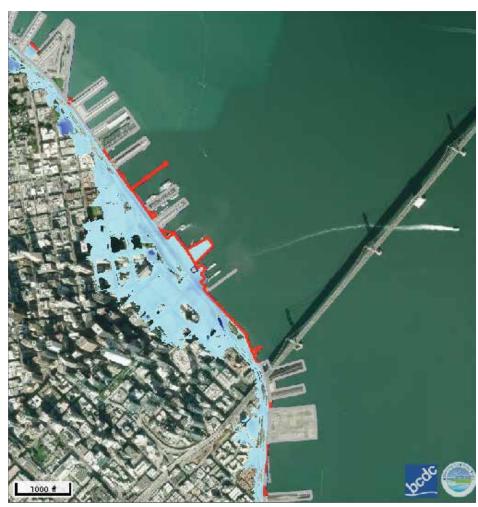
(a) Flood Insurance Rate Maps (FIRM) are created by a program within the Federal Emergency Management Agency (FEMA). They are regulatory and are the official maps that show special flood hazard areas. (b) Community flood models or supplementary maps adopted by a local jurisdiction may include more data, future projections, or other flood risk information. Comparing these two maps for the northeast quadrant of San Francisco, the modeling shown in (b) includes sea level rise data and identifies additional sections of the city that are likely to flood.

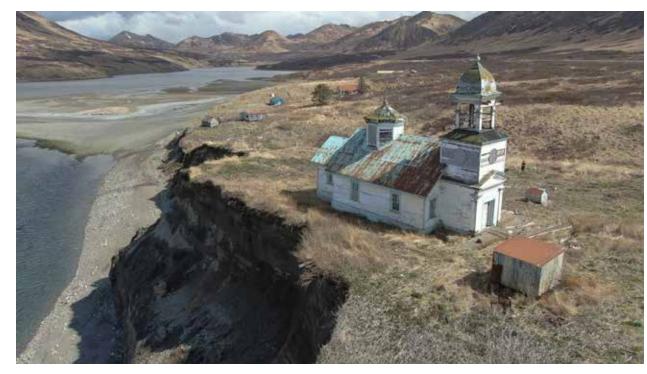
[13] The Church of Our Lord Chapel, Karluk, AK, was built in 1888 and is the oldest Russian Orthodox Church in Alaska. In danger of collapse into the Karluk River, the erosion of the bluff has been rapidly escalating, and the church sits only 25 feet from the edge. The vulnerability of the property at the edge of a river requires frequent monitoring, but a more long-term solution will be necessary for the continued preservation of the building. *Photo: Tom Pillifant*

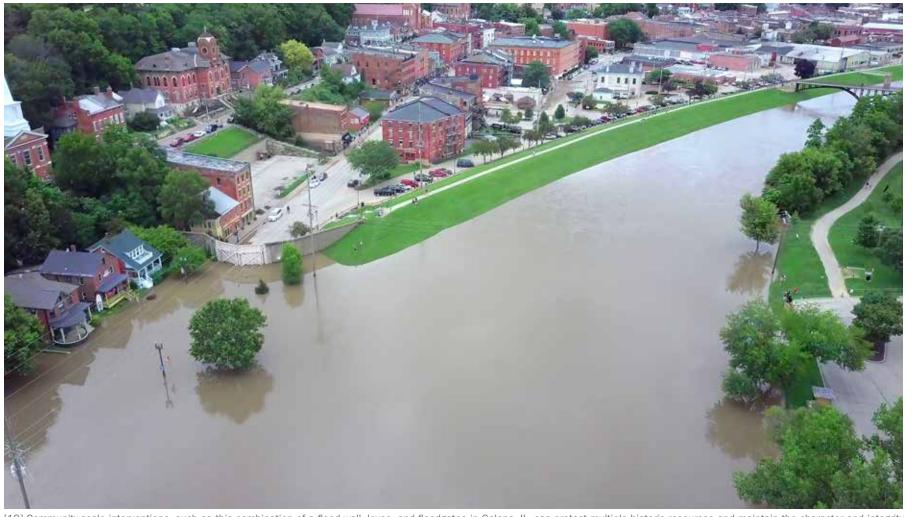
[19] Community-scale interventions, such as this combination of a flood wall, levee, and floodgates in Galena, IL, can protect multiple historic resources and maintain the character and integrity of entire historic districts and neighborhoods. *Photo: GalenaGuide.com*

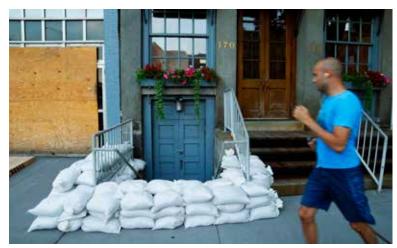
[20] Temporary measures such as sandbags can be a simple and inexpensive solution for protecting buildings in low-lying and vulnerable areas, but they are not meant to withstand moving floodwaters for extended time periods. *Photo: Eduardo Munoz/Reuters*

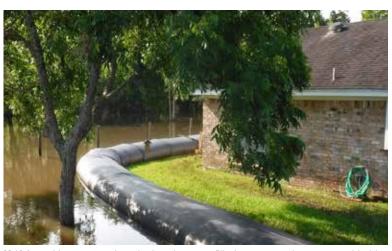
[21] A rural homeowner has deployed a water-filled temporary dam or water bladder to act as a floodwall around their residence. Water bladders require a storage area when not in use and the resources and time to fill them when a flood is imminent. *Photo: Aqua Dam, Inc*

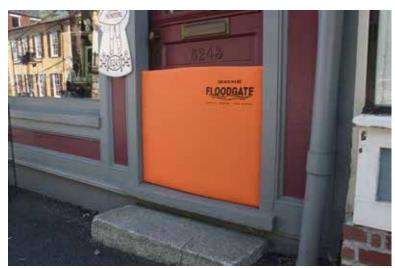
[22] This floodgate is a temporary solution that can only be deployed with enough notice of a potential flood event. Storage of the gate apparatus must be on or close to the property with ready access in order to be actively deployed. *Photo: Liz Petrella/NPS*

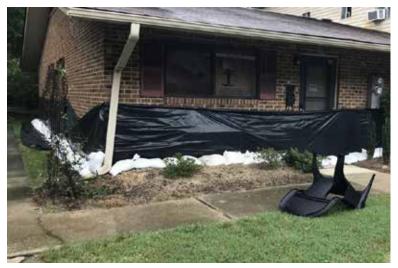
[23] A combination of different temporary measures can be an effective short-term solution to flooding. In this case, a building wrap of waterproof fabric is anchored by sandbags. *Photo: Chapelboro.com*

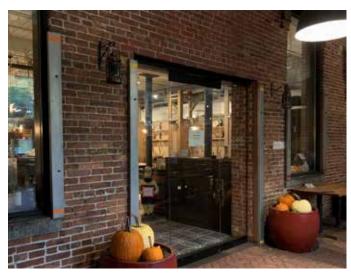
[25] Permanent stanchions at windows and doors in this former industrial mill in Baltimore, MD, are used to attach temporary floodgates to protect openings in the event of a flood. Depending on their size, color, and finish, these stanchions can be quite noticeable. In the case of an industrial property, this may not cause a significant change in historic character. In a different type of building, it is important to ensure that such permanent features blend in and are as visually unobtrusive as possible. *Photo: Jennifer Parker/NPS*

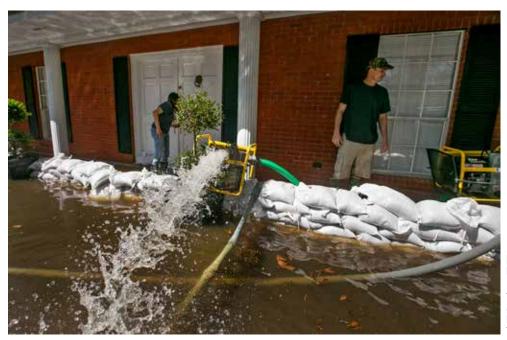
[26] Water can still seep through sandbag barriers. A property owner should have a pumping system with back-up generators to remove water from behind the barrier. *Photo: Ted Jackson, NOLA.com* | The Times-Picayune. The Advocate, 7/29/2019. The Times-Picayune/The Advocate

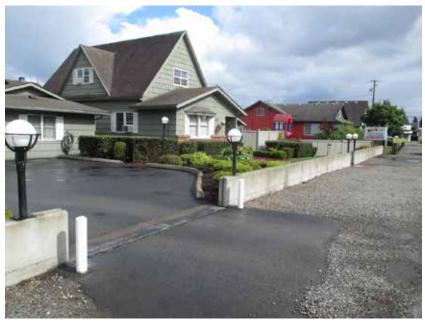
[30] This low-scale floodwall in Washington state provides flood protection without compromising the historic character of the property or obstructing views of the historic house from the street. A deployed floodgate can seal the opening at the driveway during a flood event. *Photo: French Wetmore*

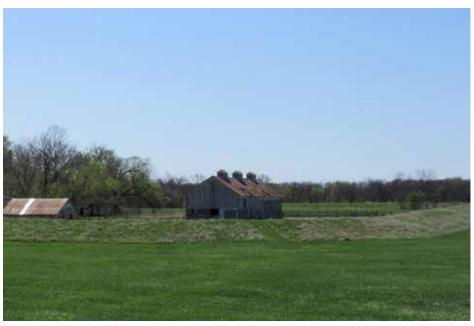
[31] This small-scale levee or berm has provided flood protection to this property in Chase County, KS, since the 1940s. *Photo: Steve Samuelson*

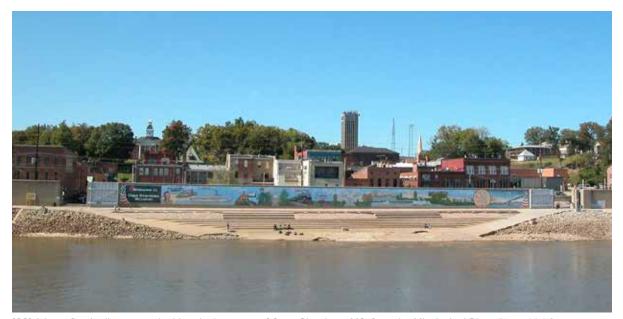
[33] A large floodwall protects the historic downtown of Cape Girardeau, MO, from the Mississippi River. Photo: VisitCape

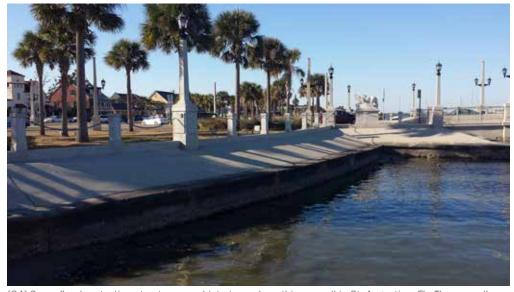
[34] Some flood protection structures are historic, such as this seawall in St. Augustine, FL. The seawall was constructed in sections over time beginning in 1696 near the Castillo de San Marcos. *Photo: Jennifer Wellock/NPS*

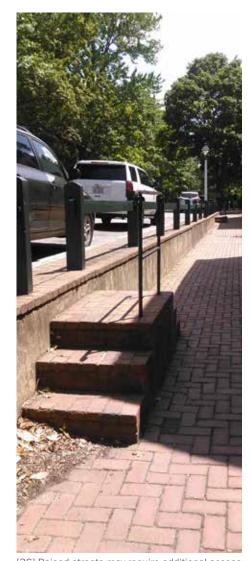
[36] Raised streets may require additional access points to residential and commercial properties if the sidewalks and buildings are not also raised. This 1890s historic example from Old Salem, NC, incorporated new brick stairs and railings. Additional considerations for accessibility would need to be addressed today. Photo: Jennifer Wellock/NPS

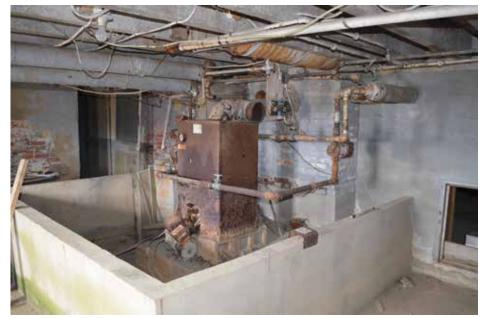
[42] Mechanical equipment that remains in a basement that is likely to flood should be enclosed behind waterproof walls. The walls may be partial height, as shown in this example, if flood waters are not expected to exceed that height. In other cases, waterproof enclosures must fully surround the equipment, which can be accessed by submarine-quality doors or hatches. *Photo: Quinn Evans*

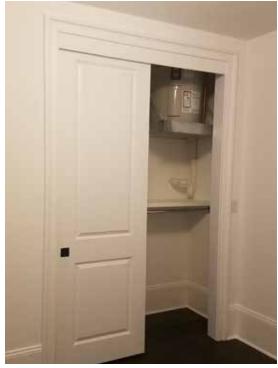
[43] Relocating mechanical equipment in interior spaces should be limited to utilitarian spaces like closets or mechanical rooms. Photo: Mary Lane Carleton

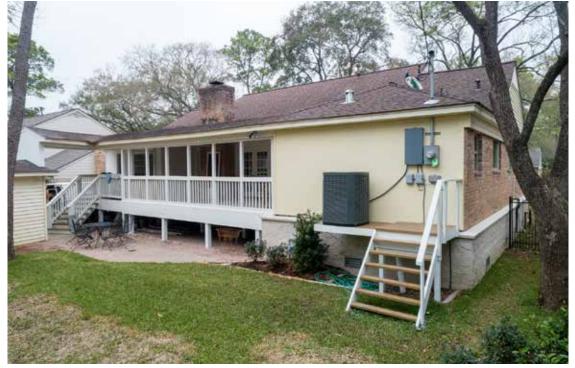
[44] Access issues must be considered when relocating exterior mechanical equipment on an elevated platform. If electrical or gas meters are moved to higher locations, stairs or a ladder may be required by the utility company to facilitate meter reading. Photo: p3elevation.com

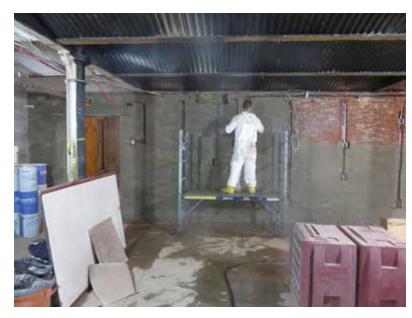
[48] A waterproof coating is applied to the interior surface of lower-level walls of the public library in Hoboken, NJ. Prior to applying such a coating, the product should be researched by building science professionals with knowledge of historic materials and methods to ensure that the coating will not cause damage to or accelerate deterioration of the structure. Photo: David V. Abramson for Hoboken Public Library

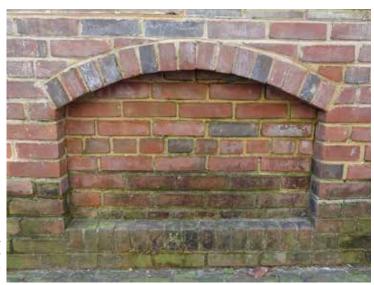
[50] To keep water out of a building, openings on secondary elevations may be permanently infilled with masonry to match or blend in with the walls. Any sills or lintels should be preserved in place, and the masonry infill should be inset to preserve the historic fenestration pattern. *Photo: Jennifer Parker/NPS*

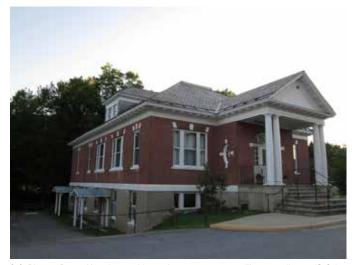
[54] Burnham Memorial Hall in Lincoln, VT, uses temporary flood barriers with permanently installed stanchions to prevent water from entering through basement-level windows and doors. The stanchions are noticeable, but do not significantly impact the historic character and appearance of the building due to their location on a secondary elevation.

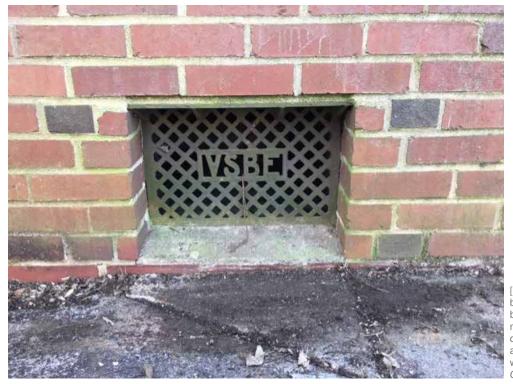
[56] To create a watertight seal around the building, any existing vents or openings below the established flood risk level must be sealed during a flood. Vents that cannot be sealed internally will require an exterior and/or interior cover to keep water from entering the building. *Photo: Chelius Carter*

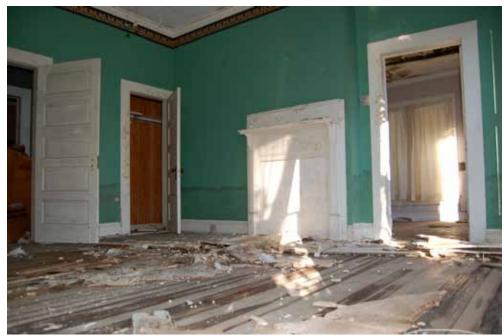
[59] Flood waters can have a significant impact on historic building interiors. Historic features and materials can often be retained and repaired and should not be preemptively removed or replaced. Much of the interior of this flooded historic property in Gulfport, MS, was able to be cleaned and retained. *Photo: Jenifer Eggleston/NPS*

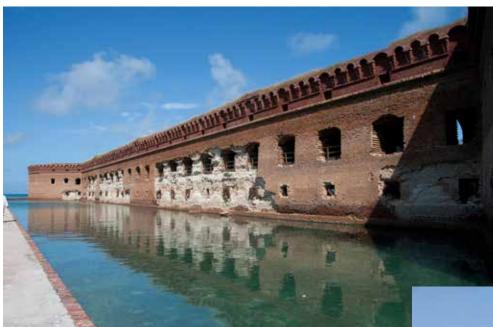
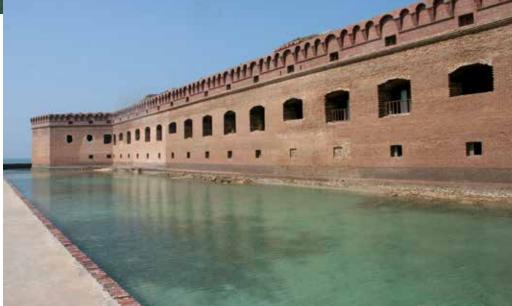
[60] Fort Jefferson located on the Dry Tortugas, FL, in the Atlantic Ocean exists in a wet environment with high salinity levels. (a) The iron components embedded in the masonry walls have reacted to these environmental factors, causing rust jacking, spalling masonry, and partial collapses (Exterior walls are shown before and (b) after repairs). Properties exposed to saltwater flooding are likely to encounter additional or accelerated damage and deterioration and may need materials science professionals involved in adaptation project planning.

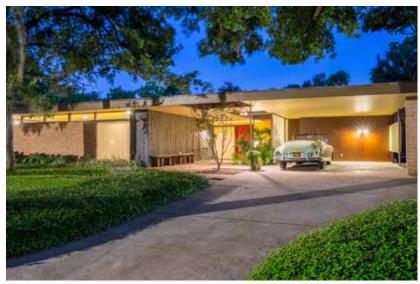
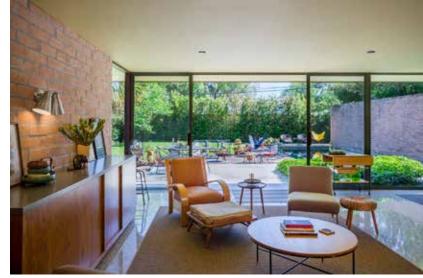
[64] The Bendit House built in 1953 and located in Houston, TX, experienced flooding in 2017 during Hurricane Harvey. Much of the original brickwork, terrazzo flooring, and solid lumber millwork was cleaned, repaired, and retained. Some of the newer paneling and more porous surfaces had to be replaced to allow for drying and repair.

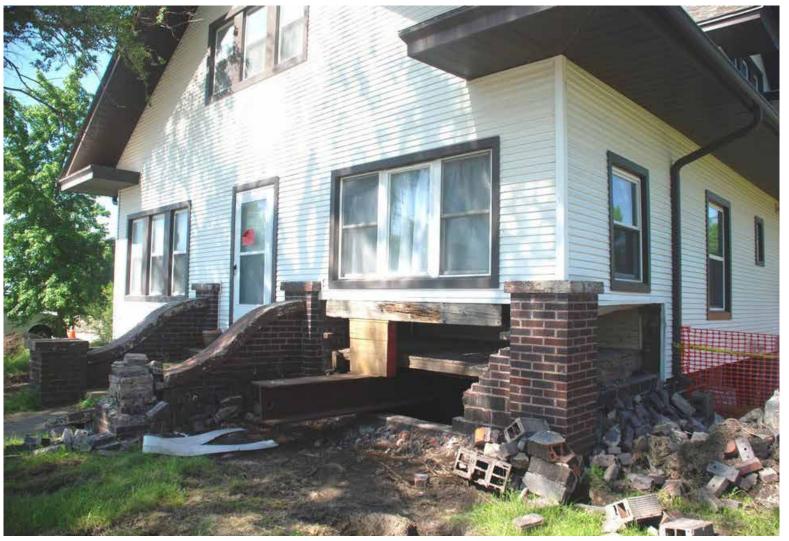
[72] Filling a basement requires access to bring the fill below grade and to maneuver compacting equipment in the space. In this example, a prior flood-damaged section of the foundation wall created an opening that allowed earthmoving equipment access to the basement. The exterior will be repaired once work is complete below grade. Photo: Mitch Paine

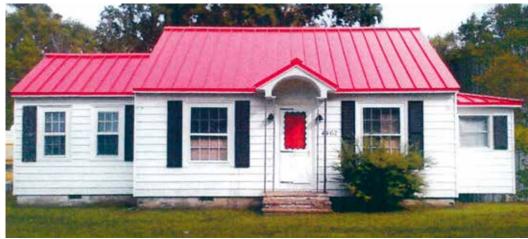
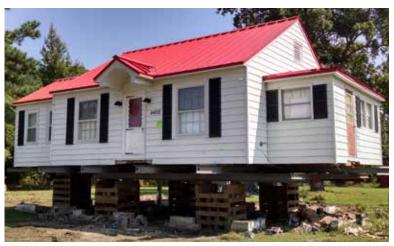
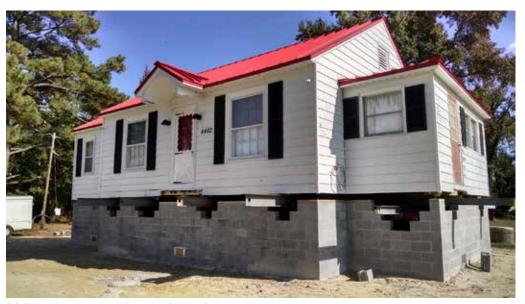
[73] The process of elevating a building: This small house is shown (a) before, (b) during, and (c) after being raised and placed onto a new foundation. The building is raised on temporary steel beams and braced on cribbing as the concrete-block foundation is built below, before being set down upon the new foundation. The building will require additional design and landscape features to finish the foundation and mask some of the change in height.

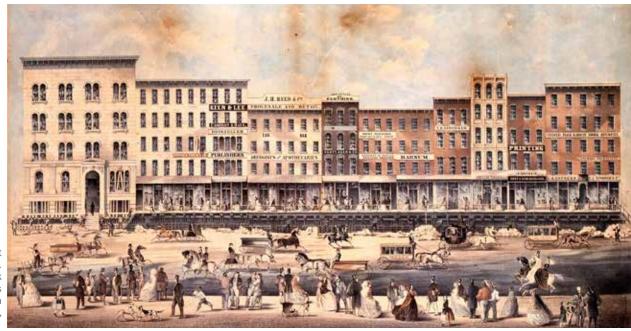
[74] Elevating masonry buildings built to the side lot lines can be difficult but has been done historically. This illustration shows an entire merchant block in Chicago being elevated at one time in 1857, as part of a larger plan to elevate the entire downtown area by four feet. Photo: Chicago History Museum, ICHi-059709

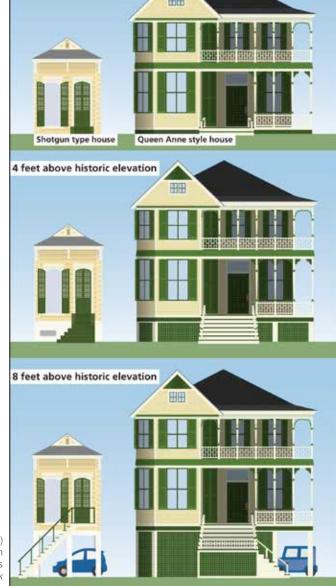
[76] Massing, scale, and proportions (tall vs. wide) are some of the important factors to consider when elevating a building and evaluating the impact on its historic character and appearance. *Graphic: Blank Space LLC for NPS*

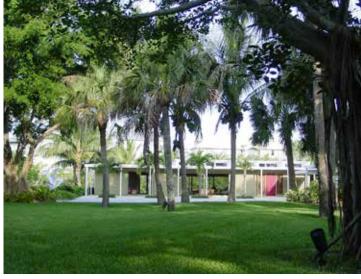
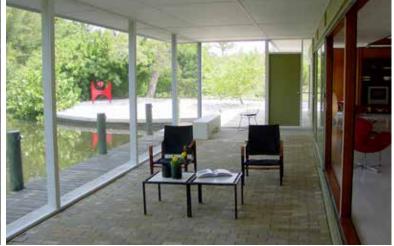
[80] A building cannot be easily elevated without impacting the historic character and appearance of the property when it has been designed to be closely connected to the landscape. For the David Cohen House in Siesta Key, FL, the architect Paul Rudolph designed the house to sit low to the ground and to have strong visual relationships to the exterior. Windows with large expanses of glass can be completely opened to the outside, bringing the outside in. Features such as flooring and wall materials continue from interior to exterior spaces. Elevating the building's spatial relationship to the surrounding landscape would not be a recommended treatment for this property.

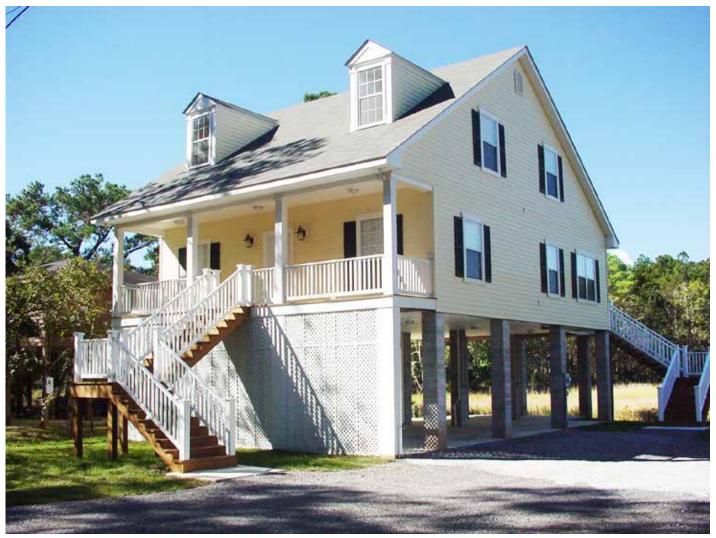
[81] When planning to elevate a building, it is helpful to create mock-ups or visual representations to illustrate the new floor height in comparison to the existing height in order to evaluate the impact on the historic character of the building. In this example, the proposal is to elevate the building to 6 feet above the existing first-floor level. *Photo: Dianne Selditch/SoundWaters*

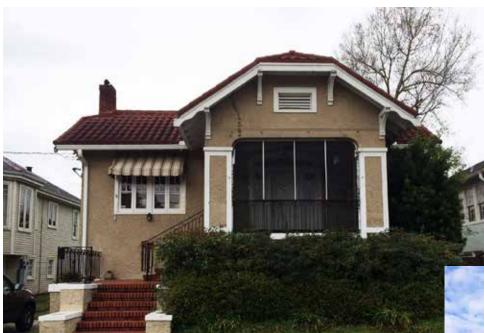
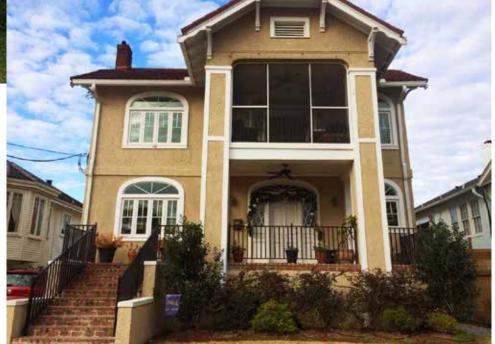
[83] This historic house has been elevated and altered to an extent that it has lost its historic character and integrity. As part of the project to elevate the house, a new story was added beneath the original one-story building. Elevating a small-scale or one-story building by an additional story is almost always not an appropriate adaption.

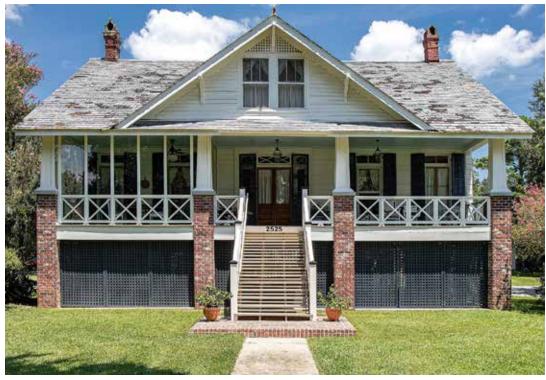
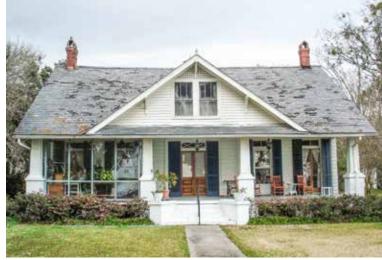
[84] This property in Mandeville, LA, is in an area of high flood risk and was elevated by an additional six feet. This necessitated a new stair and piers. In this case the original tapered porch columns were retained, and new brick piers were installed below. The new stairs are in their original location and orientation. The new porch balustrade emphasizes the porch level, while dark-colored lattice encloses a utility area below and helps to visually tie the building to the ground without it appearing like an additional story has been added to this one-story building.

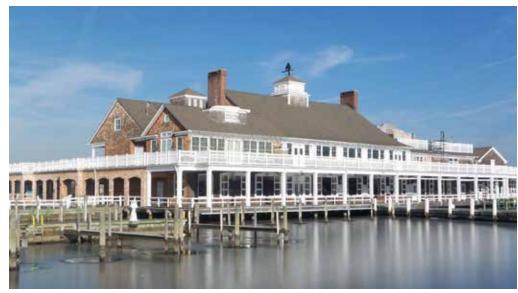
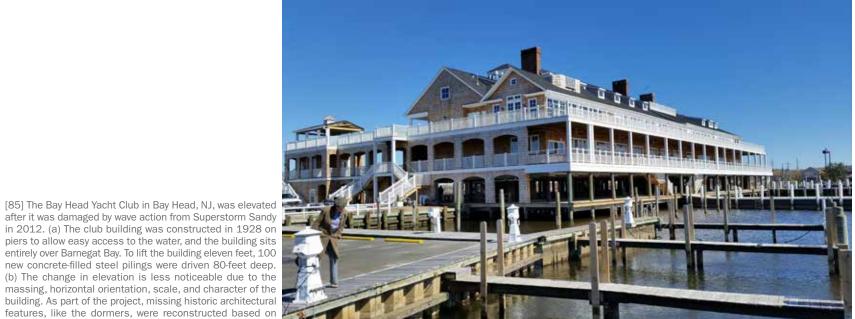
in 2012. (a) The club building was constructed in 1928 on piers to allow easy access to the water, and the building sits entirely over Barnegat Bay. To lift the building eleven feet, 100 new concrete-filled steel pilings were driven 80-feet deep. (b) The change in elevation is less noticeable due to the massing, horizontal orientation, scale, and character of the building. As part of the project, missing historic architectural features, like the dormers, were reconstructed based on

photographic documentation and physical evidence.

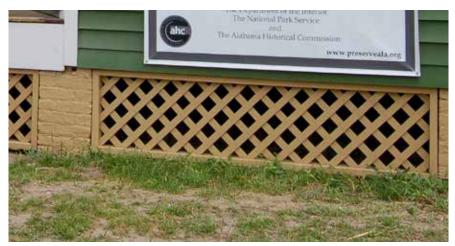
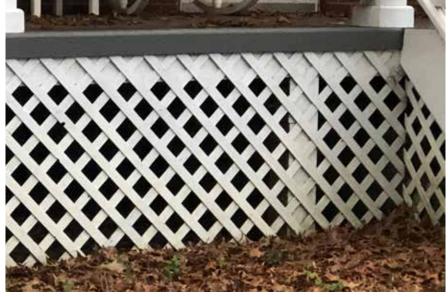
[88] (a) Lattice, louvers, or any other screening at the foundation should be located between piers (and generally recessed within the opening). (b) Lattice attached to the surface of posts or piers and without finished edges is generally not compatible with the character of traditional buildings.

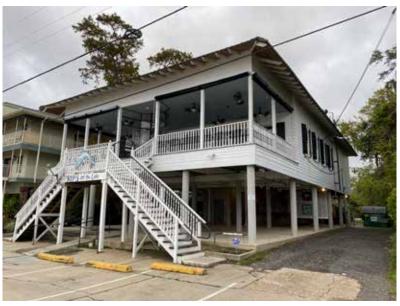
[89] This building in Louisiana has been raised on piers, but the foundation piers are set back from the face of the building, do not line up with the porch posts, and are visually undersized. New foundation piers, posts, and columns should have a visual appearance that more closely matches traditional foundation placement, size, and materials, even if that requires wrapping more modern, slender steel members with a masonry veneer. *Photo: Roderick Scott*

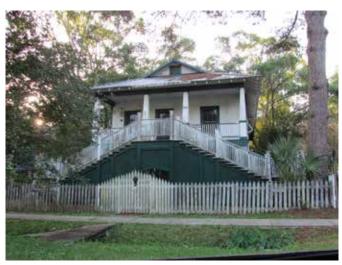
[91] Providing access can be a particularly challenging issue when elevating a property. (a) In this example, although there was enough room on the lot to maintain the original stair configuration on the front of the building, the stairs were instead located under the porch. In some historic homes this is a traditional way to gain access between porch floors, but it is rare for the primary entrance and should be avoided at the front of the building unless it was a historic configuration. (b) For a building with a smaller mass, a new monumental, double-run staircase like this can easily overwhelm the original building and change its historic character.

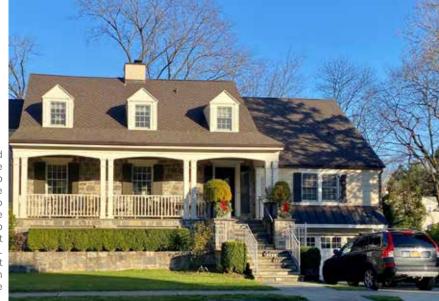
[93] This home has used elevated planting beds across the front of the house to bring the landscaping up higher and help screen the change in height. The stairs are stone, to blend in with the foundation and the planters, and a landing breaks up the long run of stairs at a point that aligns with the top of the planters. This provides a visual reference point for what was the original foundation height. The garage remains at grade level. Photo: FloodSavvy.com

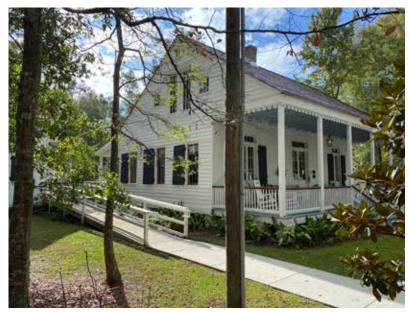
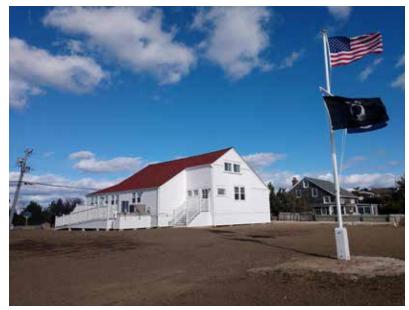
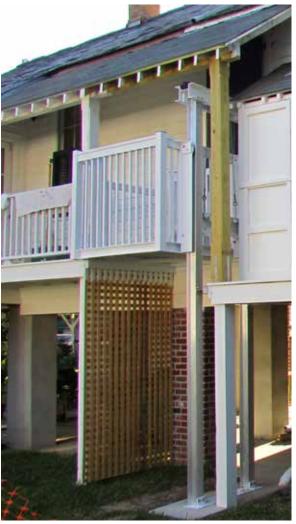
[94] Providing access for people with impaired mobility is an important consideration as part of elevating a building. Ramps, lifts, and elevators have all been used successfully, but the placement and design of such new features should be compatible with the historic building. (a) It is best to run ramps along the side of the building rather than projecting in front of the building or located in the front yard. (b) A switchback ramp was constructed along a side elevation of a former lifesaving station in New York that is located on a constrained site between a public beach and a street. (c) This platform for a lift is located on a secondary elevation and detailed to blend with the historic railing of the porch.

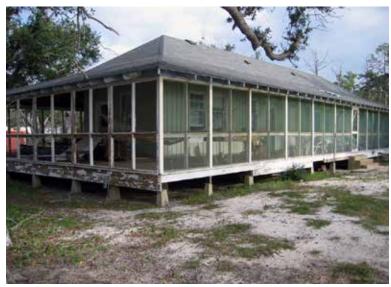
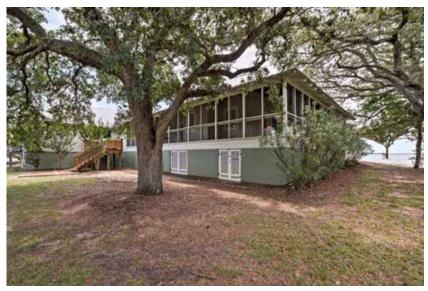
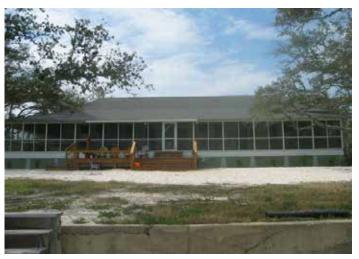
[96] Damaged by Hurricane Katrina, the Charles Marks house located along the Gulf Coast of Alabama used fill soils to camouflage the new foundation height on the water side while retaining the existing grade on the street side. (a) The original structure was supported by low, tapered concrete piers, approximately 18-inches high with an open crawlspace. (b) To bring this coastal structure into compliance with FEMA regulations, the house was elevated approximately 6.5 feet above its original height. (c) To mitigate the visual impact on the water-facing façade of the house, sand was used as fill on the site to raise the grade to within approximately 18 to 24 inches of the floor joists. The new grade gradually falls away toward the edges of the property. Retaining walls were necessary in some places to contain the sand.

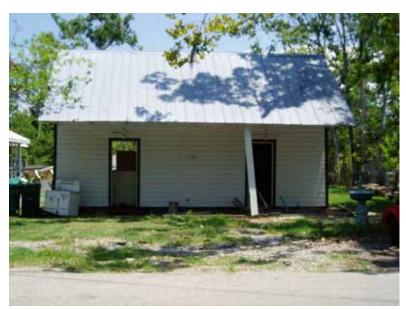
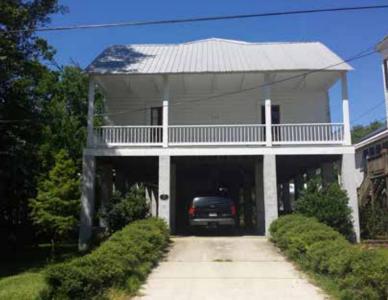
[97] Fill soils can help to reduce the visible foundation. The new elevated height of this building in Cedar Rapids, IA, has been disguised by retaining the historic full-width front stair, adding a new center stair extending to the sidewalk, and filling the front of the lot to gently slope the grade to cover the new foundation on either side of the stair.

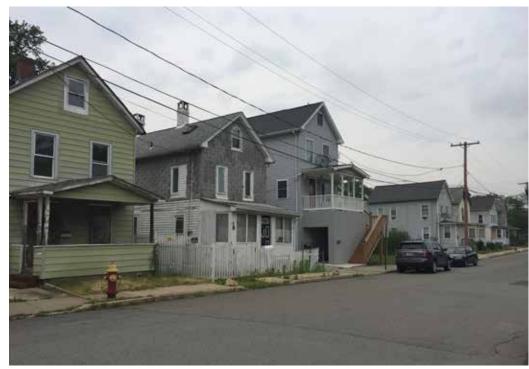
[99] Consideration should be given to the overall impact on the historic character and appearance of a district. A significantly different or random change in foundation height is inconsistent with the historic character of this district. *Photo: Jennifer Parker/NPS*

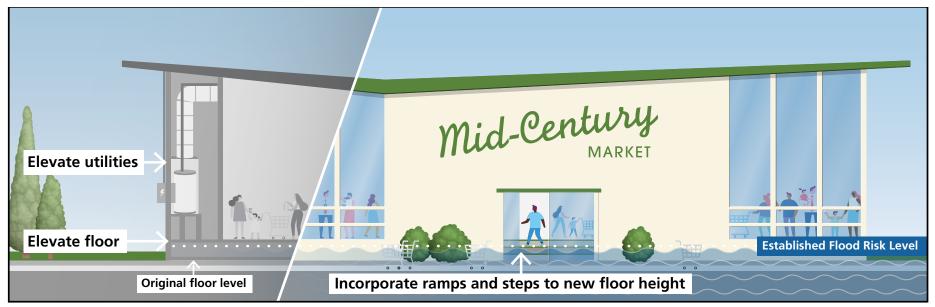
[100] Elevating the interior floor level above the established flood risk requires several building alterations, including constructing a new floor, elevating any utilities, and creating access to the new floor level. The original floor to ceiling height must be substantial enough to allow space for the new elevated first floor. *Graphic: Blank Space LLC for NPS*

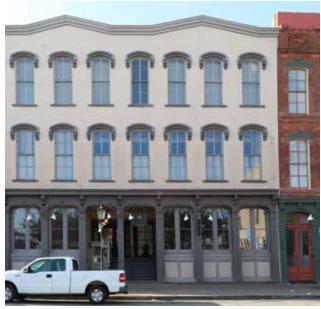
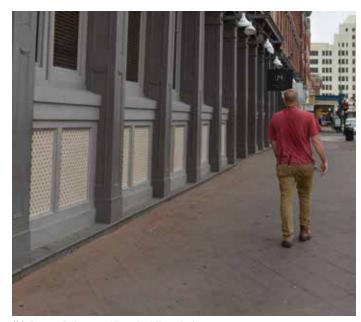
[101] (a) The storefront doors of this commercial property have been floodproofed and the interior floor elevated. Unfortunately, the new floor resulted in a change to the storefront. The inappropriate change in appearance is apparent in comparison to the neighboring building. (b) The bottom of the storefront glass is now above shoulder level for an average-height adult pedestrian. This is not a recommended treatment.

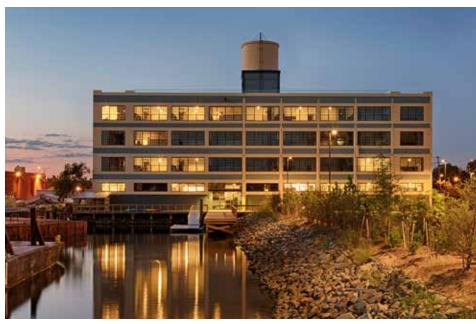
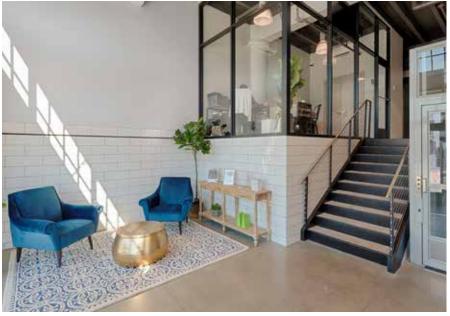
[102] The first-floor level in this former warehouse building in Norfolk, VA, has been elevated, with a ground-floor lift installed to connect the lobby entrance with the new finished floor. The new interior floor level is held back from the primary entrance and is not visible from the exterior, minimizing the overall impact of the change. First-floor windows were high enough above the historic floor level that the new floorplate is below the windows where it meets the exterior wall.

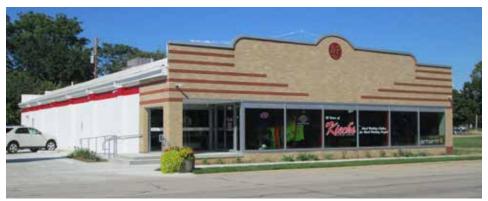
[103] This former grocery store in Cedar Rapids, IA, has a new interior floor constructed to be level with the sills of the storefront windows. This alteration does not change the exterior appearance of the historic storefront openings. The new floor extends outside to fill the corner recessed entrance, and new steps and a ramp were added to the side of the building. (a) Before the project began with storefronts boarded up. (b) After construction has been completed.

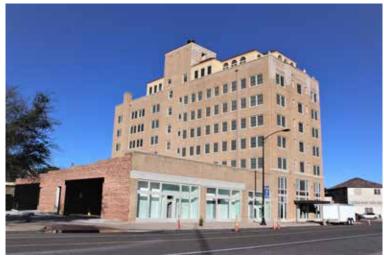
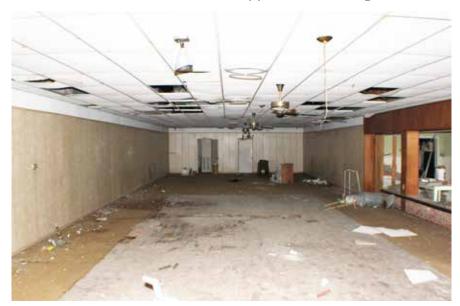
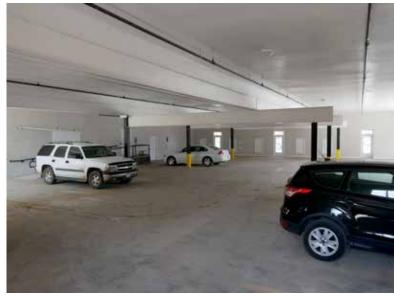
[106] This project in Texas included the conversion of former retail tenant spaces into parking as part of a larger rehabilitation. Although the conversion was not due to flood-related issues, the design principles are the same. (a) The character and transparency of the storefronts were maintained along the sidewalk. New partition walls create an interior display space and conceal the new parking area from view. (b) The altered interior retained no historic features or finishes prior to the project. (c) The space was opened up into a single parking area, and the walls and ceilings were finished to maintain the historic character. Vehicular access is provided on a secondary side elevation of the building, visible in photo (a).

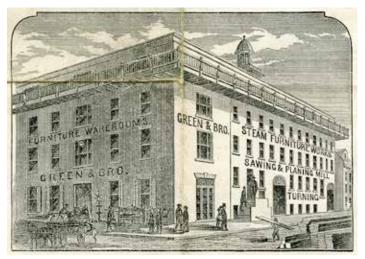
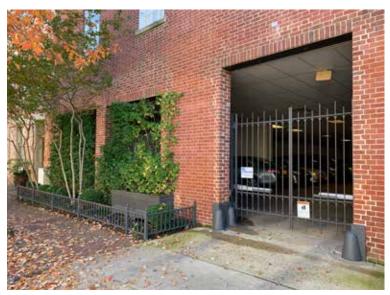
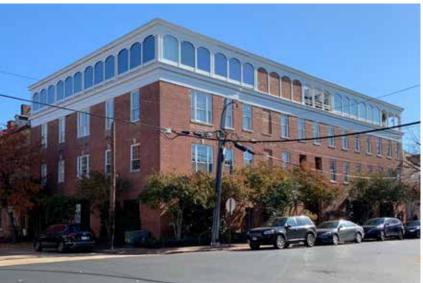
[107] (a) The former Green Furniture Factory in Alexandria, VA, was converted to apartments with parking on the first floor. (b) This project would not meet the Standards because the ground-floor openings were changed significantly and (c) a large rooftop addition was also added. Historic windows and doors on primary elevations should be retained and preserved even when the interior space becomes storage or parking.

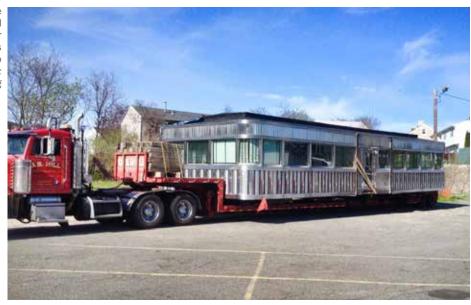
[108] Some buildings were intentionally constructed to allow for relocation. For instance, many historic diners are similar in structure to early mobile homes. Photo: Jim Paveglio, Geddes Building Movers, Inc.

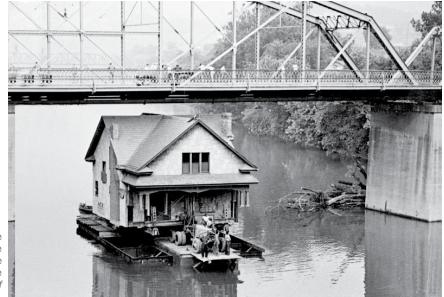
[109] At times, moving a house over water may provide more space to maneuver and facilitate keeping the building in one piece as it is moved. Photo: Courtesy of mywvhome.com

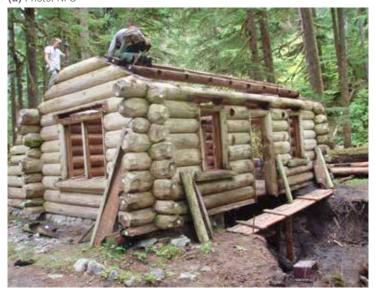
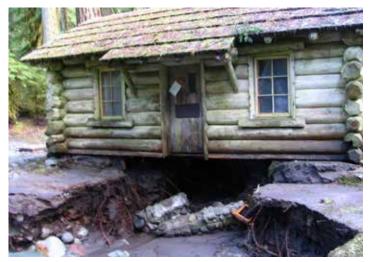
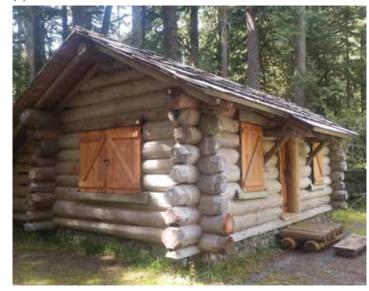
[112] The Ipsut Creek Patrol Cabin located in Washington state within Mount Rainier National Park was impacted by (a) significant flooding in 2006 that (b) resulted in a washout of the soils beneath the cabin. It was determined that the log cabin should be moved to a less flood-prone area. Prior to being relocated, the cabin was documented. (c) Each feature and building component were tagged and then carefully disassembled. (d) Finally, the building was reconstructed in a new location within the park with reduced risk for flooding.

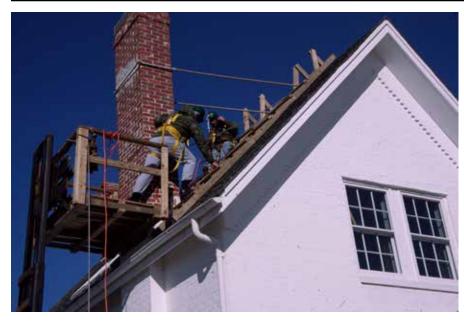
[113] Fragile features like chimneys should be evaluated and braced before a building is moved. *Photo: Mike Booher/NPS*

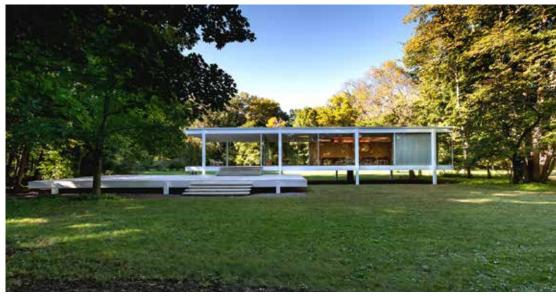
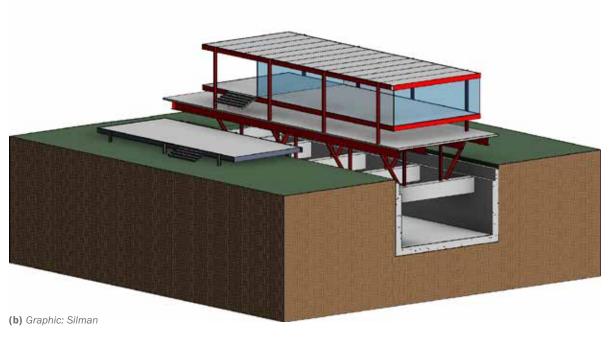
[115] (a) The Mies van der Rohe-designed Farnsworth House in Plano, IL, near the Fox River has regularly experienced flooding events since it was constructed in 1951. One method of flood protection under consideration for the house is to integrate a hydraulic system into the building's foundation. (b) The hydraulic lifts would be located in a concrete pit below the house and attached to its concrete slab/foundation. During a flooding event, the hydraulic lifts move the house and slab above the flood level and return it to its original elevation after flood waters recede.

- Hydraulic lift and anchoring systems to allow a building to remain at existing foundation height and be lifted above the flood risk level during a flooding event.
- Buoyant foundations with guideposts, also known as "amphibious architecture," to allow a building to float. Buildings are retrofitted with buoyancy blocks, vertical guideposts, and a structural sub-frame.

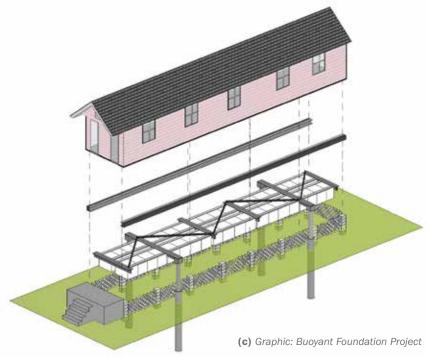
[116] (a) Properties with smaller, symmetrical footprints such as these shotgun houses are potential candidates for exploring a "buoyant foundation" approach to flood mitigation. (b) A buoyant or amphibious foundation allows a building to float during a flood event. (c) This system consists of the following primary components: buoyancy blocks that are placed under the building to allow it to float; vertical guideposts that keep the building centered above the foundation as it floats and are aligned to reconnect it with the foundation; a structural frame that ties the system together; and utilities that can either seal and break away or have long connections that can uncoil.

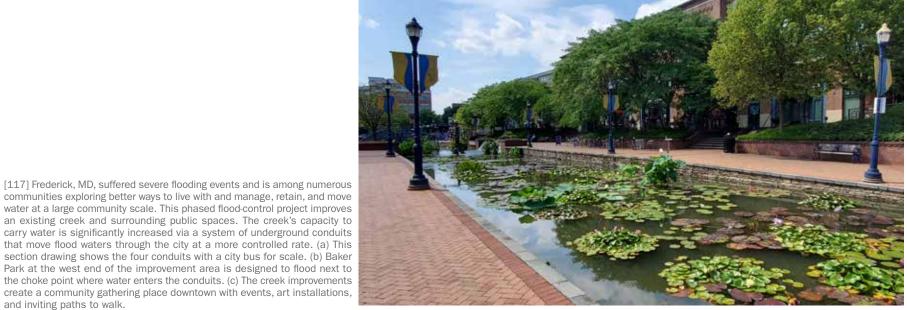
section drawing shows the four conduits with a city bus for scale. (b) Baker Park at the west end of the improvement area is designed to flood next to the choke point where water enters the conduits. (c) The creek improvements create a community gathering place downtown with events, art installations, and inviting paths to walk.

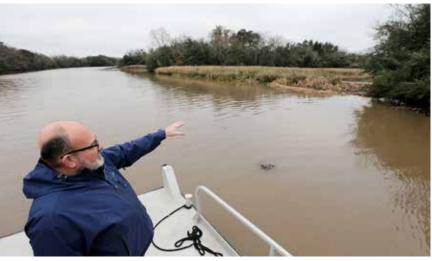
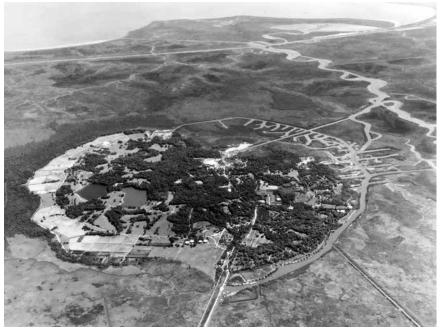
[118] Avery Island, LA, listed in the National Register of Historic Places and the historic home of Tabasco brand pepper sauce, has engaged in a program of reclaiming marshlands largely lost to manmade canal systems, erosion, and subsidence. By "canal plugging," using marsh vegetation like cordgrass, the Island has been able to protect and reestablish marsh lands and create a more sustainable and protected shoreline.

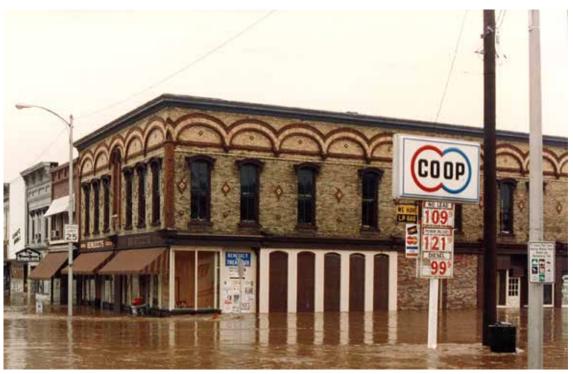
Figure 1: This 1993 flood was one of several events that led to the listing of the Main Street Historic District in the National Register. Photo: Lafayette County Historical Society

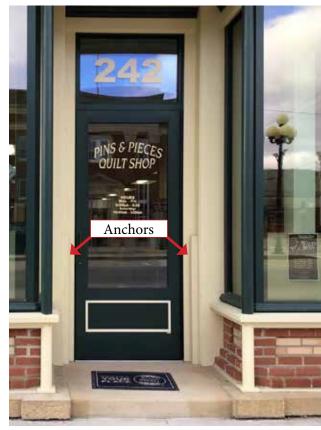
Figure 5: Door jambs were designed with integral anchors for attaching removable floodgates. The anchors are visible but painted to blend in. *Photo: Heidi Brenum*

Above grade, the storefronts were largely reconstructed to repair and improve the historic design to be stronger and more flood resilient. The new waterproof barrier consists of a two-part system with a lower level of protection that aligns with the historic storefront sill, and a taller, code-compliant interior barrier is inset from the storefront by approximately 18 inches (see Figure 4). The shorter concrete knee wall provides stronger backup for flood-related impacts to the historic brick storefront bulkhead. Existing steel columns are anchored to the new concrete foundation and the second-floor structure. With the exception of the glass, the storefront framing and features are also anchored and engineered to resist flood-born debris impacts and hydrostatic forces. All of the materials to the exterior of the tallest flood barrier are waterproof and decay resistant.

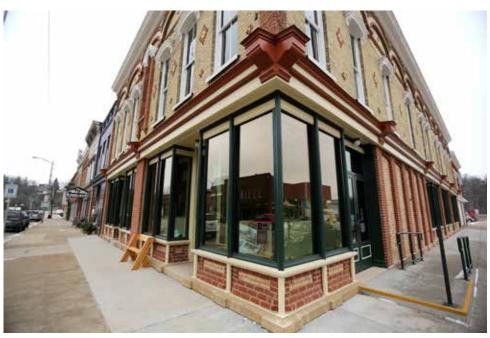
Figure 6: Exterior of the building after the dry floodproofing project is complete. The exterior steel storefront framing is a historic feature, painted green above the storefront and cream below after rehabilitation. Photo: Dave Kettering/Telegraph Herald

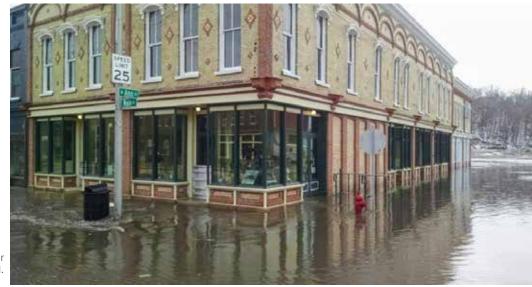
Figure 7: Floodproofing measures kept the water out of the Driver Opera House during a 2019 flood. *Photo: Brian Mesmer*

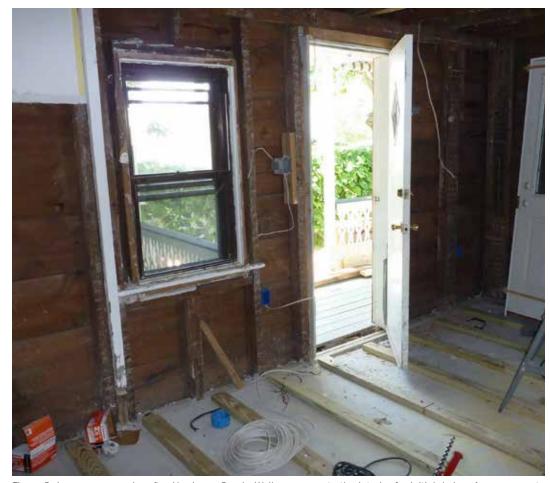
Figure 2: In-progress repairs after Hurricane Sandy. Walls are open to the interior for initial drying. A new concrete structural slab has been topped with treated wood sleepers in preparation for a new flood-damage resistant mahogany floor. Photo: Mary Delaney Krugman, JD, MSHP

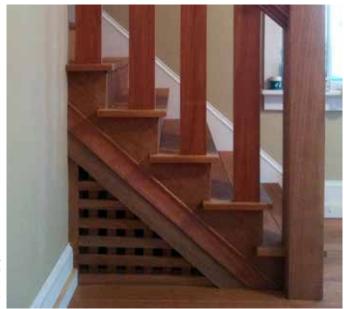
Figure 3: Instead of solid wall material, an open lattice was installed under the stair to vent an otherwise inaccessible space. Photo: Mary Delaney Krugman, JD, MSHP

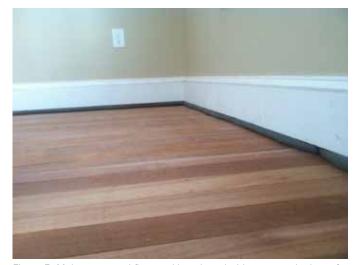
Figure 5: Mahogany wood floor and baseboard with a gap at the base for future venting. Foam insulation strip fills the gap and will be covered with removable trim. *Photo: Mary Delaney Krugman, JD, MSHP*

Walls were finished with flood-damage resistant cement wall board and closed cell insulation panels. A space was provided on the exterior wall for air circulation within the wall cavities. The baseboard and crown molding included slots and removable trim pieces to open the walls at the top and bottom, allowing air to circulate so as to dry out the wall cavities post-flood. The slots are filled with an insulating foam strip behind removable trim pieces. The foam insulation is removed immediately after a flood event.

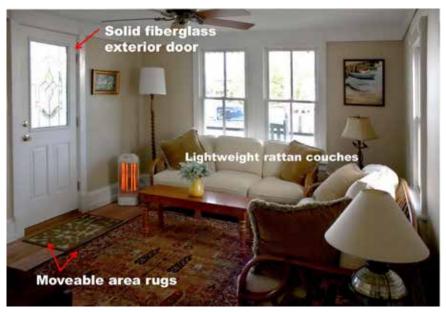
Figure 7: After repairs and wet floodproofing measures have been implemented, the new floor and wall surfaces are flood-damage resistant. The front door and windows were also replaced with more compatible designs using flood-damage resistant materials Photo: Mary Delaney Krugman, JD, MSHP

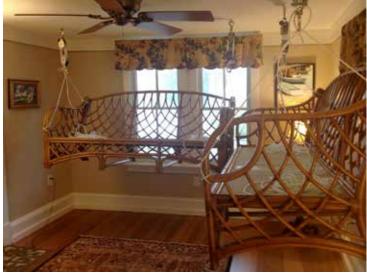
Figure 8: A pulley system lifts heavy or bulky furniture above predicted flood waters. All other contents can be moved to upper levels of the house. Photo: Mary Delaney Krugman, JD, MSHP

Krugman considered her furniture choices as she completed the project. Most contents can be relocated to the second story or elevated rear addition before a predicted flood event. However, large pieces of furniture like sofas are not easily relocated. To solve this problem, Krugman purchased lighter-weight furniture and devised a block-and-tackle system attached to hooks in the ceiling that allows the living-room sofas to be lifted above an inundation event.
