THE SECRETARY
OF THE INTERIOR'S
STANDARDS FOR
REHABILITATION &

GUIDELINES
ON FLOOD
ADAPTATION FOR
REHABILITATING
HISTORIC
BUILDINGS

U.S. Department of the Interior National Park Service Technical Preservation Services These Guidelines were previously issued as a text-only version in November 2019. This illustrated version was revised to include diagrams, photographs, and other changes and replaces the prior version.

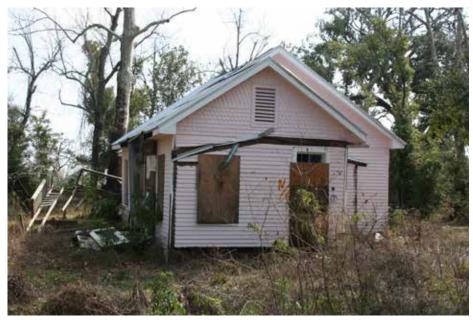
Figure 3: Hurricane Katrina destroyed the wrap-around front porch and knocked the house off the pier foundation. This photo was taken after the site had been cleared and windows and doors were temporarily boarded. Photo: Mississippi Department of Archives and History, Mississippi Historic Resources Inventory (HRI) Database. http://www.apps.mdah.ms.gov/Public

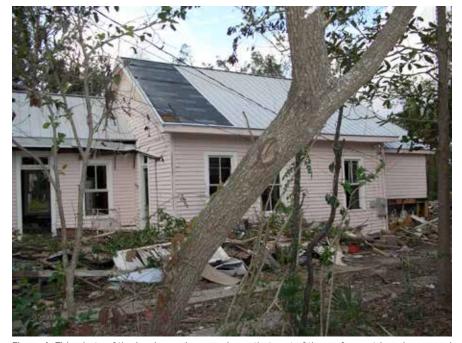
Figure 4: This photo of the hurricane damage shows that part of the roof was stripped away, and debris littered the site around the house. Photo: Mississippi Department of Archives and History, Mississippi Historic Resources Inventory (HRI) Database. http://www.apps.mdah.ms.gov/Public

severely damaged in 2005 by Hurricane Katrina which caused massive damage to many properties along the Gulf Coast. The storm completely destroyed and washed away the L-shaped front porch, part of the roof was stripped away, and the pier foundation was swept out from under the house. When the storm surge receded, the house was left sitting directly on the ground.

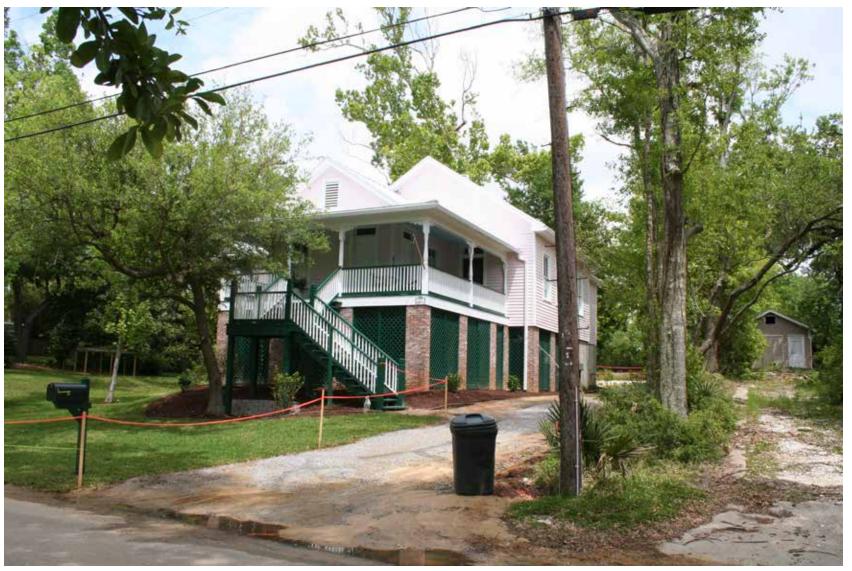
Figure 5: A taller foundation was constructed to elevate the house above the established flood risk level. While the house is higher than it was historically, the change is still in keeping with the historic character of the house, which had been on a tall foundation historically. The change is also consistent with historic regional traditions of adapting buildings to flood events. Additionally, the details of the foundation, with the brick piers and painted lattice, matches features of the historic design. The stairs access the porch in the historic location, but the extended run required by the taller foundation is turned 90 degrees below the landing to allow a surviving tree to remain in front of the house. A small retaining wall behind the tree holds fill that was added around the house to mask some of the change in height. Photo: Mississippi Department of Archives and History, Mississippi Historic Resources Inventory (HRI) Database. http://www.apps.mdah.ms.gov/Public

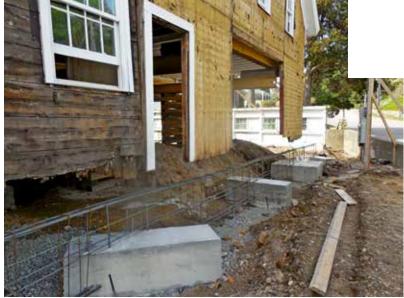
Figure 3: The structure was lifted in sections several feet in the air to provide space and access for foundation work. *Photo: GNCB Consulting Engineers*

Instead, the building was lifted two feet above grade to provide some measure of flood protection while maintaining the historic character of the property and easy pedestrian access to the new retail spaces on the lowest level. Elevating this 7,000-square-foot building was complicated, even though the frame structure is relatively lightweight and easy to separate from the existing stone foundation. Existing interior and exterior finishes were removed prior to work beginning. Historic materials were marked and stored for future reinstallation. With the structural components exposed, the building was stabilized and divided into five separate sections. Each section was lifted independently to a temporary height of eight feet above the ground.

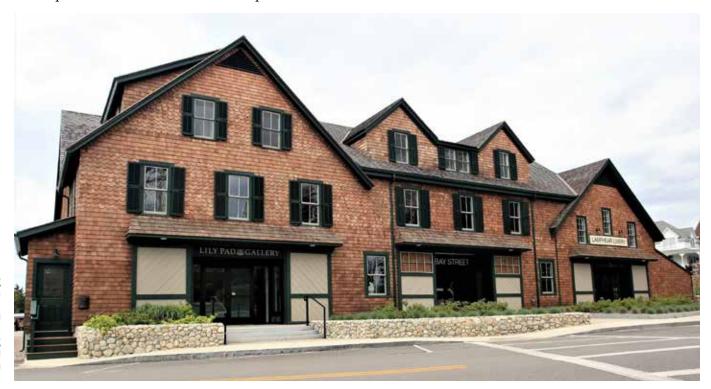
Figure 5: View of the building after the floodproofing and rehabilitation project was complete. The historic barn doors and many historic windows were preserved. Damaged or missing shingle siding was replaced in kind. The foundation is now two feet taller than it was at the start of the project. Wet floodproofing of the first floor provides additional resiliency and protection for floods that exceed the new elevation height. *Photo: Pariseault Builders*

Since elevating the building did not eliminate the flood risk to the first level of the building, the lowest level was wet floodproofed. This treatment included strengthening the ground-floor structural frame, installing engineered flood vents, and using flood-damage resistant materials at the floors and walls of interior spaces. The condition of the building before the project began required a substantial amount of replacement materials for deteriorated features and finishes. Almost all materials were replaced in kind with durable marine-grade wood.

Utilities and equipment were relocated to a new elevated mechanical room created in the back of the upper floor that required new exterior louvers for adequate ventilation. By selecting a combination of flood adaptation treatments—elevating the building, wet floodproofing, and elevating utilities—the project team was able to preserve the historic character and features of Lanphear's Stable while making the building more resilient to future floods.  $\mathfrak{S}$

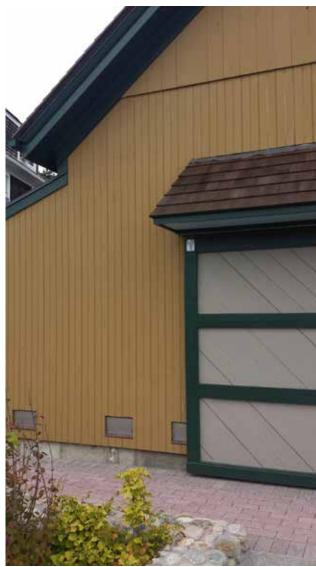
Figure 7: As part of wet floodproofing the building, engineered vents near the bottom of exterior walls are designed to allow water to flow in and out of the building during a flood. This allows water pressure to equalize on both sides of the wall and reduce stress to the structural system. Photo: Jennifer Wellock/NPS
