A Recommendation for an
ENHANCED FUJITA SCALE
(EF-Scale)

Submitted to
The National Weather Service
and
Other Interested Users

June 2004

WIND SCIENCE AND ENGINEERING CENTER
Texas Tech University
Lubbock, Texas 79409-1023

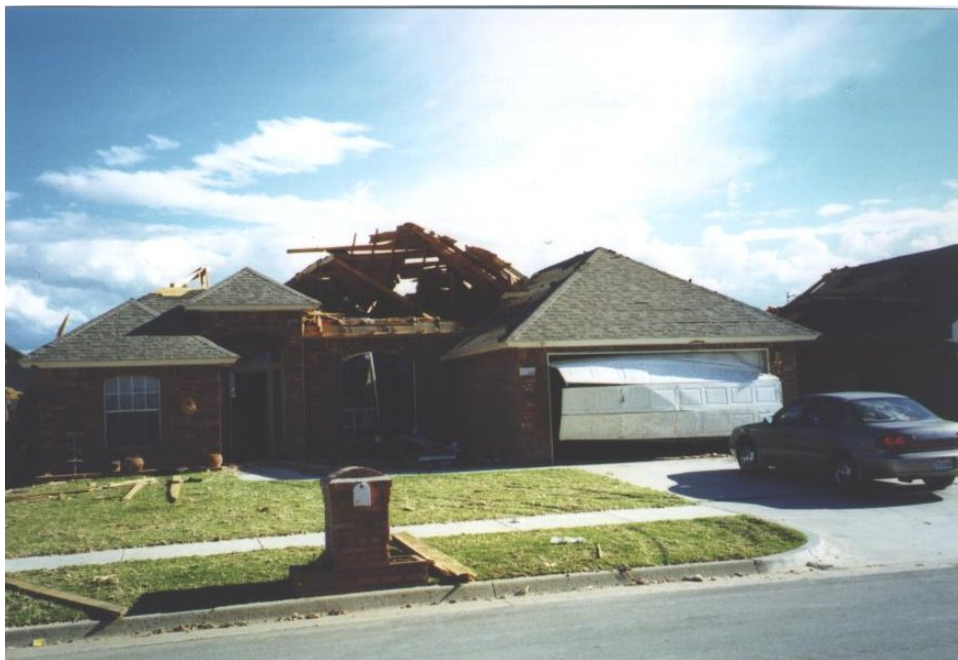
FR12: DOD 2: Loss of roof covering (<20%)

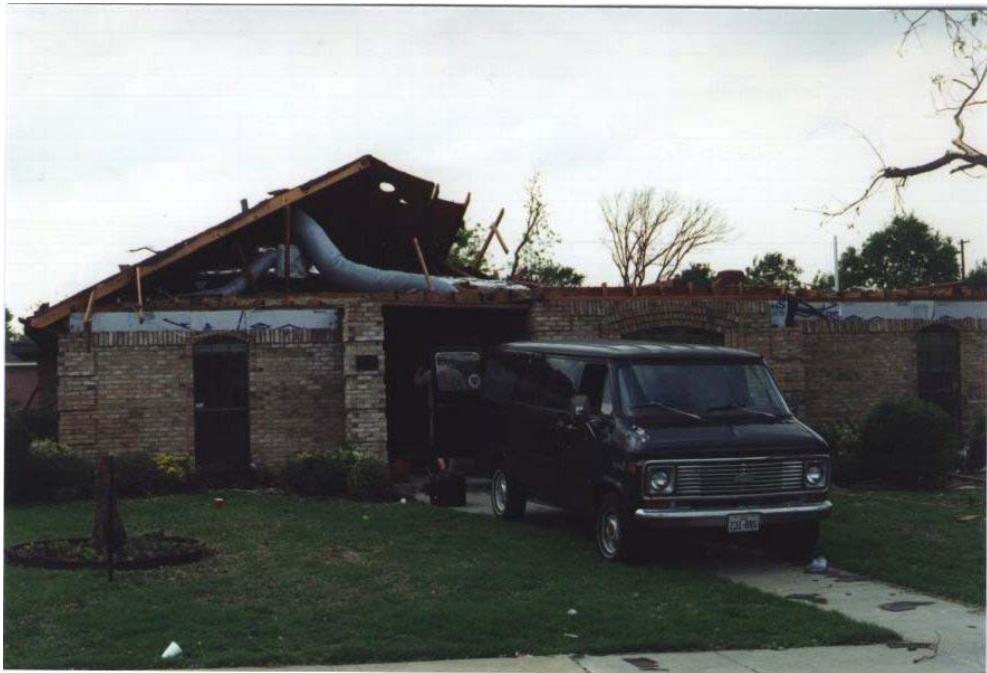
FR12: DOD 4: Uplift of roof deck and loss of roof covering (>20%); garage door collapses outward

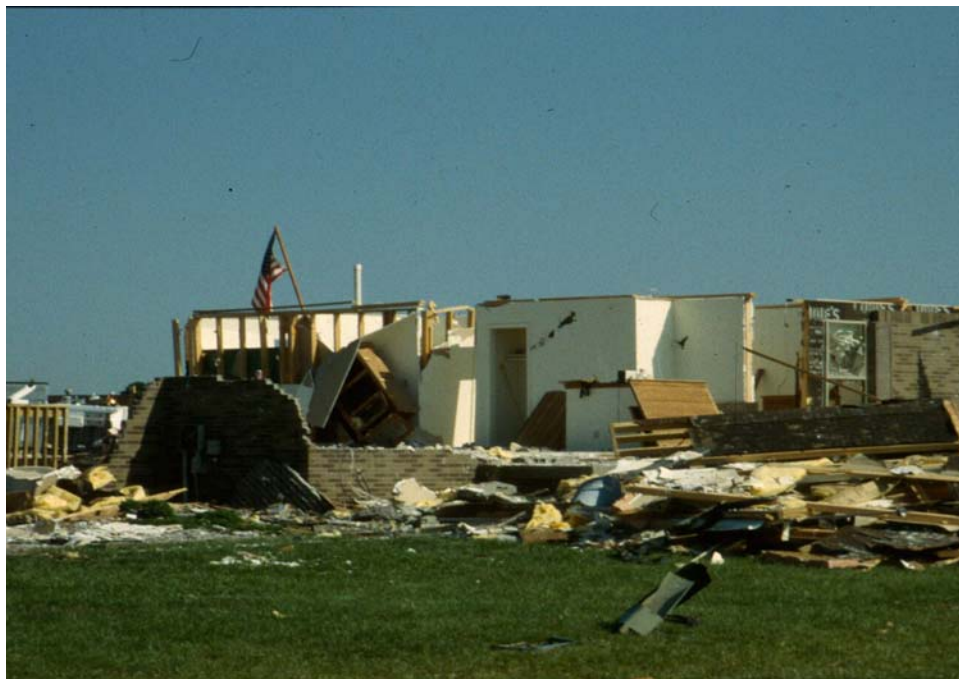
FR12: DOD 6: Large sections of roof removed; most walls remain standing

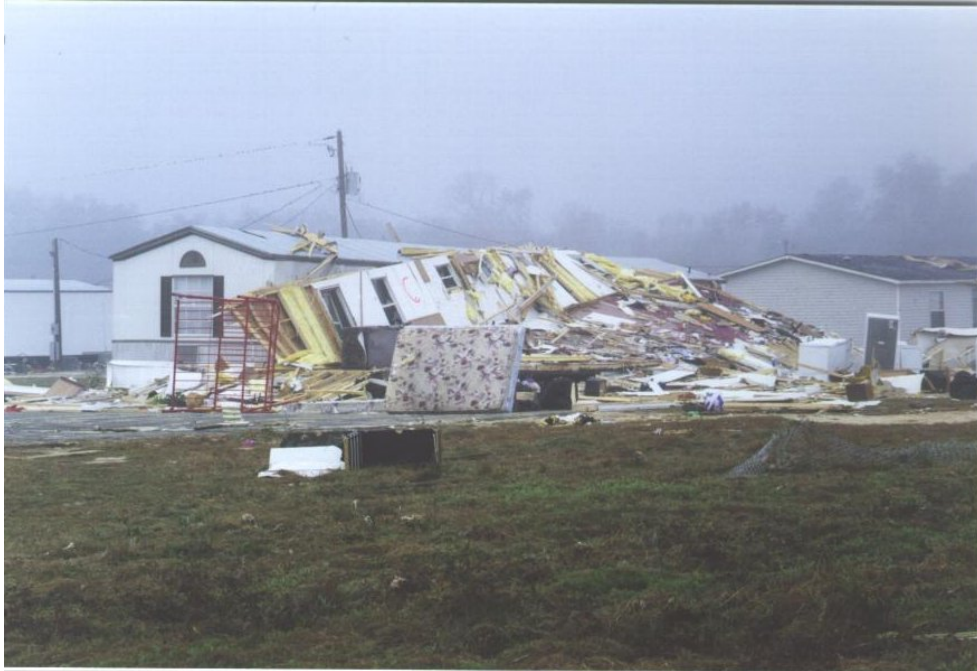
MHSW: DOD 6: Destruction of roof and walls leaving floor and undercarriage in place

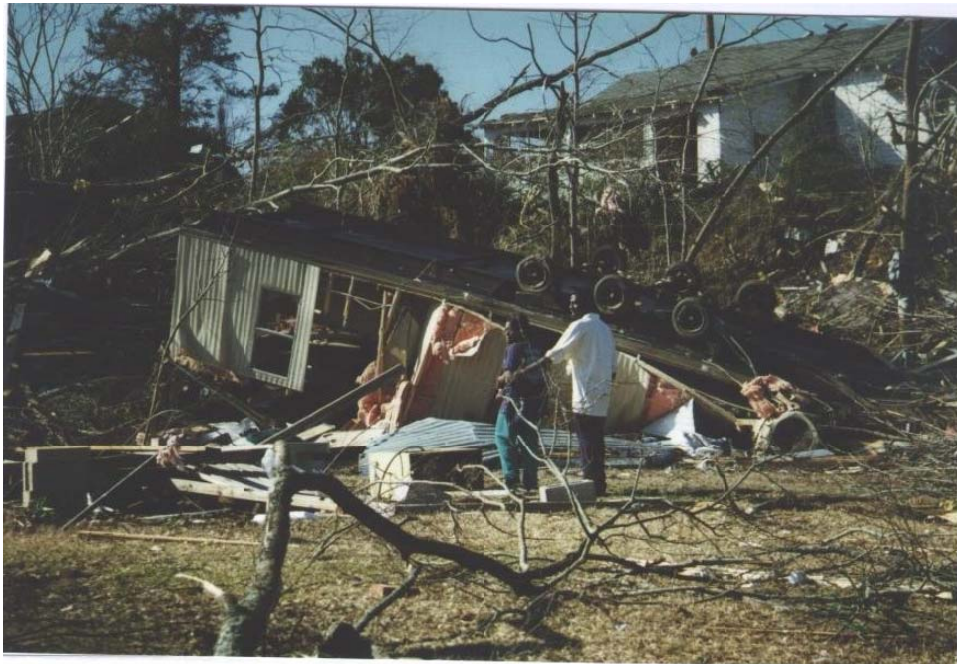
MHSW: DOD 9: Complete destruction of unit; debris blown away

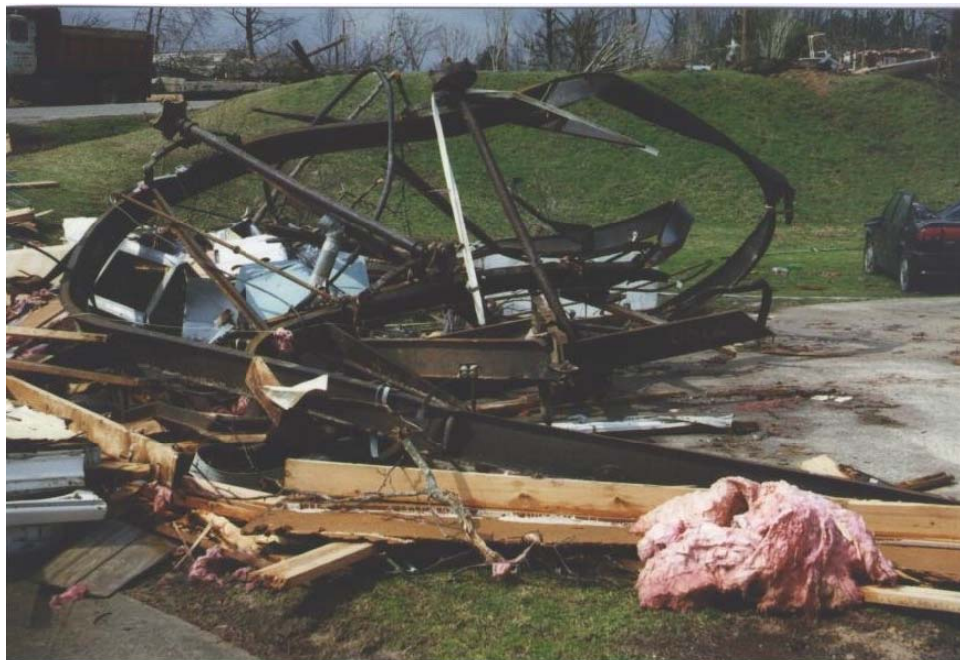
MHDW: DOD 11: Undercarriage separates from floor; rolls and tumbles, badly bent

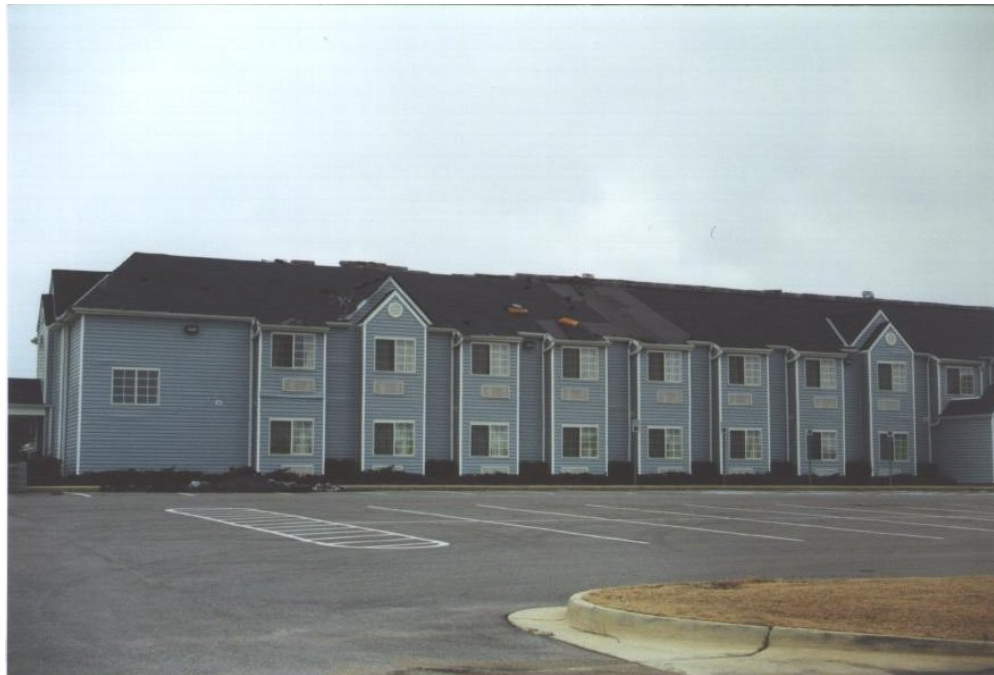
ACT: DOD 2: Loss of roof covering (<20%)

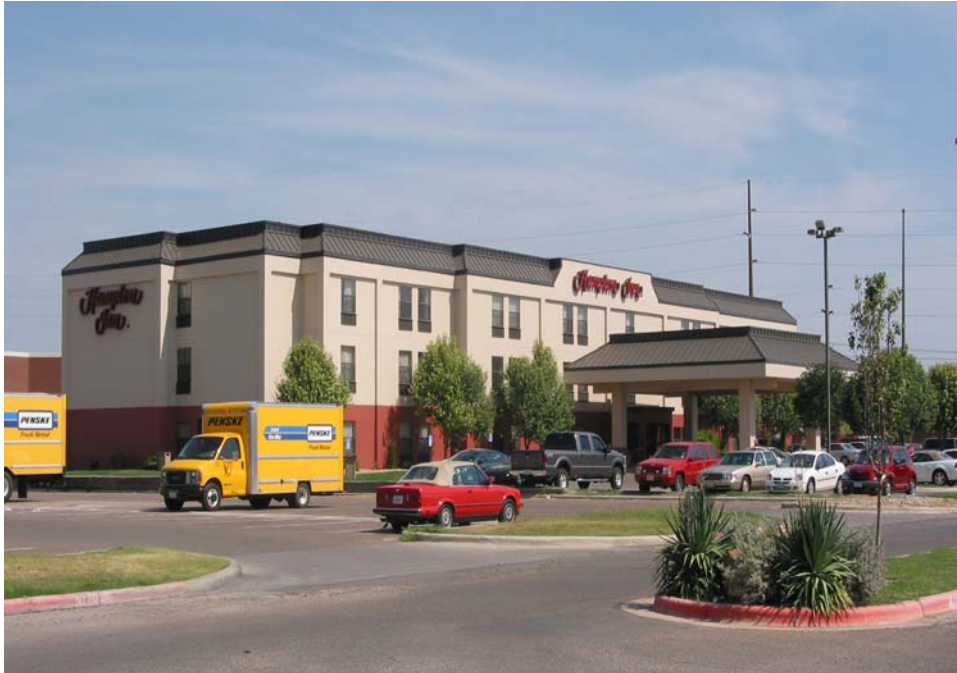
M: Less than five stories; one or more rectangular modules; flat, gable, hip, or mansard roof; asphalt shingles, tile, slate, or BUR covering; plywood or metal roof decking; stud walls with EIFS, stucco, or wood siding or brick veneer; canopy over driveway at entrance; exterior walkways or balconies

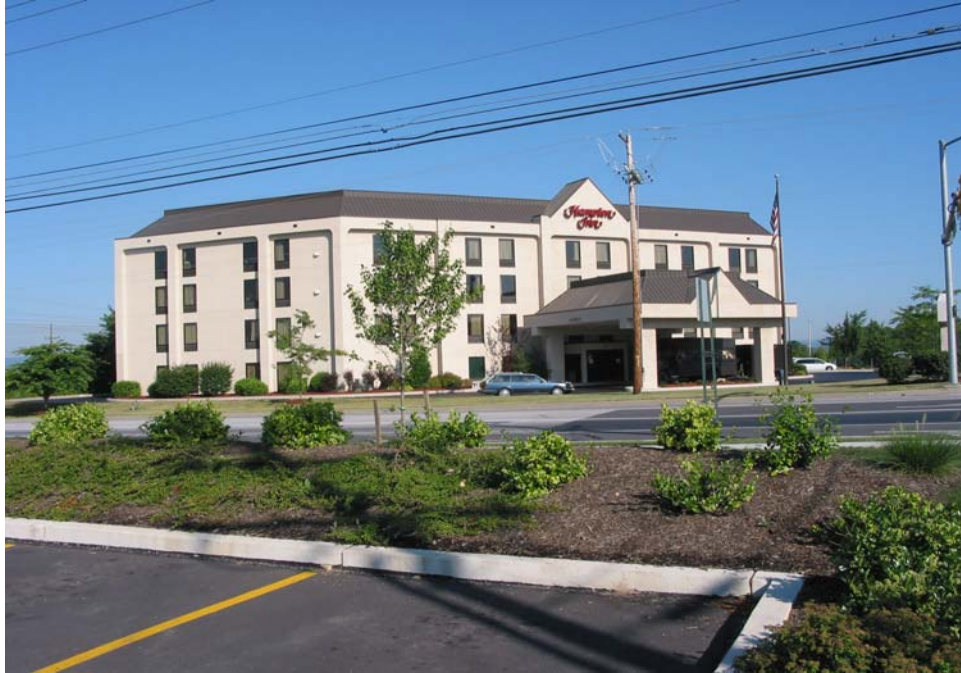
MAM: Four stories, rectangular plan, mansard roof, pre-cast, hollow-core roof & floor system, CMU load-bearing walls, EIFS exterior walls

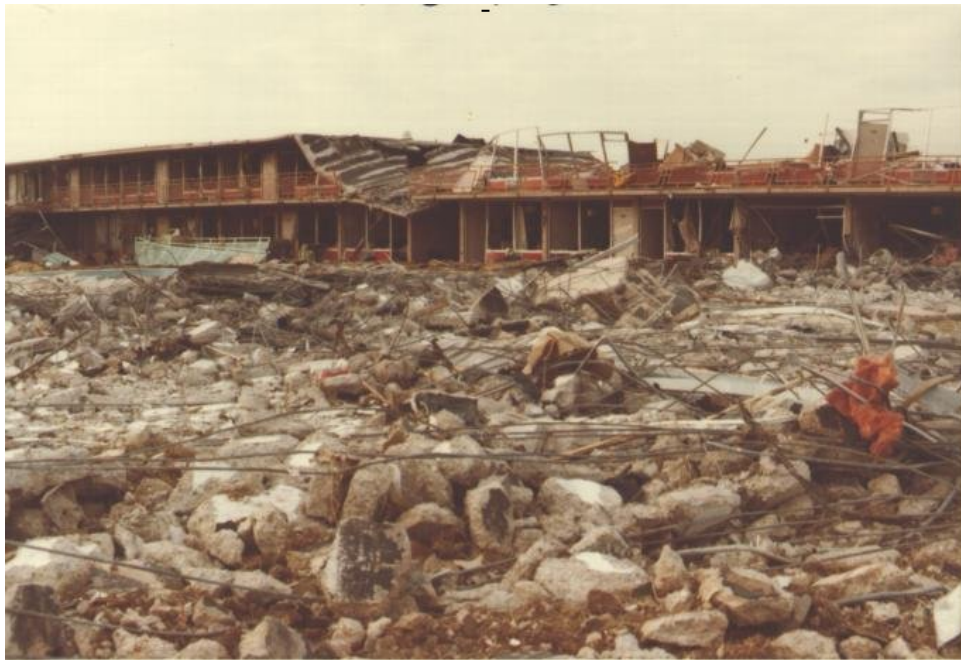
MAM: DOD 4: Uplift fo pre-cast roof decking

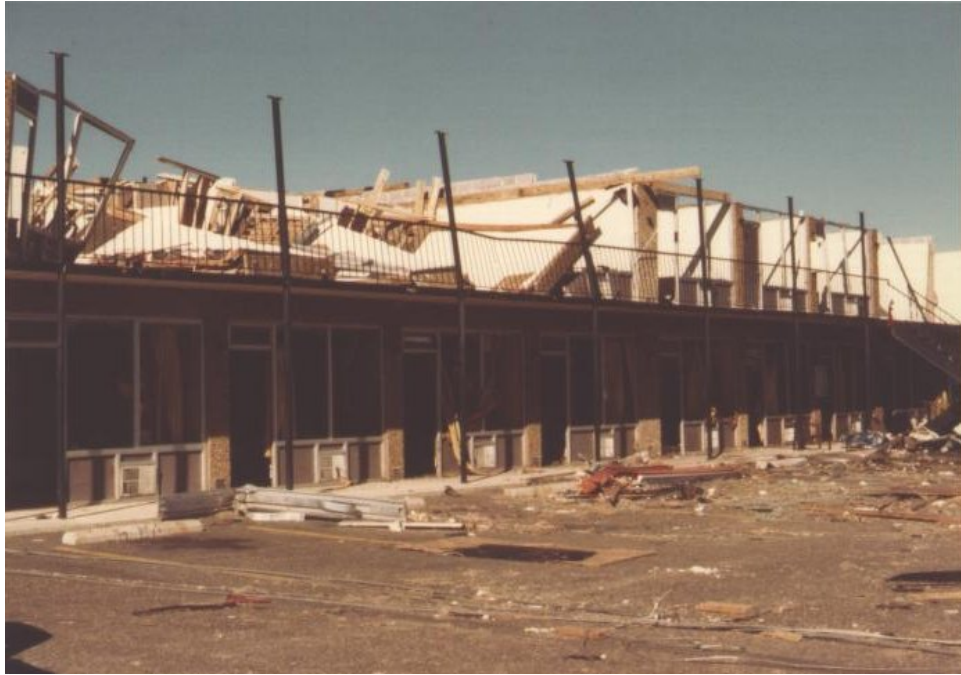
MAM: DOD 5: Collapse of top story walls

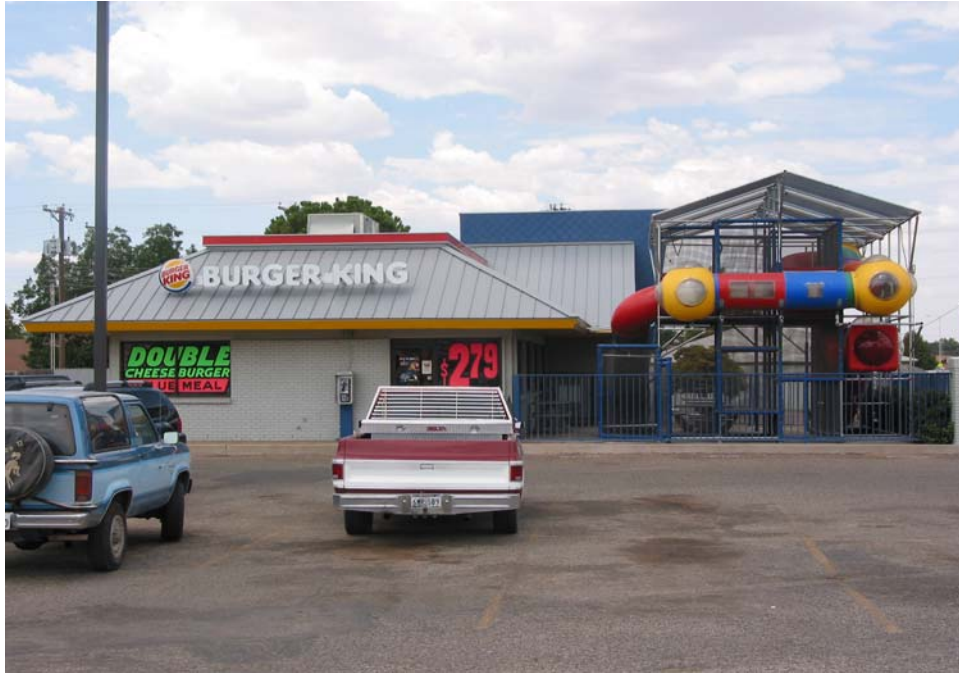
SRP: Hip roof, metal panel roof, wood trusses and stud walls, metal or vinyl siding

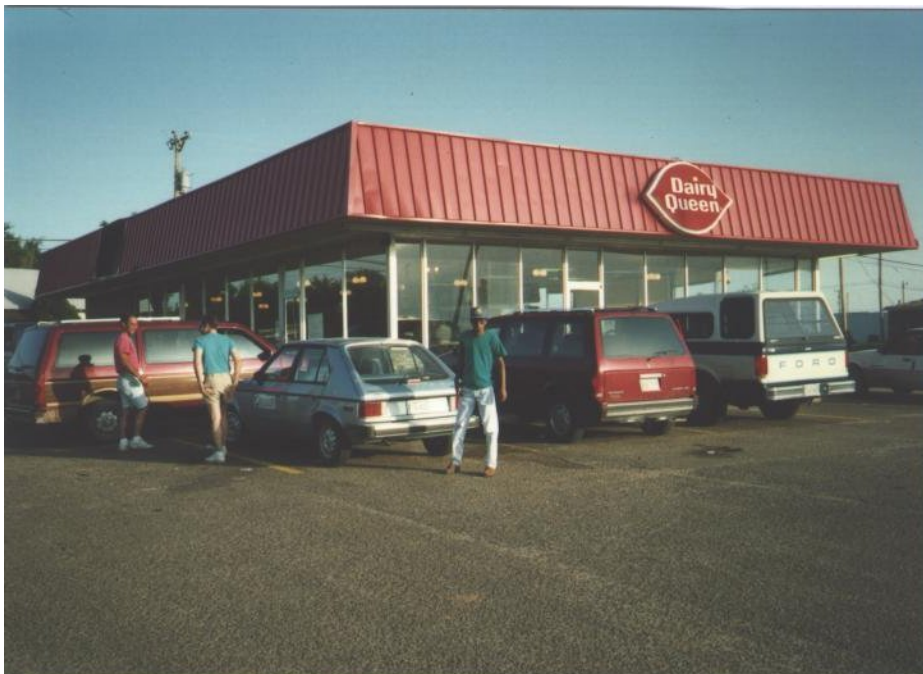
SRP: DOD 3: Broken glass in windows and doors

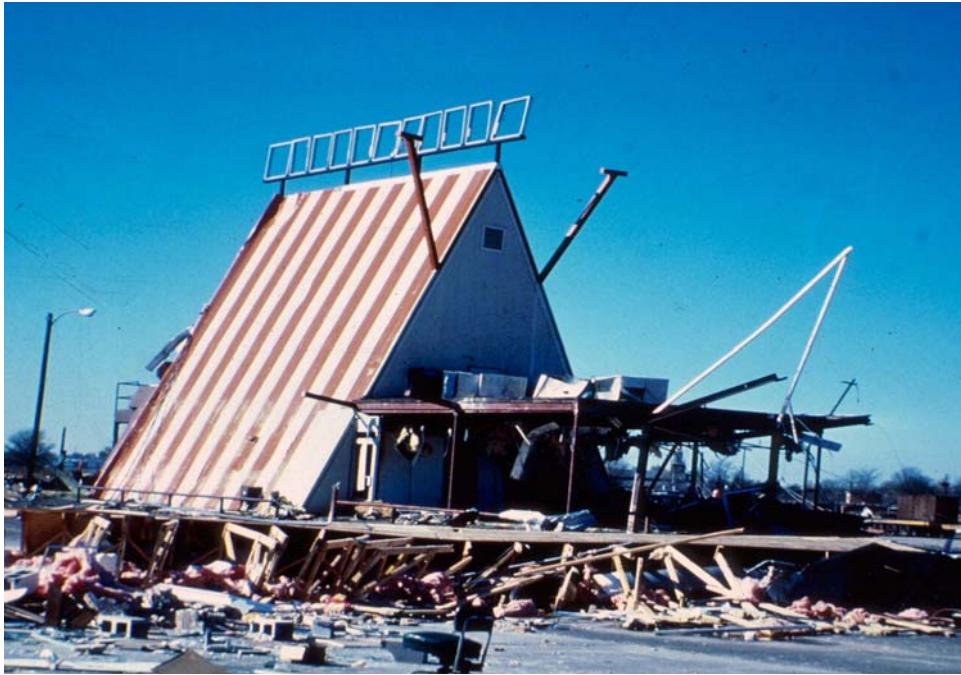
SRB: DOD 5: Canopies and covered walkways destroyed

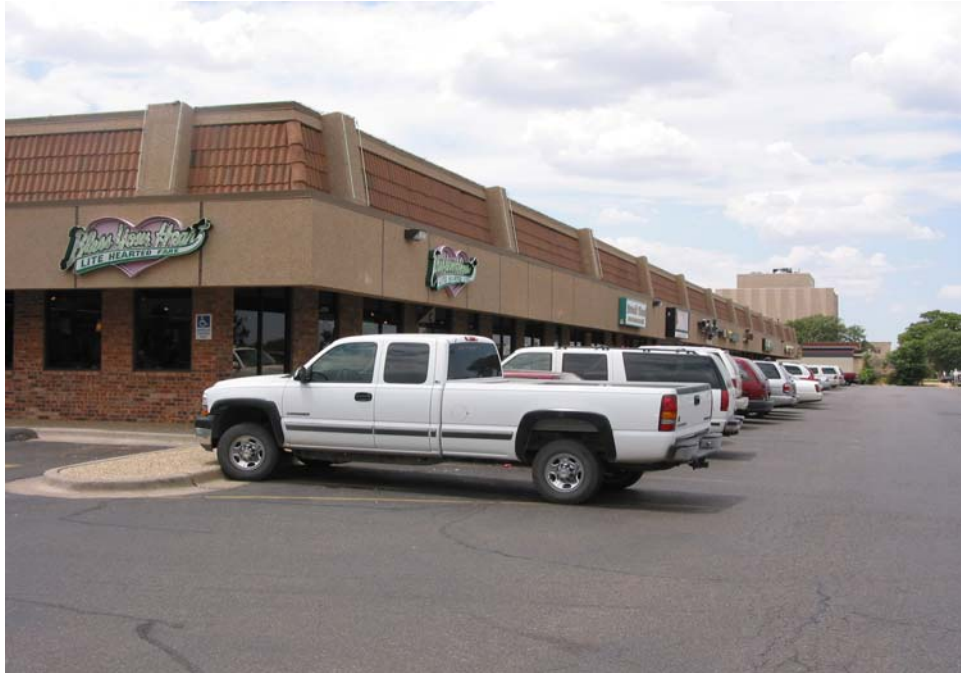
SM: Long, rectangular, single-story building; flat roof with parapet; BUR or single-ply membrane roof system with rigid insulation; wood, metal, or wood-fiber cement roof panels; concrete block walls or stud walls with brick veneer; large glass windows and glass entry doors; canopy or covered walkway attached to building

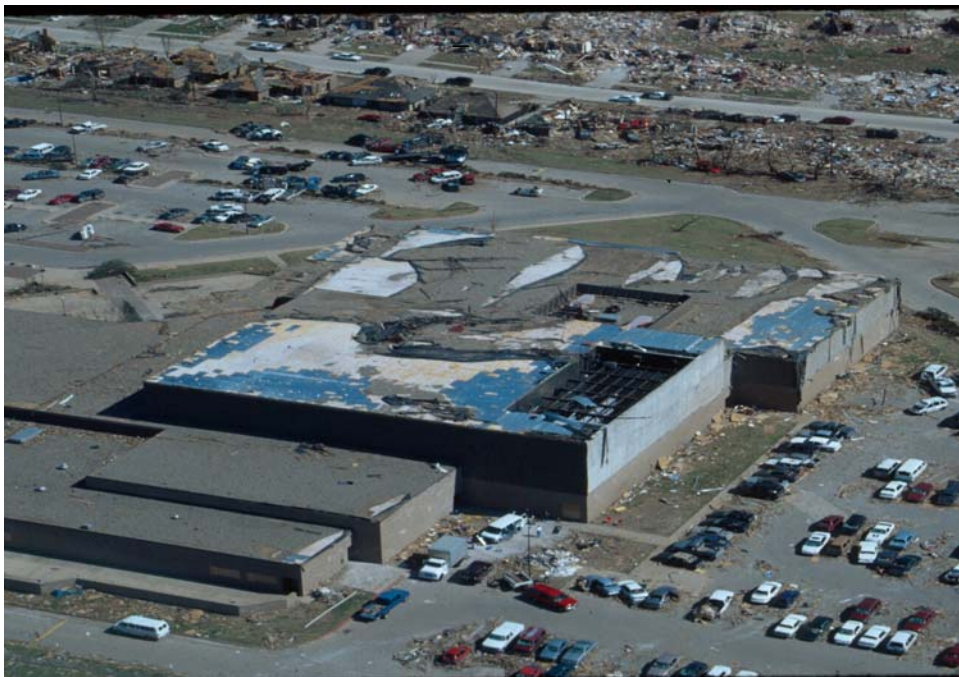
LSM: DOD 4: Uplift of some roof decking; significant loss of roofing material (>20%); loss of rooftop HVAC

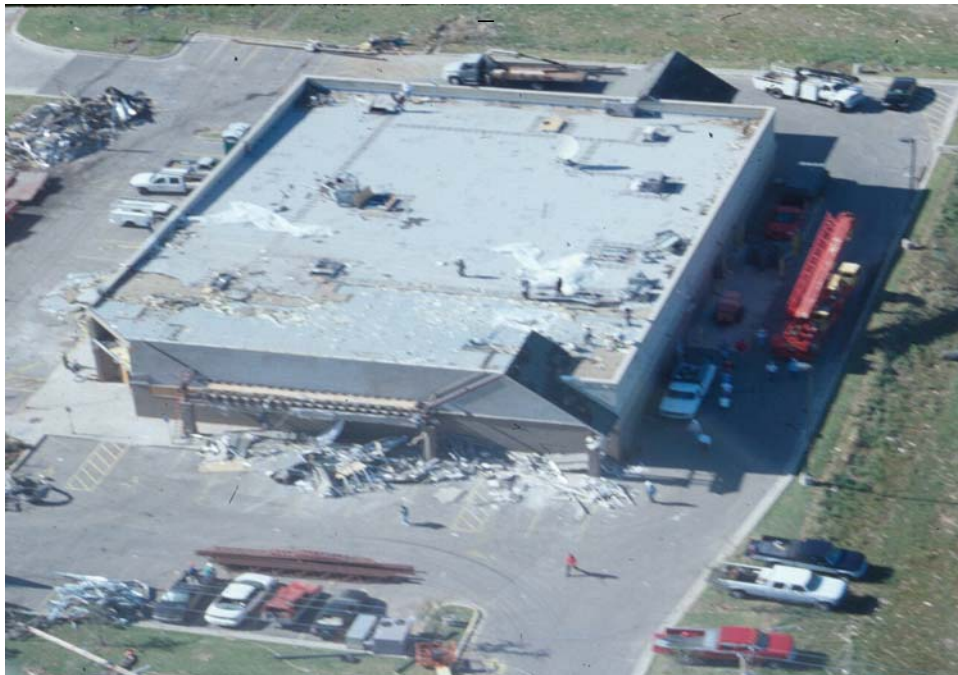
LIRB: DOD 3: Significant loss of roofing material; loss of rooftop HVAC

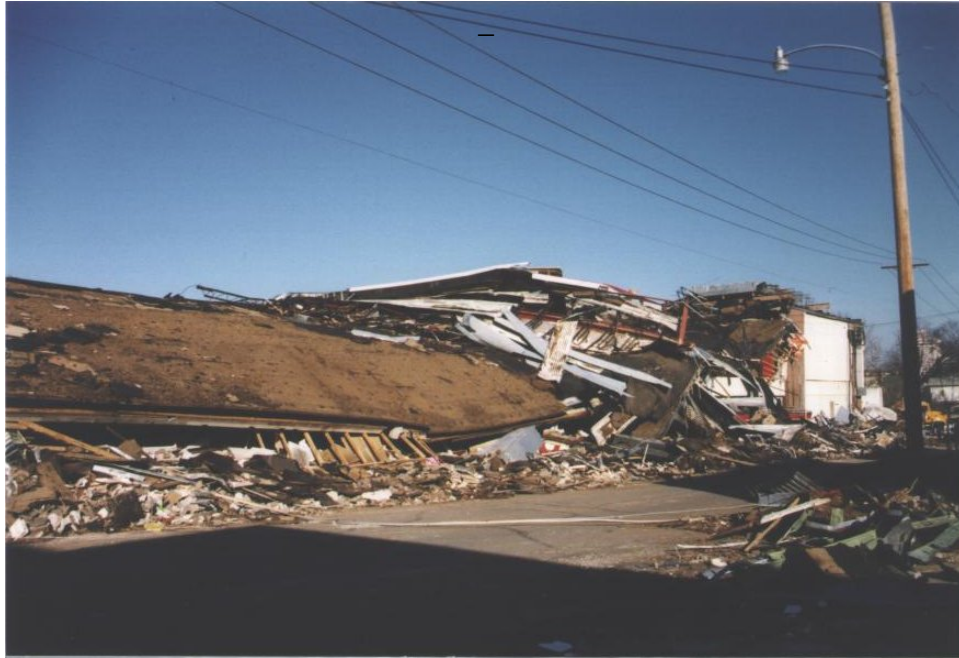
LIRB: DOD 4: Long span roof structure collapses downward

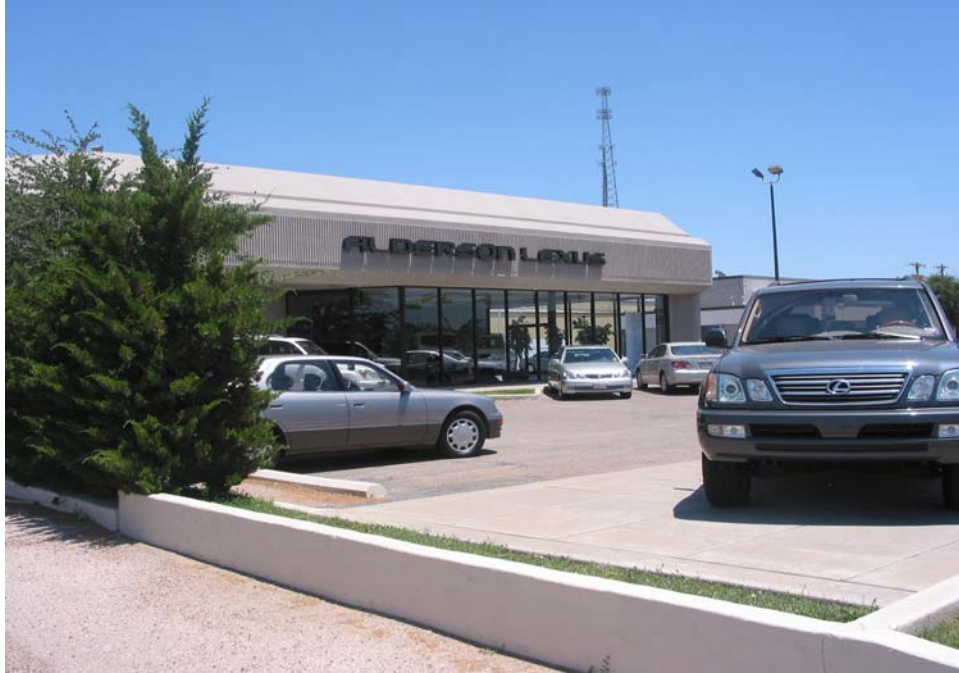
ASR: Single story with flat roof; BUR or single-ply membrane; metal or plywood roof deck; stud walls with EIFS, stucco or tilt-up panels

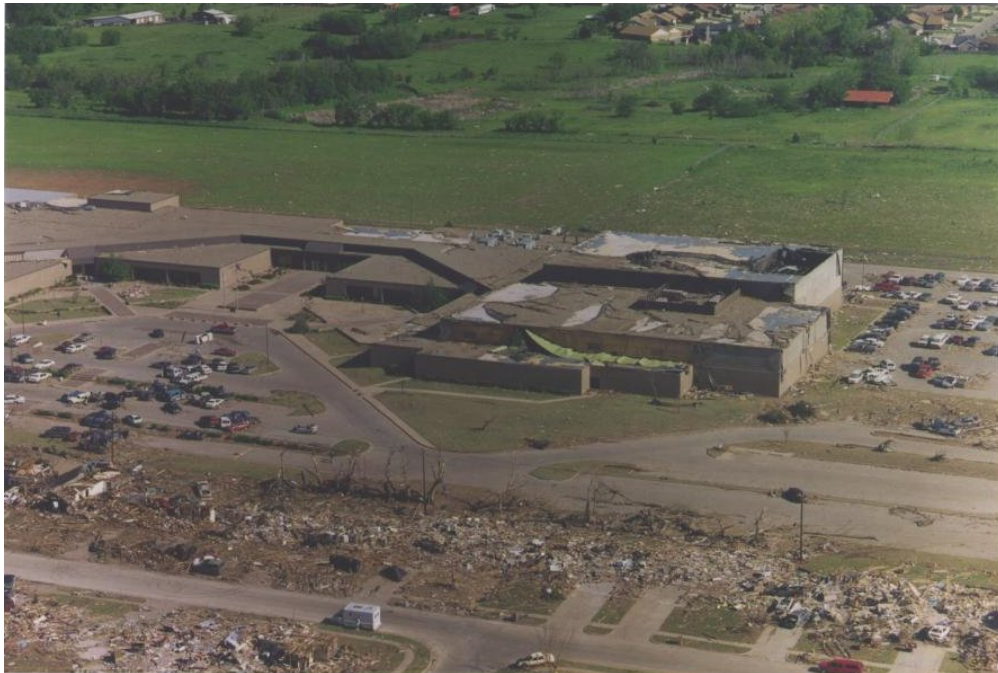
ES: DOD 5: Significant loss of roofing material (>20%); uplift of roof decking

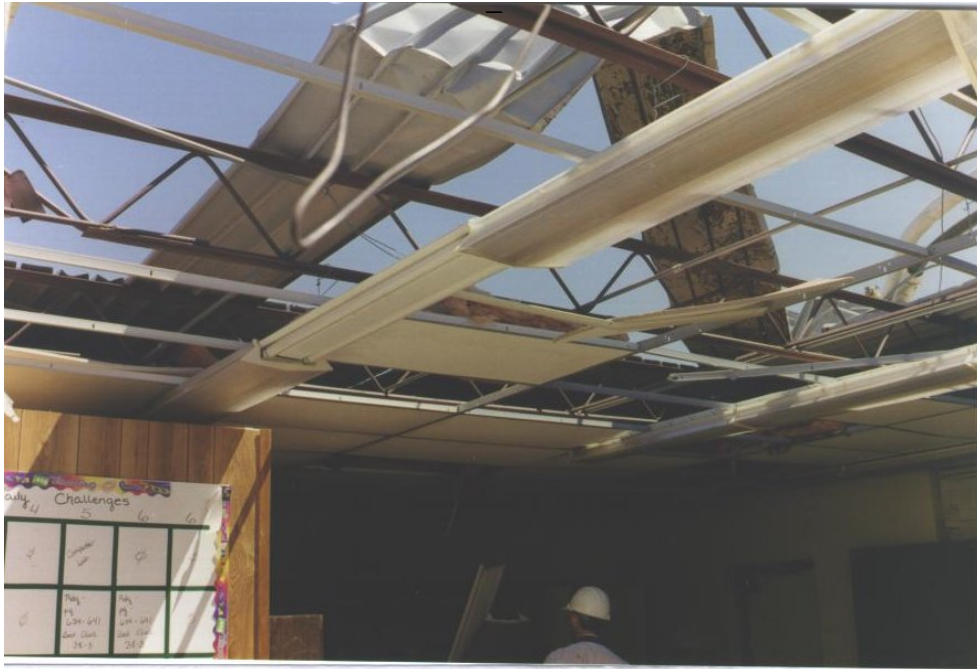
ES: DOD 5: Significant loss of roofing material (>20%); uplift of roof decking

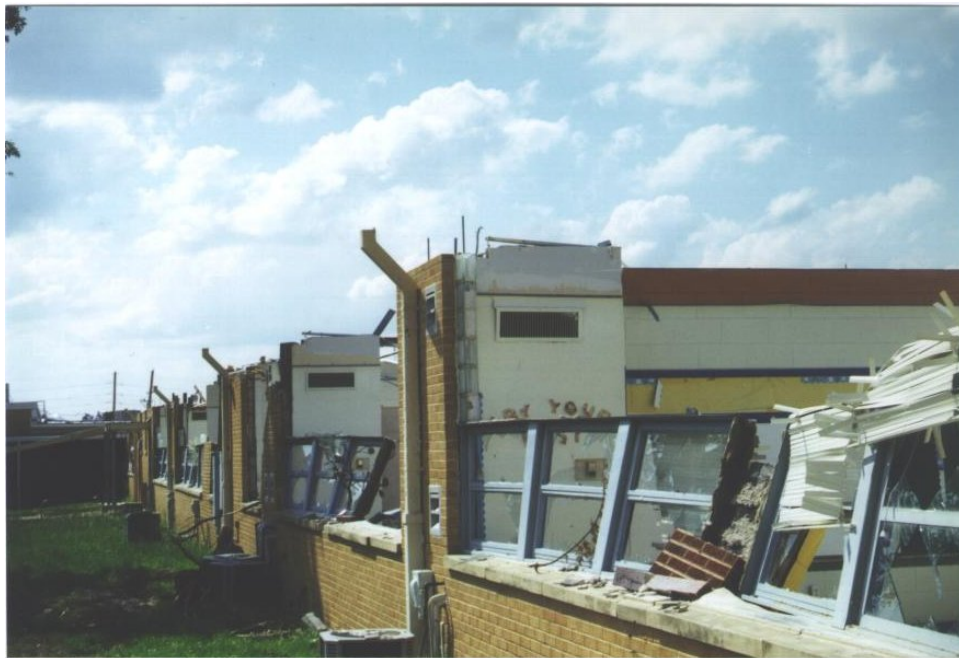
ES: DOD 7: Uplift of entire roof structure

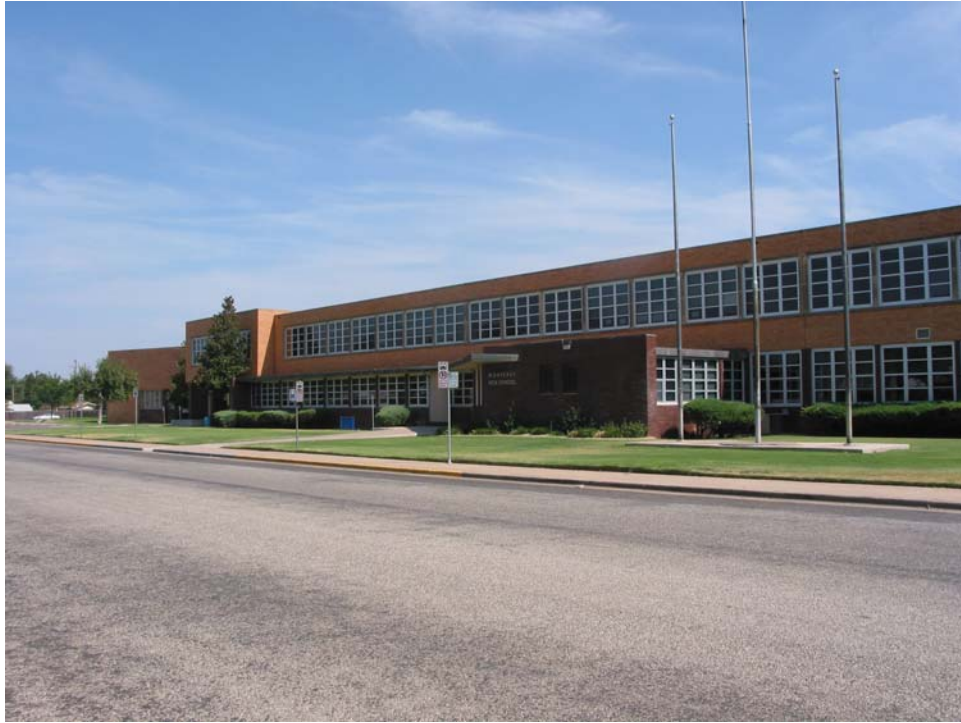
JHSH: Generally one or two story with flat roof; BUR or single-ply membrane roof with gravel; block walls with brick veneer, stucco, or EIFS, metal or glass curtain walls; large percent window glass

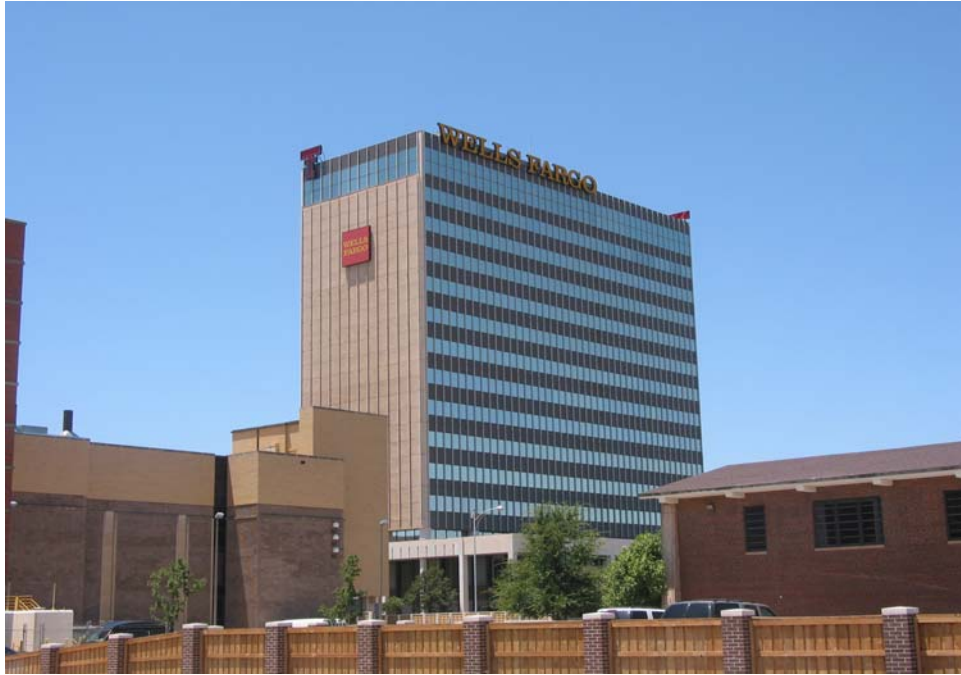
MRB: Generally rectangular shapes; flat roof with parapet and penthouse; BUR or single-ply membrane with or without gravel; metal deck, poured gypsum, or concrete deck; glass or metal curtain walls, marble panels or pre-cast concrete wall panels

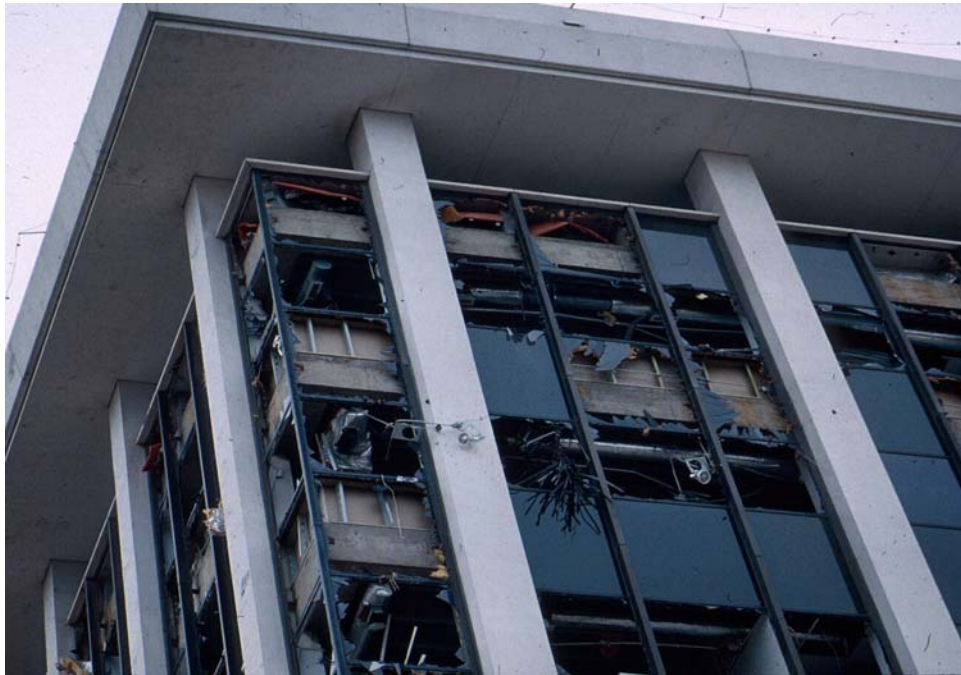
MRB: DOD 6: Broken glass in curtain walls; damage to building interior

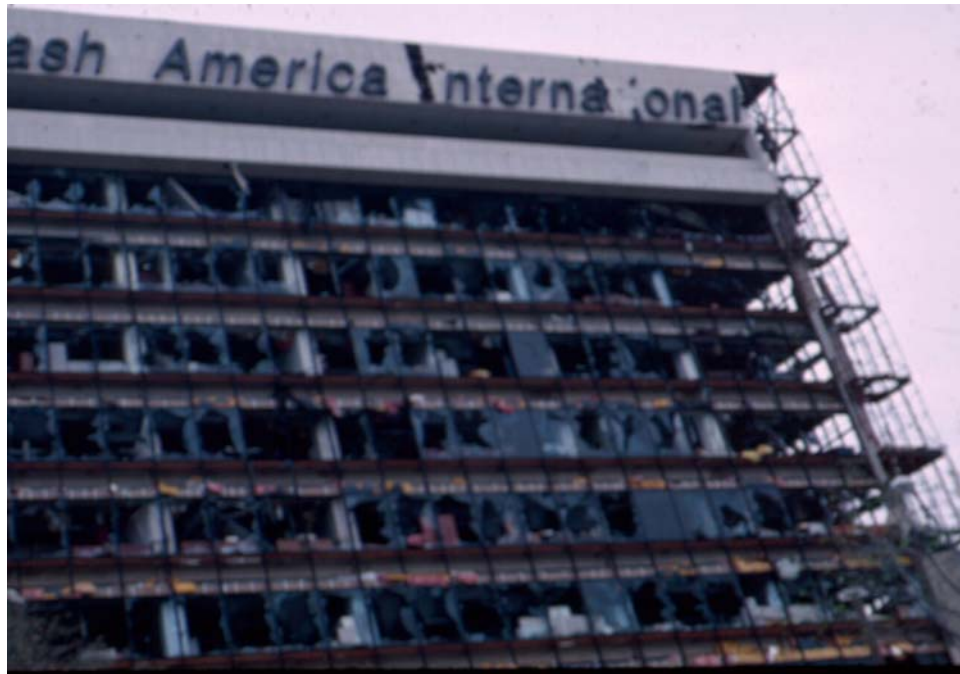
MRB: DOD 9: Failure of exterior walls

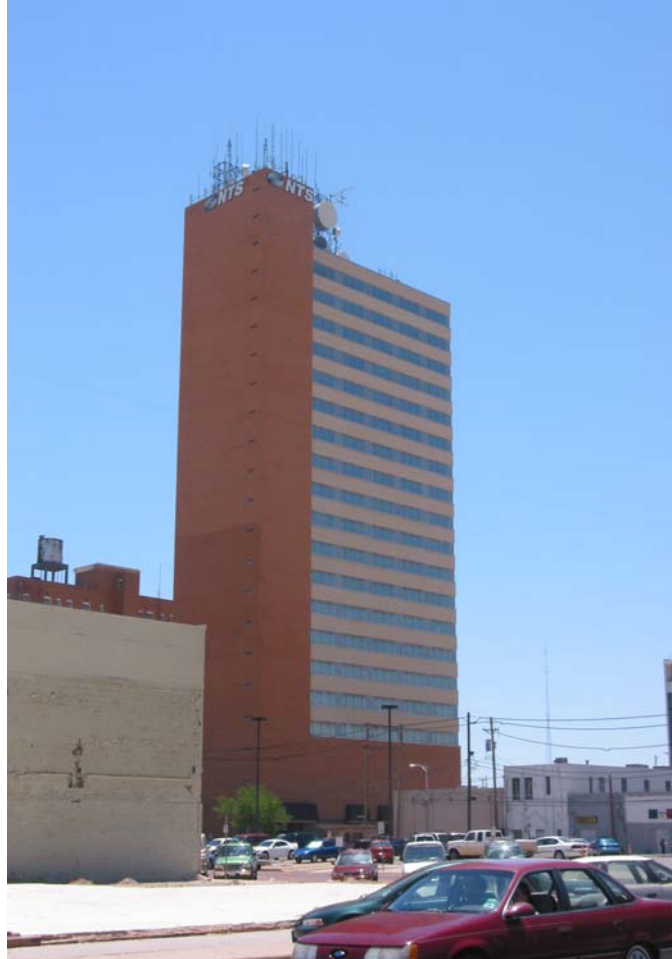
HRB: Rectangular or complex shape; flat or complex roof shape;
Single-ply membrane, polyurethane foam, metal, or copper roof system;
penthouse; glass or metal curtain wall, masonry,
or pre-cast concrete wall panels

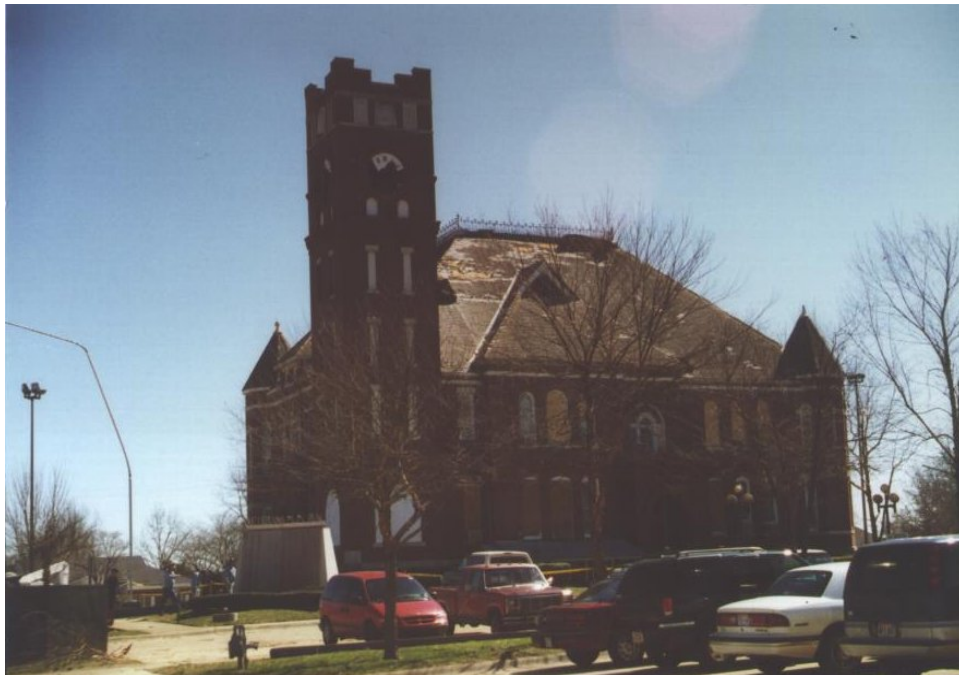
IB: DOD 6: Uplift of light-weight roof deck and insulation; significant loss of roofing material (>20%)

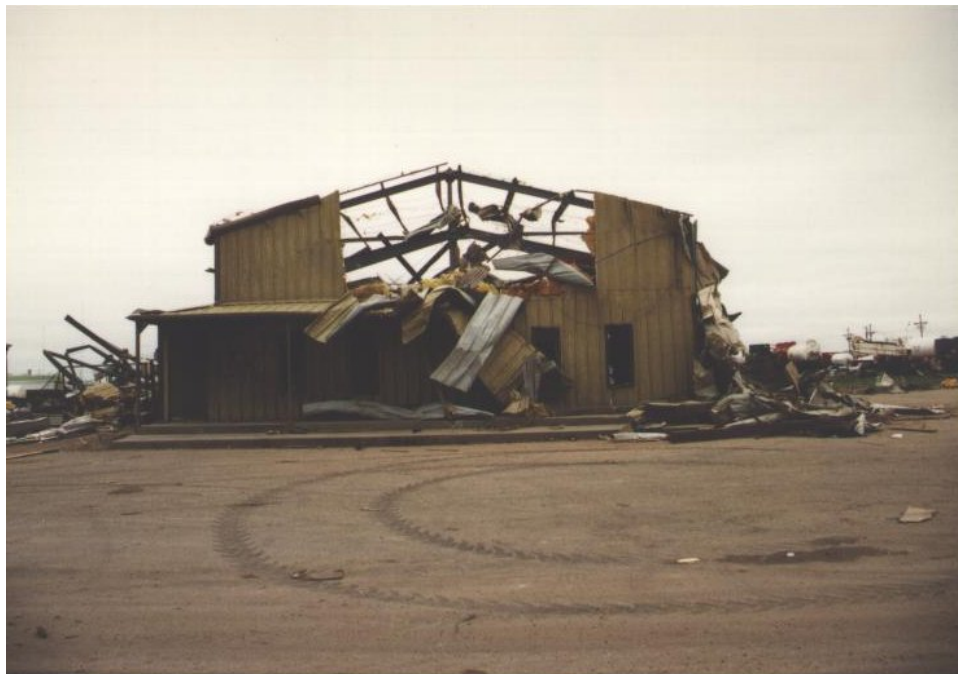
MBS: DOD 7: Collapse of rigid frames

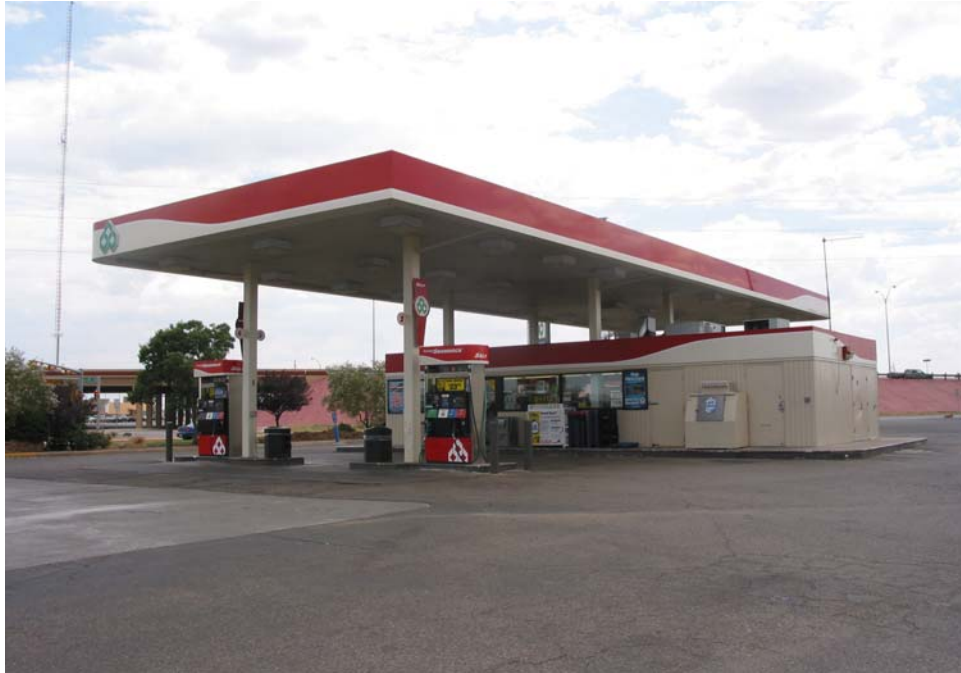
SSC: Large rectangular free-standing canopy supported on columns; metal panels cover bottom side of canopy; metal or plastic fascia materials cover perimeter of canopy

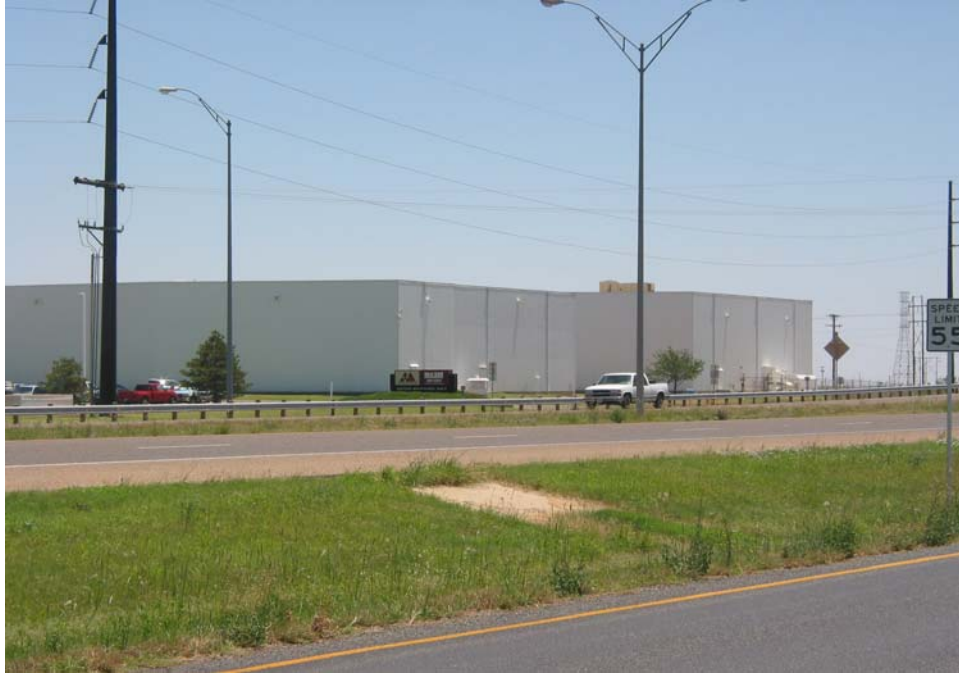
WHB: Rectangular in plan with flat roof; BUR or single-ply membrane roofing system with or without gravel; masonry bearing walls, tilt-up precast concrete wall panels or stud walls with wood panels; large overhead doors

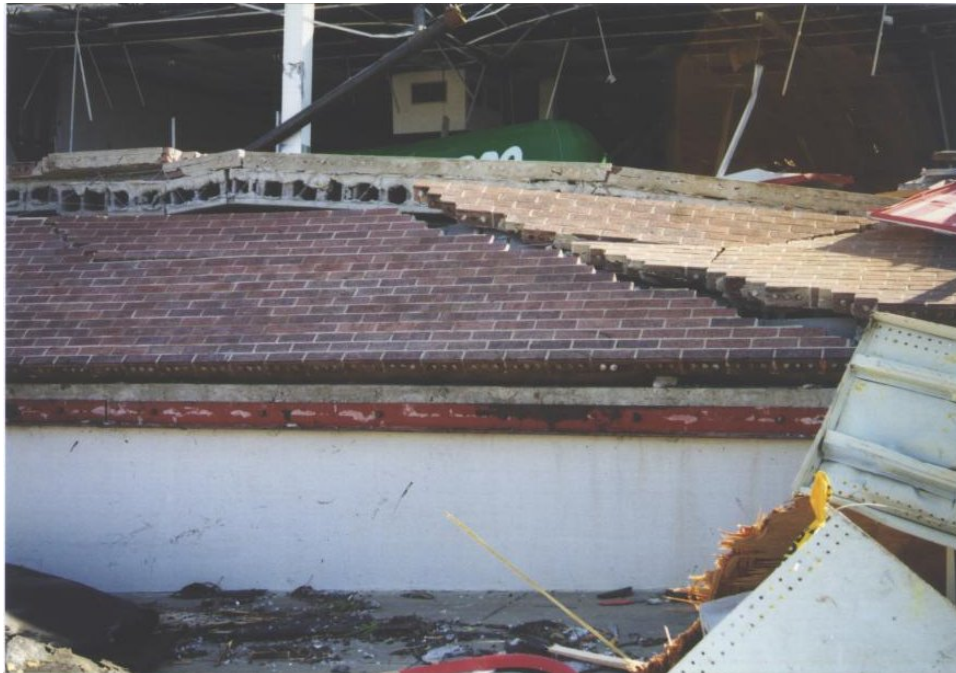
WHB: DOD 6: Collapse of non-bearing exterior wall

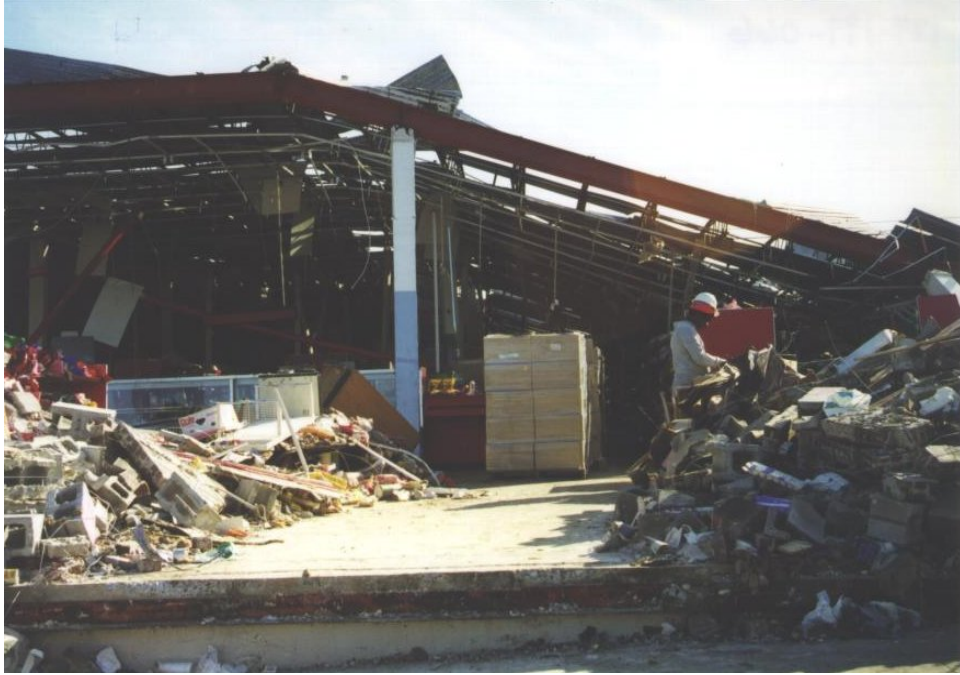
WHB: DOD 7: Total destruction of a large section of building

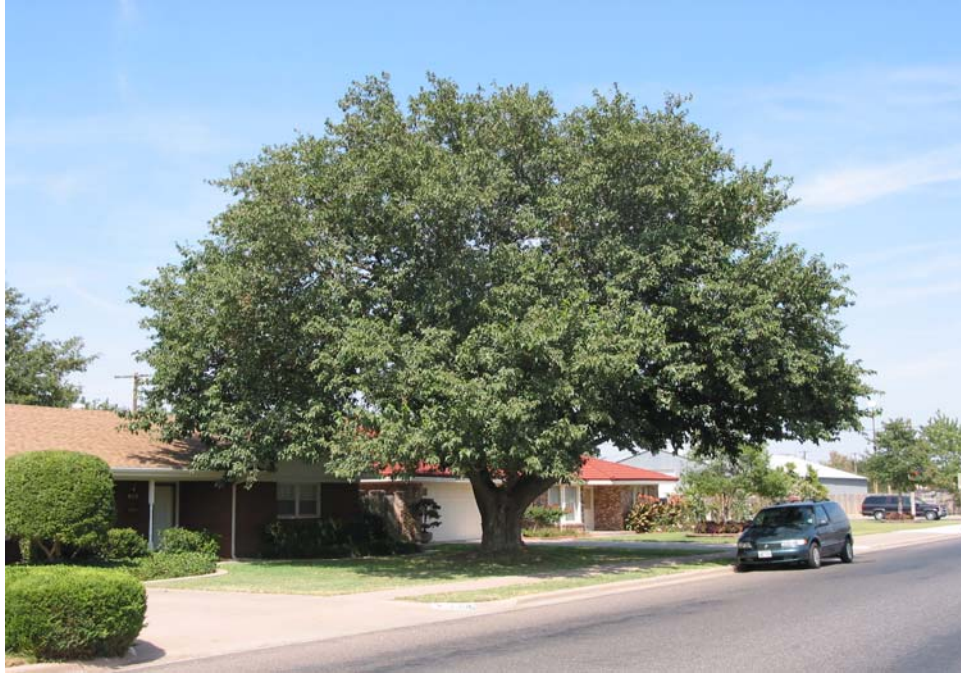
TH: Oak, Maple, Birch, Ash
