A Recommendation for an
ENHANCED FUJITA SCALE
(EF-Scale)

Submitted to
The National Weather Service
and
Other Interested Users

June 2004

WIND SCIENCE AND ENGINEERING CENTER
Texas Tech University
Lubbock, Texas 79409-1023

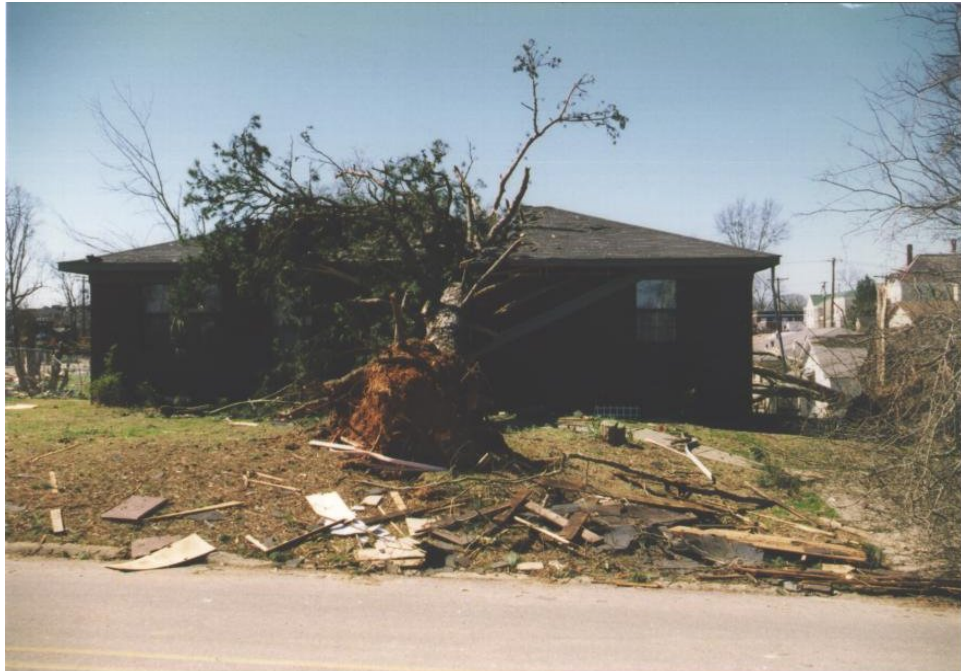
TH: DOD 4: Tree uprooted

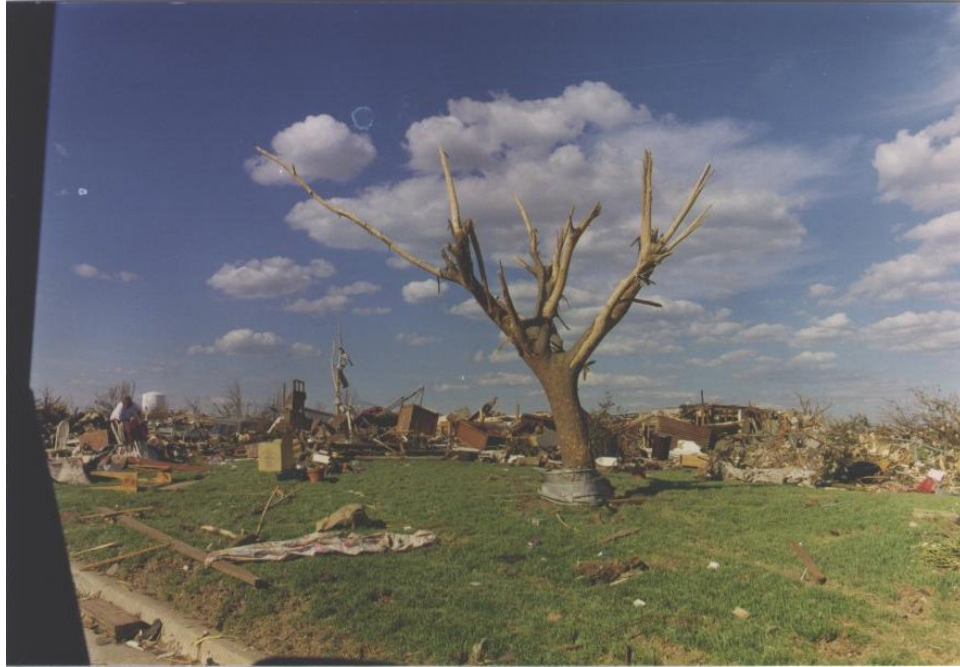
TH: DOD 5: Tree debarked with only stubs of largest branches remaining
