Kuigmek: one who watches the river

October 2021

Alaska-Pacific
River Forecast Center
6930 Sand Lake Road
Anchorage, AK 99502-1845
907-266-5160
1-800-847-1739
<http://weather.gov/aprfc>
nws.ar.aprfc@noaa.gov

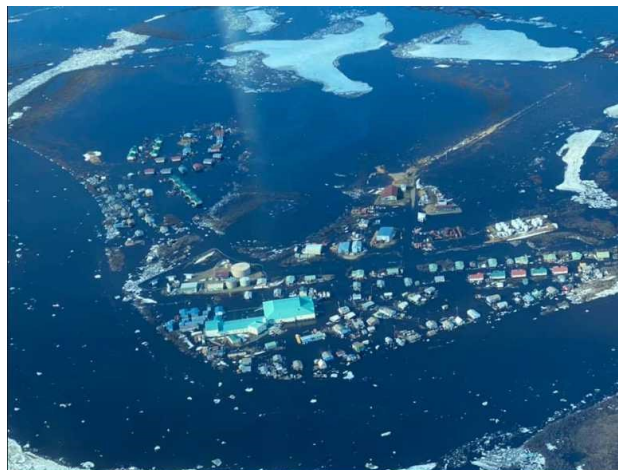
Figure 1: Photo of Flood Conditions in Buckland in

May, 2021 from Facebook.

Alaska's most impactful ice jam flood this past spring occurred in Buckland (*Inupiaq: Kaniq*). The Buckland River is 67 miles long and flows northwest to the Chukchi Sea; the village is home to about 400 residents. In mid-May, 2021, an ice jam formed causing flood water to inundate more than 20 homes. Shortly after, the governor issued a disaster declaration. Since 1985, there have been eleven notable ice jams on the river that have resulted in minor to moderate flooding in the village. These floods tend to have: 1) daily high and low temperatures above freezing the day before flooding occurs; 2) above normal freezing degree days before and throughout the ice jam; 3) and high temperatures above freezing on the day of the ice jam and until the jam breaks. These

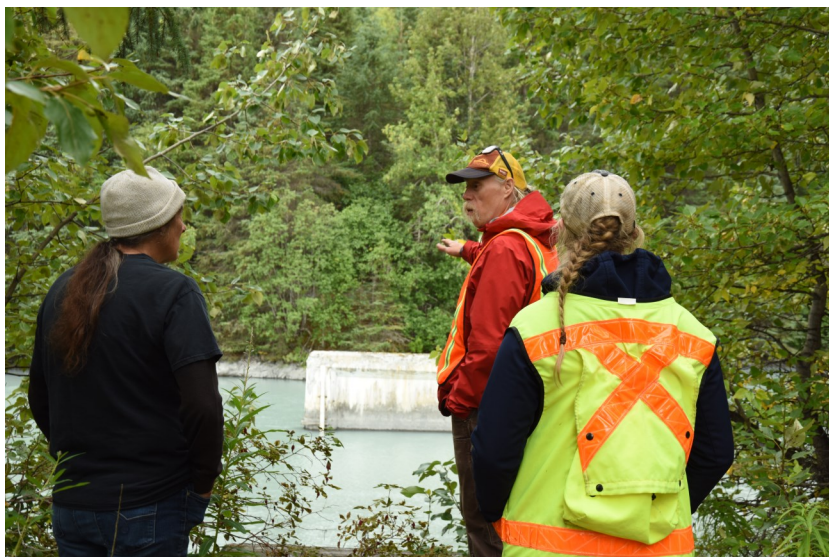
Figure 6: *Celiene Turner, Johnse Ostman, and Jess Sanow at the Trail River gage near Moose Pass.*

A visit to the staff gage at Trail River near Moose Pass was also informative for forecasters. It took a phone call to our long time observer Celiene Turner to find the gage on the remains of a mid-river pier from a old bridge. Celiene uses binoculars to take the reading each morning. Any changes to this site would require boat access. It was great to meet Celiene and hear from her about past high water and flood events. We could not do this job without our reliable observers!

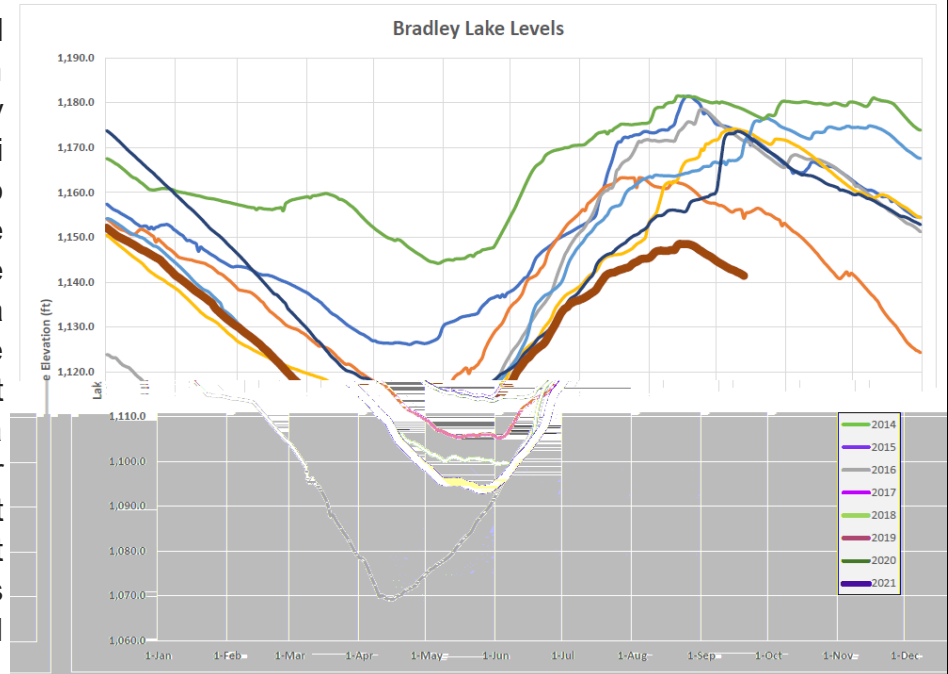
Figure 13: Bradley Lake Levels courtesy of Homer Electric Association.

The dry summer on the Kenai impacted the lake levels even with the new Battle Creek Diversion. Bradley Lake is the hydropower facility that provides electricity to the railbelt. The operators shared the following graphic about lake levels with a few facts and caveats. Usable lake elevation begins at 1,080' elevation. In 2016, levels were intentionally dropped below 1,080' for maintenance. In 2019, the ability for Bradley energy to leave the Kenai Peninsula was limited due to scheduled maintenance and the Swan Lake fire impacting the transmission system through a significant portion of the year. The spillway elevation is at 1,180'. Lake level is a representation of the total water being stored by all of the project participants, i.e. the Railbelt utilities; thus elevation is dependent upon both inflows and utility use.

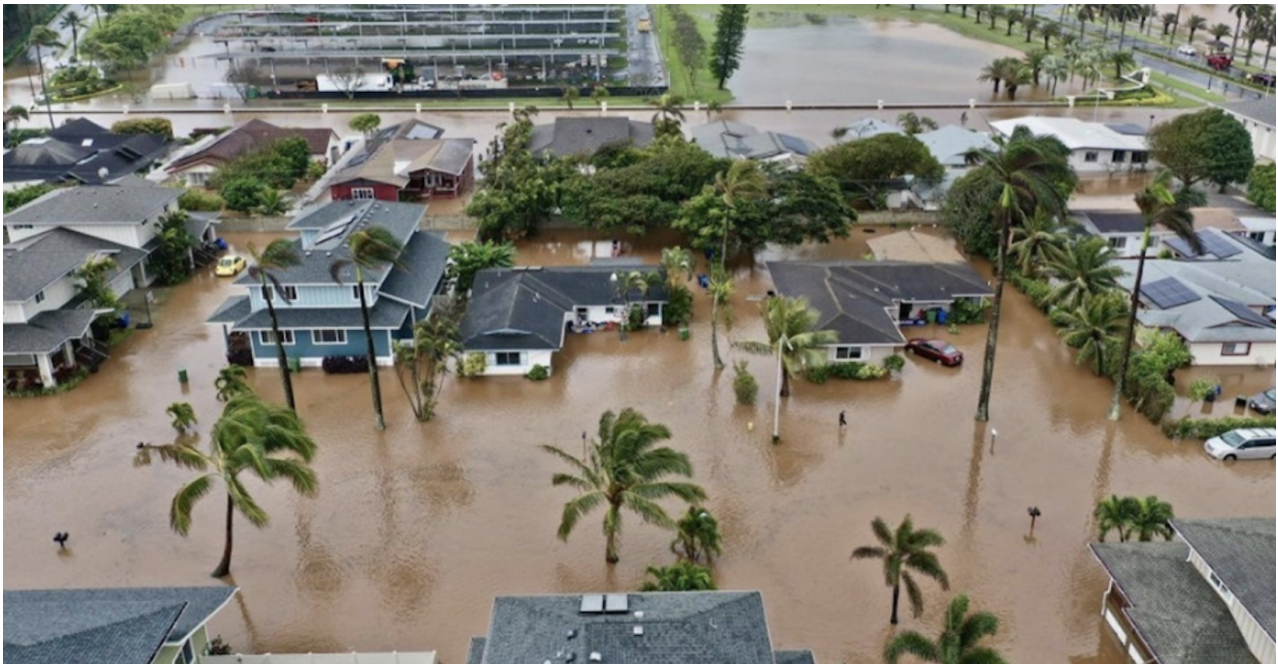
Figure 15: Flooding photo by HawaiiNews on Instagram.

We never forget about our responsibilities in Hawaii, though the climate could not be more different. This spring, Hawaii saw devastating floods in March from heavy rain on the islands. Multiple homes were destroyed and one person was killed. Landslides, power outages, and road and bridge damage were widespread. The Kaupakalua Dam was compromised and scheduled to be removed. Thousands of people were ordered evacuated from their homes. Freshwater supplies were impacted and public officials ordered water boiling requirements and conservation. No stranger to heavy rain, this March 2021 was more extreme than usual in its intensity and devastation. This occurred on top of the stress of the COVID-19 pandemic and economic disruptions. We wish our Hawaiian friends plenty of Aloha this year.
