Kuigmek: one who watches the river

January, 2018

**Alaska-Pacific
River Forecast Center
6930 Sand Lake Road
Anchorage, AK 99502-1845
907-266-5160
1-800-847-1739
<http://weather.gov/aprfc>**

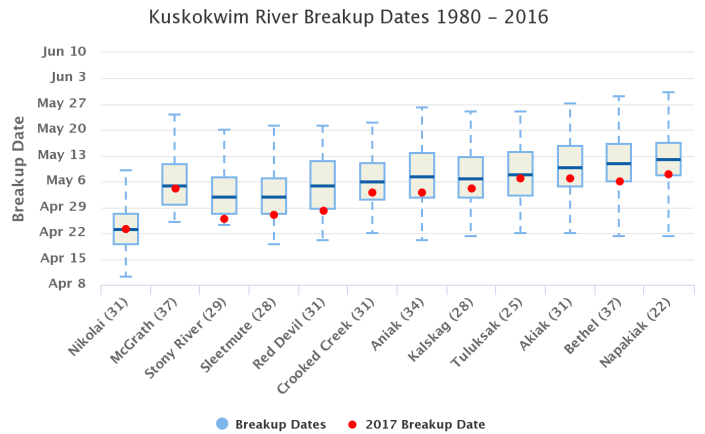
Box and whisker plots show 2017 breakup dates (red dots) at Yukon and Kuskokwim River communities relative to past years. The statistical median is the middle line in the box and the box contains half of the observed years. The whiskers show the minimum and maximum dates. These and other plots can be found at <https://www.weather.gov/aprfc/riverView>

River breakup this past spring was very mild. The Yukon and Kuskokwim Rivers broke up early, with the timing on other major rivers closer to normal. We had no reports of significant breakup flooding in 2017. Instead, near drought conditions in Southwest Alaska impacted communities that rely on shipping; we received several reports that low water in early summer delayed river barge traffic on the Kuskokwim.

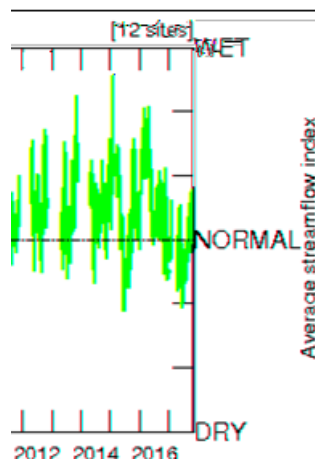
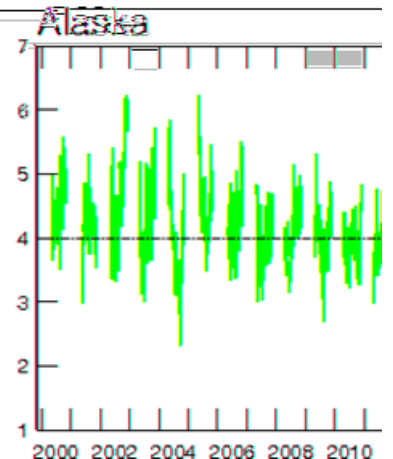
Explanation - Percentile classes							
Low	<10	10-24	25-75	76-90	>90	High	No Data
	Much below normal	Below normal	Normal	Above normal	Much above normal

Average Streamflow Percentile and Index at 12 primary USGS Gages in Alaska. Images: USGS (waterwatch.usgs.gov).

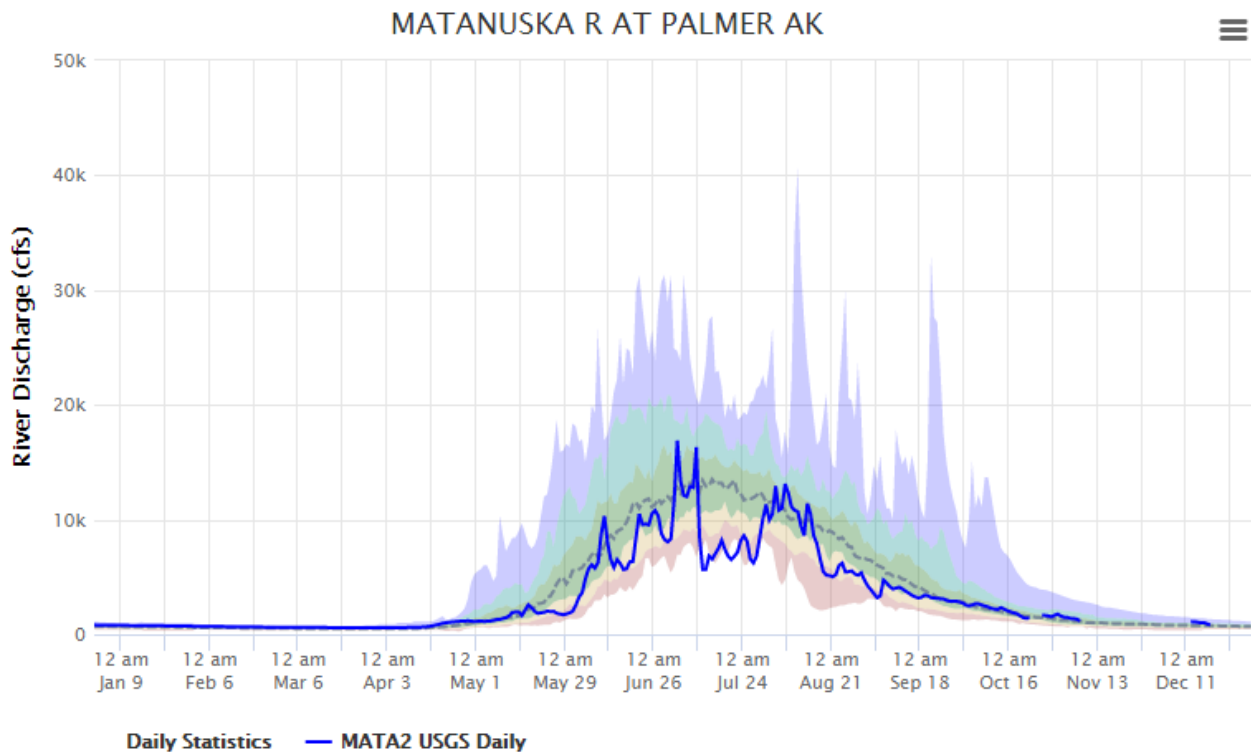
River Discharge on the Matanuska River at the USGS gage near Palmer. The dark blue line is the daily mean discharge during 2017. The dashed line represents the long term average flow and the colored bands correspond to historic daily high and low flows (frequency percentiles: 10%, 10-25%, 25-75%, 75-90%, 90%). Image: APRFC.

Events and impacts included continued erosion on the Matanuska River, although the river's stage and discharge were generally at normal levels or below. Low water conditions were reported issues not just on the Kuskokwim and smaller rivers in Southwest, but also on the Yukon and some of its major tributaries. There was minor flooding near Big Delta. Large-scale flooding in the Tetlin Road area in late July and early August was caused by warm and wet conditions upstream contributing to a breach of the Tanana bank into a historic floodplain.

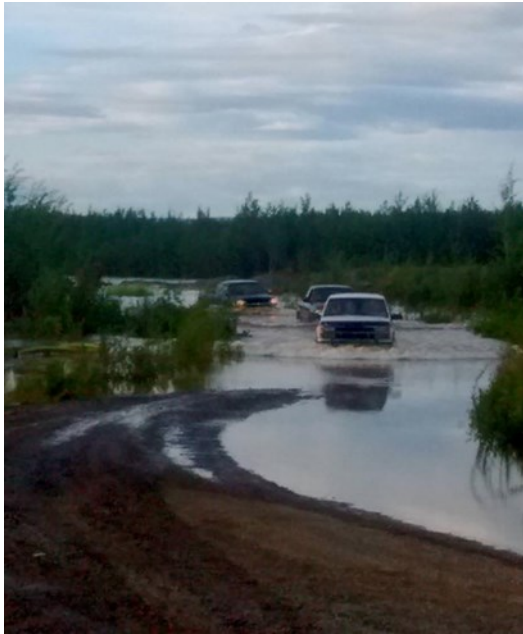
Photos: Tetlin Road flooding from Tanana River. Credit: Paul Kelley, used with permission.

Late in July, we got word that the road out to Tetlin was flooded and impassable. With help from local observers, the Fairbanks Civil Air Patrol, and satellite imagery, we were able to determine the source of the flood water as a breach in the Tanana River. The summer in the upstream watersheds—the Nabesna and Chisana Rivers—was anomalously warm and wet. Rain and snowmelt contributed to high water on the Tanana, which eroded a narrow natural levy between the river and an historic floodplain. Eventually, that water crossed the Tetlin Road and disrupted travel to village residents and commercial use well into mid-August.

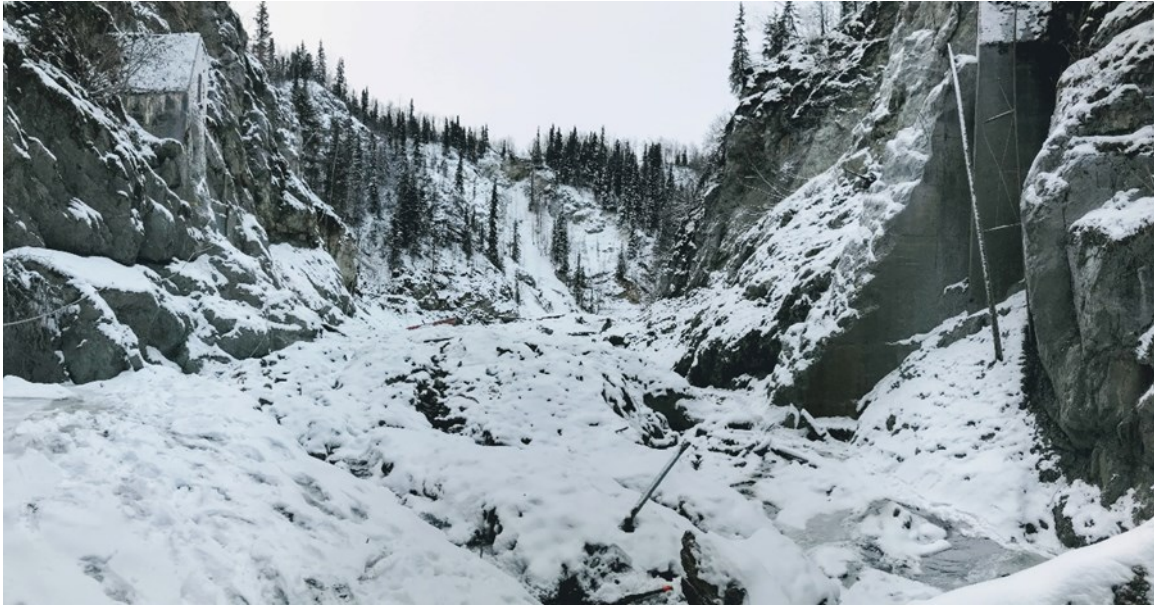
Photo: Looking upstream at remnants of the lower Eklutna Dam. Demolition of this concrete arch dam is ongoing. Credit: Crane Johnson, APRFC/NWS.

A series of strong storms, beginning in late August, washed out the Power Creek Road in Cordova and caused subsequent power supply changes. Smaller precipitation events contributed to runway flooding in Seward, several times this summer. In the Anchorage area, another hydrologic side note was the ongoing removal of the Eklutna dam this summer. In mid-September, Kobuk experienced minor flooding from heavy and persistent rain.

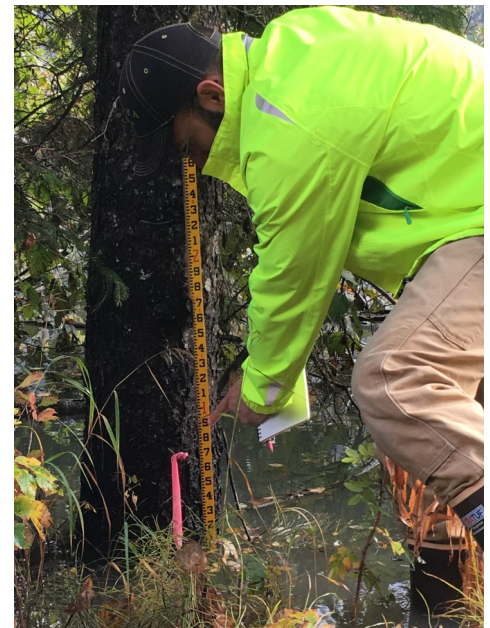
(Left) APRFC Hydrologist Celine van Breukelen (taking picture) explains the ADCP measurement profile to the boat-driver's grandson. (Right) Anchorage NWS Service Hydrologist Andrew Dixon uses pine needles deposited by flood water to determine the high water level near Cooper Landing, Kenai after the Snow GDL outburst. Photo credit: Jessica Cherry, APRFC/NWS.
