Kuigmek: one who watches the river

December, 2018

**Alaska-Pacific
River Forecast Center
6930 Sand Lake Road
Anchorage, AK 99502-1845
907-266-5160
1-800-847-1739
<http://weather.gov/aprfc>
nws.ar.aprfc@noaa.gov**

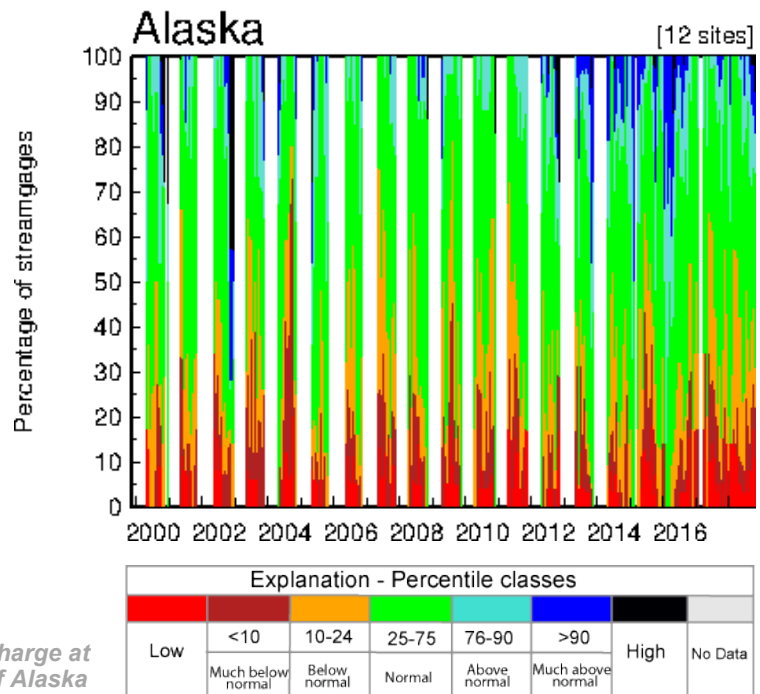
Figure 2: USGS characterization of water discharge at 12 long-term gages across the state of Alaska

Alaska's Water Year 2018 (Oct 1, 2017-Sept 30, 2018) was characterized by a record-breaking warm winter in the northern and western parts of the state, extremely low concentrations of sea ice in the Bering Sea, and more than average precipitation in the southwestern part of the state. The warm season brought persistent drought in Southeast, and persistent precipitation to the Interior, Southwest, and eastern North Slope. The Chena, Sagavanirktok, and Kuparuk Rivers went into Fall 2018 freezeup with very high, if not record water levels, while Southeast remains in drought. Figure 2 shows the condition of 12 Alaska Rivers at long-term gages going into freeze up.

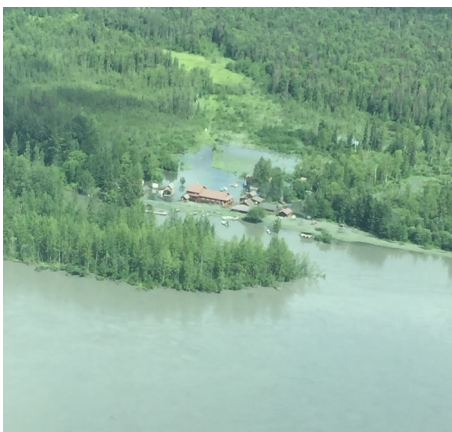
Figure 3: 2018 flooding on Yentna near Lake Creek. Photo credit: Don Bolton, NWS

Consistent heavy rain led to high water on the Yentna and Skwentna Rivers in mid-June, with flooding in some locations. The picture here is flooding at a fishing lodge on the Yentna River near Lake Creek. The headwaters of the Skwentna and Yentna Rivers begin in the southwestern Alaska Range, and are known as the Yentna River after they come together. The Yentna joins the Susitna River just before it empties into Cook Inlet. There are quite a few lodges in the area where Lake Creek meets the Yentna because the clarity of Lake Creek's water makes it ideal for fishing. The downside to the river proximity for these lodges is their vulnerability to flooding. The Skwentna area also has a number of individual homes and recreational cabins, but we had few reports of impacts to buildings up on the Skwentna. Some local aircraft landing strips were inundated and a layer of silt was left behind. Thanks to our observers out there (Cyndie Abbot and Steve Childs) and everyone who called in to report impacts. The Yentna gage was the third most looked at gage on our website this summer.

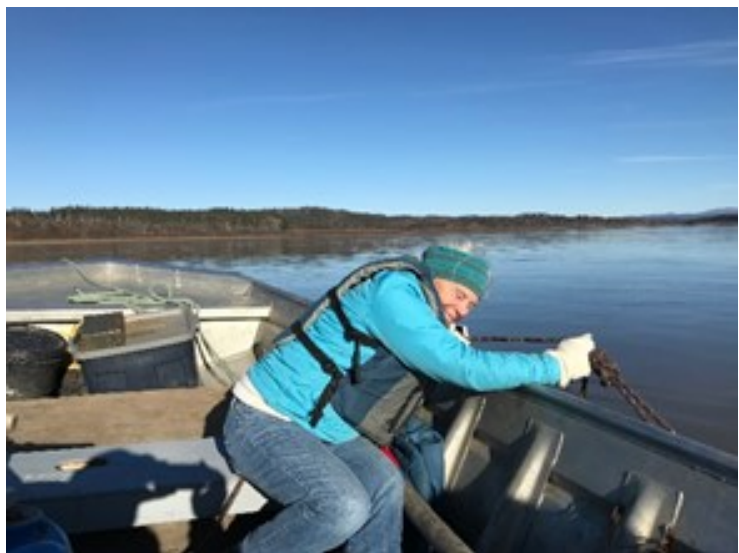
Figure 8: NWS Service Hydrologist Karen Endres making a river discharge measurement from a boat. Photo credit: Eric Holloway.

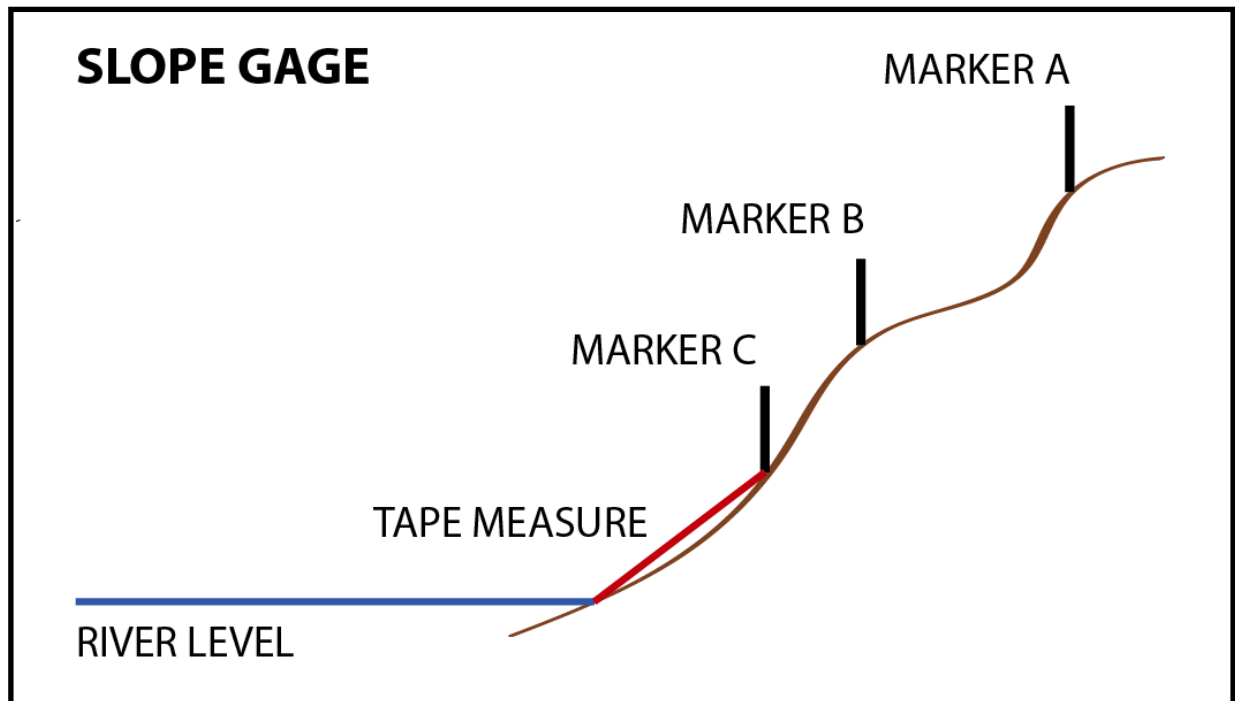
Figure 9: Diagram of a slope gage profile along a river bank.

The stage of a river or lake is the height of the water surface above some established datum or reference elevation. At most Alaska measurement sites, the reference elevation is selected for convenience. For example, rather than reading a gage as 428.3 feet mean sea level, the gage reading is 8.3 feet, with the elevation of the 0.0 reading of the gage corresponding to 420.0 feet. A reading of 8.3 feet also **does not correspond** to the water depth in a river. At most sites, the National Weather Service has established flood stages that correspond to the water level that will begin to cause flooding of structures and/or a threat to public safety.

Slope profile gages are installed at river locations that are not spanned by a bridge or do not have a permanently installed staff gage to measure water levels. A slope profile gage consists of a marker or series of markers anchored in the bank. Markers are usually metal rods (rebar) driven into the bank, with a metal survey cap attached to the top of the rod. The NWS installs these markers during the initial site visit when the riverbank is surveyed. The slope gage is read by measuring from one of these markers to the water's edge. An estimate of river stage or water level can then be determined by combining this slope measurement with the riverbank survey that was done by NWS staff. Figure 9 shows a typical river bank with surveyed slope markers in place. Slope measurements are received by the APRFC on a daily basis during open water season. They are converted to a river stage and displayed publicly on the internet, and integrated into our forecast model. The weblink for that site is:

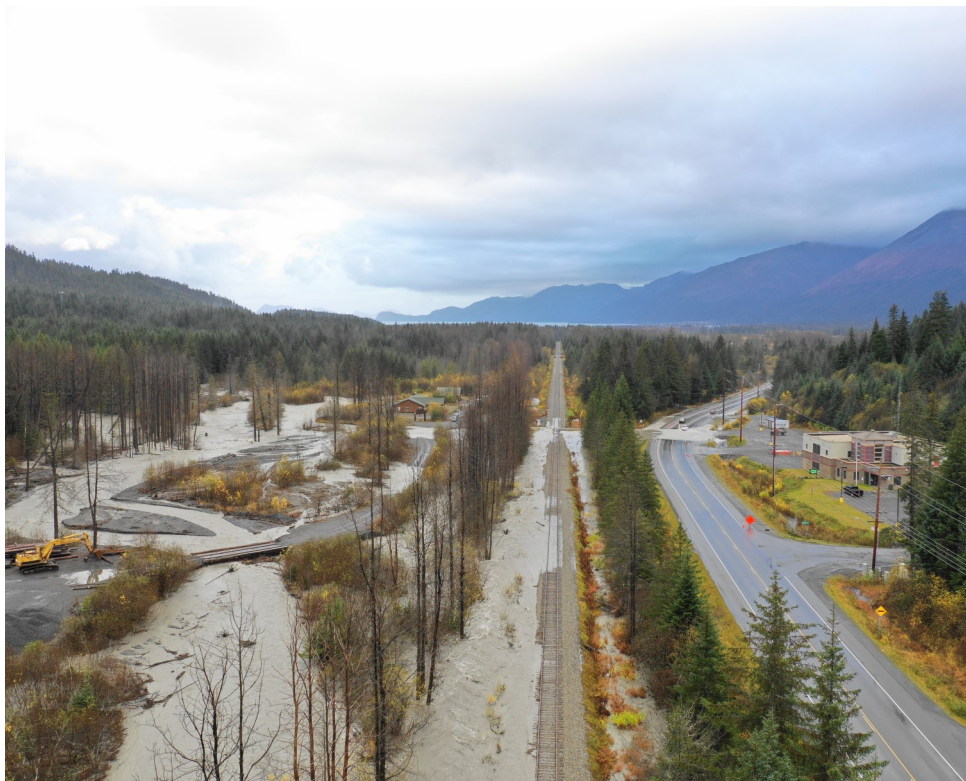
Figure 10: heavy equipment is helping preserve this bridge near Seward by removing gravel from the streambed as it's washed down by heavy rain. Photo courtesy of Alaska DOT&PF.

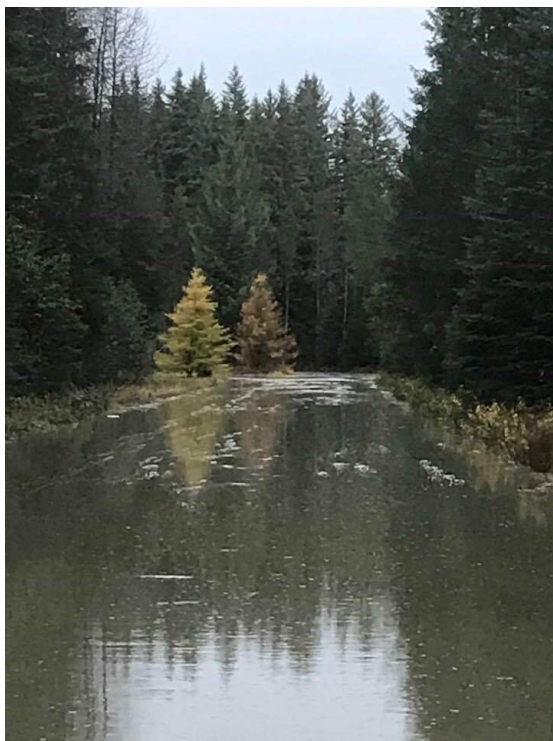
Figure 12: October, 2018 flooding of Wilson Rd and Rink Creek area in Gustavus, AK. Photo: NWS Spotter Deb Woodruff
