National Weather Service Des Moines

Storm Survey Results from Union County/Creston on April 14, 2012

Updated on April 17, 2012

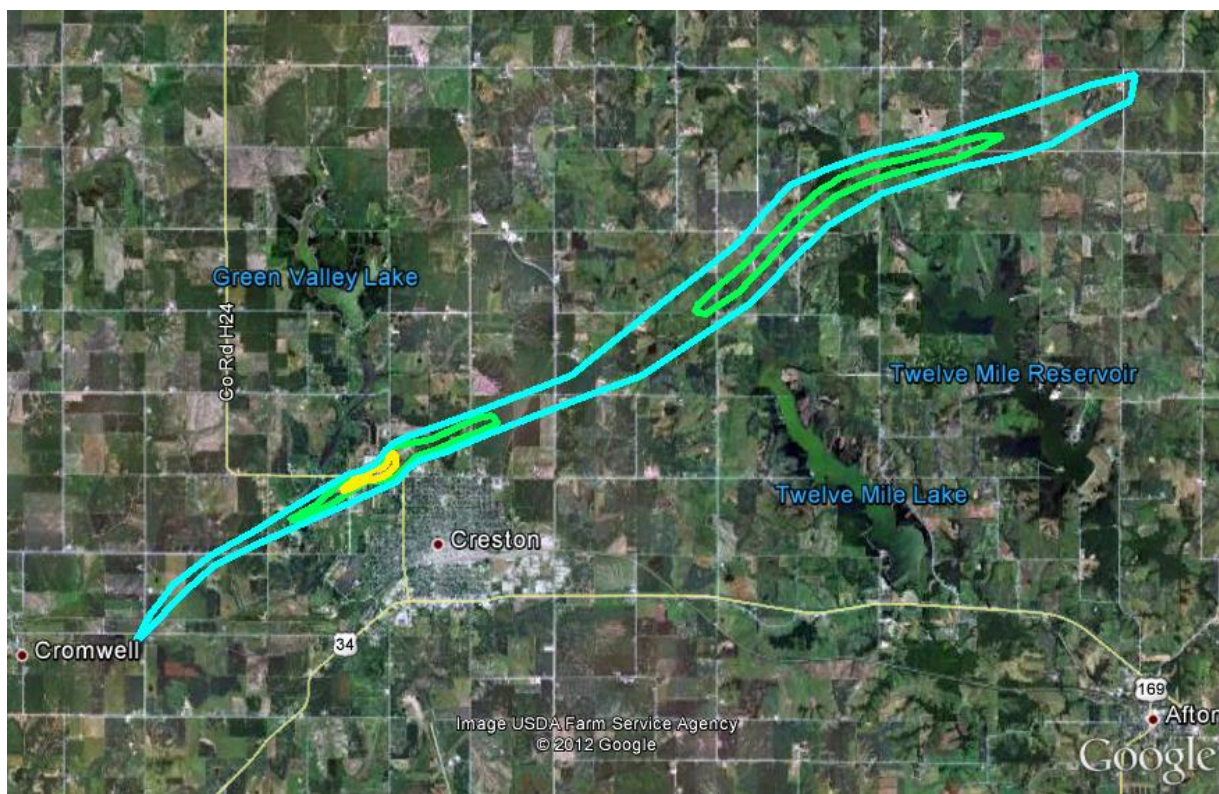
The path of the Creston tornado. Overall path length was 14 miles. The light blue contour denotes EF0 damage, green denotes EF1 damage, and yellow represents EF2 damage.

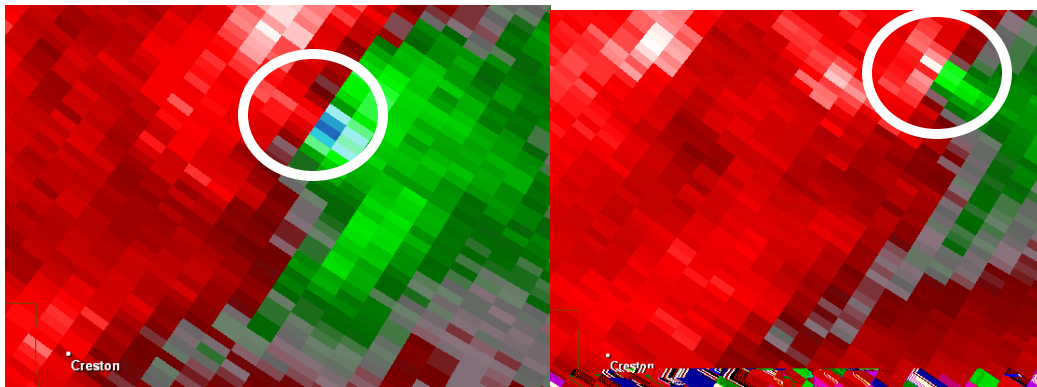
7:09 and 7:14pm: The tornado tracks away from Creston and dissipates. Creston is at the lower left corner of the two images.

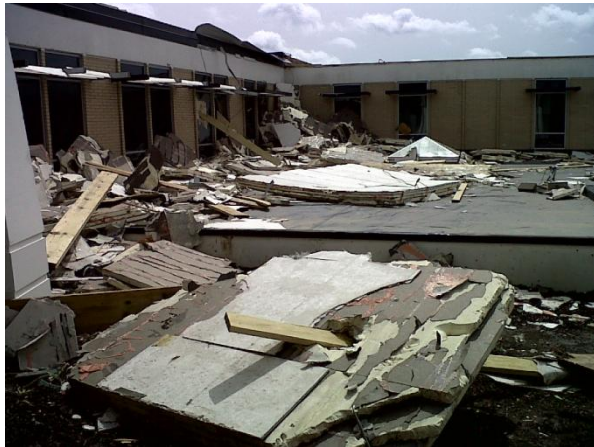
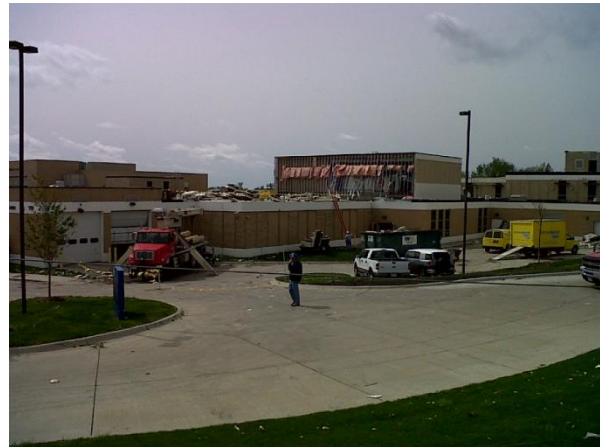
EF2 Damage Area 1:

The Greater Regional Medical Center in northwest Creston sustained rather substantial damage. A part of the building lost much of its roof and had a wall collapse. Winds were estimated near 120 mph.

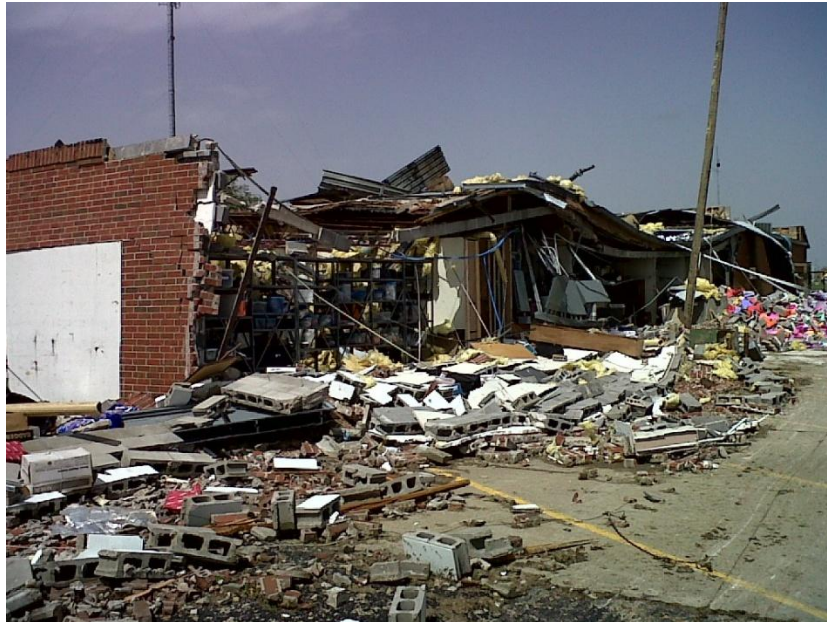
EF2 Damage Area 2:

The Green Hills Educational Center also sustained significant damage as the storm rolled through. The school completely lost its roof and one of its walls. Winds at this point were estimated near 130 mph.

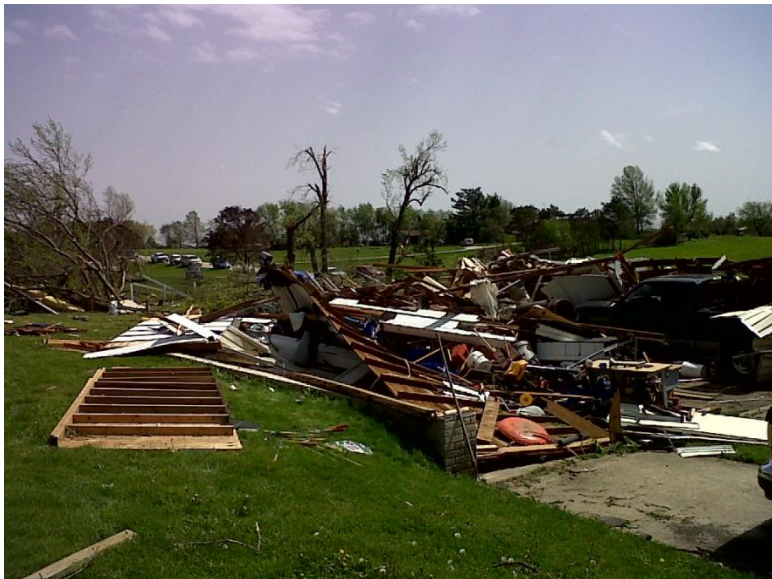
A one-story residence sustained major damage just west of Creston.

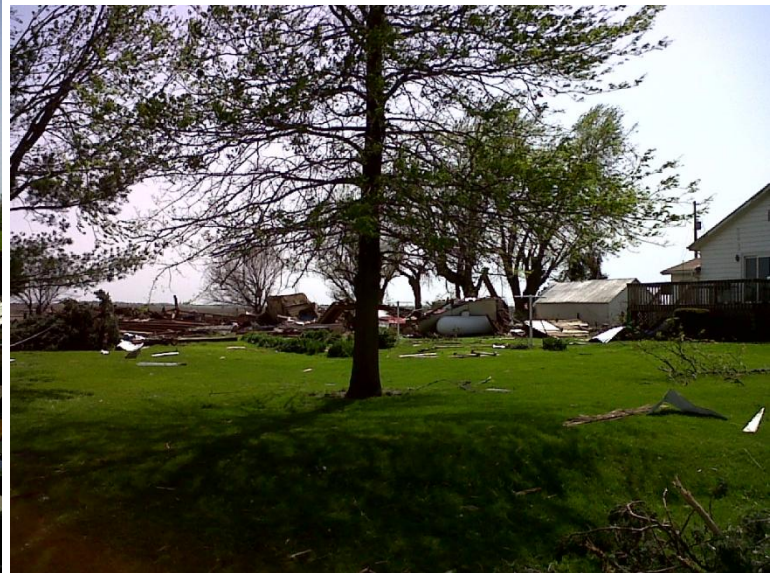
Debris clutters a yard north of Creston.

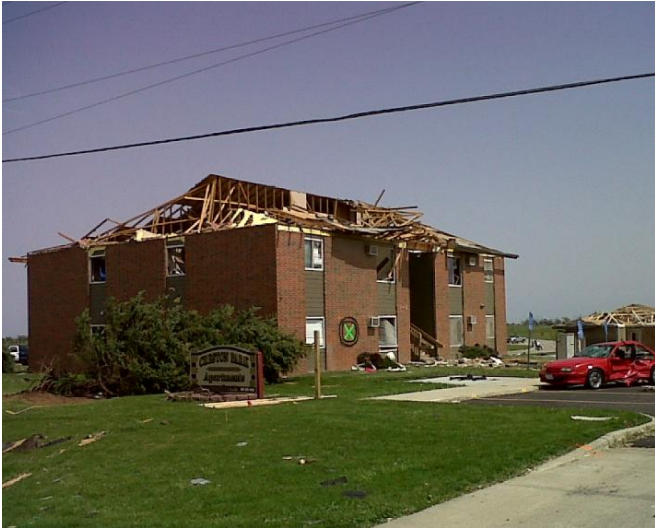
*An apartment building sustained roof damage.
Cars in the parking lot were dented and
damaged.*

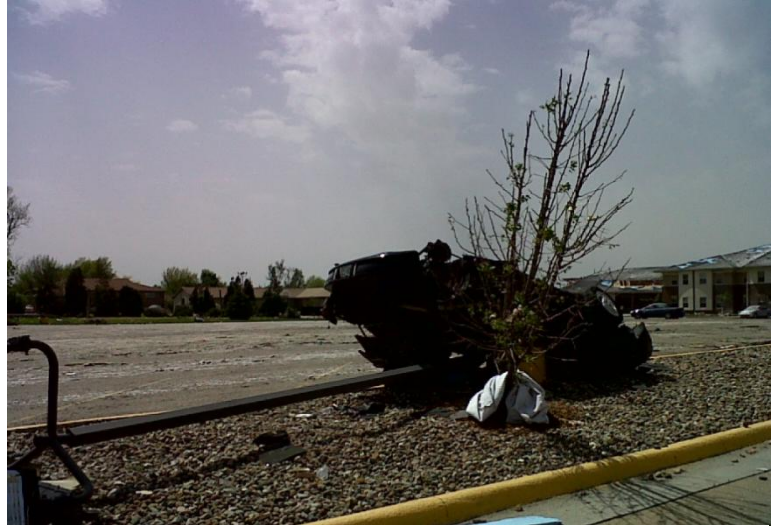
*A car was completely flipped on the north side of
Creston.*
