# Preliminary Damage Survey

## Atlanta, NE Tornado Phelps County

# Preliminary Damage Survey Additional Information **Overview**

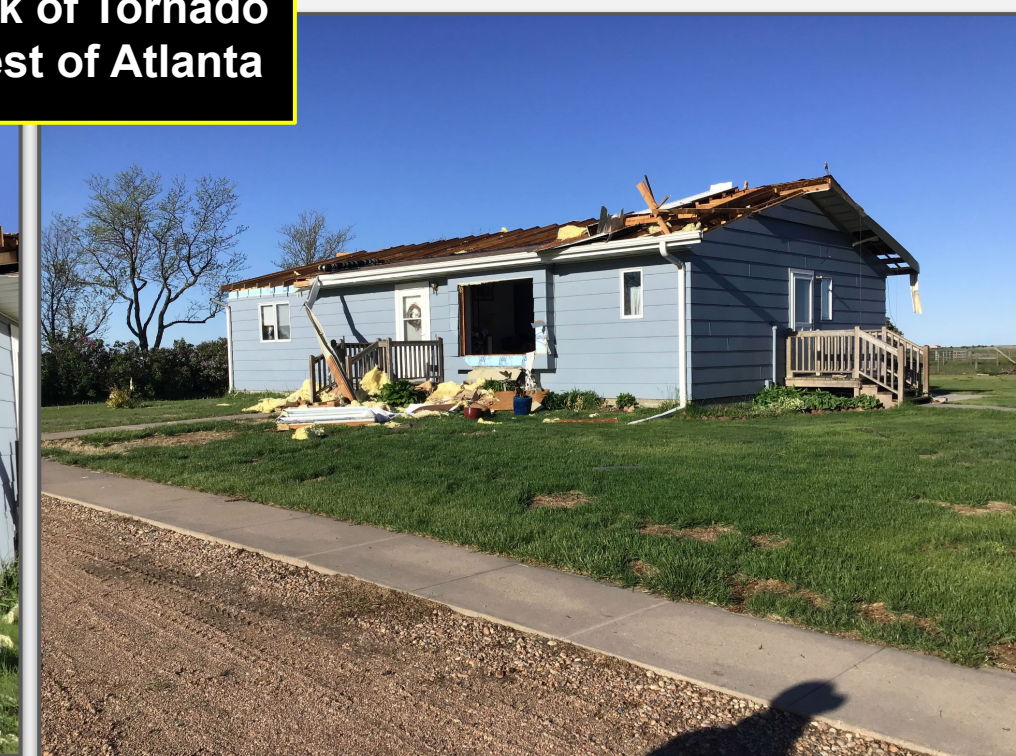
Photos of damage  
and track of Tornado  
northwest of Atlanta

Brief tornado touched down near G Rd just W of Atlanta. EF-1 damage occurred at this location, primarily to the roof of a home. Resident witnessed the circulation move NE, out the now broken large front window, into adjacent field. Damage/debris ceased about a half mile NE, just S of 728 Rd.

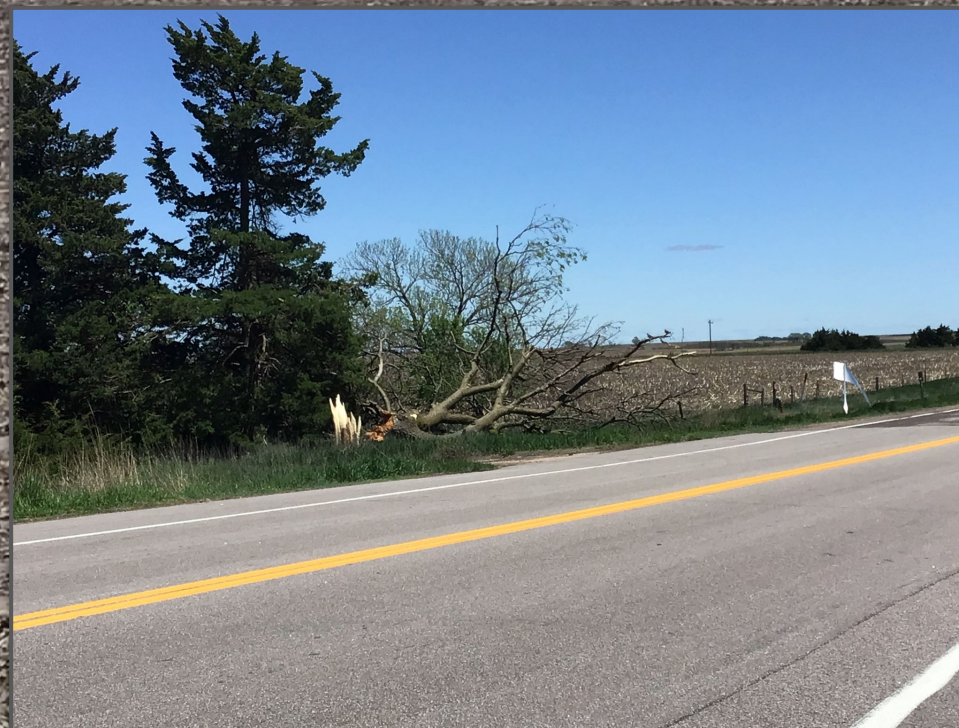
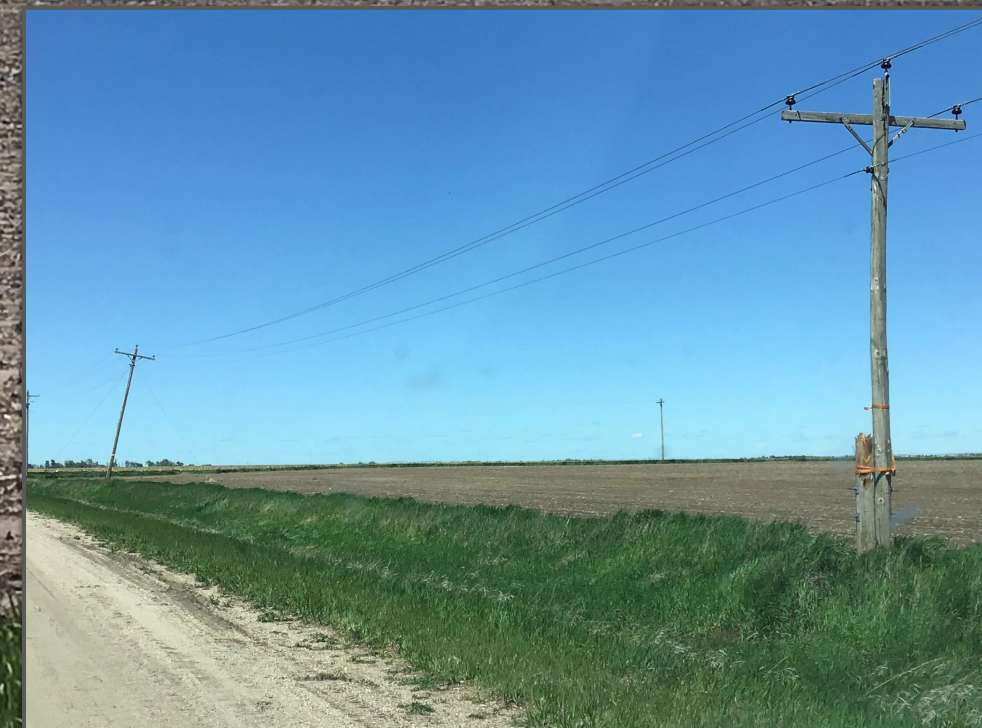
Photos of damage along  
with the track of the  
Tornado west and  
northeast of Ragan

Weak and somewhat intermittent tornado touched down near the intersection of Hwy 183 and Hwy 4, then moved NE. Damage was limited to trees, pivots, and a few power poles along its roughly 7 mile track. The tornado lifted along the Harlan/Phelps county line between T Rd and U Rd.

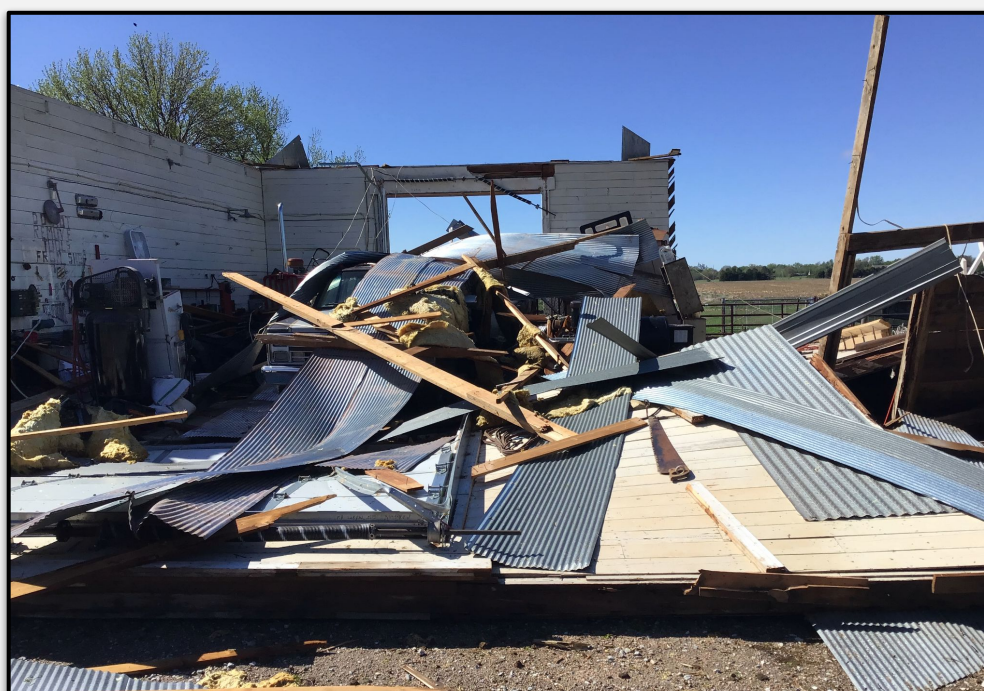
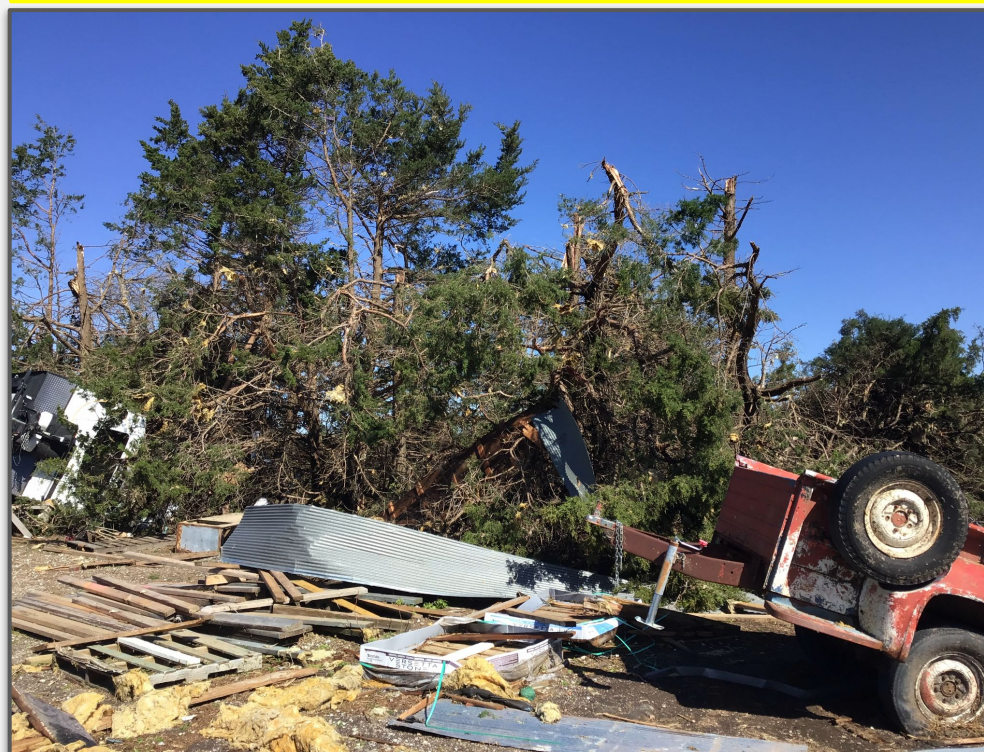
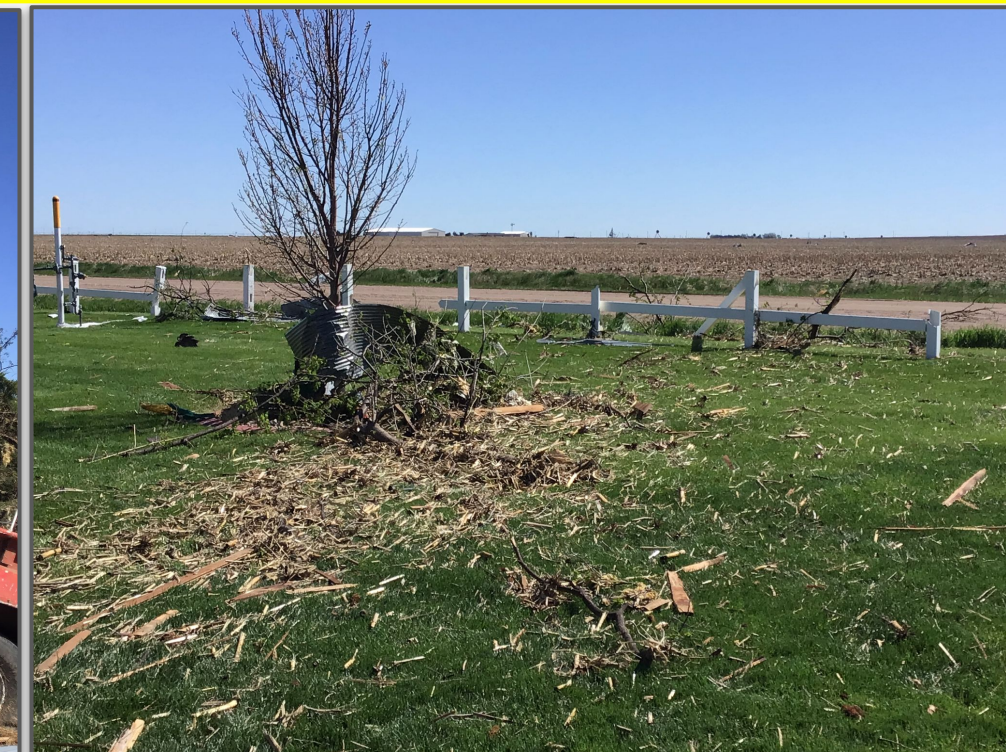
Photos of some of the damage and track of Tornado North-Northeast of Holdrege

EF-1 tornado touched down near the north side of the golf course, then moved ENE, then NE, ending near the intersection of 736 Rd and Q Rd. The tornado reached peak intensity and width near Lincoln St just NE of the town of Holdrege where significant damage to outbuildings, some newer and well-built, was noted. Damage also occurred to roofs of a few homes. Based on the damage track, the peak width of the tornado was about 1000 yards, or about 0.6 of a mile. Numerous pivots and trees were damaged, and several power poles snapped. Additional damage was noted to the S and SE of this track, near the fairgrounds and southeast side of Holdrege. It is currently unknown if this damage was a possible second tornado (continuation of the mesocyclone that produced the tornado near Atlanta), or if this was caused by strong rear flank

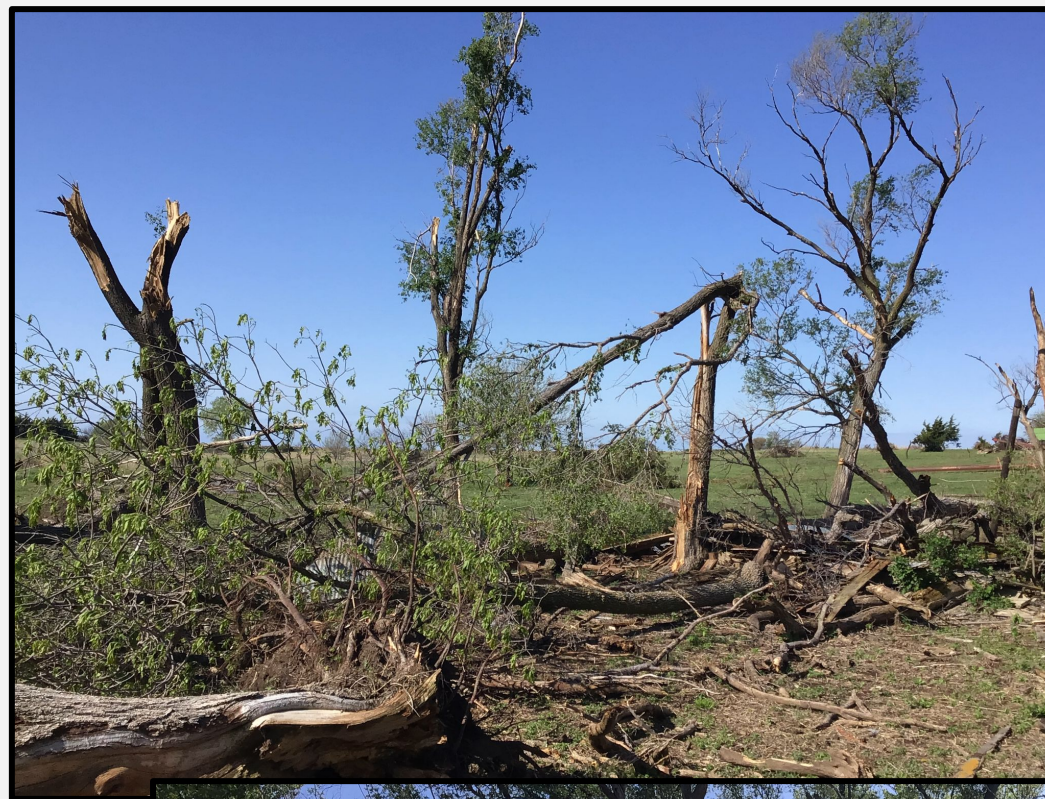
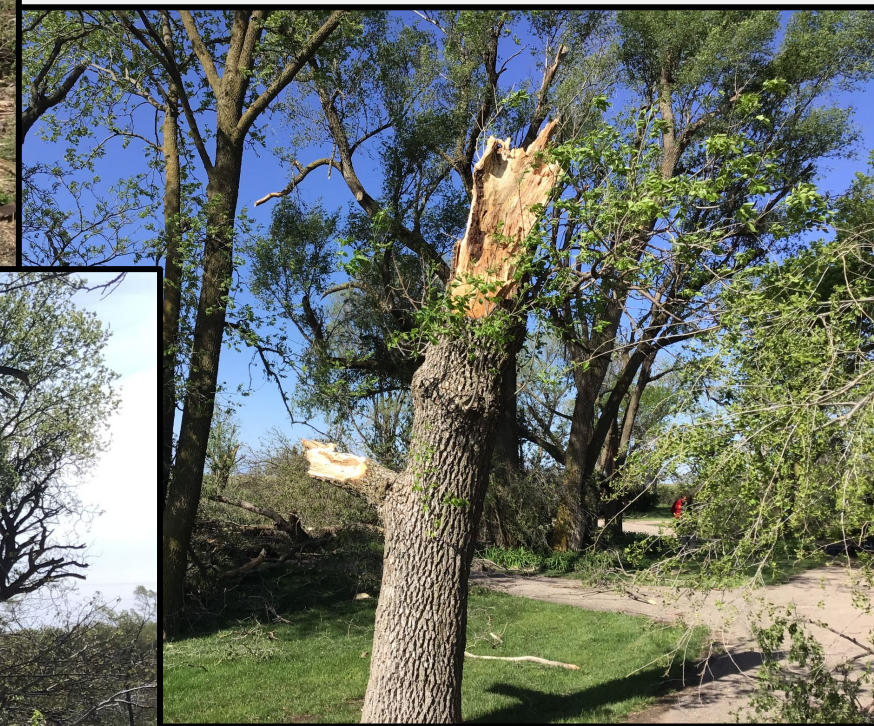
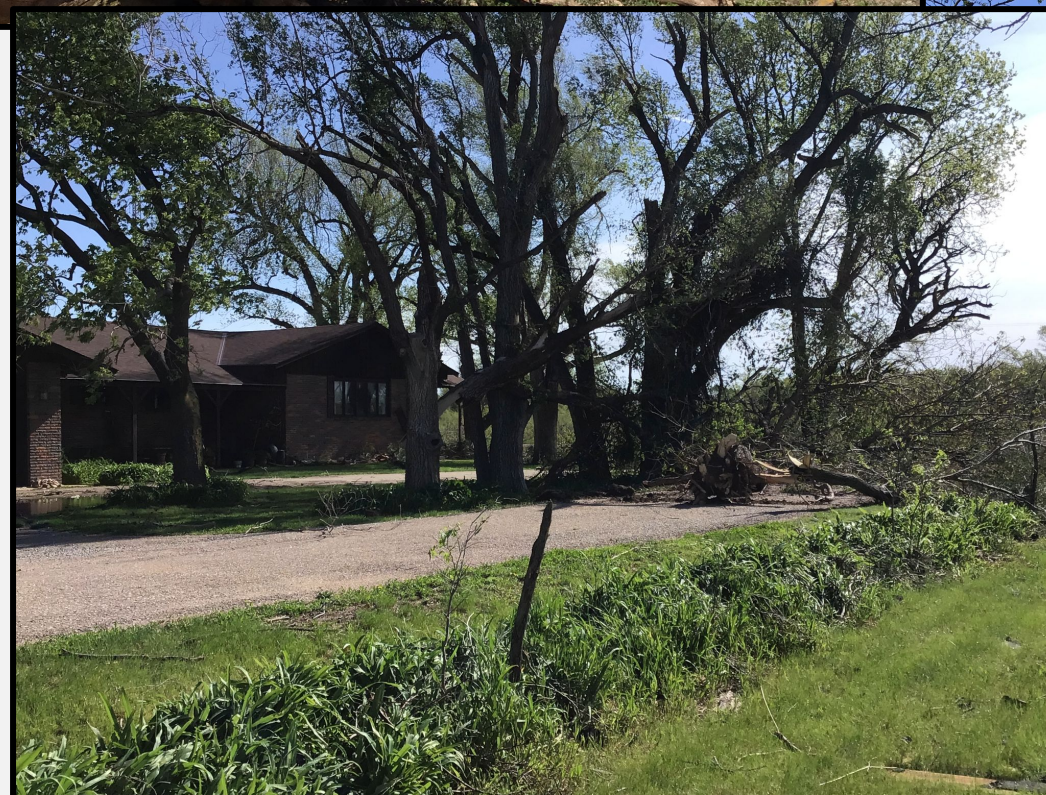
The tornado started just west of Highway 78 between 5-6 miles north of Guide Rock. The worst damage along its path occurred at a nearby farmstead, at which there was widespread tree damage and minor damage to the home. The tornado crossed the highway and sporadically damaged some trees for the next couple miles. The tornado eventually grazed another farmstead and damaged a couple of areas of cedar trees. A resident noted fence damage and debris in a fence north of the farmstead. The tornado likely ended at or near a farmstead in far western Nuckolls County where some tree damage and outbuilding damage occurred.
