RISING WATERS

Louisville, Kentucky Flash Flood August 4, 2009

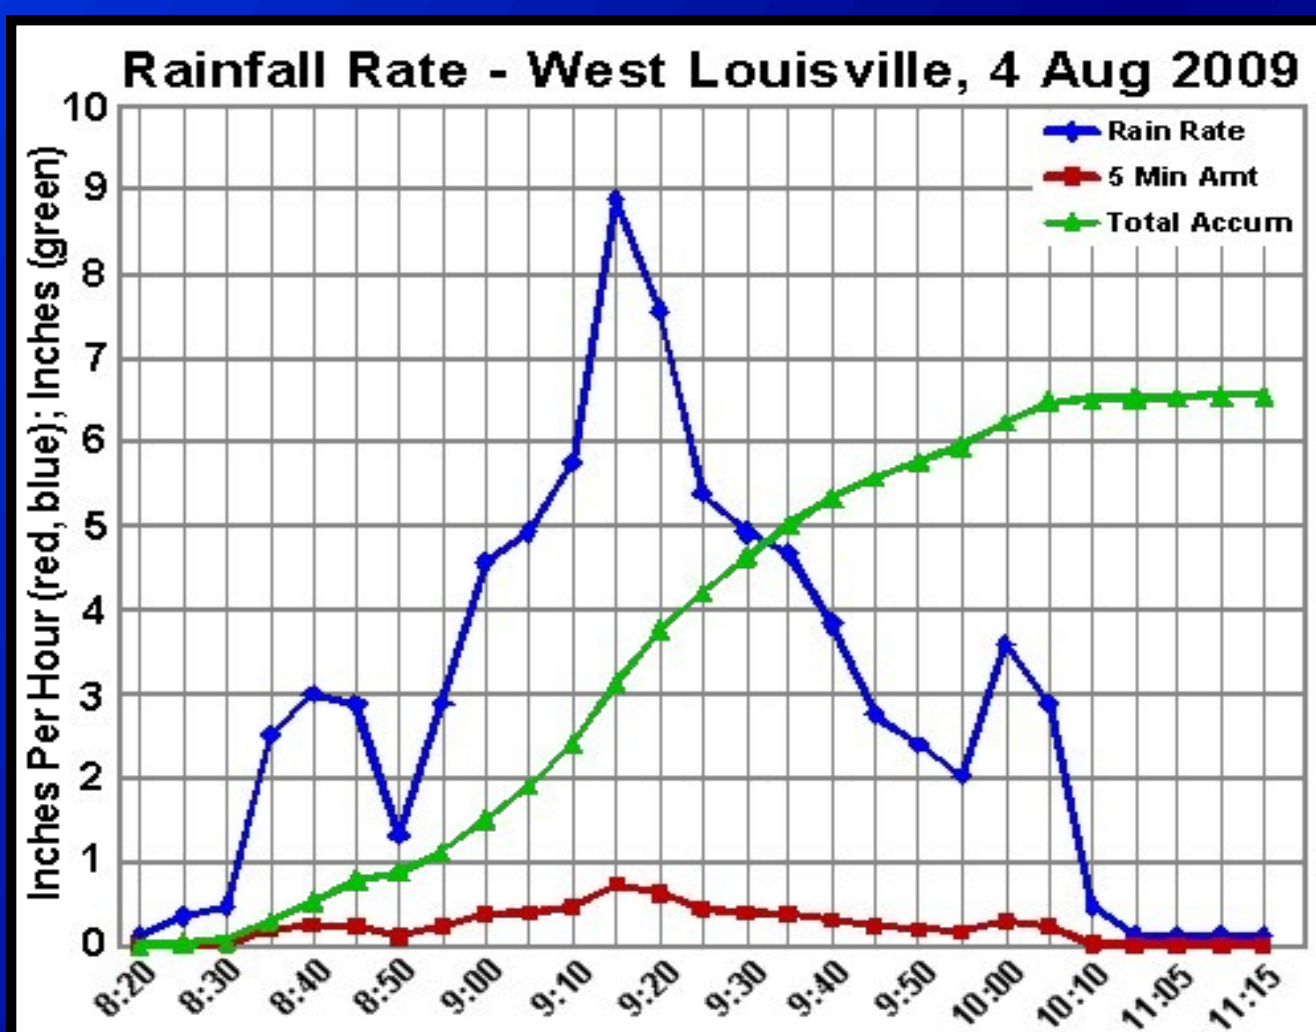
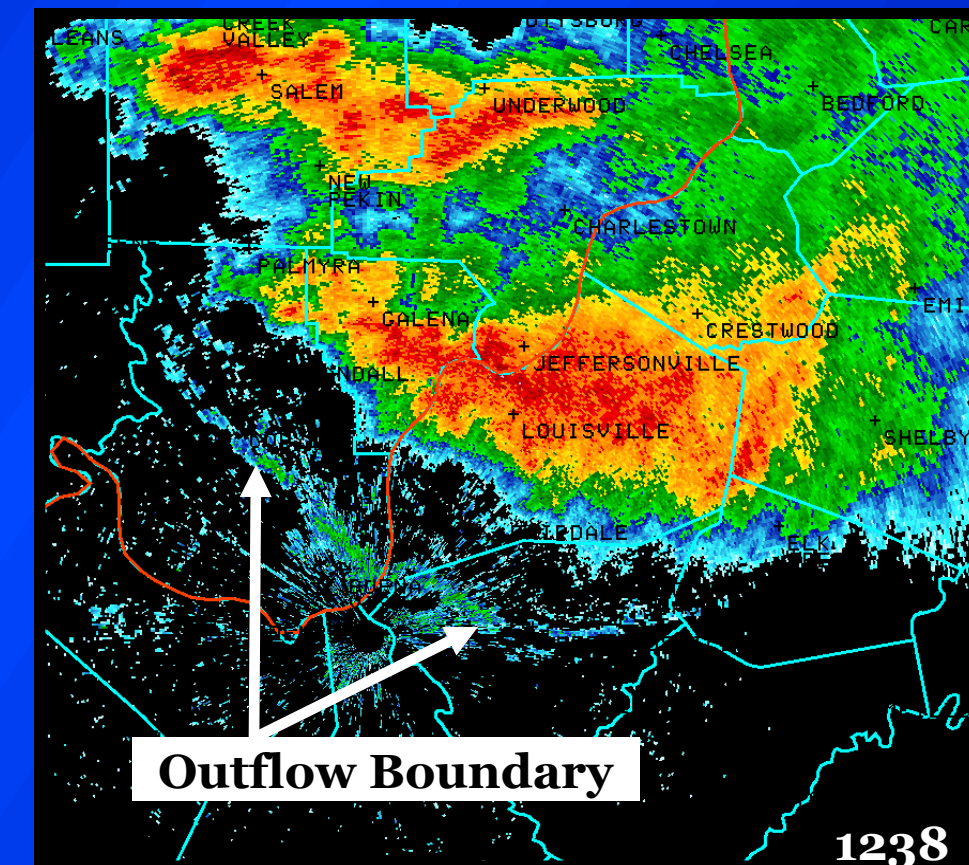
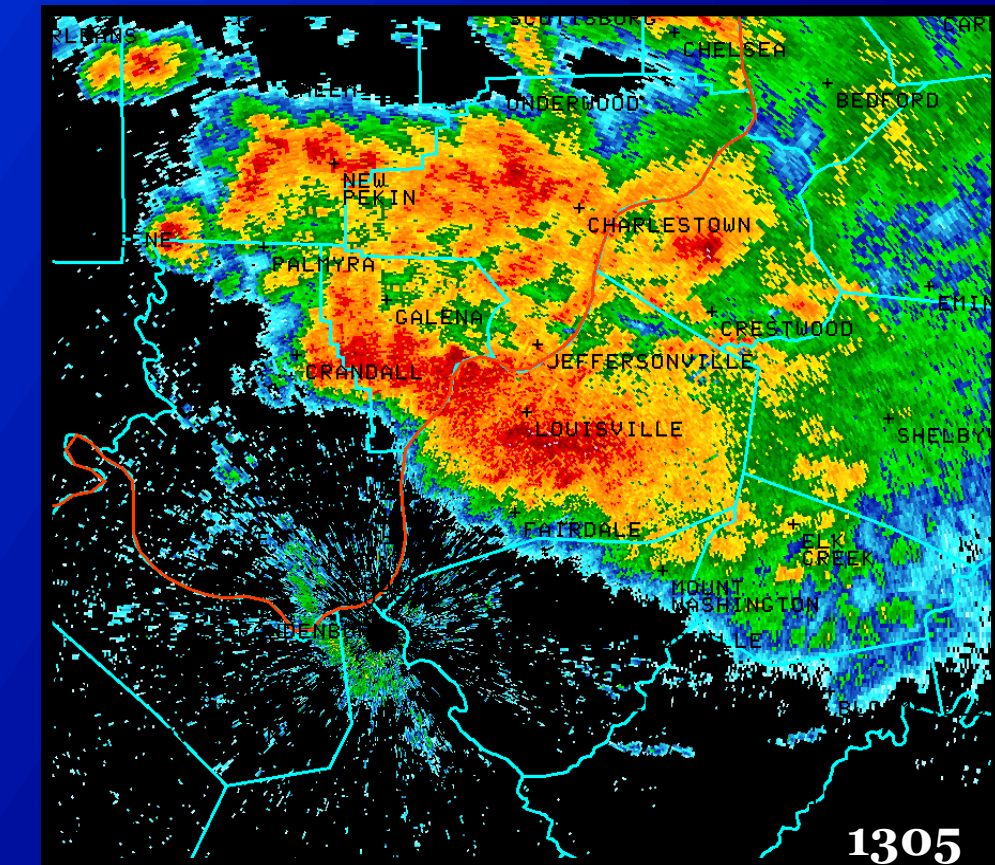
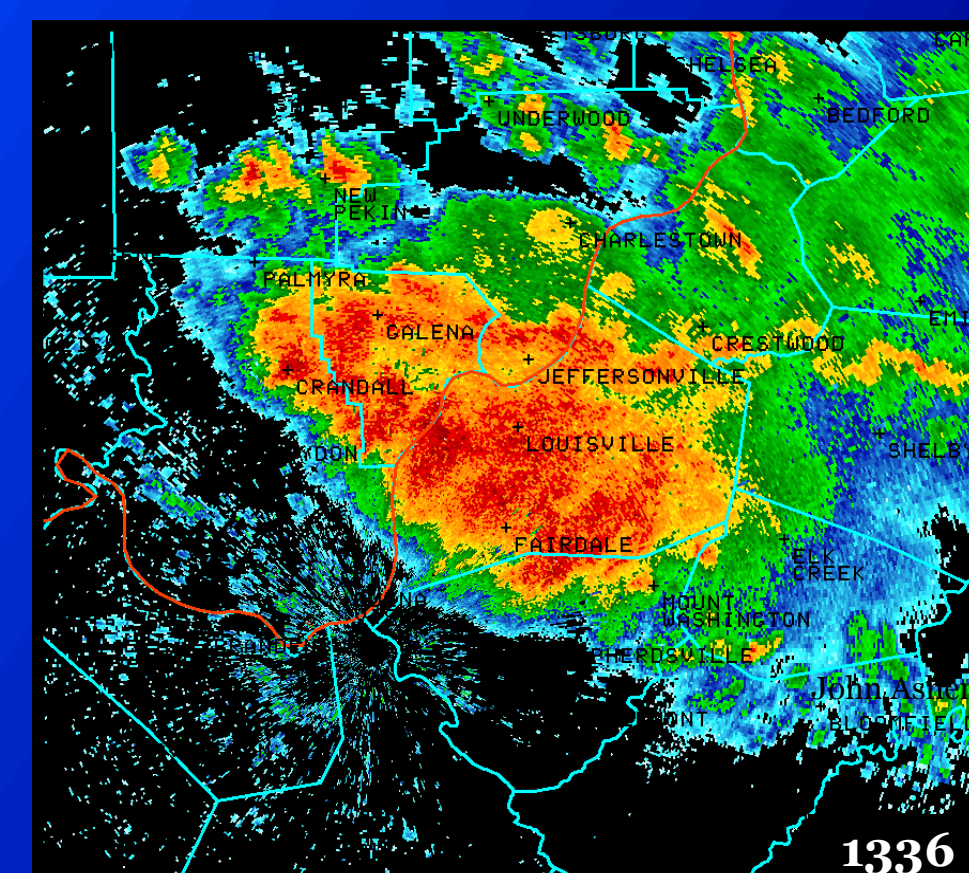
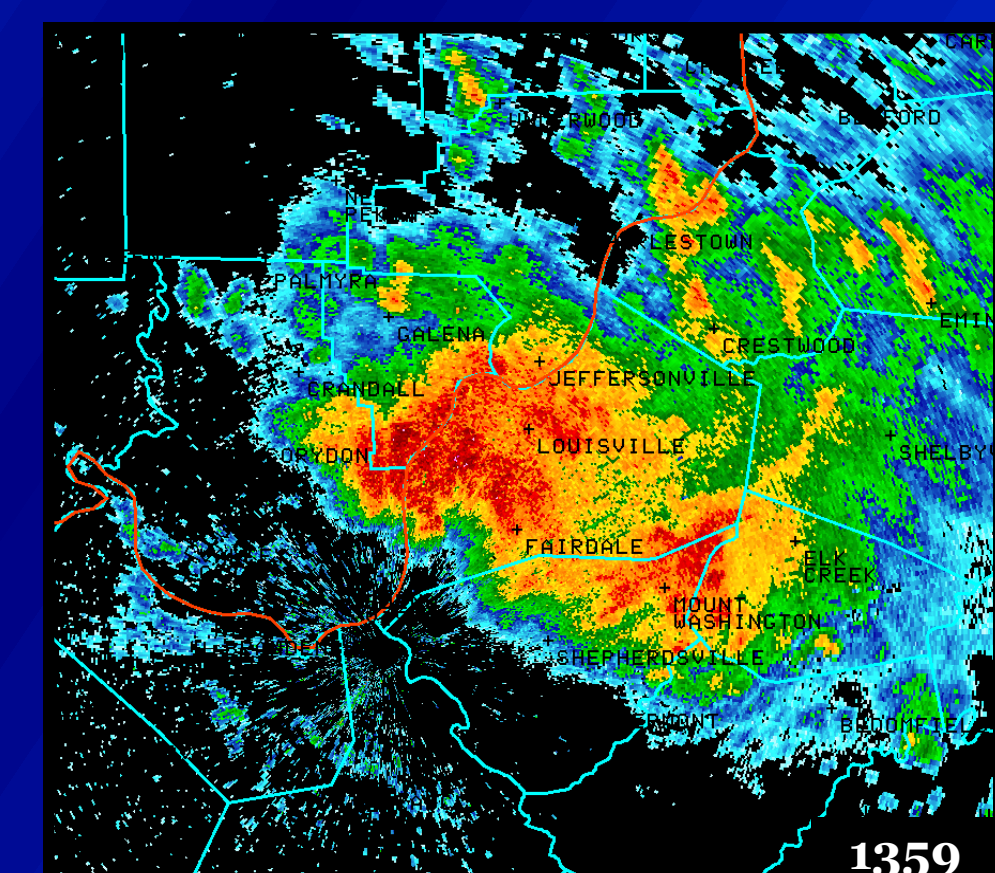
NWS Louisville Doppler radar from 1238 to 1359 UTC. Regenerative cells are evident on the storm's northwest side, producing the effect of a stalled storm complex.

The graph at left highlights the unbelievable rainfall rates this storm produced: 8.8" per hour during the most intense period. The total rainfall map shows the west end of the city receiving an unprecedented 7.04" during the event.

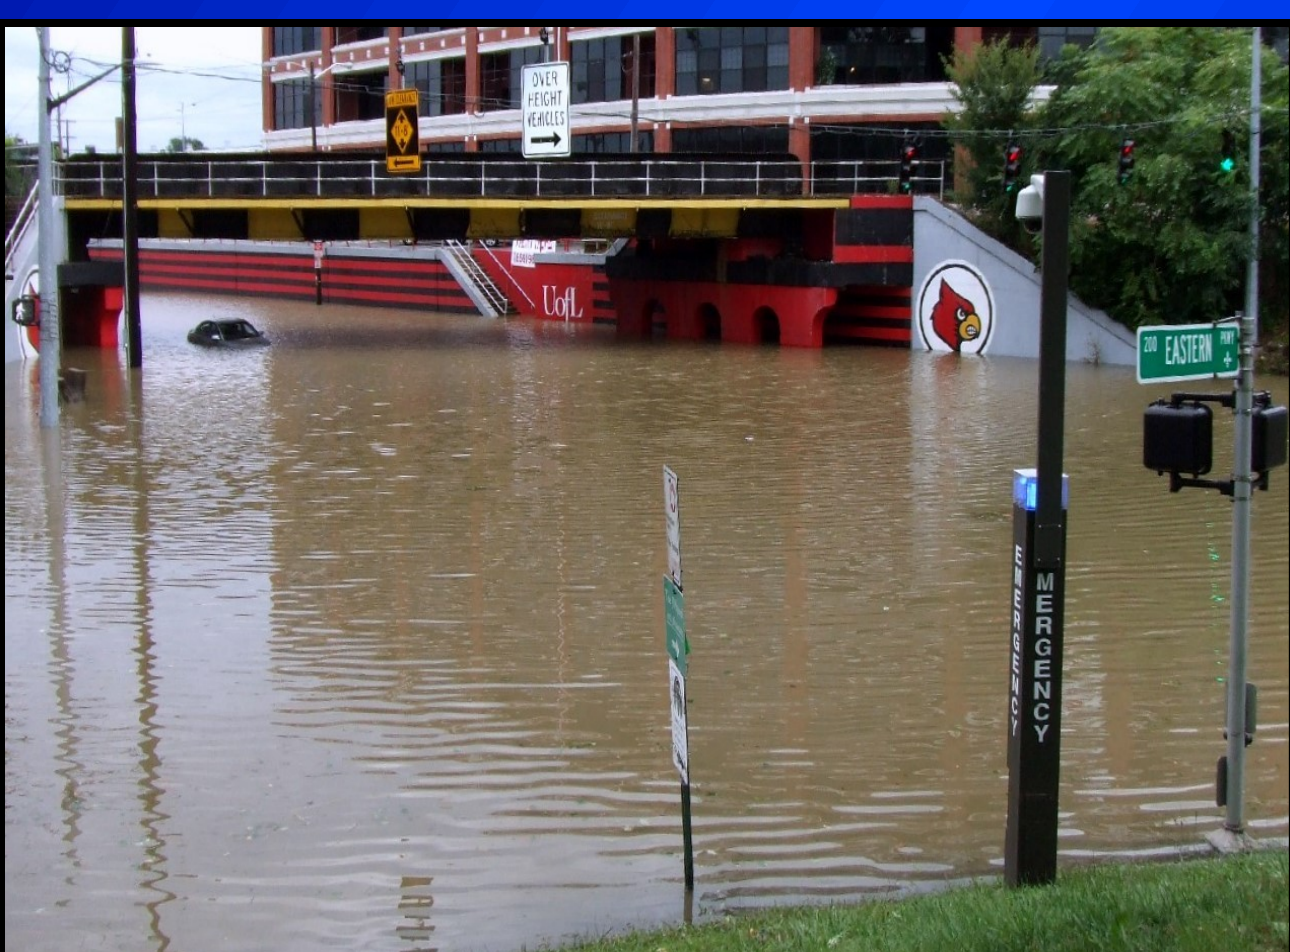
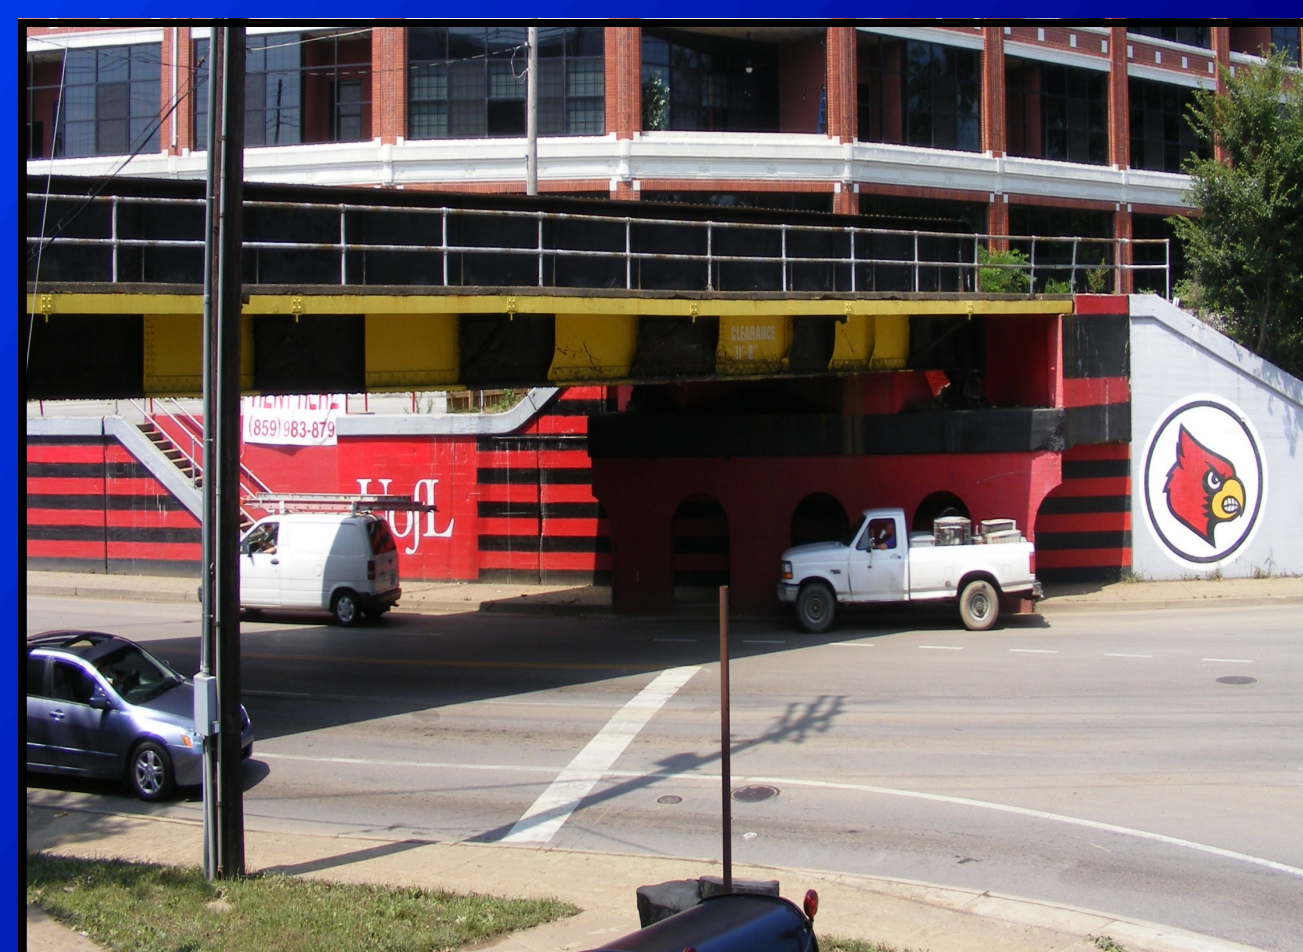
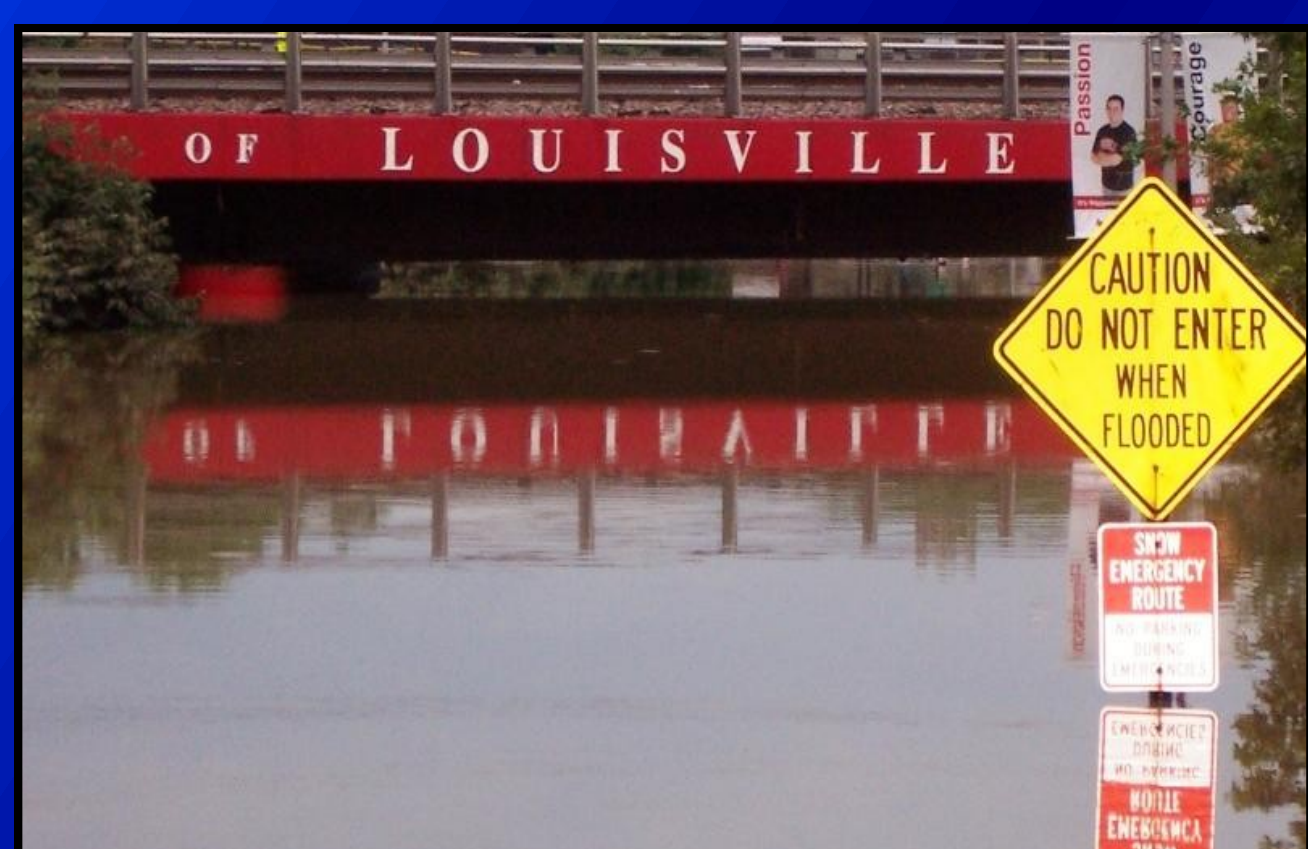
Eastern Parkway and 3rd Street intersection during and after the flood. The clearance under the bridge is 11'8". Below is another bridge on East Brandeis Avenue with a clearance of 15'8".

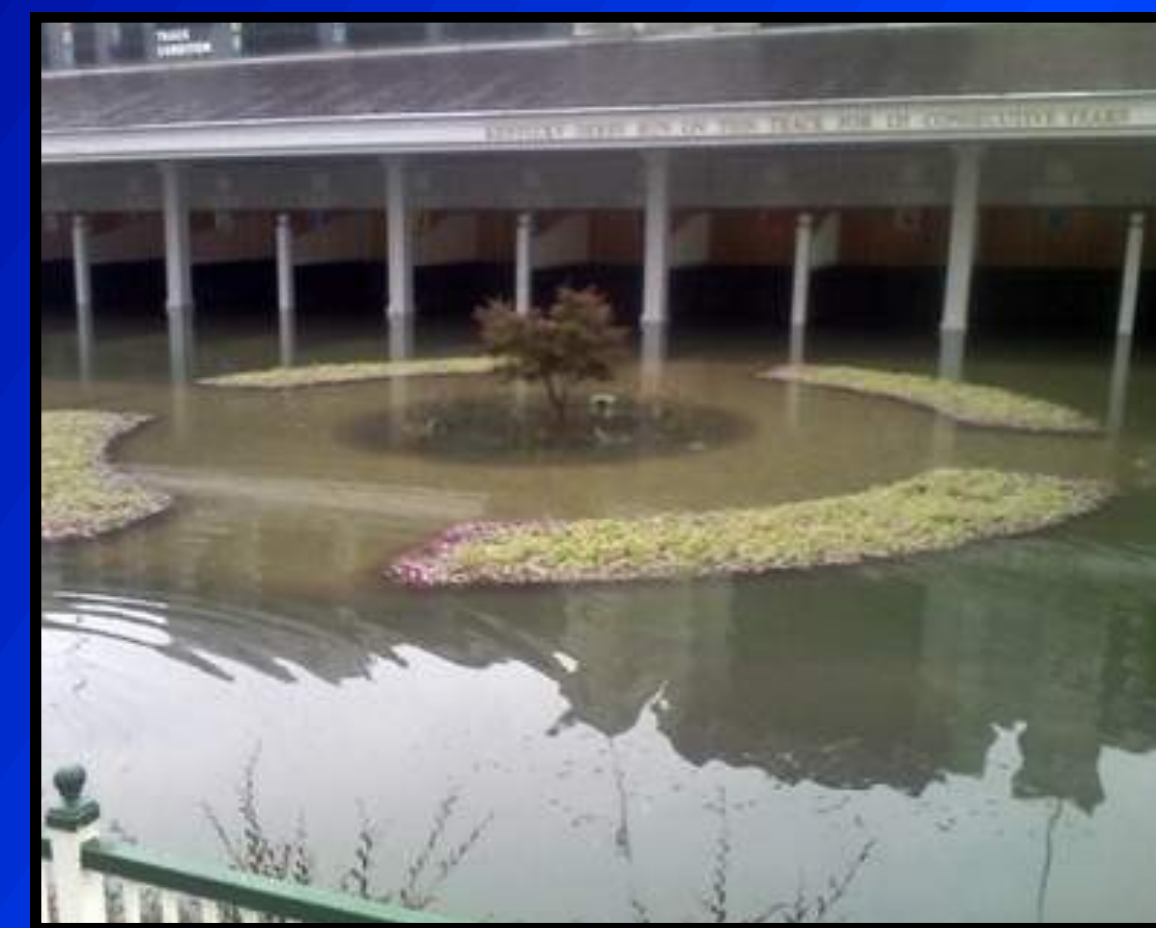
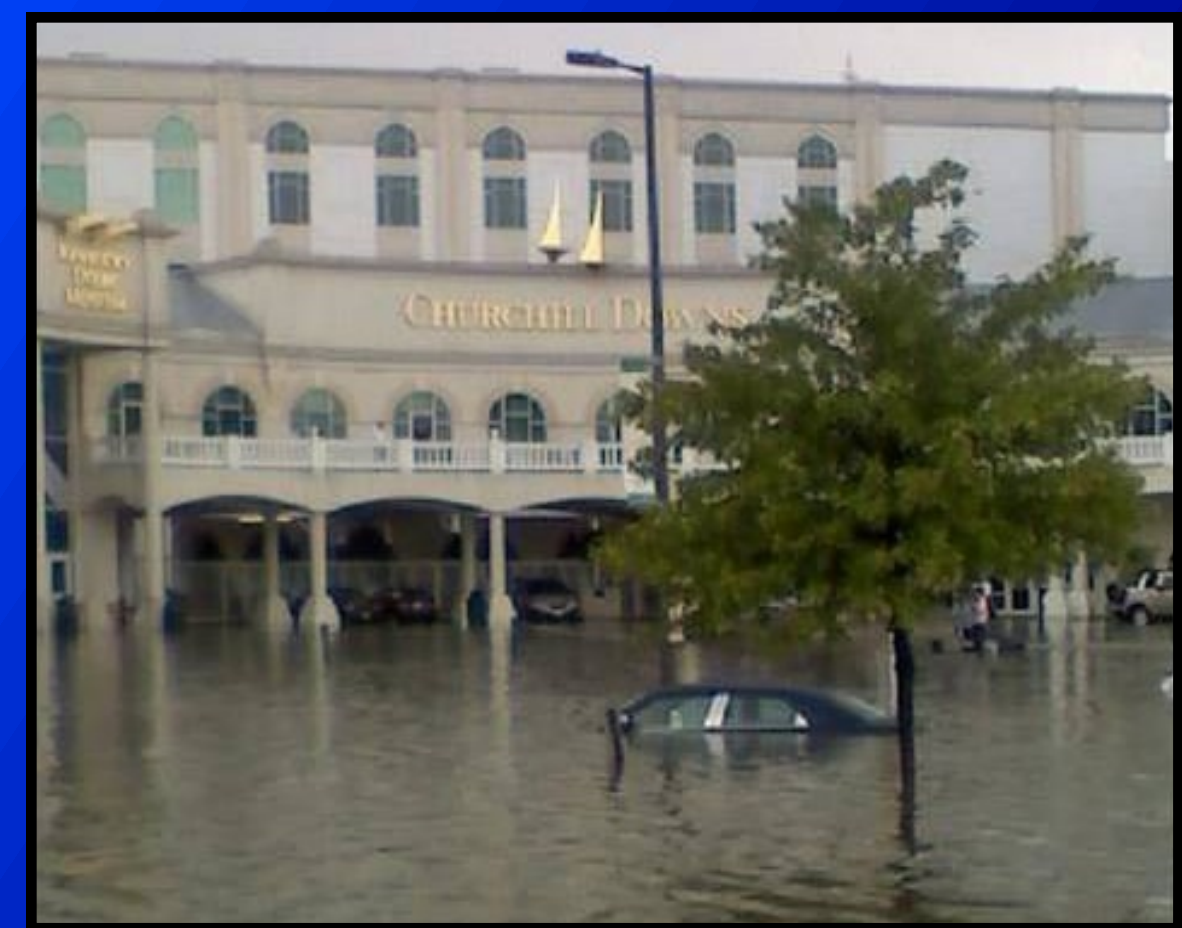
Historic Churchill Downs Racetrack with flooding in the paddock (left) and front entrance (right).
