NMDOT

ENVIRONMENTAL
BUREAU

2022 Lordsburg Playa Dust Storm Mitigation -Phase 3 -

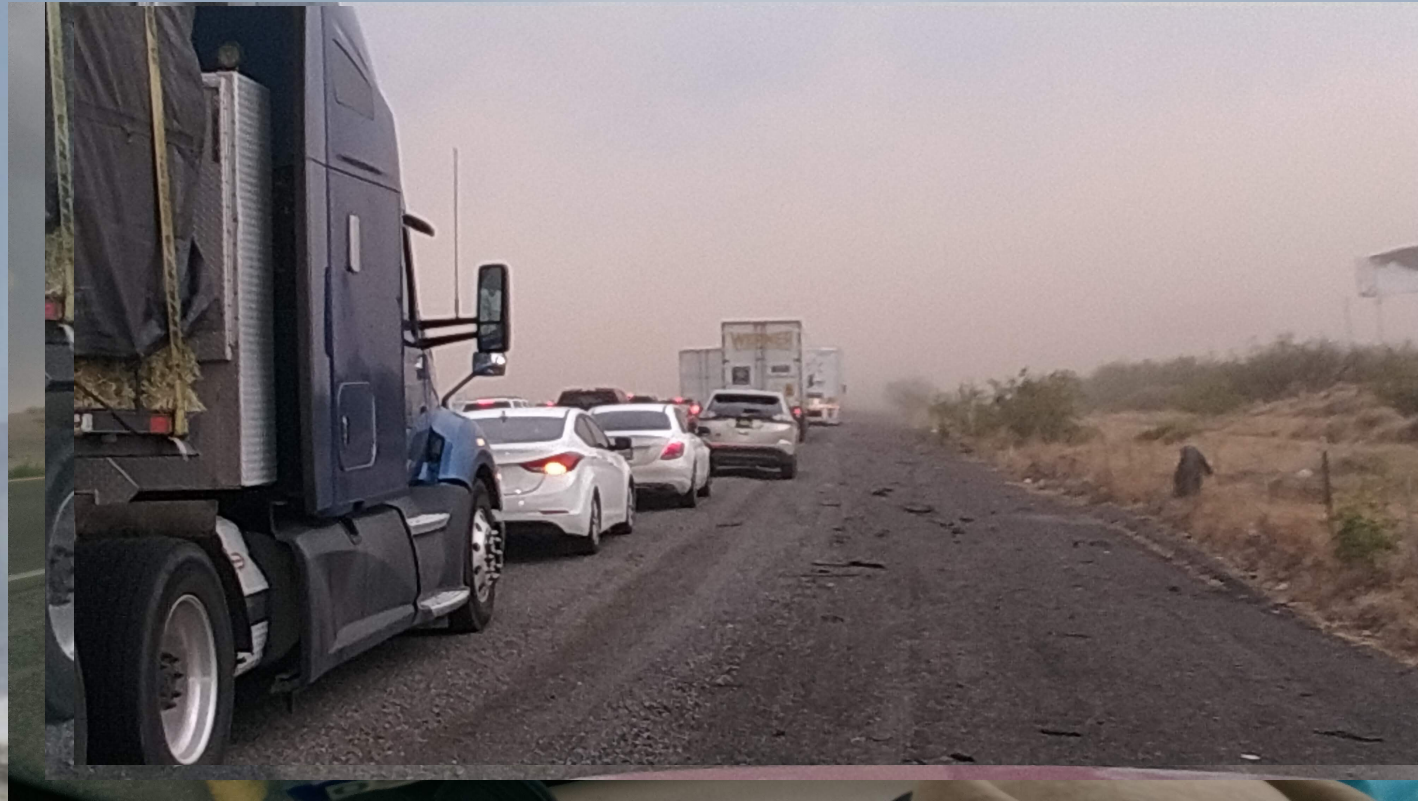
July 6, 2020: Dust Event I-10 MP 7

← Billboards
Disappear

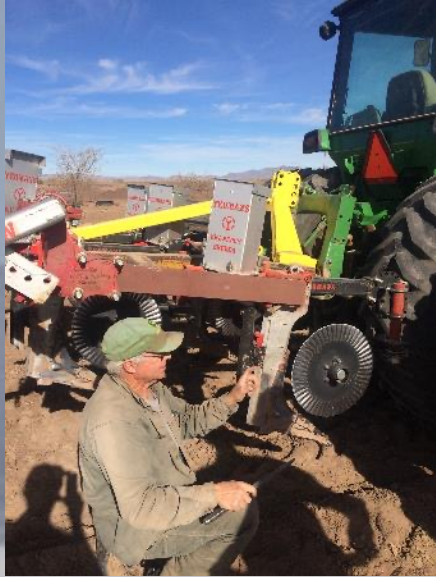
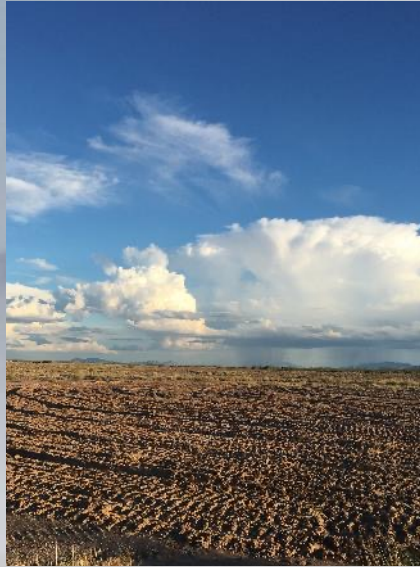
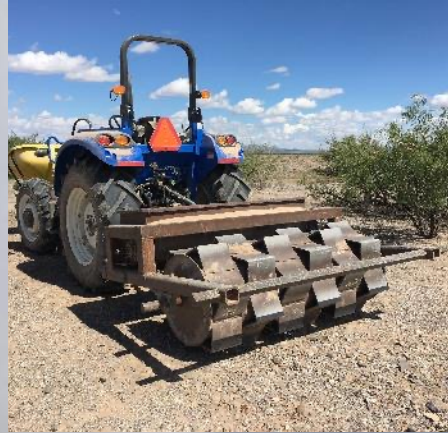
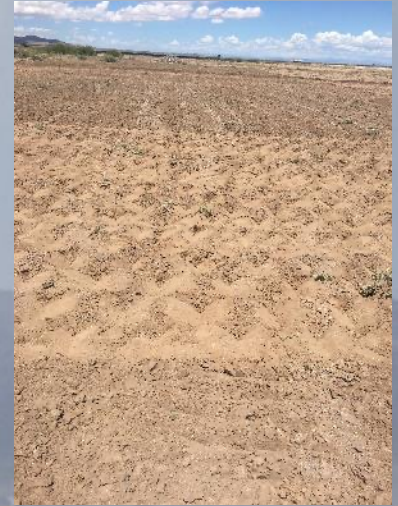
Phase 3 Dust Mitigation Area

Keyline plowing, Imprinting, Tackifier, Fencing

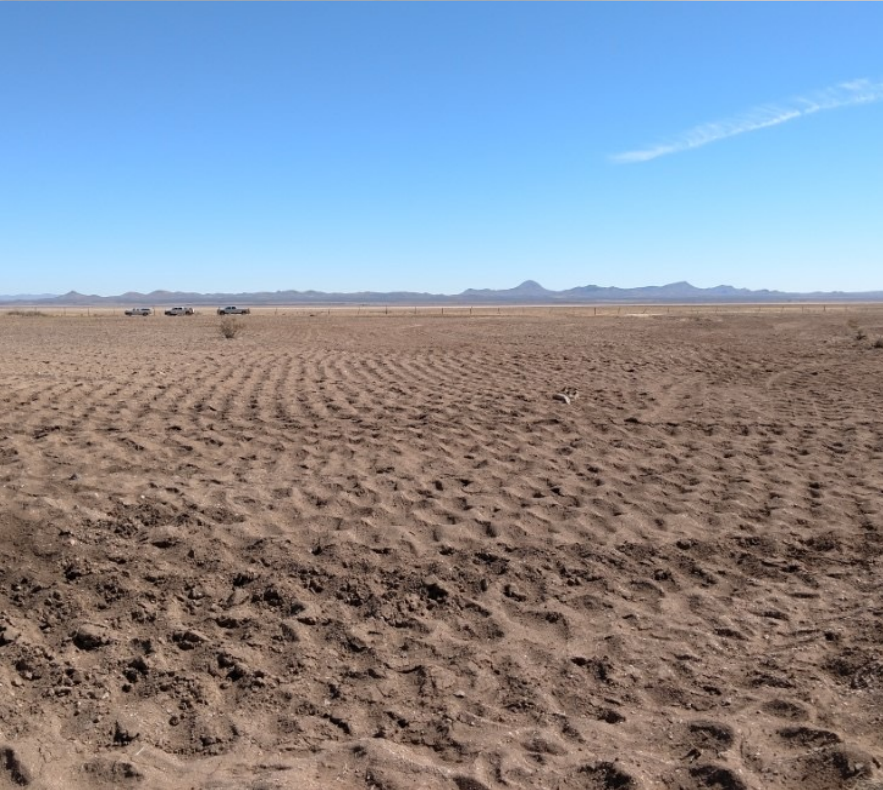
December 2020

Keyline, Imprint & Seeding on Degraded Grassland

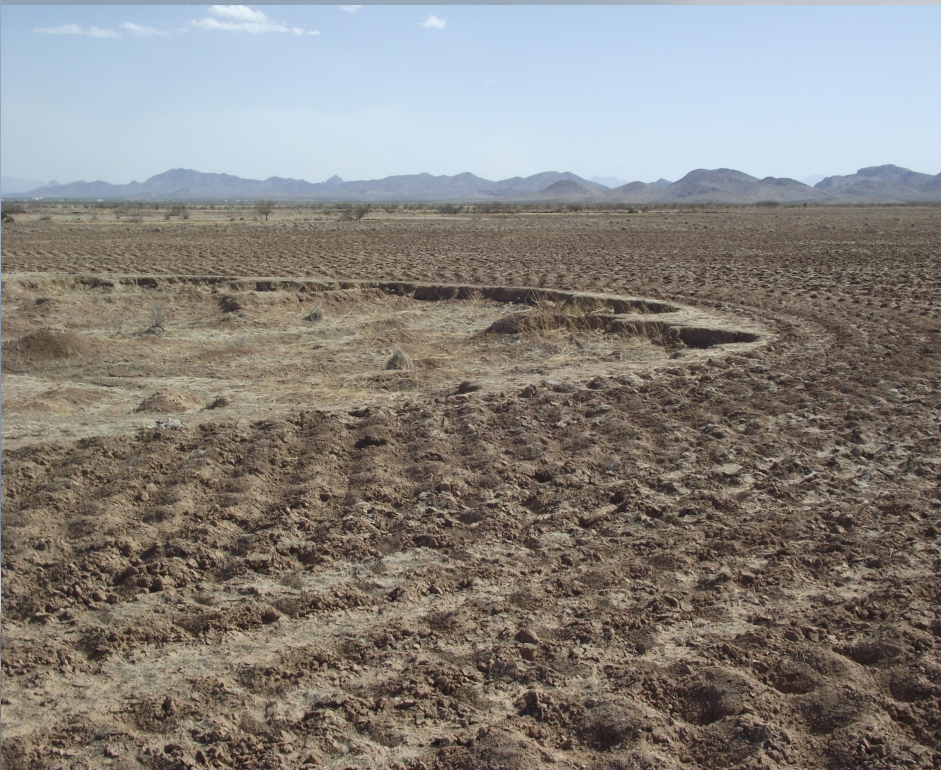
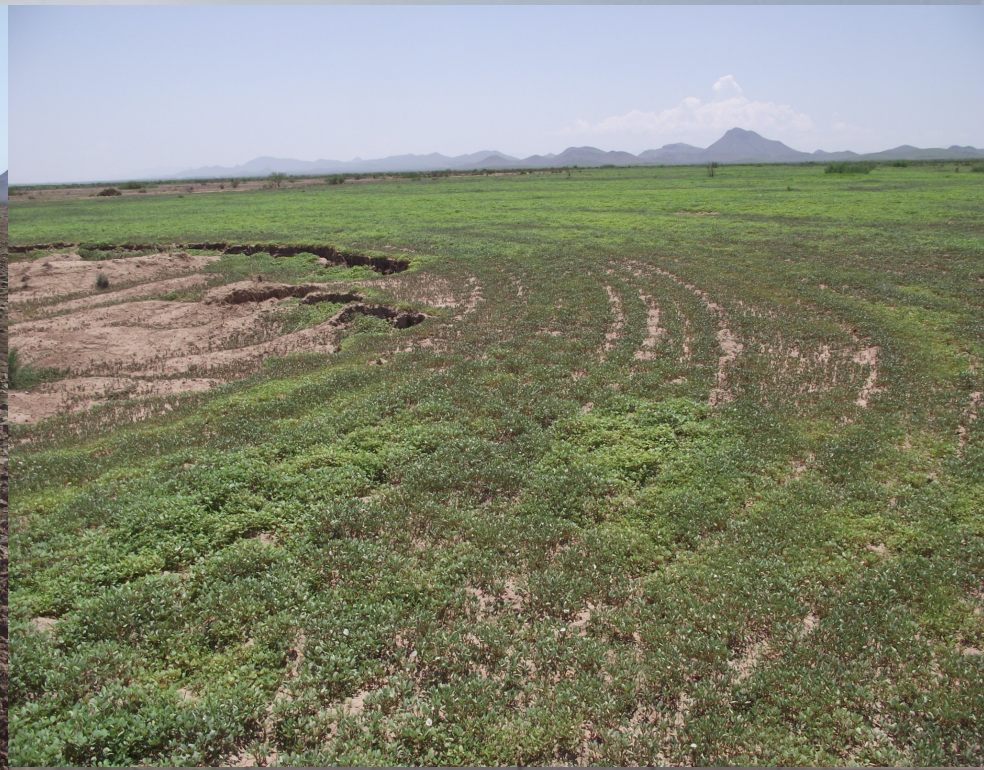
Keyline, Imprint & Seeding Around Erosion Headcut

December 2020

July 2021

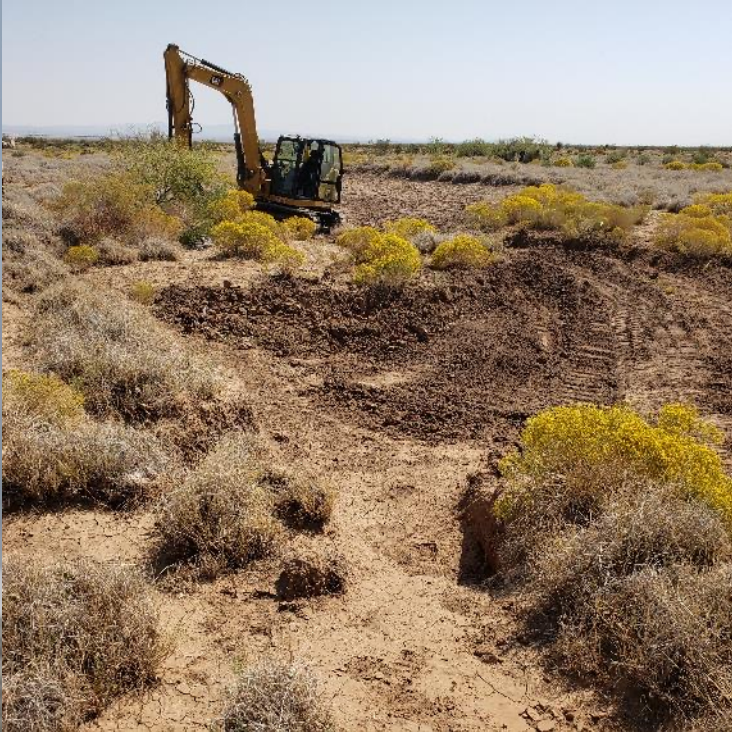
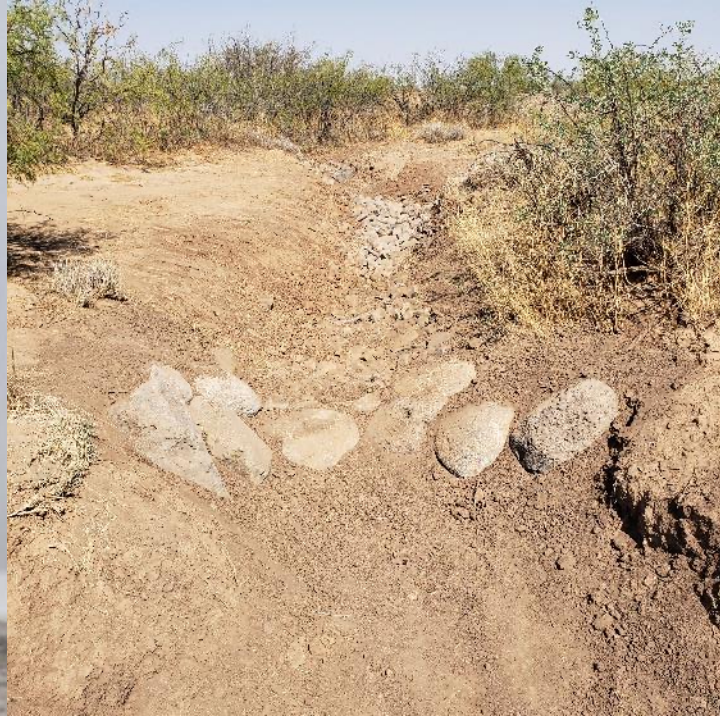
Phase 3 Dust Mitigation Area

Plug & Pond, Erosion Control

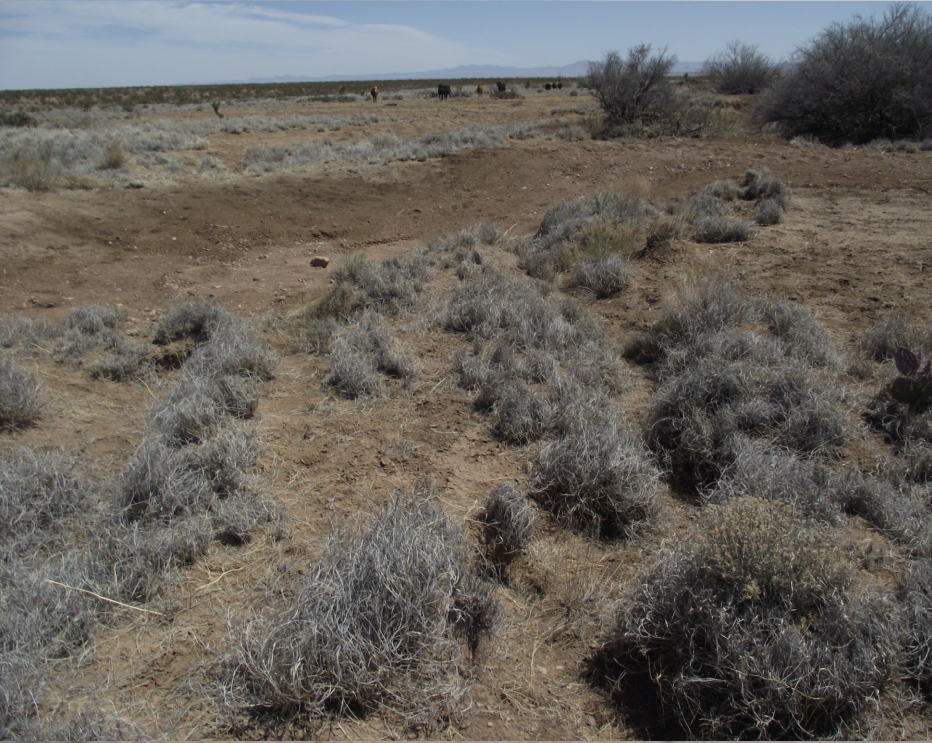
December 2020

Plug & Pond to Restore Sheet Flow

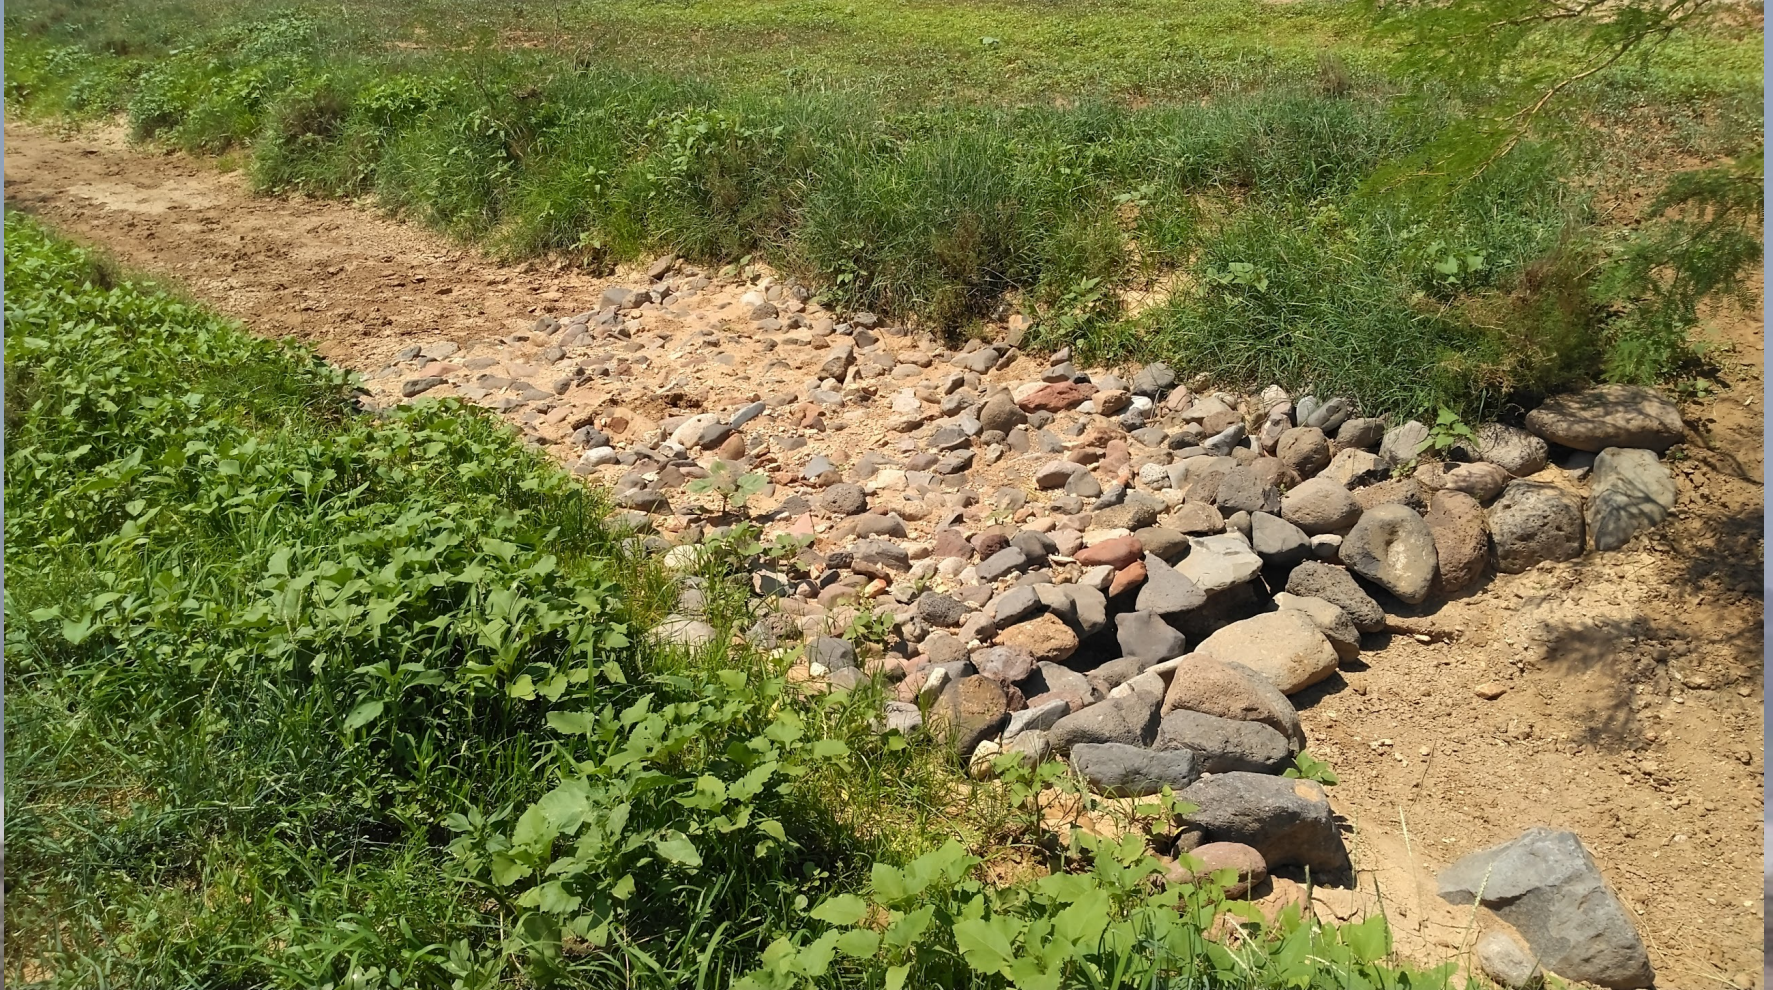
1-Rock Dam Stops Downtcutting, Promotes Sheet Flow
