A Recommendation for an  
**ENHANCED FUJITA SCALE**  
(EF-Scale)

Submitted to  
The National Weather Service  
and  
Other Interested Users

**WIND SCIENCE AND ENGINEERING CENTER**  
Texas Tech University  
Lubbock, Texas 79409-1023

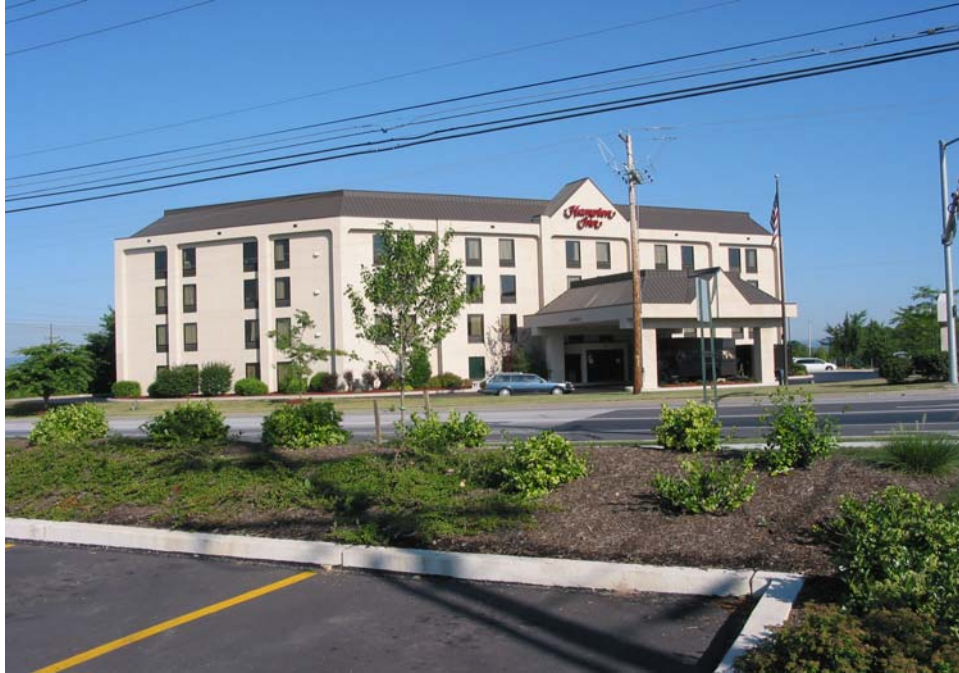
MAM: Four stories, rectangular plan, mansard roof, pre-cast, hollow-core roof & floor system, CMU load-bearing walls, EIFS exterior walls

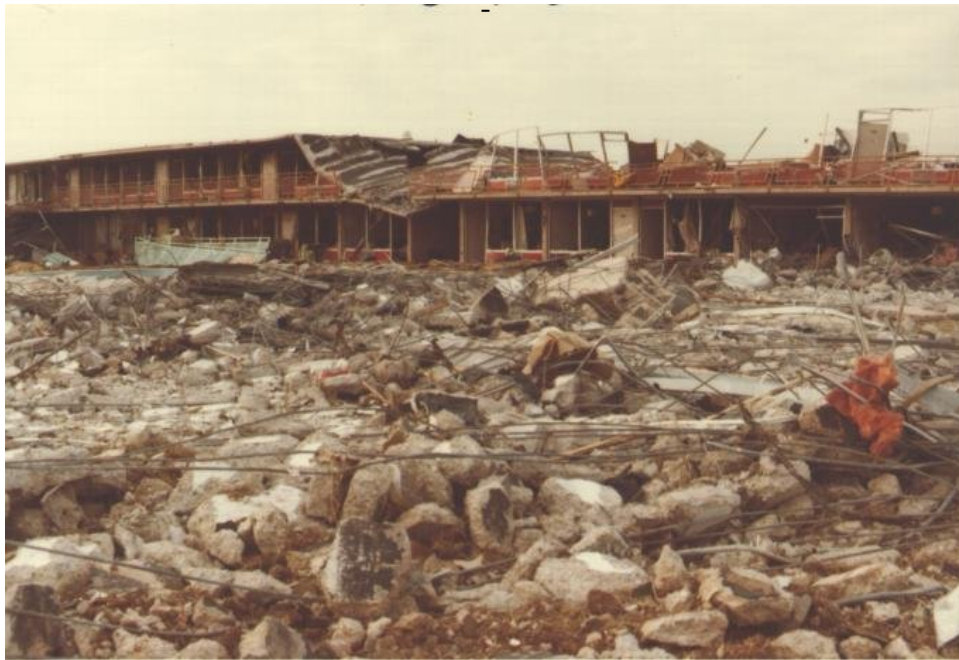
MAM: DOD 4: Uplift fo pre-cast roof decking

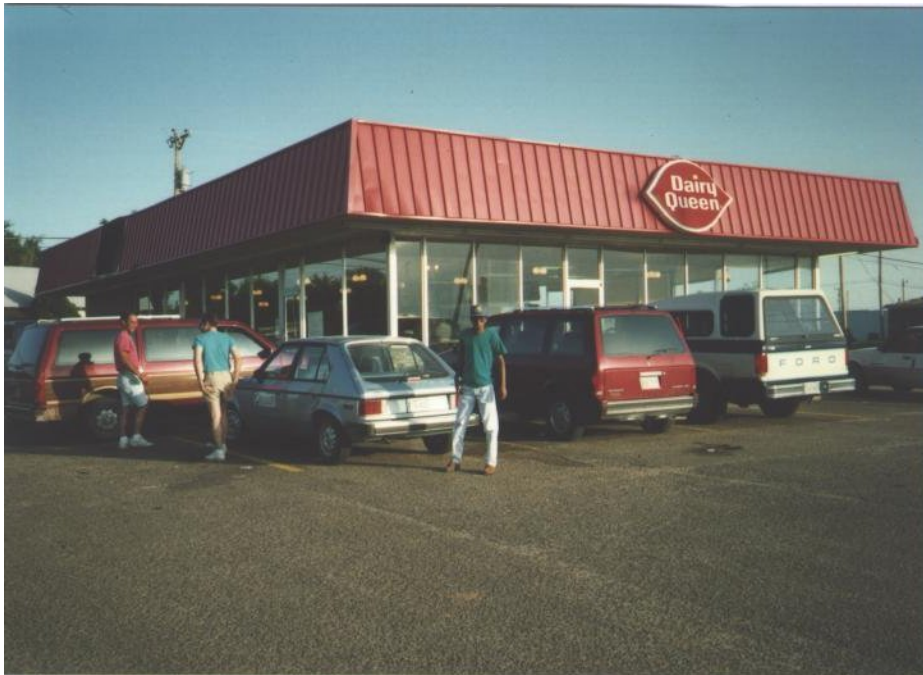
SRP: DOD 3: Broken glass in windows and doors

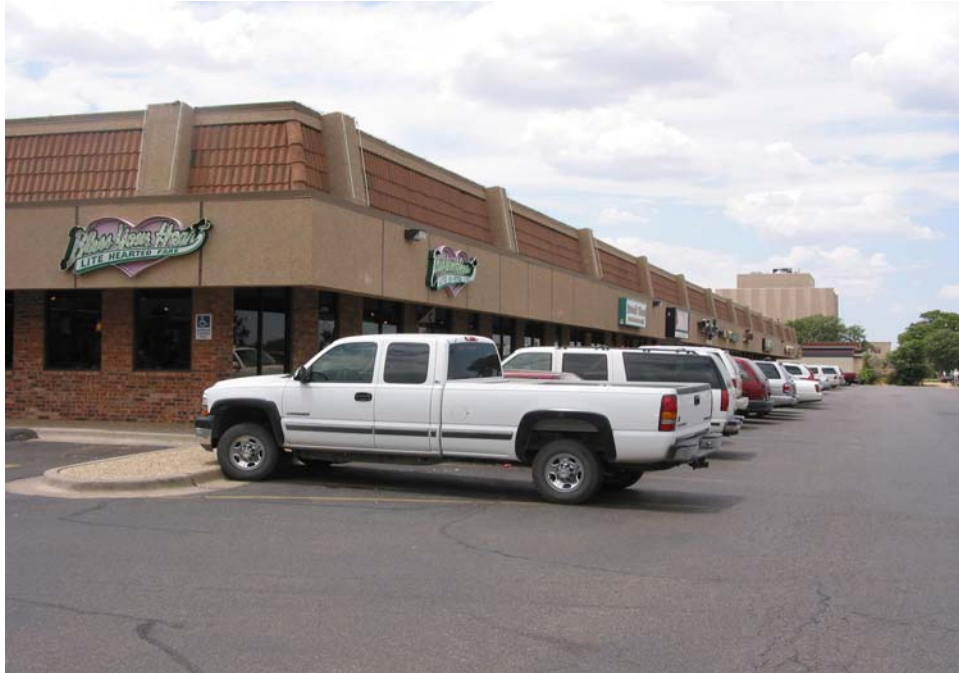
SM: Long, rectangular, single-story building; flat roof with parapet; BUR or single-ply membrane roof system with rigid insulation; wood, metal, or wood-fiber cement roof panels; concrete block walls or stud walls with brick veneer; large glass windows and glass entry doors; canopy or covered walkway attached to building

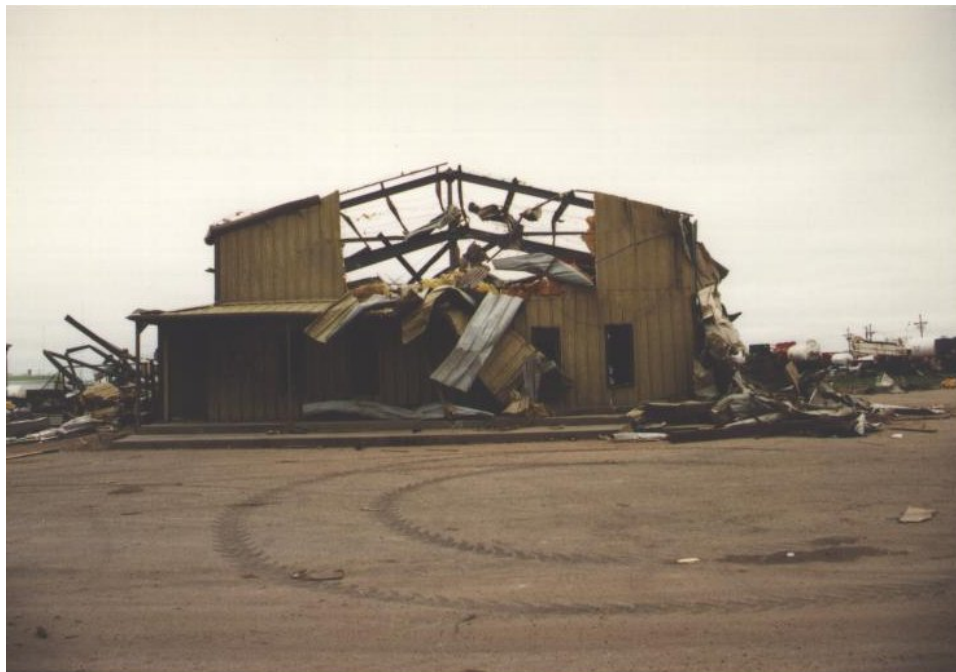
MBS: DOD 7: Collapse of rigid frames
