Newsletter of **Environmental, Disaster, and Crises Management Strategies**

Issue No. 5 | November 2017

Flash Flood in West Attica (Mandra, Nea Peramos) November 15, 2017

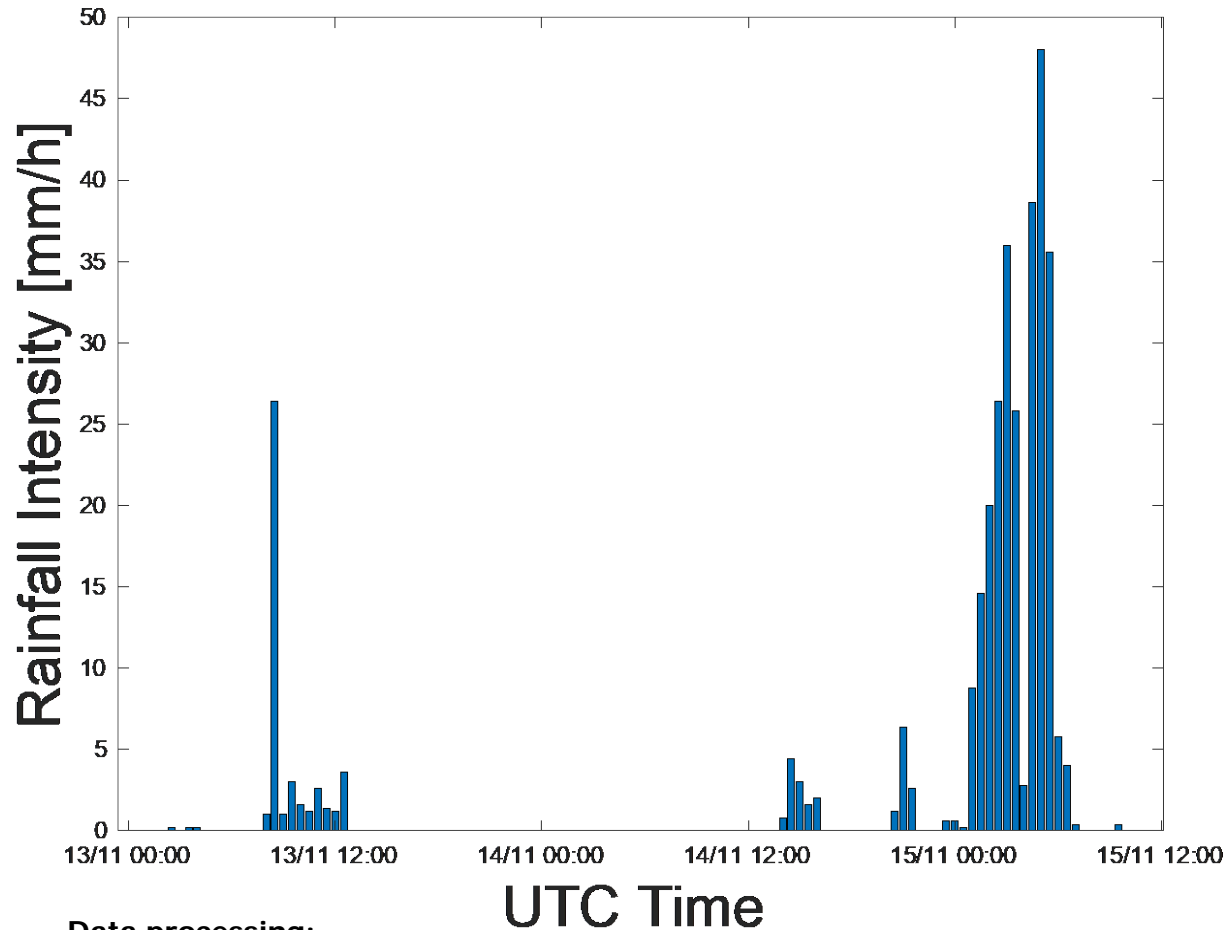
METEOROLOGICAL DATA: RAINY ASSESSMENT OF NASA SATELLITE IMAGES

The storm that caused the flash flood that hit the West. Attica was characterized by a short duration and intense locally selective intensity of precipitation. These two characteristics are typical of the storms that cause flash flood in Mediterranean. The result of rainfall calculation of IMERG (Integrated Multi-satellite Retrievals for GPM) based on NASA, has captured all the spatio-temporal features of the storm and shows its extreme event. According to these initial estimates, the upstream area of Mandra received ~ 150mm of rainfall in about 7 hours (from 00:30 to 30:30 on 15 November 2017), an amount corresponding to about 40% of its annual rainfall area.

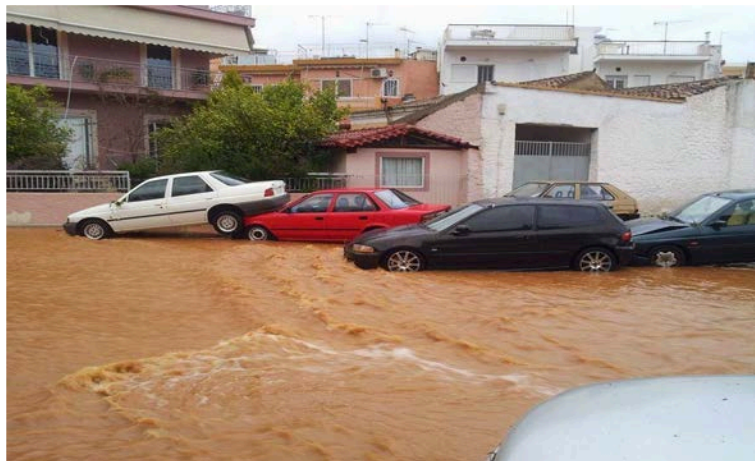
FLOOD IN MANDRA'S SETTLEMENT, 27/2/2015

Successive storms occurred in West and North West Attica. Stronger in the mountainous regions, Mount Father and Myrini. On December 27, 2015, at 20:30, they hit Mandra and caused flooding in the water basins of the area, particularly the streams flowing through the settlement. Material damage to buildings and infrastructure and materials was observed.

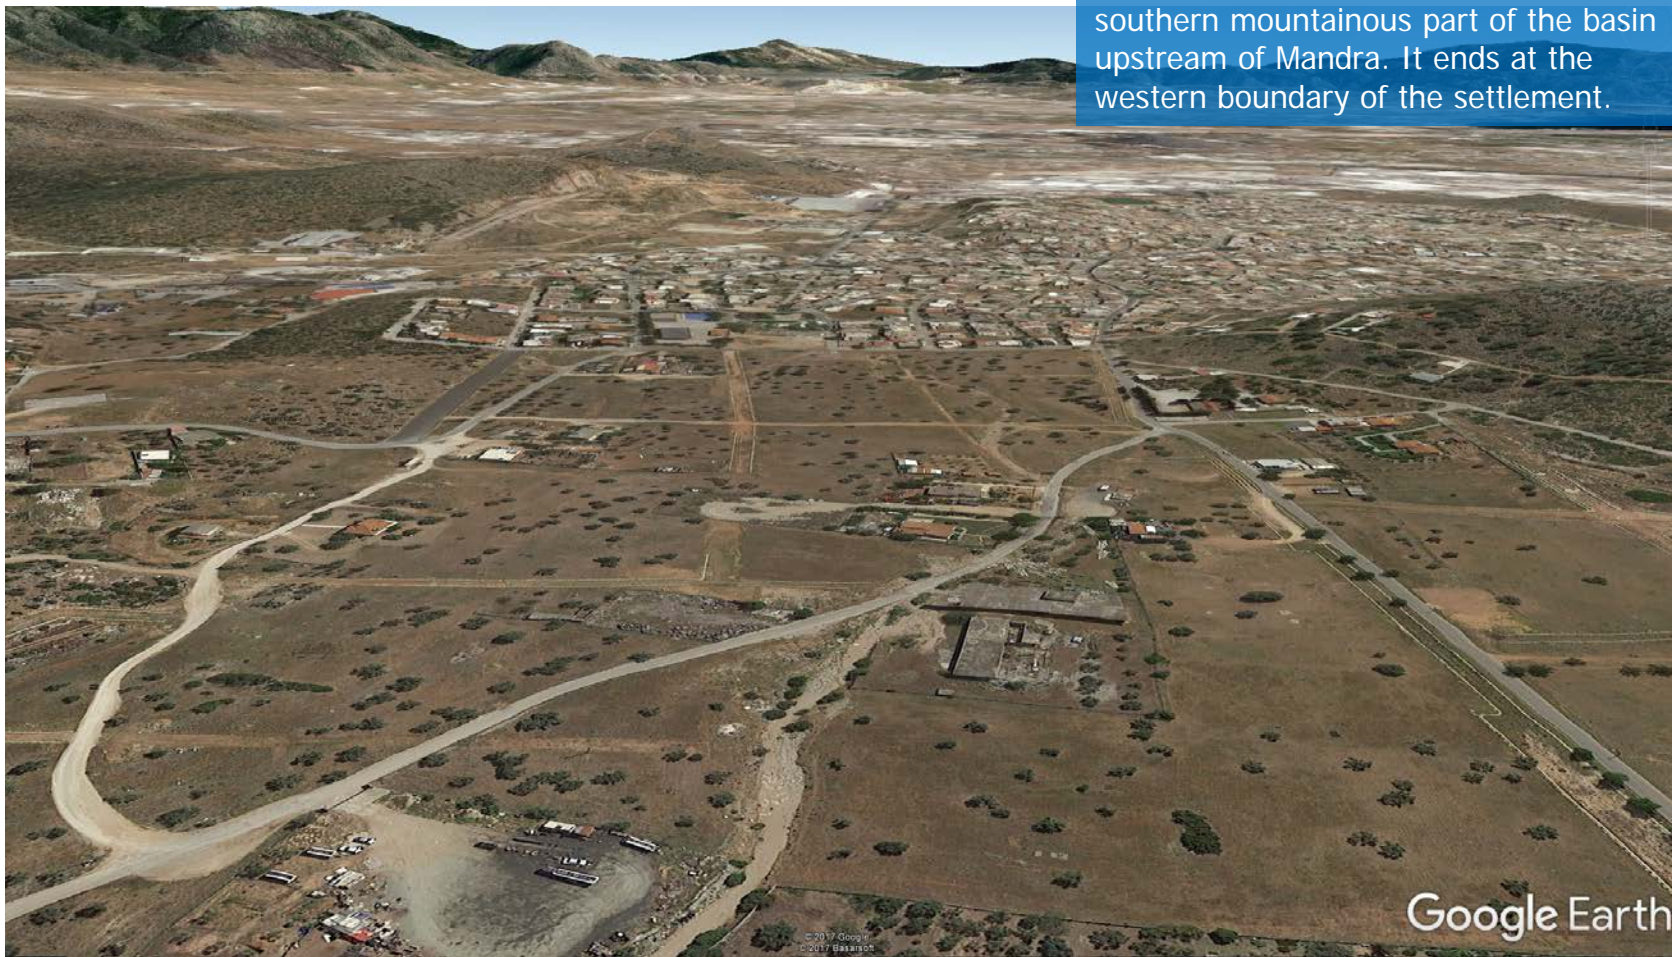
AG. AIKATERINI STREAM, UPSTREAM OF MANDRA

The stream of Ag. Aikaterini discharges the southern mountainous part of the basin upstream of Mandra. It ends at the western boundary of the settlement.

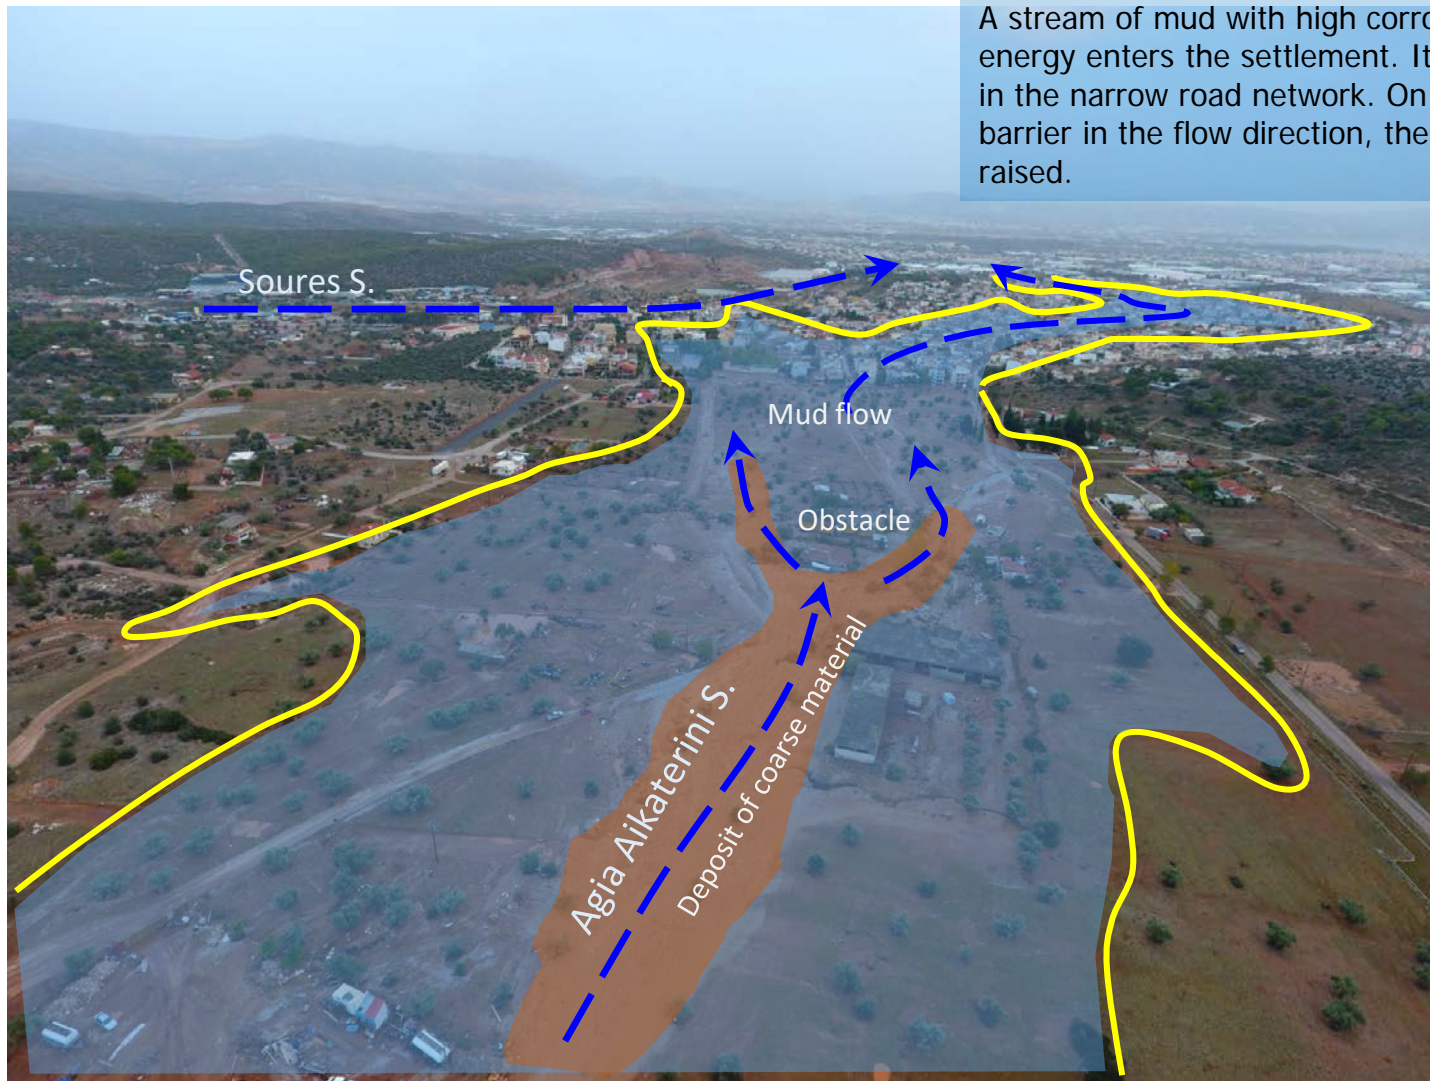
AG. AIKATERINI STREAM, UPSTREAM OF MANDRA, FLOOD FIELD, 15/11/2017

A stream of mud with high corrosive energy enters the settlement. It is caught in the narrow road network. On each barrier in the flow direction, the level is raised.

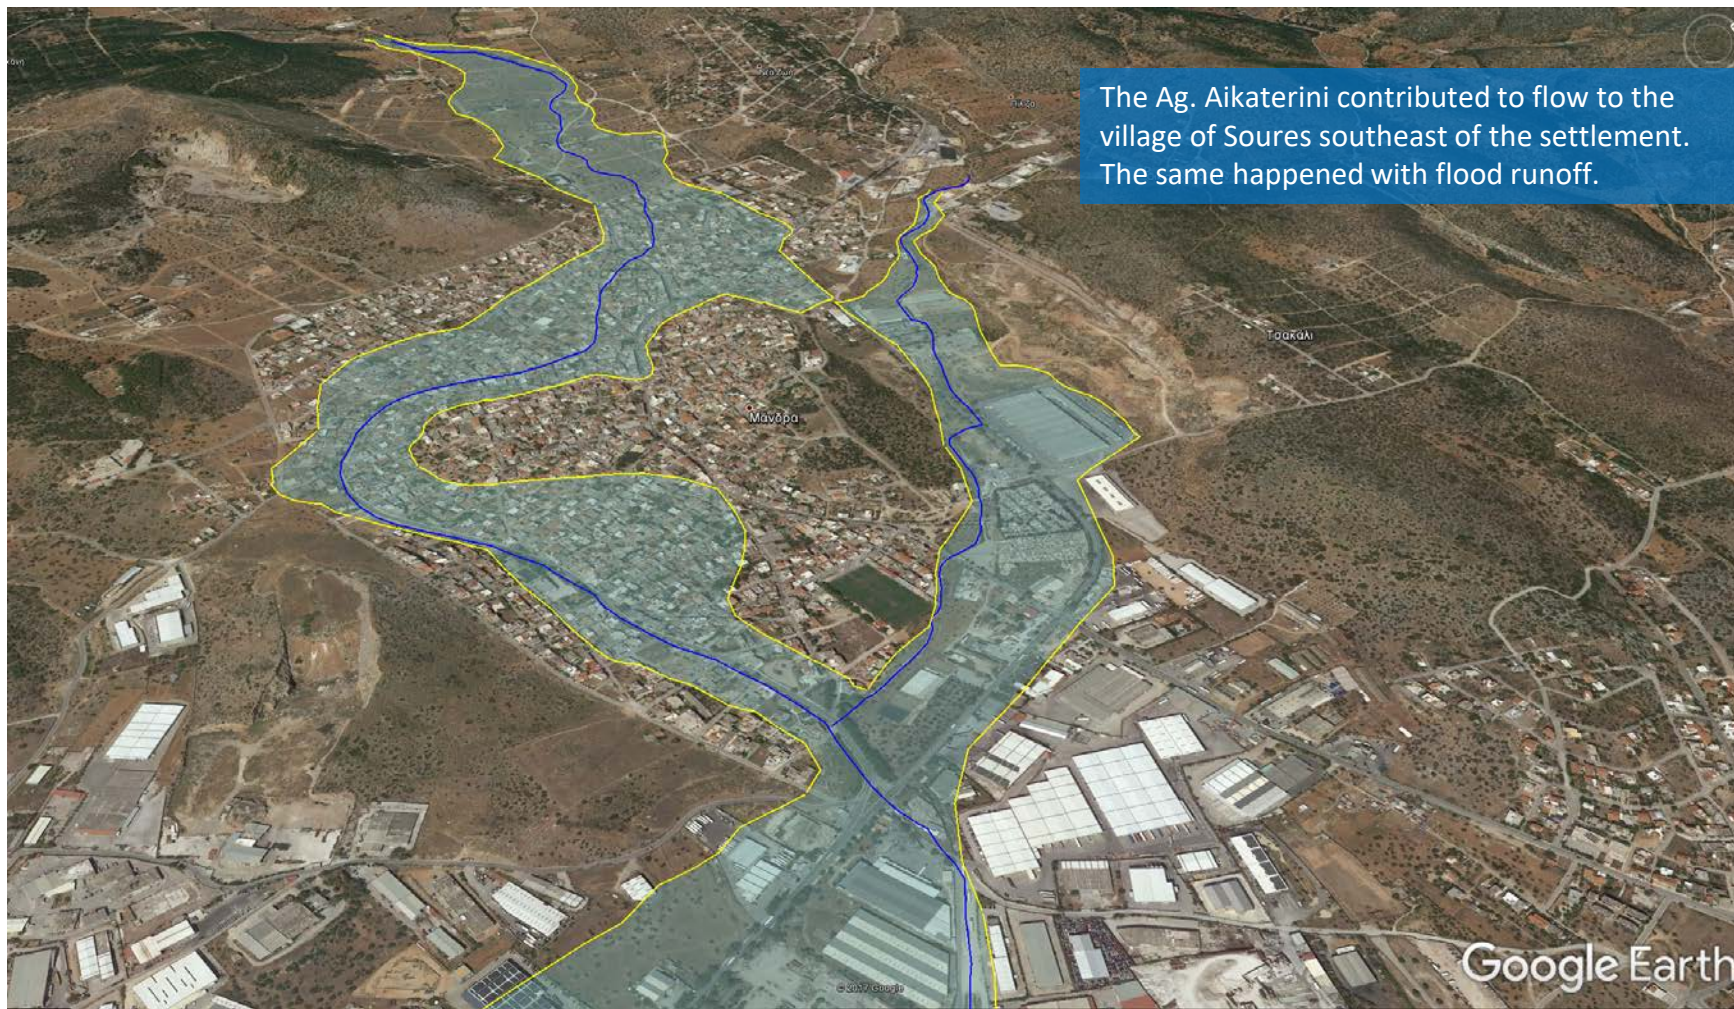
AGIA AIKATERINI, UPSTREAM OF MANDRA, 16/11/2017

The Ag. Aikaterini contributed to flow to the village of Soures southeast of the settlement. The same happened with flood runoff.

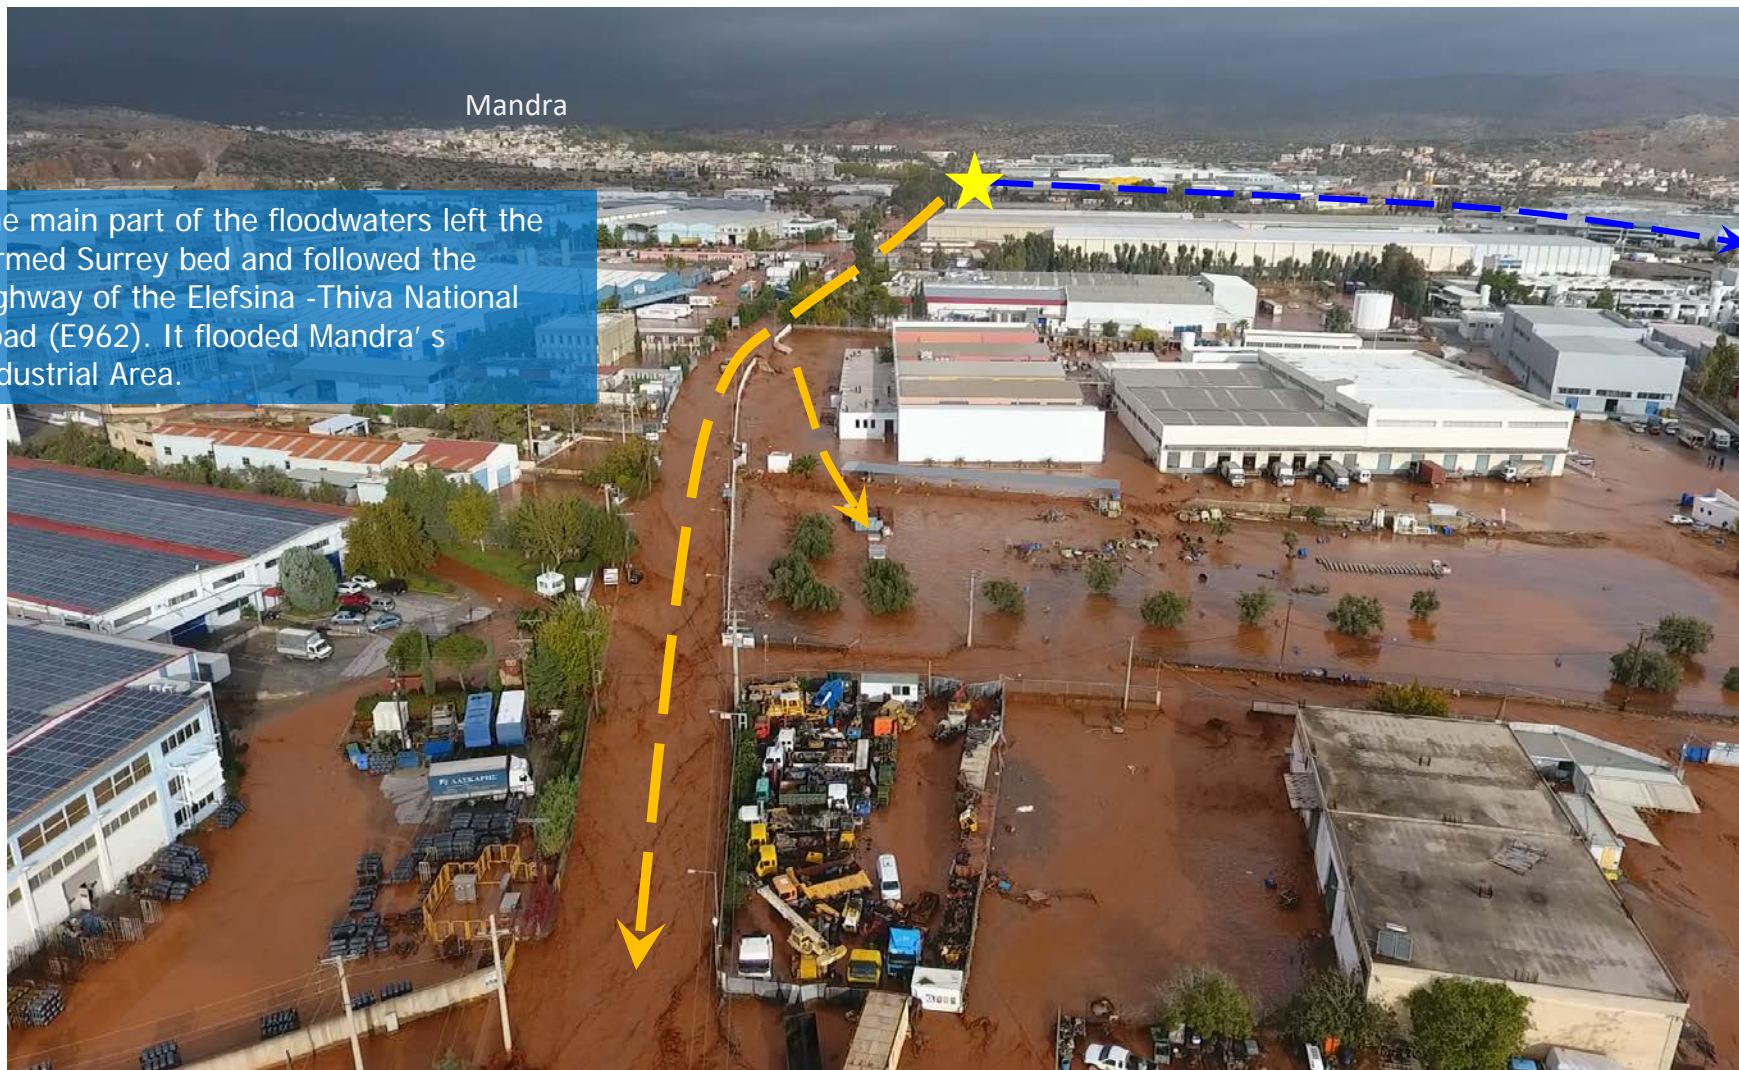
AGIA AIKATERINI, UPSTREAM OF MANDRA, 16/11/2017

The main part of the floodwaters left the formed Surrey bed and followed the highway of the Elefsina - Thiva National Road (E962). It flooded Mandra's Industrial Area.

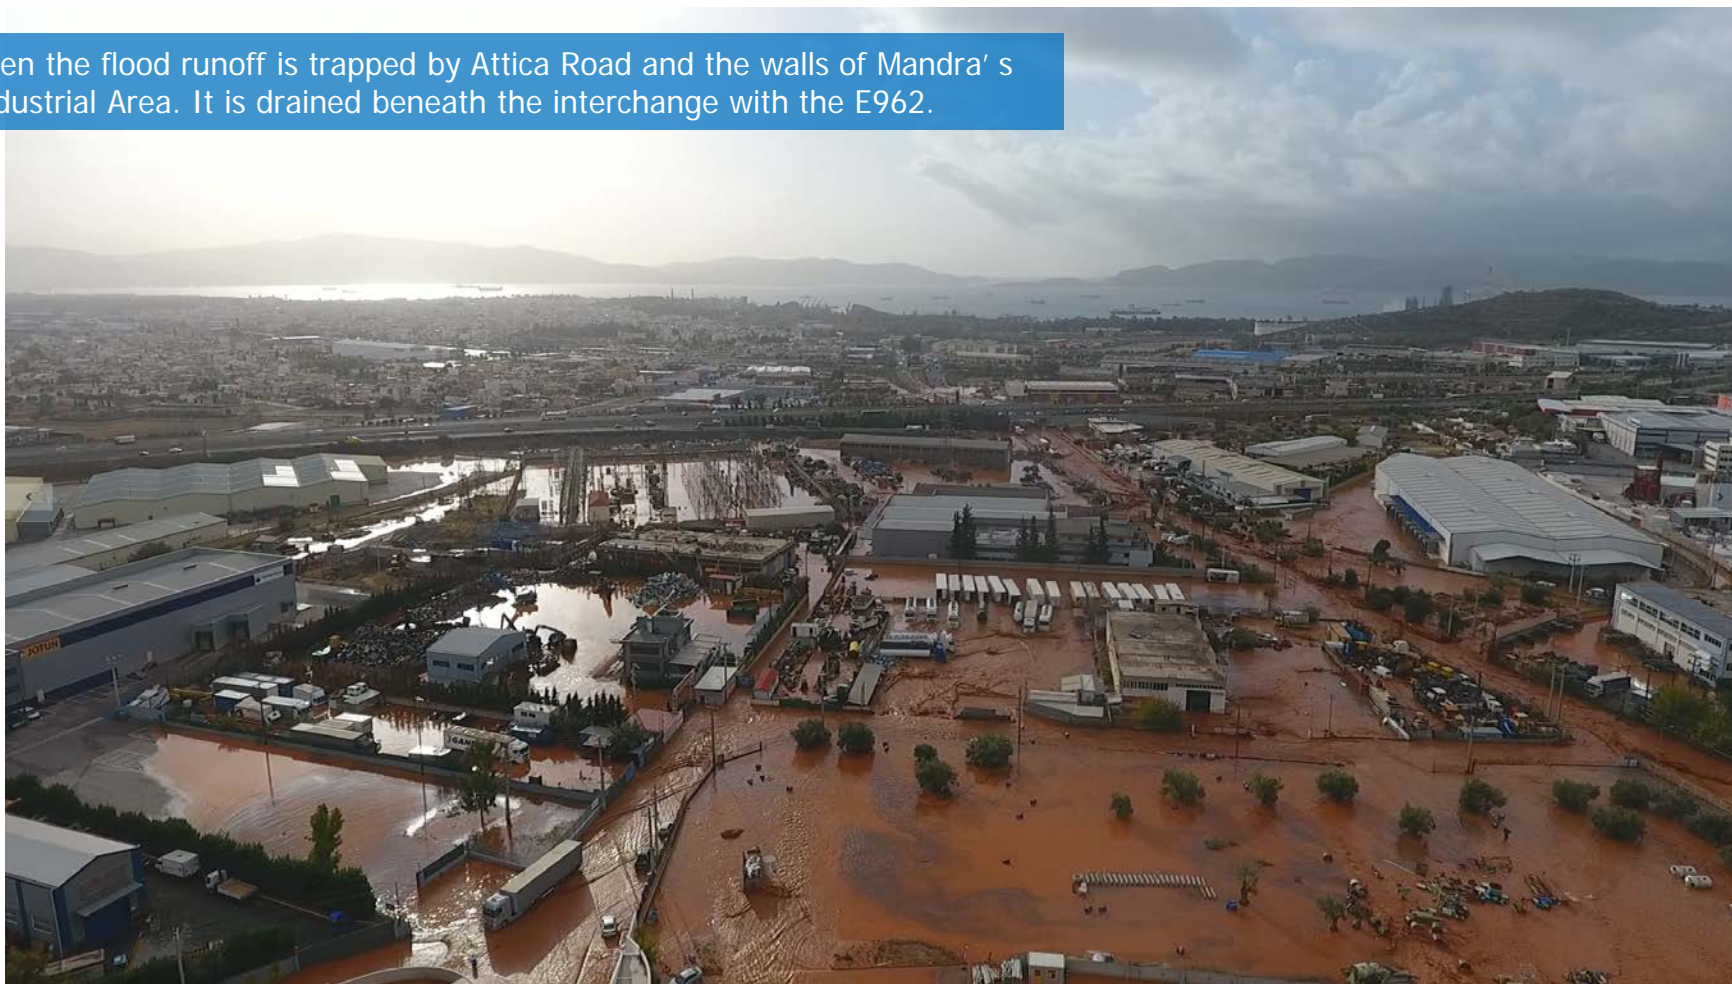
INDUSTRIAL AREA OF MANDRA AND ELEFSINA, 15/11/2017

Then the flood runoff is trapped by Attica Road and the walls of Mandra's Industrial Area. It is drained beneath the interchange with the E962.

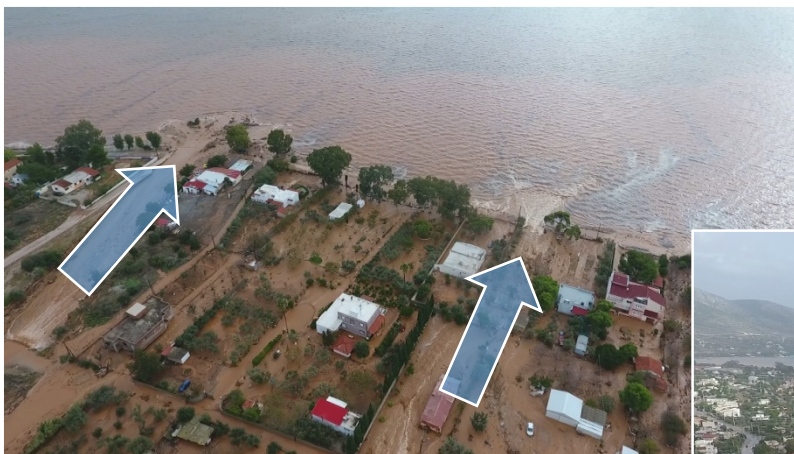
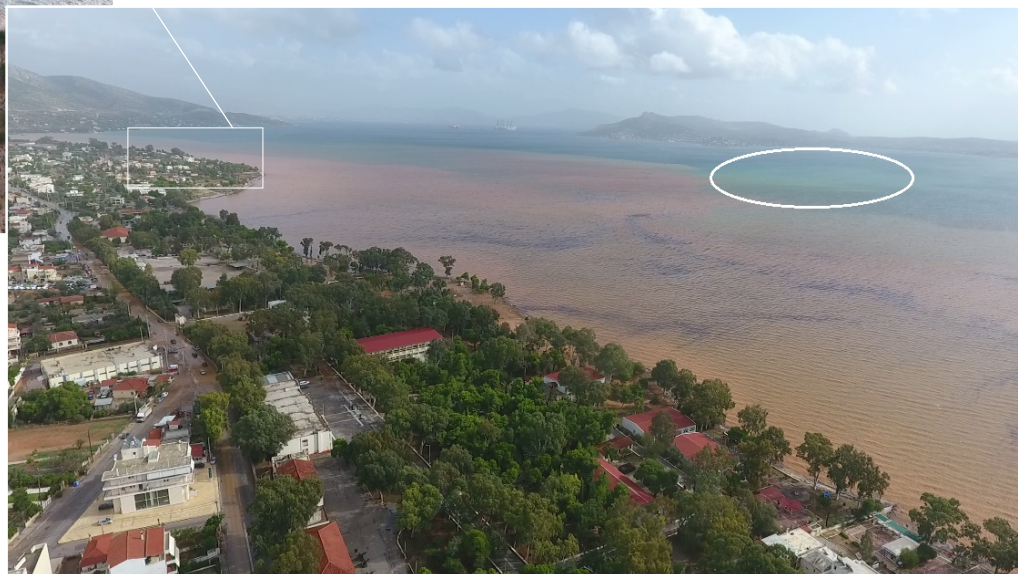
DESCRIPTION OF MATERIAL TRANSPORT METHOD AT THE SEA, COASTAL ZONE, NEA PERAMOS

At the point where the mechanism of deltaic formation of the rays develops, two points with high flow rates are observed. The consequence of these speeds is to stir the bottom material at the estuary points. The scraping of the bottom because of the large volume of mud that surrounds the coastal zone is not evident in the friction area but is noticeable at a greater distance (about one kilometer from the coast) where there is no more mud on the surface.

Two zones of material concentration in the estuary

- A. Deposits of litter and other materials along the coast.
- B. Sludge deposits on the coast and offshore turbidity

A. The construction works and large transverse structures and other structures are encased in blocked materials.

B. Excessive amounts of water and sludge overflow and form a diffuse flow that collects superficially in morphological humiliations alongside the former natural bed. They enter the city plan and flood the area.
