Tropical Cyclone Debby

Open File Report

Prepared by the South Carolina State Climatology Office

Storm History and Impacts Report

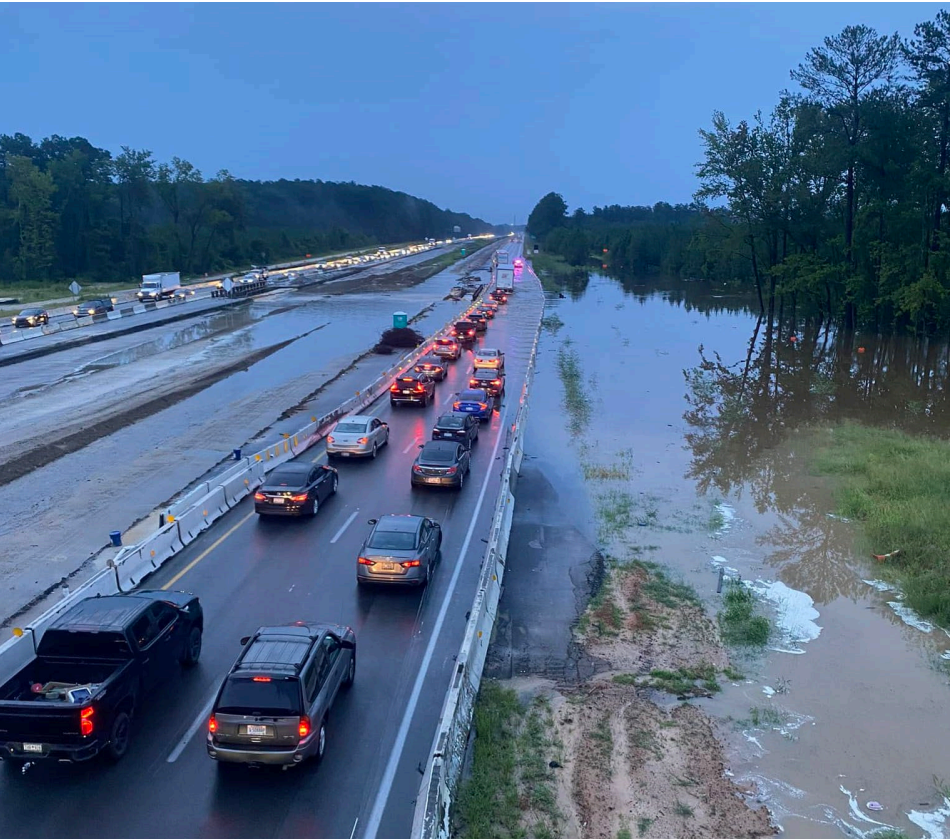
Motorists became stuck on I-26 near Ridgeville on August 8 because of flash flooding.

Heavy rain in the Lowcountry led to widespread flash flooding and numerous road closures. One example was along I-26 at mile marker 189 near Ridgeville. The interstate had to be closed in this area at around 8 a.m. on August 8 as it became impassible due to flooding. The flood waters damaged the eastbound lanes, resulted in them remaining closed for a few days while they were repaired. The detour around the closure resulted in delays of up to an hour some commuters relying on the interstate. One eastbound lane and the westbound lanes reopened on August 9 after waters receded and the other lane reopened on the morning of August 10 after the repairs were completed.

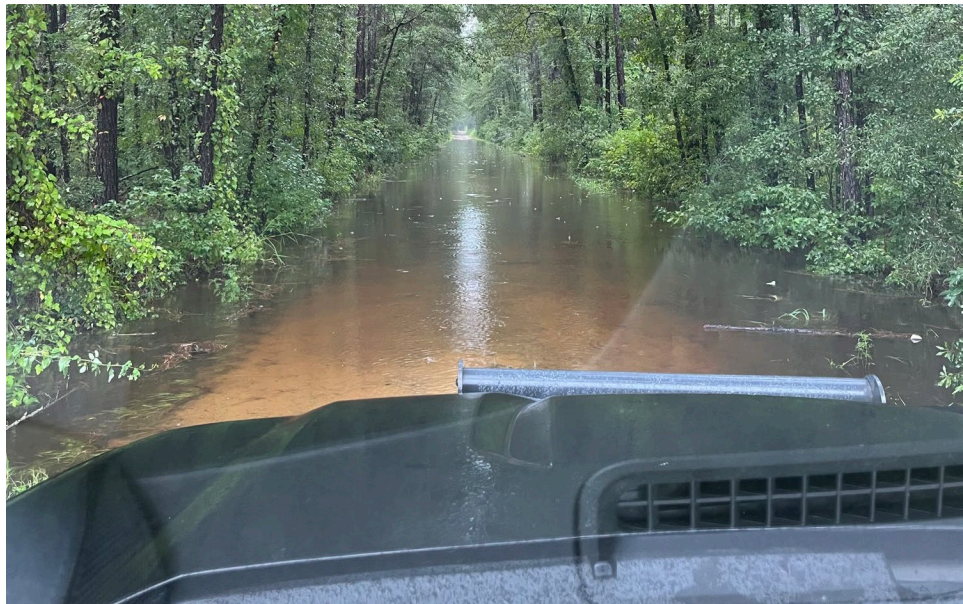
Flooding slowed access to a radio repeater in Colleton County.

Flash flooding initially prevented technicians from reaching a radio repeater facility in Jasper County on August 6. With help from SCDNR law enforcement vehicles, the technician was able to reach and perform maintenance on the equipment.

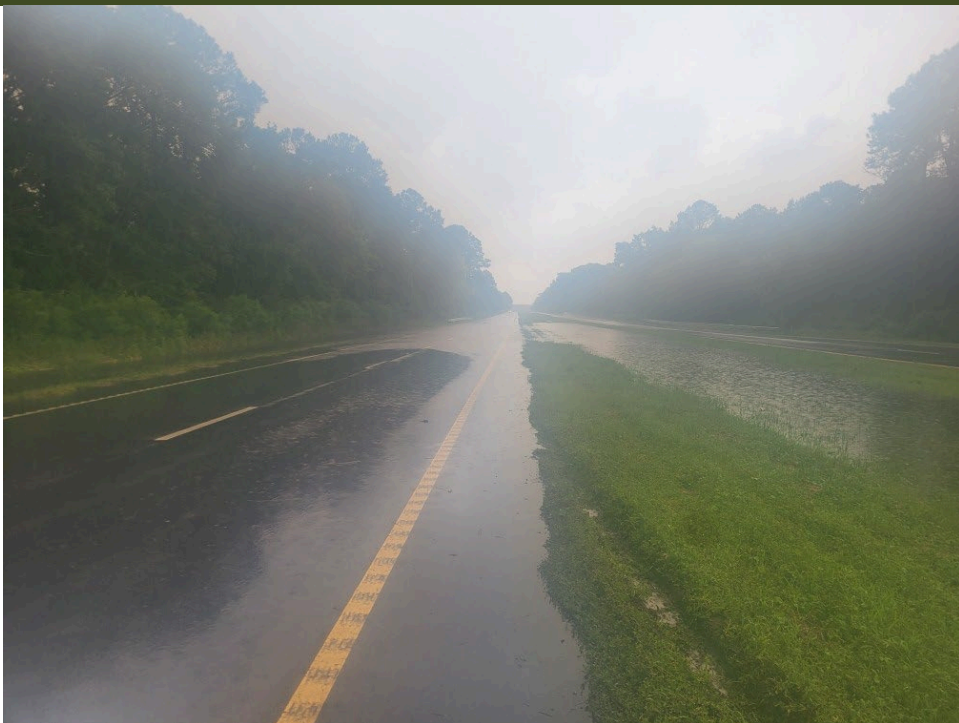
Flash flooding on August 6 along U. S. Highway 17 near Seewee Road in Awendaw led to the closure of the road for a time and detours around the flooding.

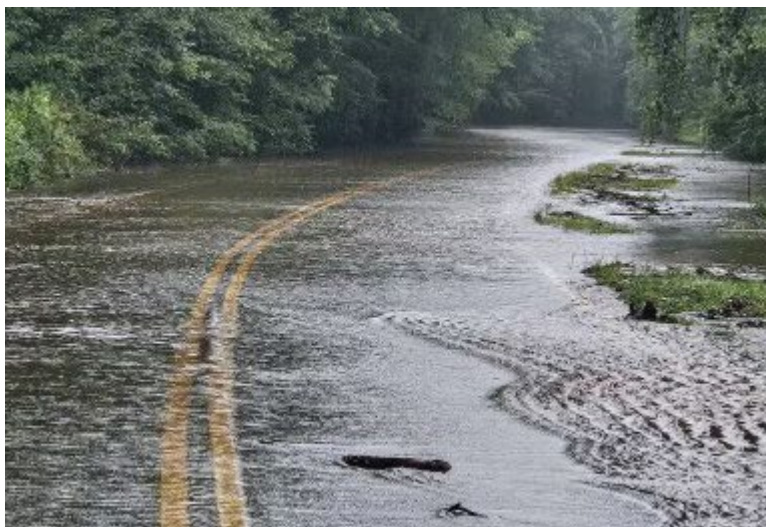
Flash flooding also occurred on Guerins Bridge Road in Awendaw, leaving it impassible on August 6.

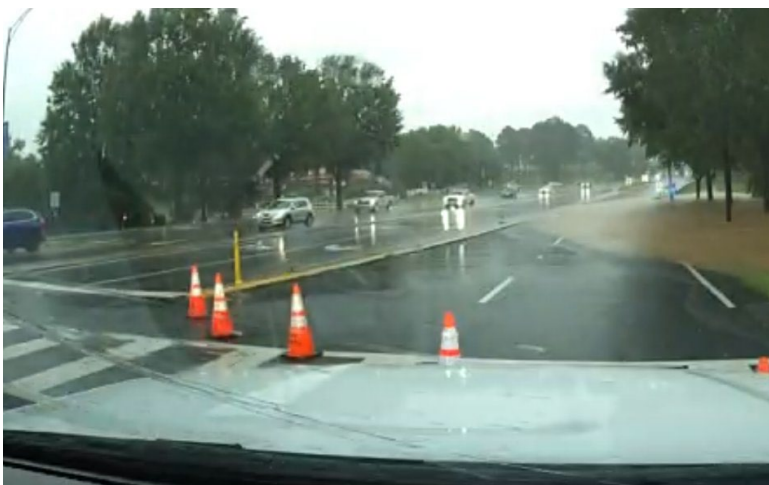
Flash flooding closed the eastbound lanes of Dave Lyle Boulevard near Chamberside Drive on the morning of August 8.

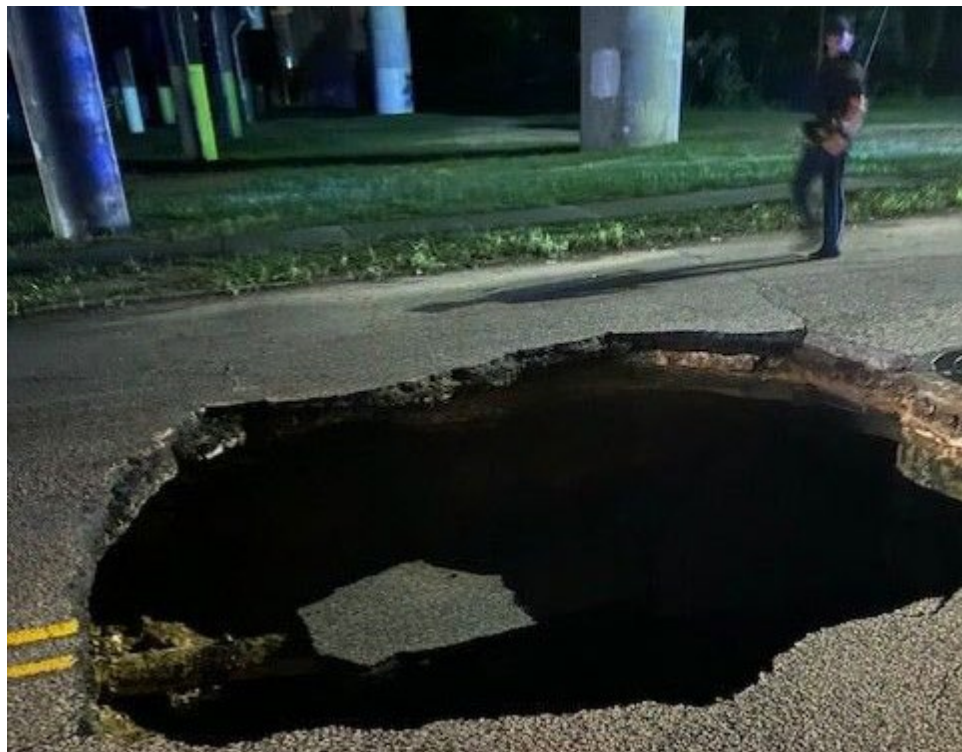
This sinkhole to form on Romney Street in Charleston on August 7. The cause was a burst pipe; it's unclear if rainfall from Debby caused the pipe to burst.

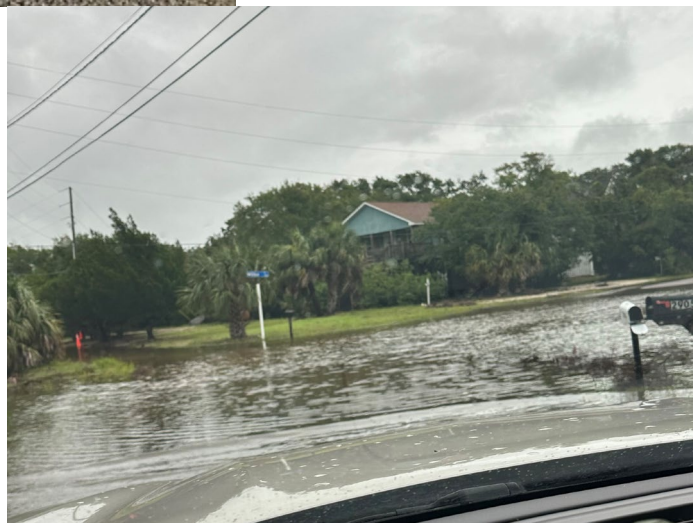
Flooding in Edisto Beach on August 6
Photo Credit: Ruben Carter, Colleton County Sheriff's Office

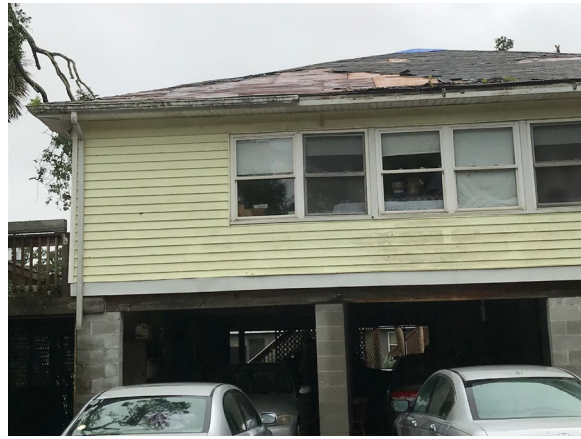
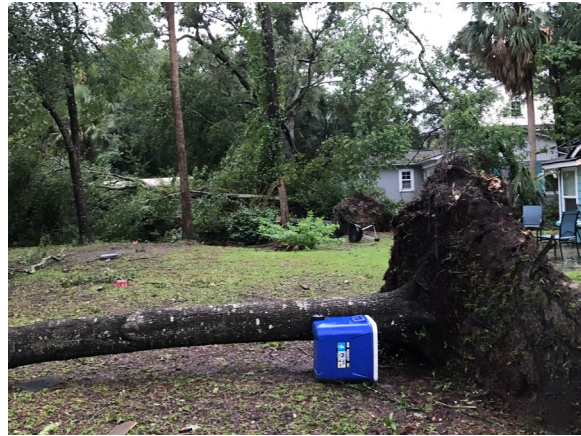
Tornado 1: Isle of Palms, Charleston County

This tornado began as a waterspout over the Atlantic that came ashore near 25th Avenue. It tracked along 25th Avenue and northwestward across Waterway Boulevard before lifting over the Intracoastal Waterway. It caused considerable tree damage along its path, with many trees uprooted or snapped. There was also minor structural damage to several homes such as stripped shingles and stripped siding, along with the front door pulled off one home.

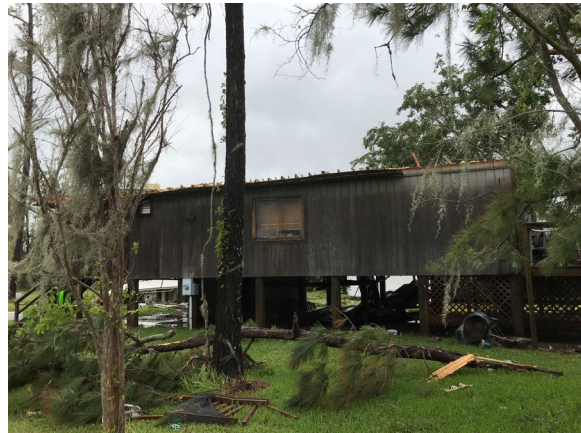
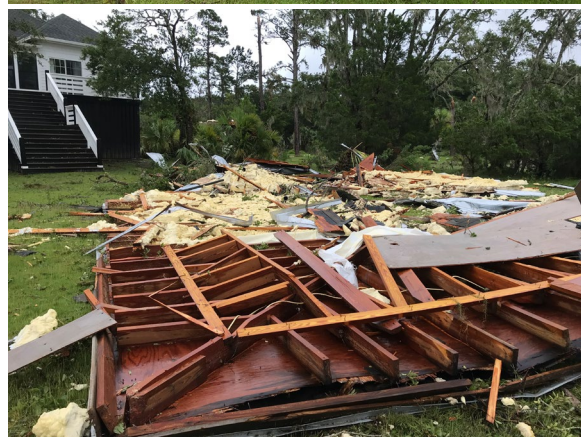
Tornado 2: Edisto Beach Area, Colleton and Charleston Counties

This tornado was a waterspout over the Atlantic Ocean that moved ashore on Edisto Island near Coral Street. It moved northwestward across Palmetto Boulevard and Jungle Road, then Palmetto Road, Palmetto Pointe Lane and Cocktail Lane. The worst damage was to homes and trees along Fishing Creek Drive.

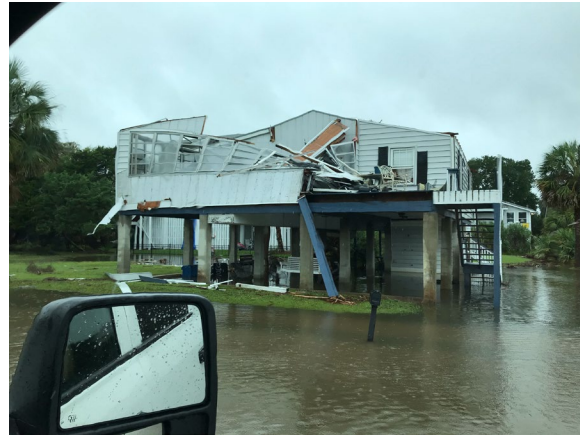
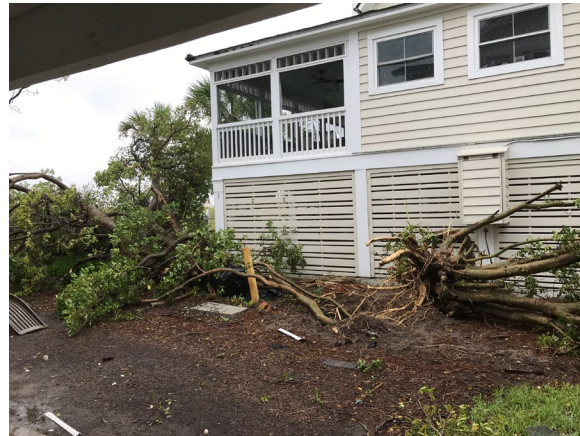
Tornado 3: Second Edisto Beach Tornado, Colleton County

This tornado began as a waterspout that came ashore near the intersection of Point Street and Laroche Street. It moved across Palmetto Boulevard, Myrtle Street, Lee Street, Neptune Street, and the southwest part of the Plantation Course at Edisto. The tornado caused damage to numerous trees and minor structural damage, including the demolition of a screened porch along Palmetto Boulevard.

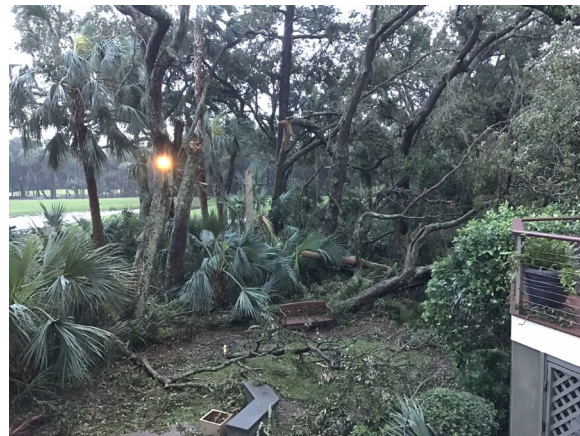
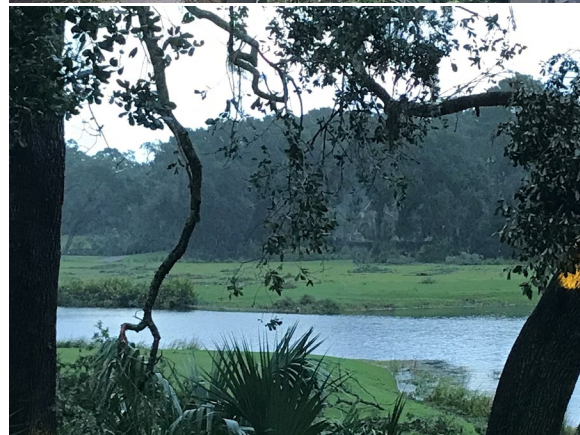
Tornado 4: Kiawah Island, Charleston County

This tornado began as a waterspout over the Atlantic Ocean and came ashore along Surfsong Road, then moved northwestward over Glen Abbey, Doral Open, Governors Drive before ending over marshland near Rhetts Bluff Road. The tornado caused no structural damage but caused some tree damage and left debris over the golf course along its path.

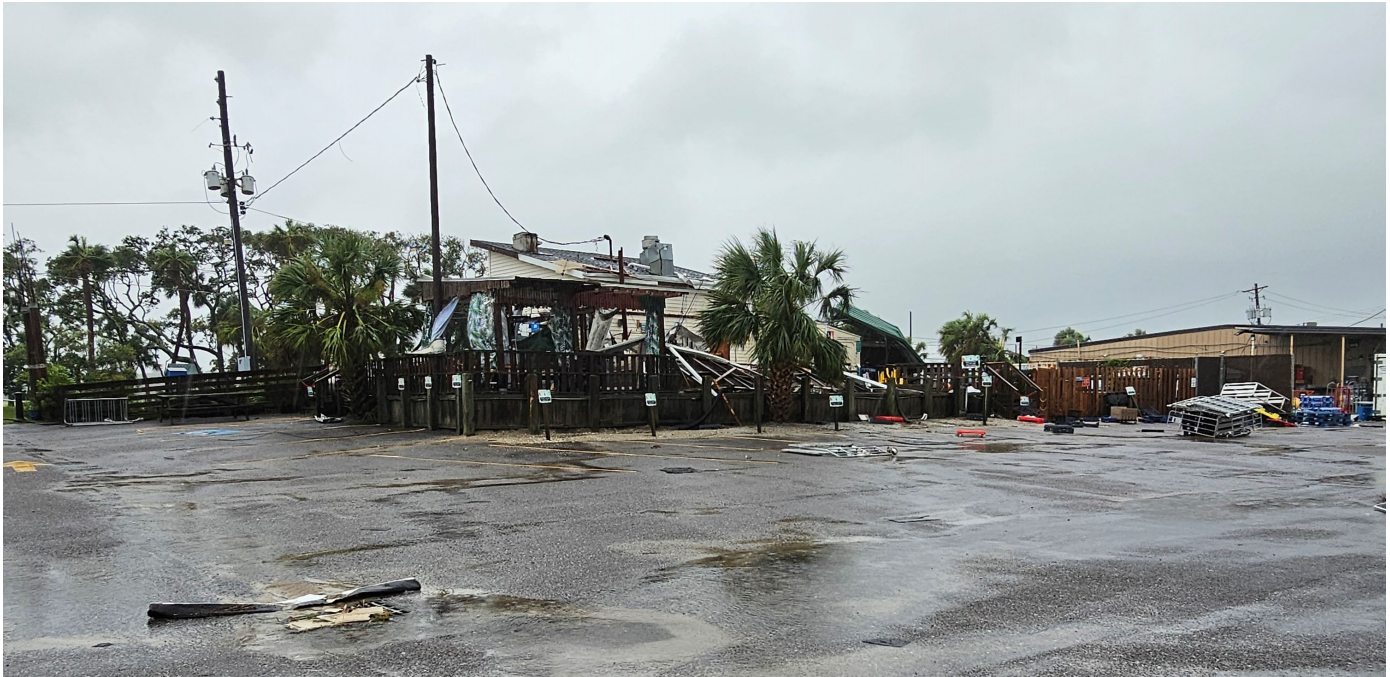
McConkey's Jungle Shack in Edisto Beach suffered major damage from the First Edisto Beach Debby Tornado. The restaurant was closed for many days after the tornado.

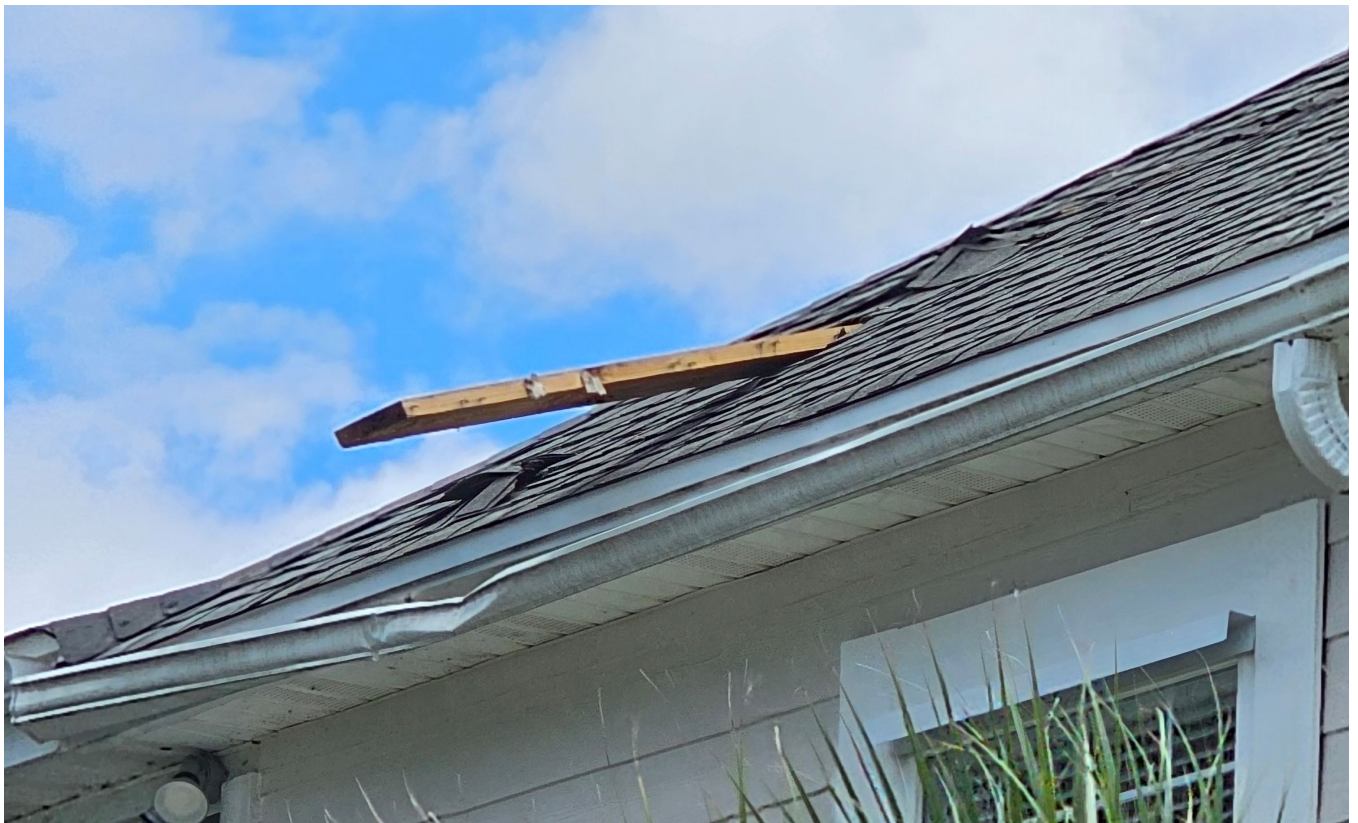
A home along Neptune Street in Edisto Beach had a board driven into its roof by the Second Edisto Beach Debby Tornado.

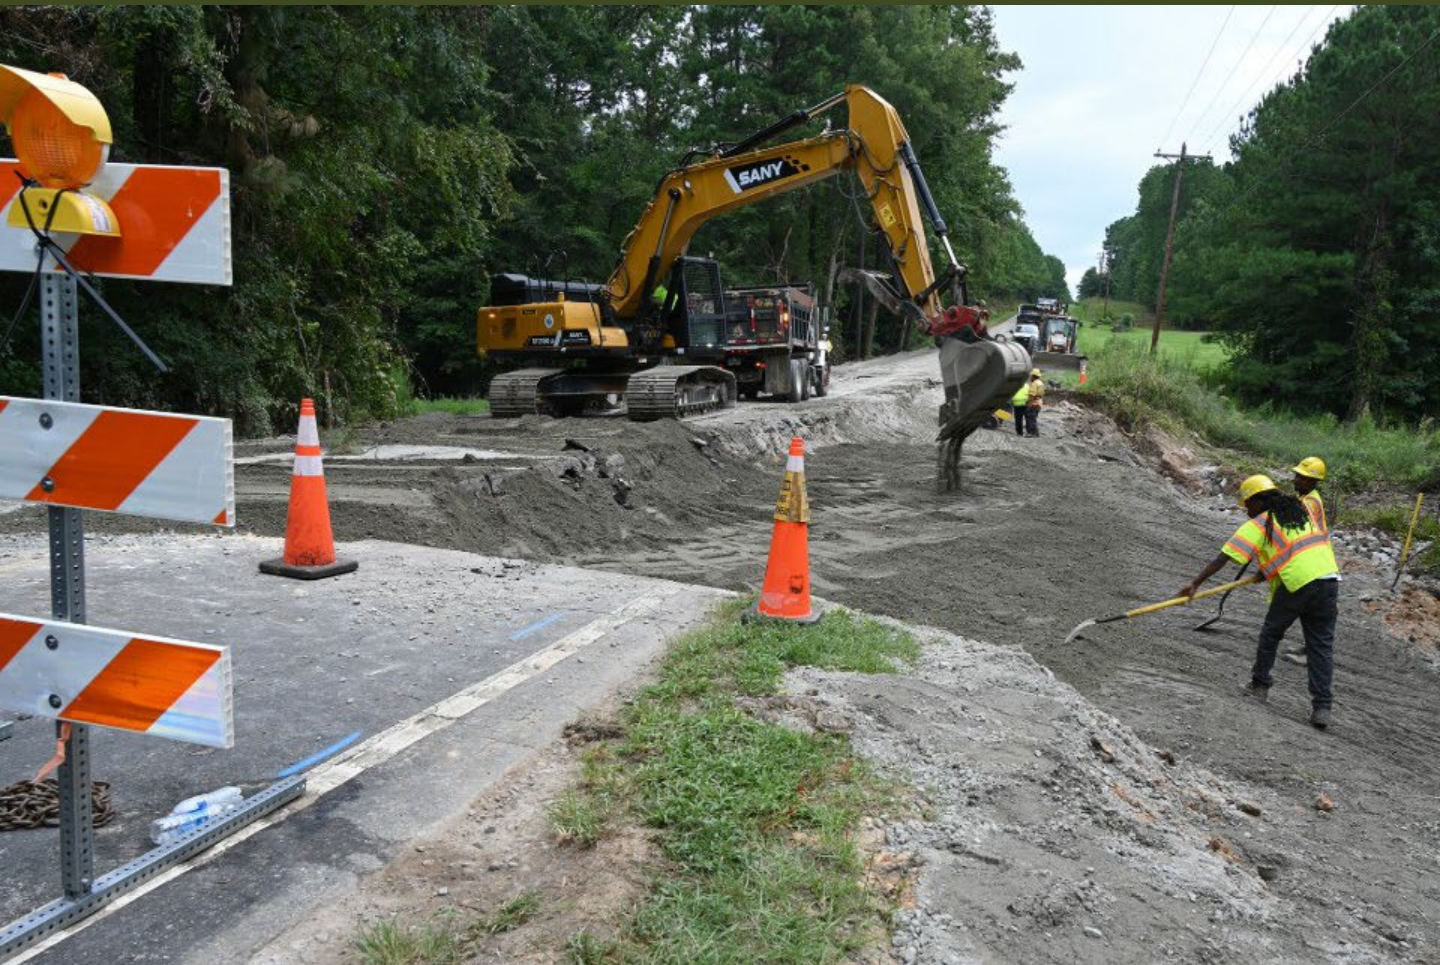
An SCDOT crew works to repair a washed-out section of Dubard Boyle Road in Richland County on August 15.
