Annual Evaluation Report for the  
Abandoned Mine Land Program

Administered by the New Mexico Mining and Minerals Division

For Evaluation Year 2019  
July 1, 2018 to June 30, 2019  
Prepared by Denver Field Division  
September, 2019

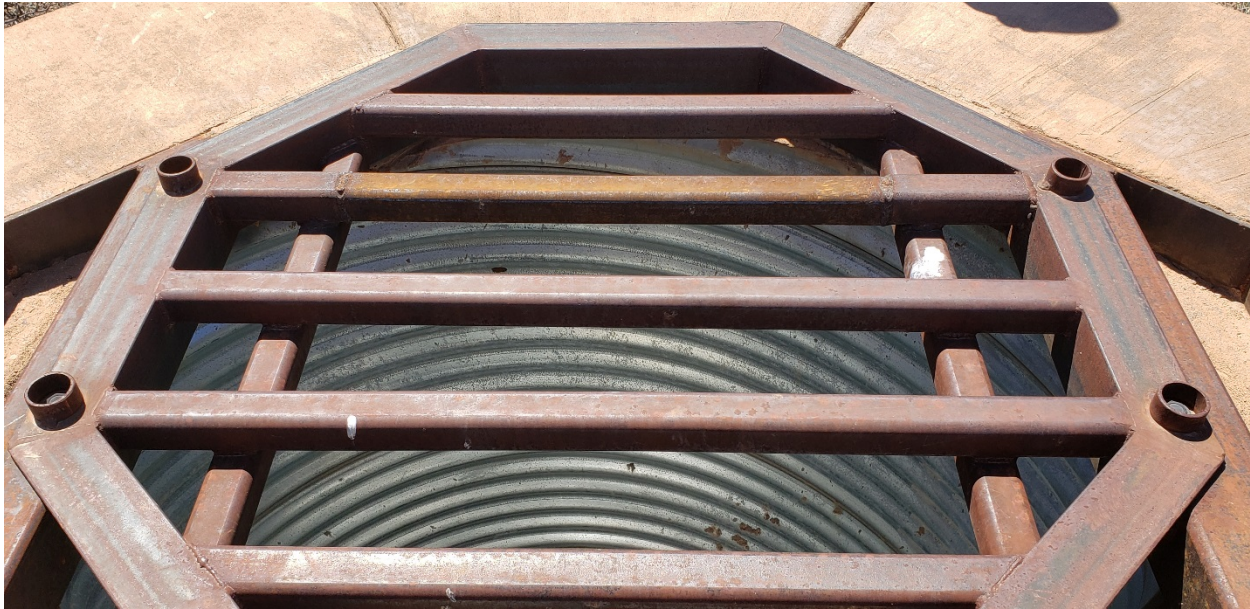
Figure 1. Lake Valley site, monument # 829-20.

Project / Site	Year Completed	Feature ID	Feature Type	Reclamation Method	Comments	
Lake Valley Phase I  eAMLIS key: NM-448	2005	<i>Stone Cabin Mine</i>				829-20: Evidence of vandalism at second cross-member from top (cutting) and subsequent repair (welding) by BLM. See Figure 1.  829-23: Bat-use evident (guano). See Figure 2.
		829-02	Shaft	PUF plug		
		829-08	Shaft	PUF plug		
		829-20	Shaft	PUF plug with bat grate and concrete collar		
		829-23	Shaft	Bat cupola with concrete collar		
		829-24	Shaft	Bat grate with concrete collar		
		<i>Coney Island Claim</i>				
		831-03	Adit decline	Backfill with imported material		
		<i>New Era Claim</i>				
		832-02	Adit	Bat gate in rock bulkhead		
		832-04	Shaft	Airflow PUF plug with concrete collar and scoria fill / berm		
		832-05	Shaft	Airflow PUF plug with concrete collar and scoria fill		
		832-06; adit	Adit	Bat gate		
		<i>Crescent Claim</i>

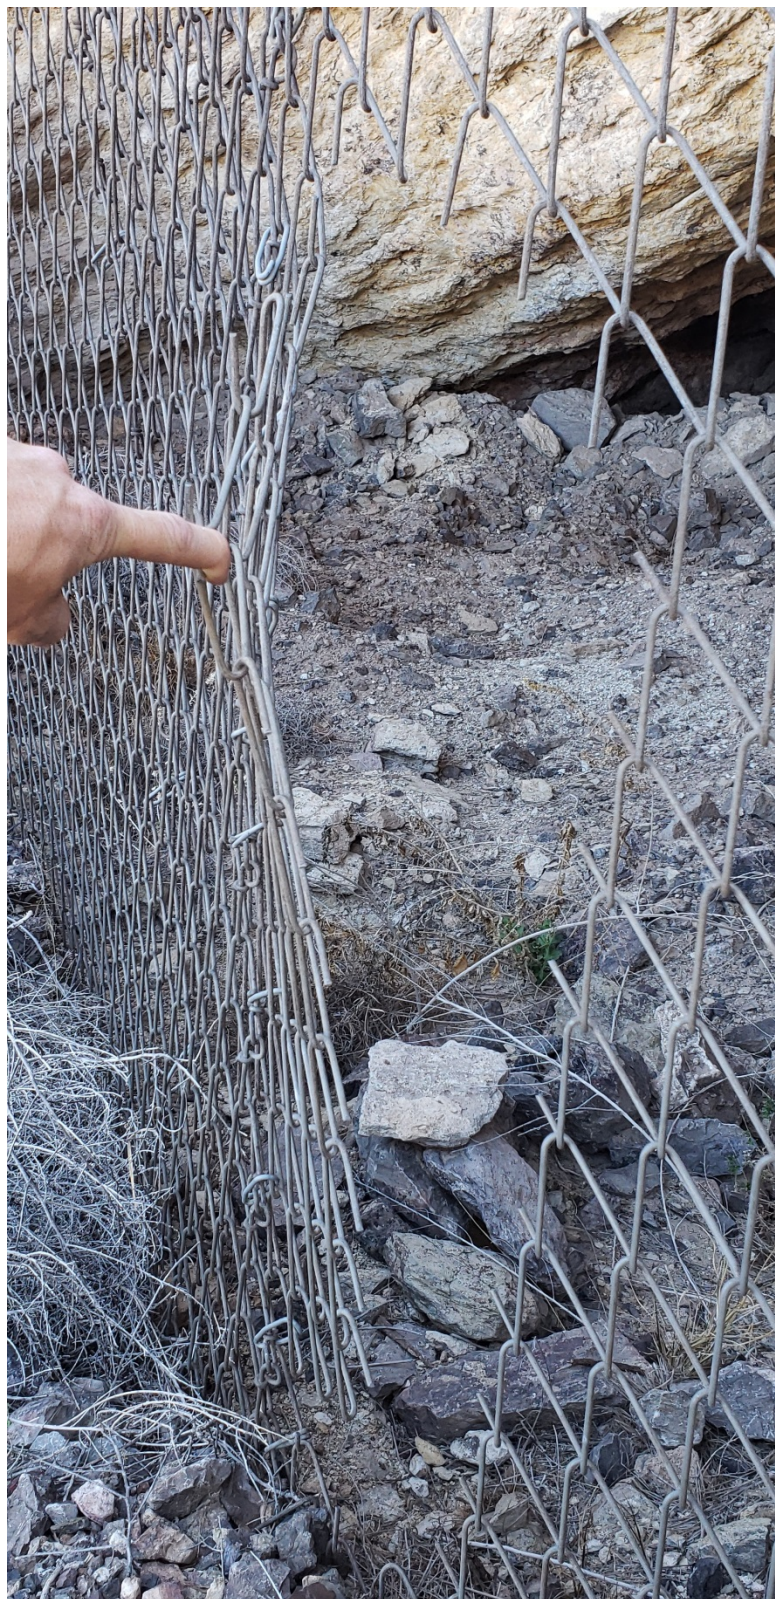
Figure 3. Lake Valley site, monument # 045-119S.

Project / Site	Year Completed	Feature ID	Feature Type	Reclamation Method	Comments	
Lake Valley Phase II eAMLIS key: NM-448	2008	<i>Carolina Lode</i>				045-119S: mesh had been vandalized (cut); in need of repair. See Figure 3.
		045-003T	Stope opening	CSP plug		
		045-004T	Stope opening	CSP bat gate with toroid tire plug and backfill		
		045-005Ta	Adit	Toroid tire plug		
		045-005Tb	Shaft	Bat compatible CSP riser with toroid tire plug		
		045-026T	Adit	CSP bat gate, backfill		
		045-118S	Shaft	CSP riser in PUF with bat grate		
		045-119S	Stope opening	80k-psi, high strength steel mesh

As is typical with evaluations of long-term reclamation success, some maintenance will be required to ensure continued protection of the public. At the Lake Valley site, Carolina Lode and

North Carolina Lode, mesh netting has been cut at features 045-119S and 046-028S, respectively. Feature AML-6 at the Spar Group site should be evaluated for minor subsidence and the presence of rattlesnakes. At the Sugarite and Yankee Vukonich sites, abandoned plant protector tubes and wooden stakes should be collected to show off the successful gob stabilization in a more natural light.

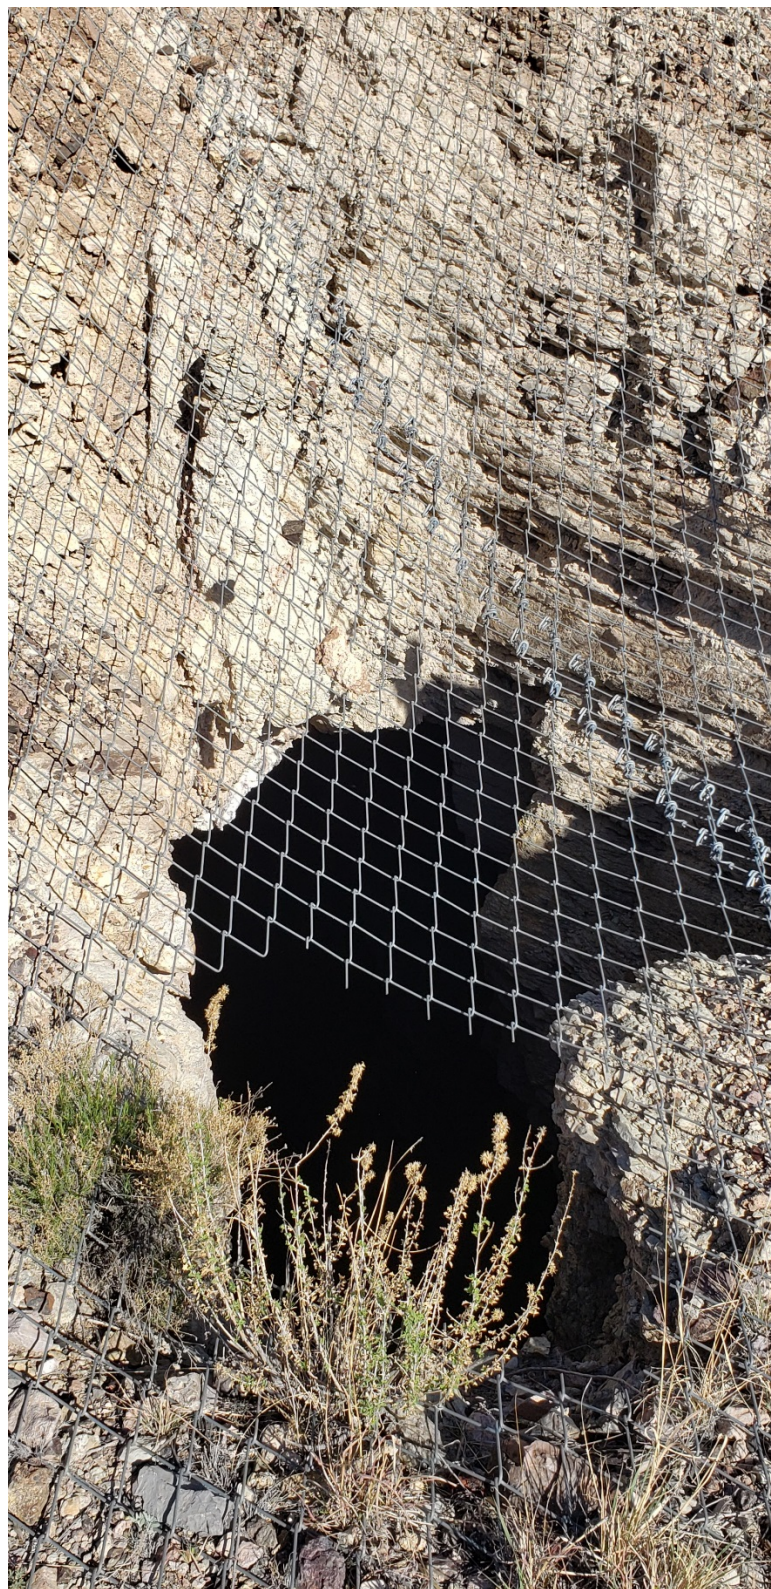
Figure 4. Lake Valley site, monument # 046-028S.

045-120Sb	Stope opening	Toroid tire plug with backfill and boulder barrier	
<i>North Carolina Lode</i>					
		046-007T	Adit	CSP	046-028S: steel mesh had been vandalized (cut); in need of repair. See Figure 4.
		046-028S	Shaft	80k-psi, high strength steel mesh	
		046-115S	Shaft	Bat cupola with PUF plug, CSP riser, and scoria fill	
		046-124S	Stope opening	Toroid tire plug	
		046-133S	Shaft	Bat grate with PUF plug and rock fill	
<i>Roberts Shaft</i>					
		045-122S	Shaft	Bat cupola with concrete footing	
		045-132S	Decline adit / stope opening	Toroid tire plug, bat gate in CSP with PUF plug, and backfill

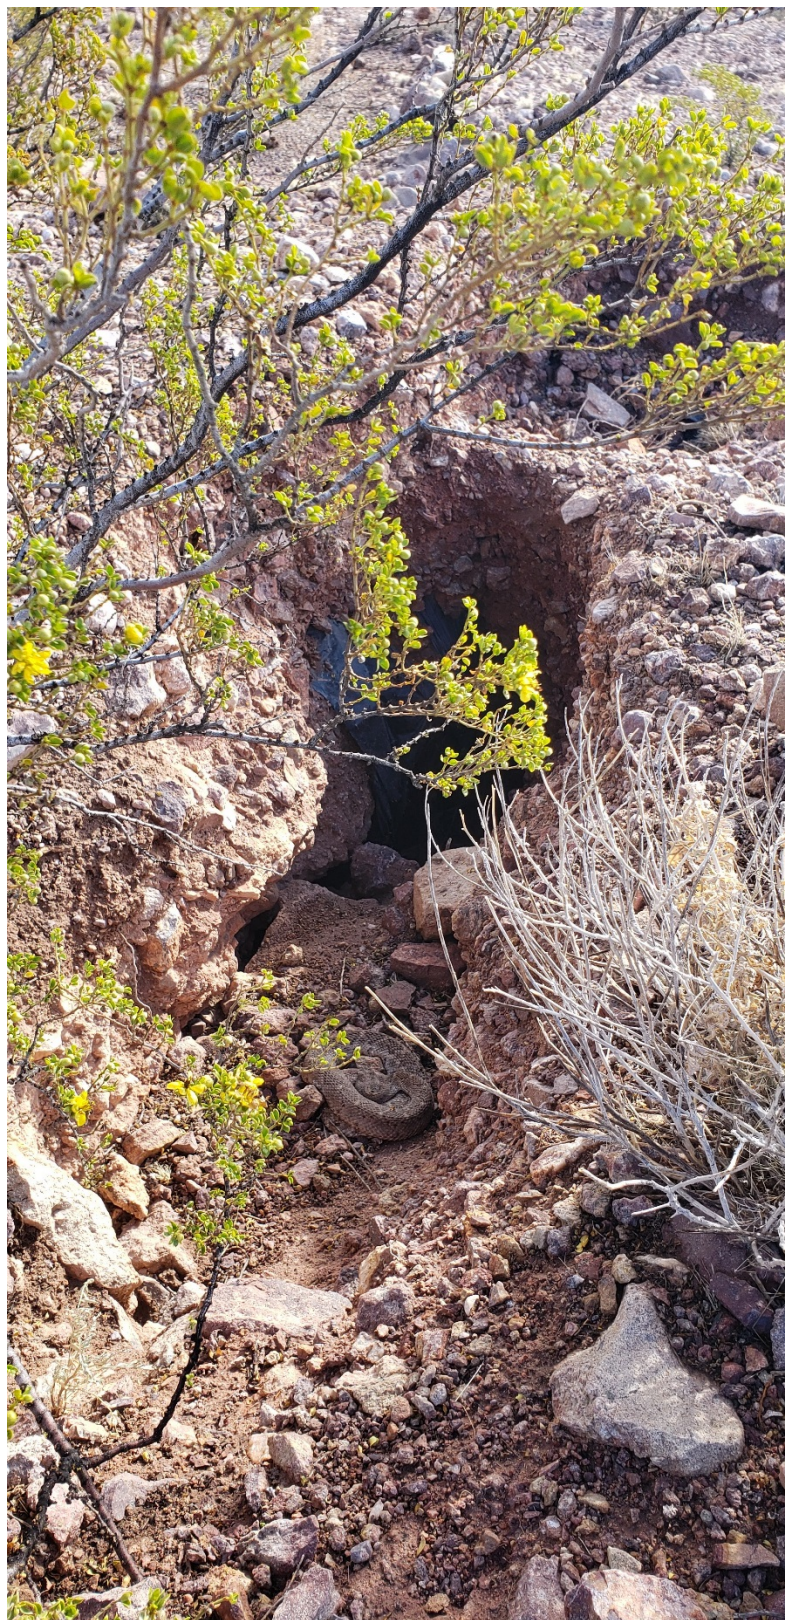
Figure 5. Spar Group site, monument # AML-6.

Project / Site	Year Completed	Feature ID	Feature Type	Reclamation Method	Comments
Spar Group  eAMLIS key: NM-247	2004	AML-1	Stope opening	Backfill	AML-6: backfill had subsided slightly but rattlesnake prohibited closer inspection. See Figure 5.  AML-7: See Figure 6.  AML-9: fresh bat guano and owl pellets observed.  AML-13 and AML-21: surface pocks aiding in stabilization and revegetation.
		AML-6	Stope opening	Backfill	
		AML-7	Shaft	Bat cupola with owl perches	
		AML-8	Shaft	Bat cupola	
		AML-9	Shaft	Bat cupola	
		AML-10	Shaft	Bat cupola	
		AML-13	Shaft	Backfill	
		AML-14	Shaft	Backfill	
		AML-17	Shaft	Bat cupola	
AML-21	Stope opening	Backfill

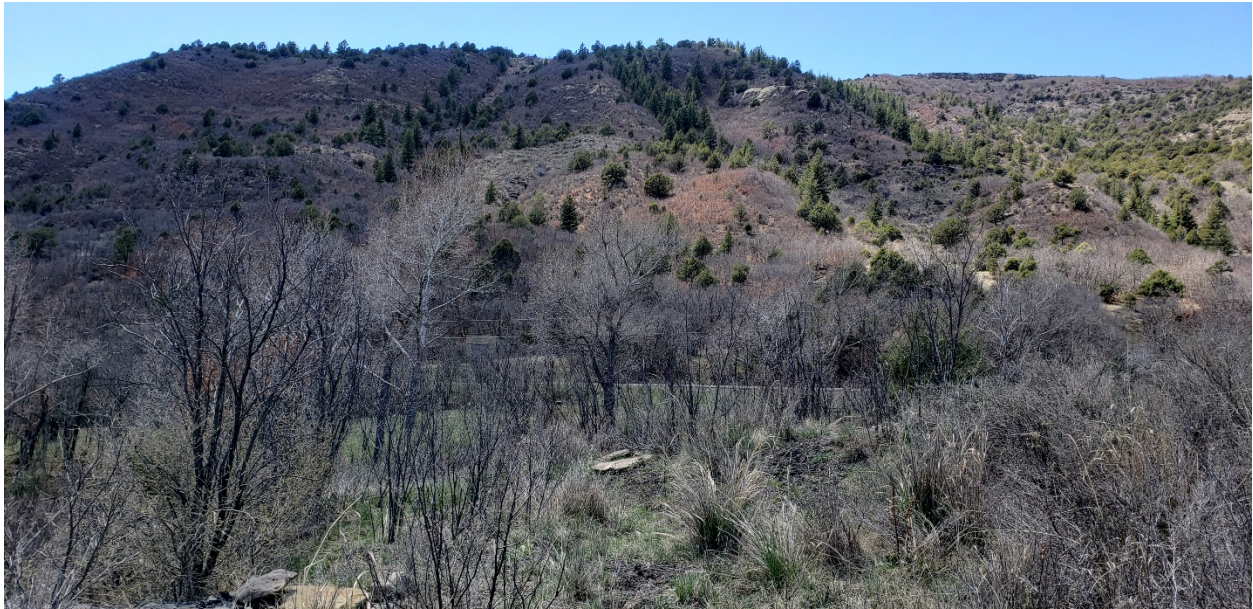
Figure 7. Sugarite site, reclaimed coal waste piles A1 and A4.

For this inspection we observed reclaimed gob piles A-2 and A-7 on the east side of Sugarite Canyon, completed during Phase III, and piles A-4 and A-1 on the west side of Sugarite Canyon, completed during Phase IV. AMLP staff explained the numerous reclamation techniques deployed, including extensive soil amending; staked, incised straw bale terracing; hydromulching; coir roll terracing; gully branch-packing; rock-gabion armoring; and revegetation.

In the revegetated areas we observed well established juniper, Woods' rose, fourwing saltbush, Gambel oak, and locust. To counteract the sodic gob, daichon radish were planted as a nitrogen fixer, while New Mexico locust is well adapted to saline soils. Several Team members did note a bit of plastic coir roll and straw wattle plastic mesh, as well as cardboard seedling protectors, straw bales, wattles, and wooden stakes that had failed to decompose over time, even though Sugarite Canyon is situated in the wettest region of New Mexico. According to the construction specifications, "protection tubes . . . shall be rated to photodegrade in two years, plus or minus six months." Similar language was not found for the wattle and coir roll specifications, but clearly the photodegradation process was not yet complete. AMLP staff indicated their disappointment with the particular product used at this site for that reason. Despite having been completed four years apart, both sets of reclaimed piles appeared similar in their stability, vegetative maturity, and blending into the undisturbed surroundings of Rocky Mountain juniper, Gambel oak, and mountain mahogany. Importantly, at the time of evaluation Chicorica Creek was running clear with early snowmelt and no evidence of coal gob. Overall, we found this reclamation to be successful on a long-term basis. See Figures 7 and 8.

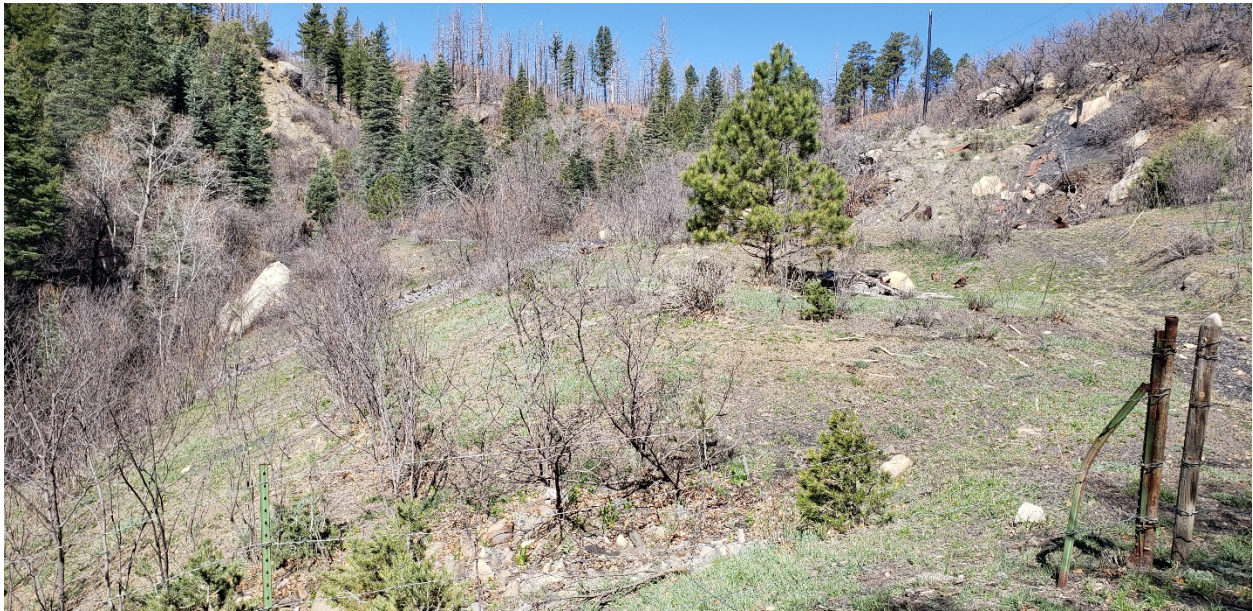
Figure 9. Yankee Vukonich project, gob site D.

We evaluated a sample of the sites that comprise the Yankee Vukonich project, on both state and private property. At gob site D, located on state land, we observed waste piles that had been stabilized and regraded to approximate the contours of surrounding topography, mature locust plantings, and historic resource avoidance areas. We also evaluated two riprap drainage channels that were constructed as part of the original project. Both were stable at the time of evaluation, and the creek to which they report was running clear, but AMLP staff pointed out one of the rock rundowns required reconstruction due to the failure of its geotextile fabric base. AMLP staff indicated the geotextile fabric has failed in its design-function as a drainage channel base layer on other projects as well, and that they’ve discontinued using it in that application. As at the Sugarite Canyon site, we observed plastic plant protector tubes and wooden stakes that had yet to photodegrade. See Figure 9.

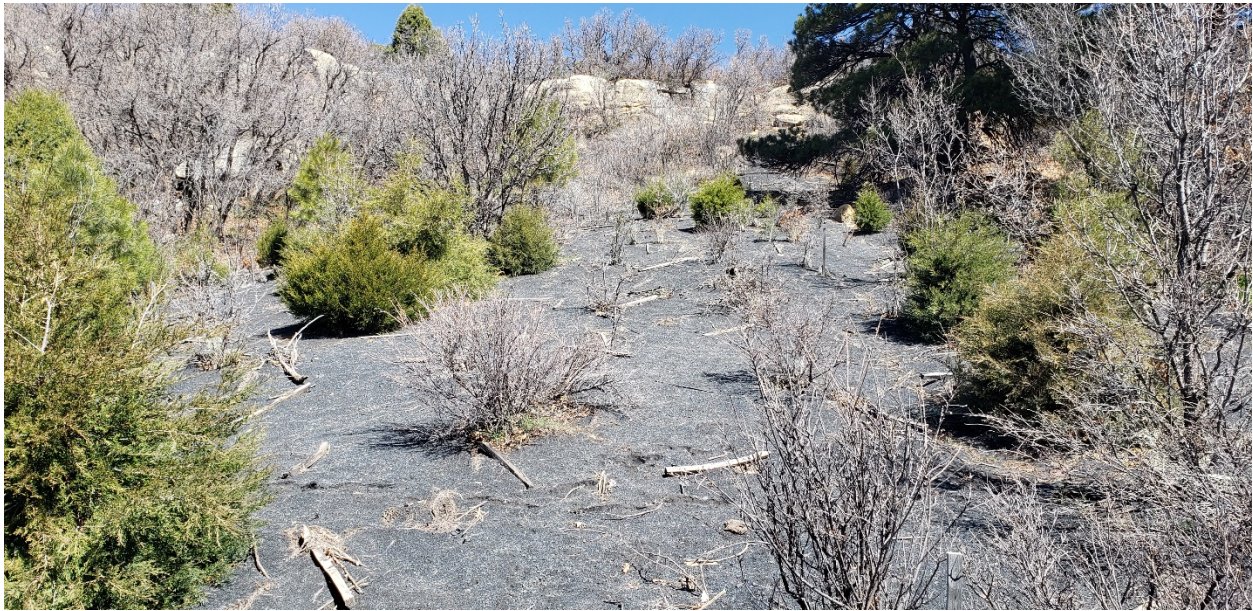
Figure 10. Yankee Vukonich project, gob site B.

At gob site B, located on private property and reclaimed in a similar manner as site D, the Team observed that vegetative establishment was more sparse, though the reclaimed waste piles were likewise stable and had been recontoured. We did note several factors likely influencing the difference in reclamation success between the two sites, including landowner preference—this meant creating the smallest disturbance possible for reclamation at site B, precluding any soil borrowing and capping—and elevation. Whereas site D is situated at approximately 7,370 feet in a canyon which had a running creek and snow drifts in shady areas at the time of this evaluation, site B is located at an average elevation of 7,670 feet on an exposed, south-facing slope which dries out quickly. Jute netting was still intact, wooden stakes were scattered about, and many of the original locust and juniper plantings were well-established. The Team agreed that vegetation at site B would further mature and improve as plant litter accumulates and gob-tolerant species continue to propagate. See Figure 10.
