Cane Run and Royal Spring Watershed-Based Plan

EPA Project Number: C9994861-06

Prepared by:

Executive Summary

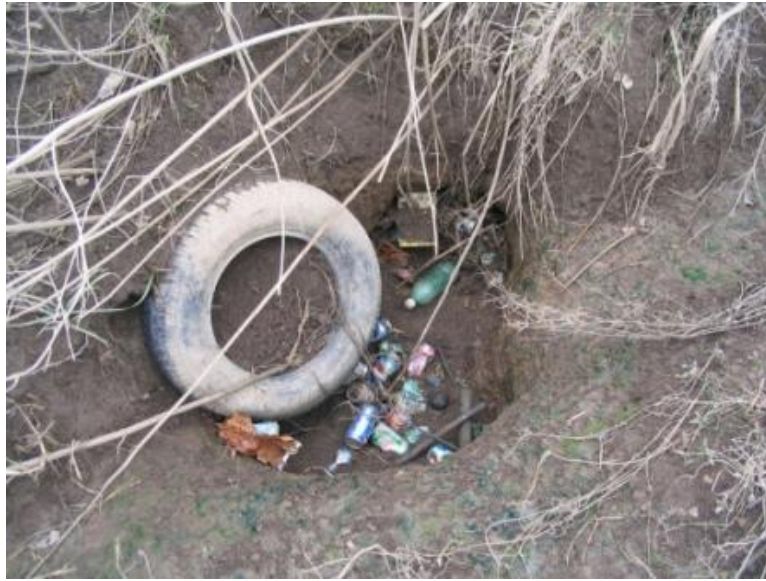
Figure 5. Typical karst conduits within the Cane Run

Large swallets, like the one shown in Figure 5, are present in portions of the watershed and drain the surface flow to the groundwater system. The Royal Spring groundwater basin (located near Georgetown, KY) and the upper Cane Run surface water basin overlap considerably. At baseflow conditions, a series of swallets within the stream channel of Cane Run divert all water to the Royal Spring. As a result, the gauging station at Cane Run near Bonerail (ID# 03288200) records no flow during these periods. Flow data is only available during high flow periods as surface runoff reaches the Cane Run.

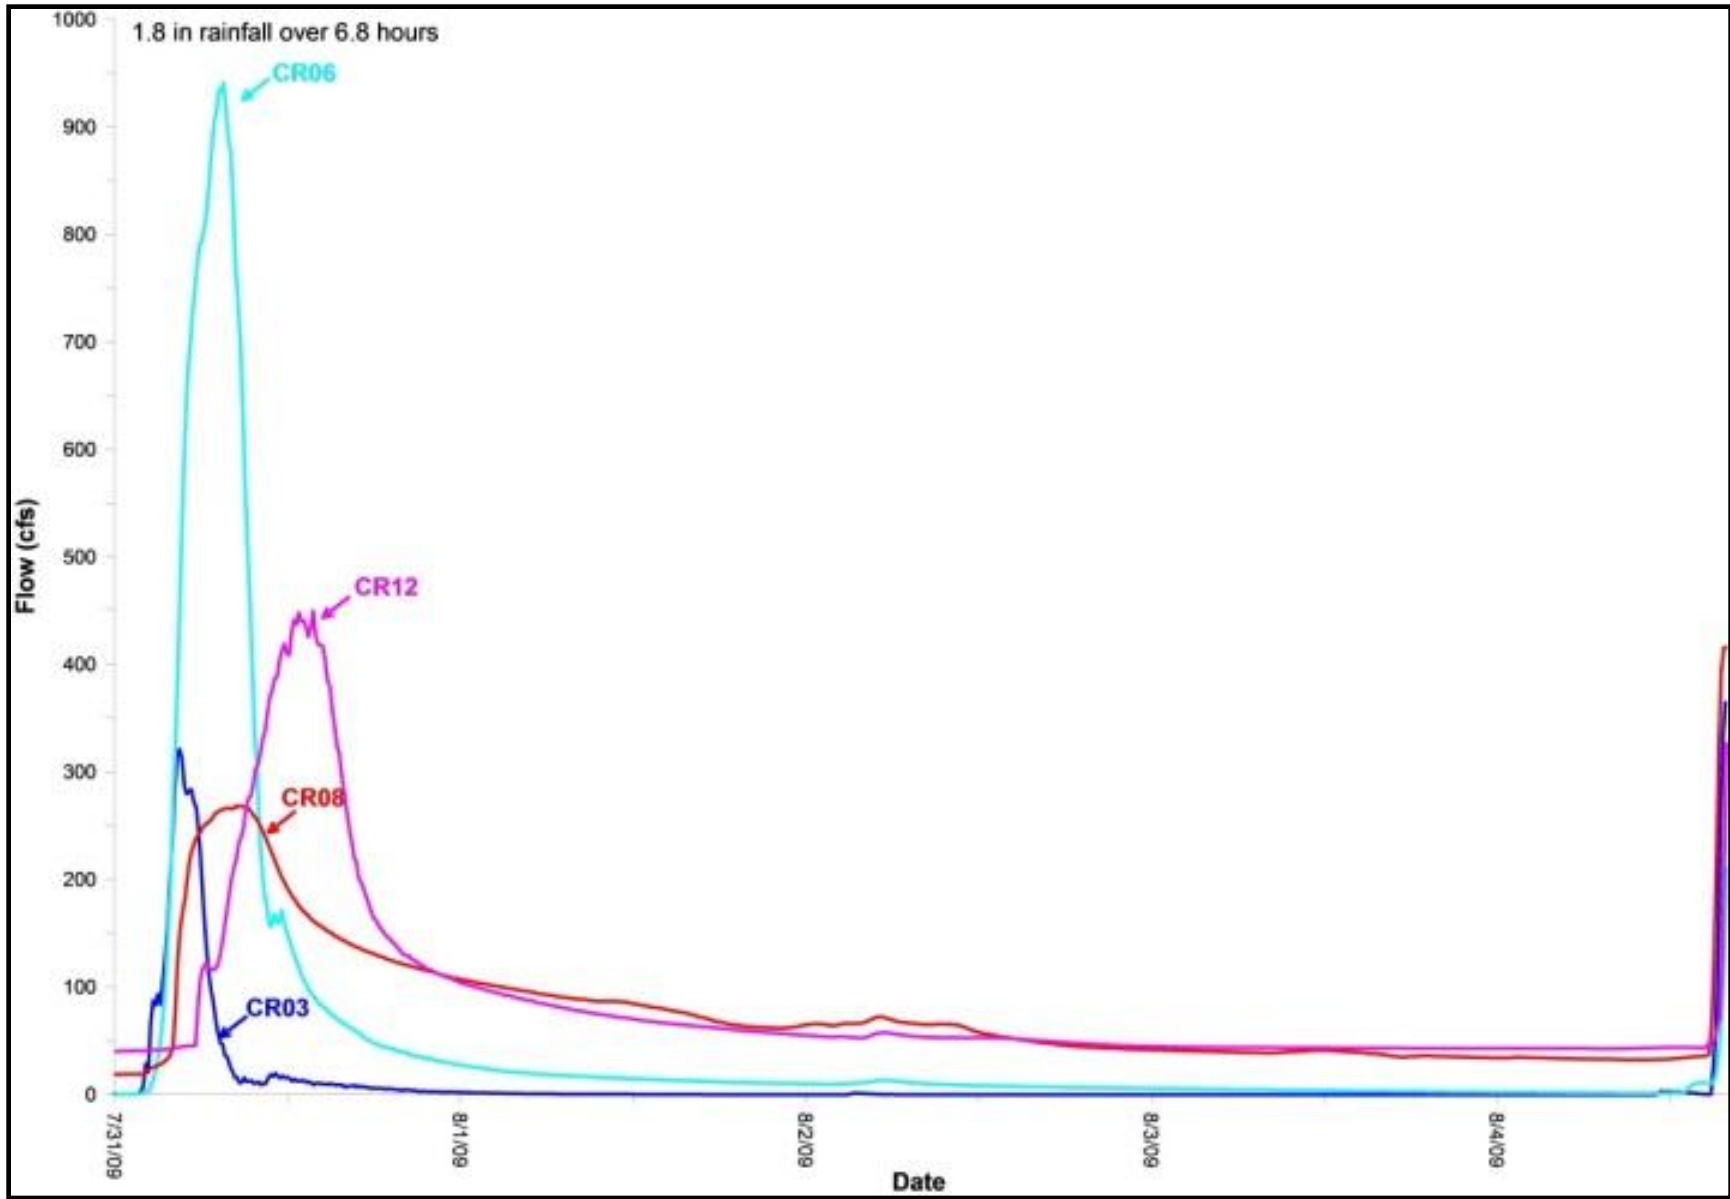
Figure 23. A representative storm hydrograph for several of the CRWP monitoring sites

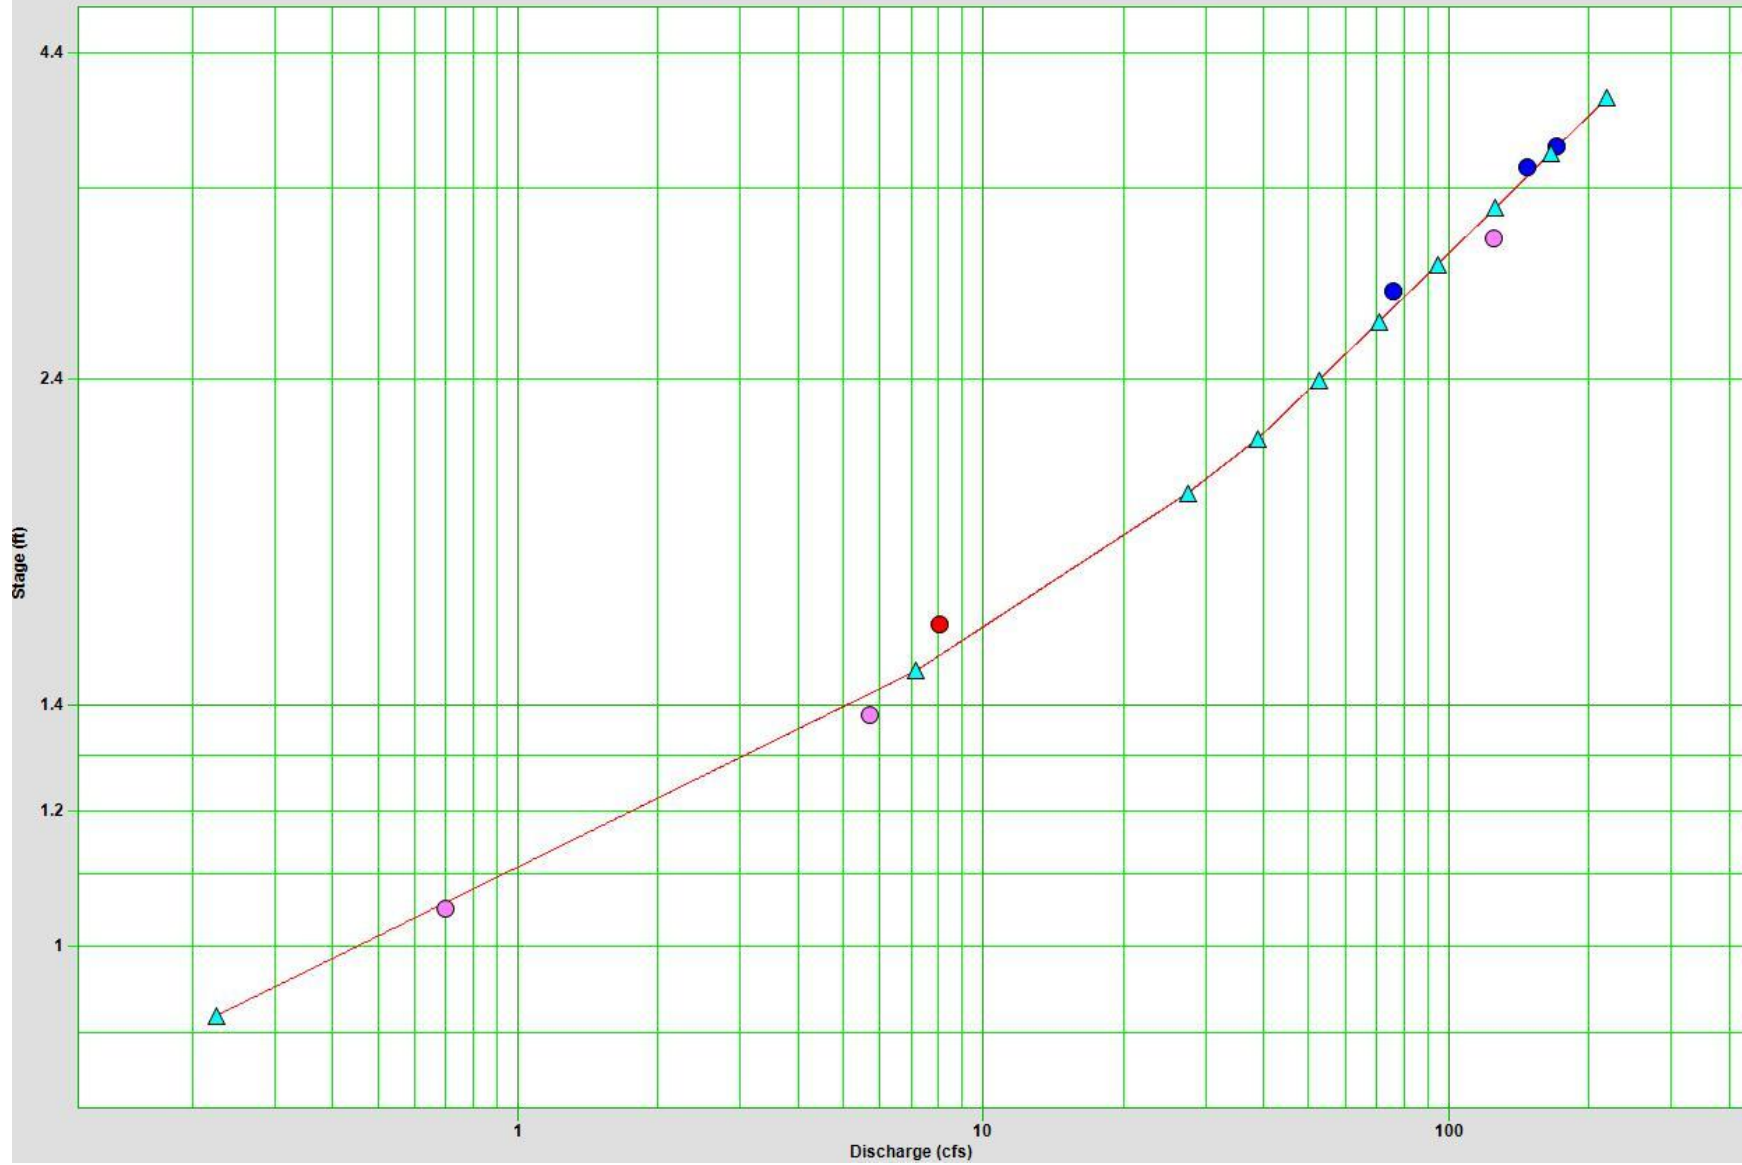
Figure 24. Stage-discharge curve for CR03

UK, in cooperation with the U.S. Geological Survey (USGS), also developed stage-discharge curves for the Cane Run. These curves, and the rating tables found in Appendix S, describe the relationship between the height of the stream (stage) with the discharge (amount of water) at a specific cross section of the stream (Figure 24, Figure 25, Figure 26, and Figure 27).

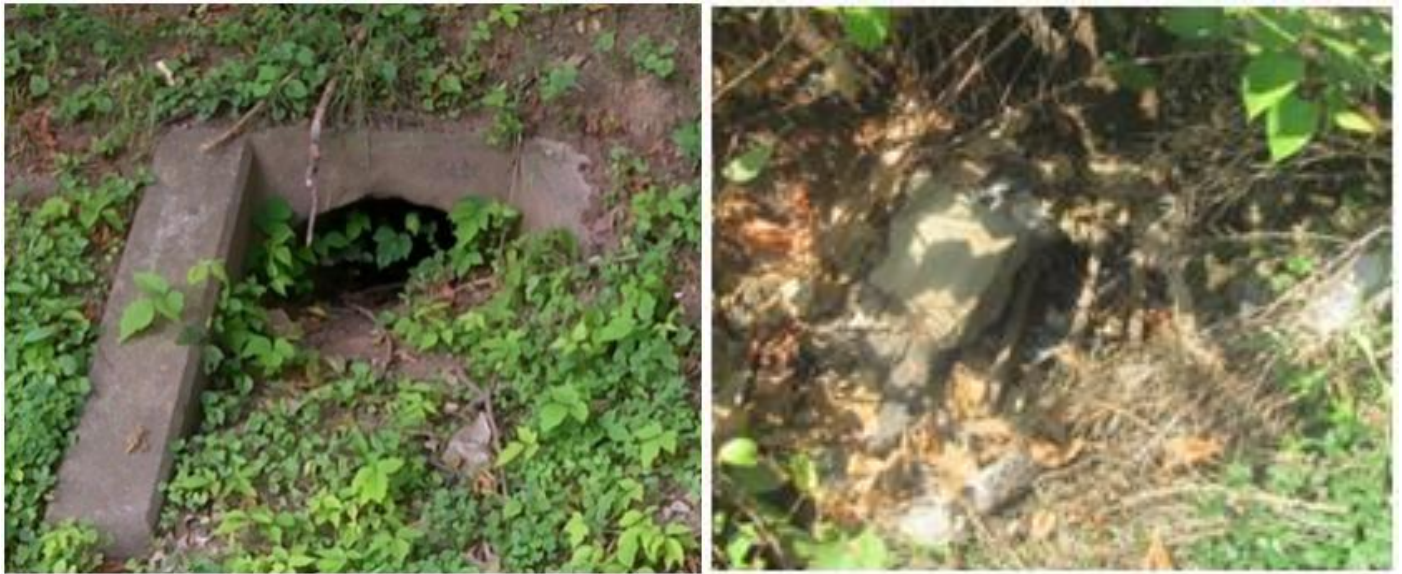
Figure 29. Endwall filled with mud and vegetation; Endwall filled with trash and debris

The students began by inspecting the creeks and looking for signs of pollution, such as trash, sewage, and bank erosion. They walked the streams that ran through Lexmark Park, the Russell Cave Road/Hollow Creek Road area, the Nandino Boulevard area, the West Loudon Avenue area, and the Highlands subdivision. In order to supplement the limited information provided by LFUCG, the students were asked to locate and take GPS points of all pipes that discharge into the streams. Most pipes were located at concrete endwalls and had no flow; however, some endwalls were filled in with mud and vegetation or trash and debris (Figure 29). There were also several endwalls that had structural damage or around which the bank was eroded (Figure 30); these problems were reported to LFUCG.

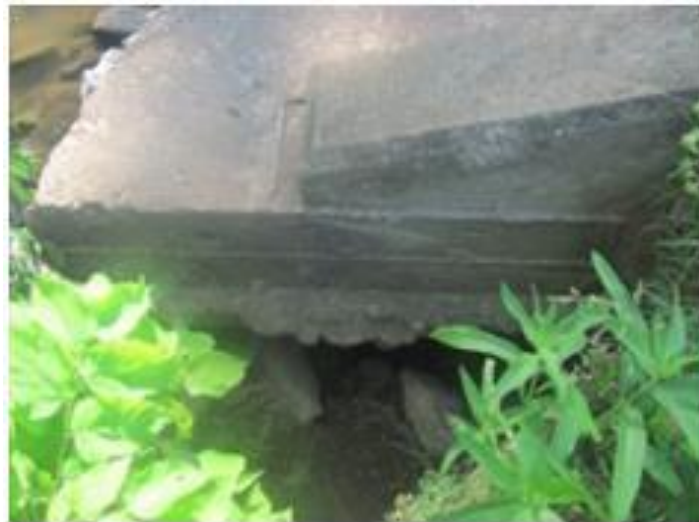
Figure 30. Bank eroded around endwall

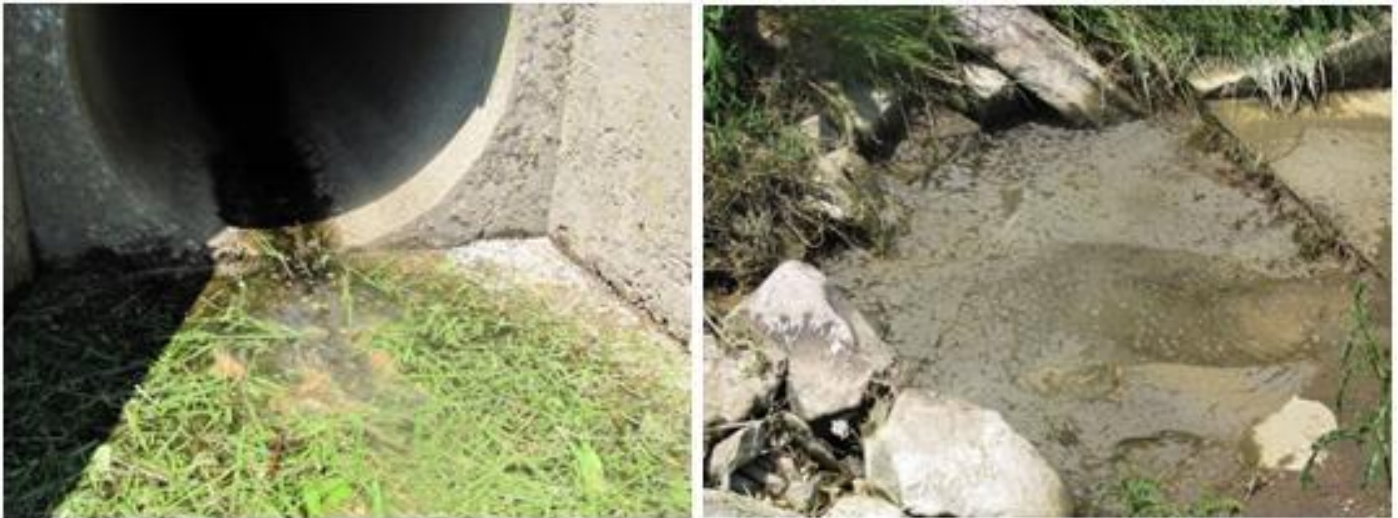
The students found that some pipes had water flowing out, but did not test for ammonia or detergent unless they saw signs of pollution. The pipes that exhibited signs of pollution were tested using the field tests. As Figure 31 shows, in one pipe there was a brown thick liquid accumulating at the endwall, which appeared to be a sign of pollution; however, upon testing, the students found a low level of ammonia and no detergent present. The endwall, also shown in Figure 31, is located in Lexmark Park, and the sudsy appearance of the water gave some indication of pollution. The water, when tested, contained 0.25 mg/L of ammonia and some detergent. The low levels of ammonia and detergent found at these two endwalls indicate that the discharge was not harmful.

Figure 31. Brown liquid discharging from endwall; Sudsy water discharging from endwall

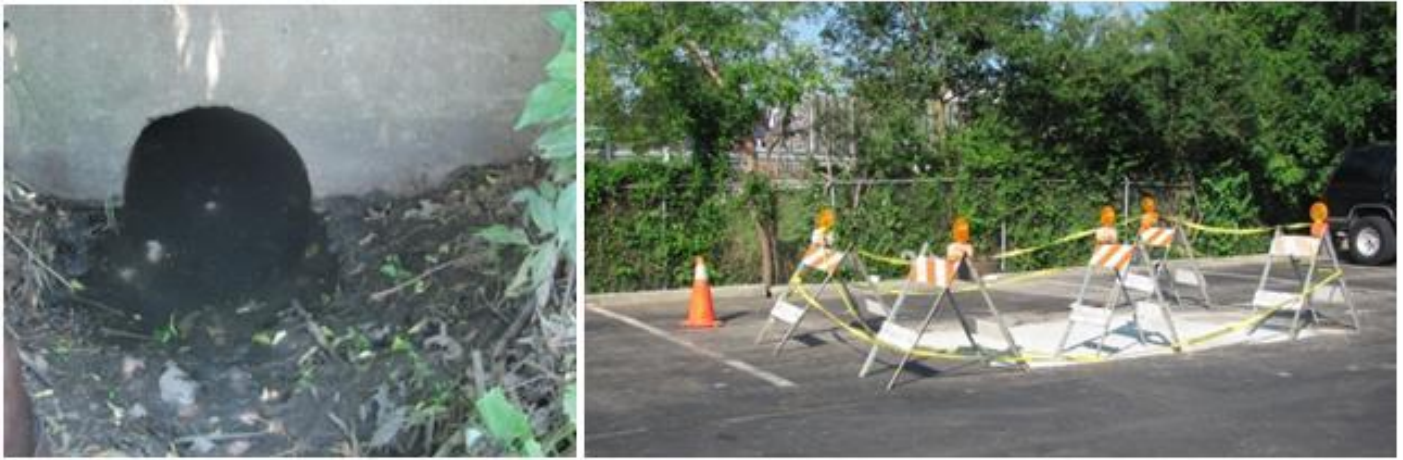
The worst pipe discharge was found in the stream off of Russell Cave Road (Figure 32). The students smelled a very foul odor upon approaching this endwall. They tested the water and found ammonia levels greater than 8 mg/L and some detergent, which indicated that there might be sewage present. An environmental inspector from LFUCG was contacted and came out to inspect the pipe. He took a sample and tested it for *E. coli* and found very high levels. It was later determined that there was a sewer line break at the Paddock Apartments nearby. The apartment complex was issued a citation and the problem was fixed.

Figure 32. Sewer from line break; Construction on sewer line break

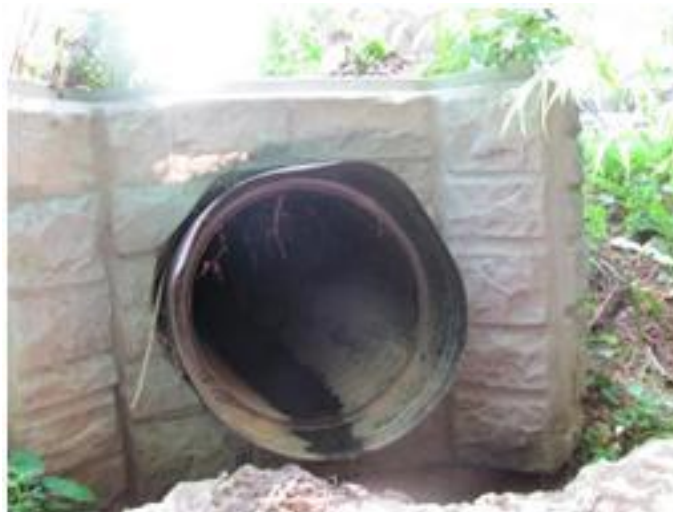
Just downstream from where the sewage was found, a faux rock endwall with a plastic pipe was found (Figure 33). The pipe was discharging a foul smelling liquid into the stream. The students tested the liquid and found it to contain greater than 8.0 mg/L of ammonia and some detergent. They followed the pipe up into a parking lot and found that it was connected to a drainage grate. The environmental inspector also checked this pipe and informed the students that there was not much that could be done about it.

Figure 33. Faux rock endwall

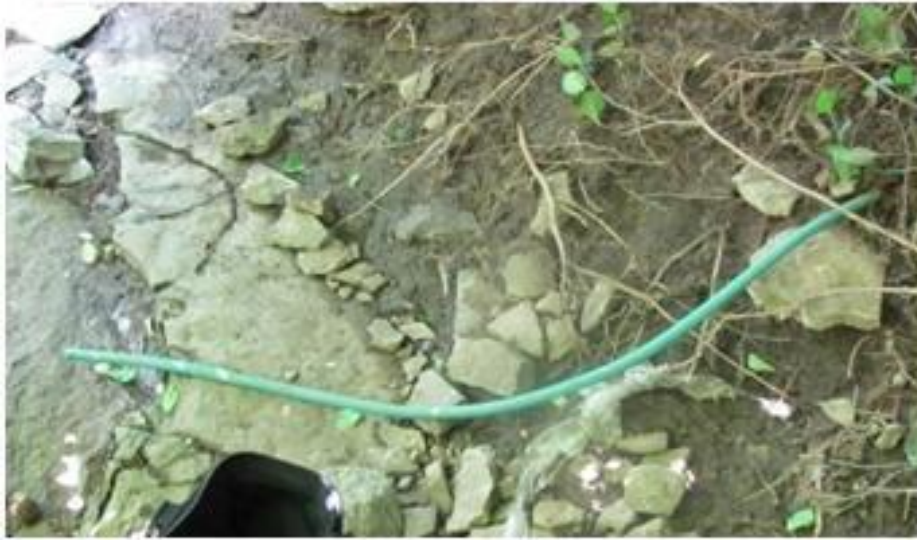
Several pipes of an unidentified origin were also found running into the streams. One such “pipe” was a 5-foot section of garden hose sticking out of the bank in a stretch of stream that runs parallel to New Circle Road (Figure 34). The students attempted to pull the hose out of the bank, thinking that it was just litter and had gotten stuck in the bank. The garden hose, however, would not budge, and they were unable to pull it from the bank, leading the students to believe that it was connected to something above the bank. The end of the garden hose appeared to be wet, but there was no flow, and the hose was not near the water in the stream.

Figure 34. Garden hose sticking out of side of bank

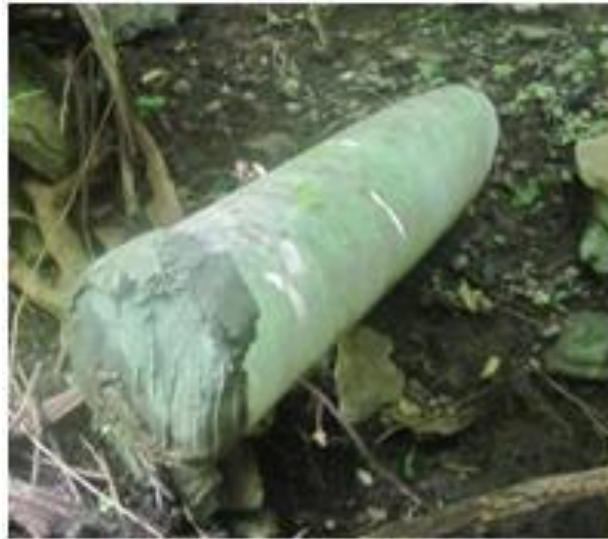
The students found a 10” PVC pipe protruding 3’ off of Nandino Boulevard (Figure 35). The pipe was sealed shut with what appeared to be some sort of plaster. The pipe was dripping, but the liquid had no odor or other sign of pollution and the students did not test it.

Figure 35. PVC pipe sealed shut

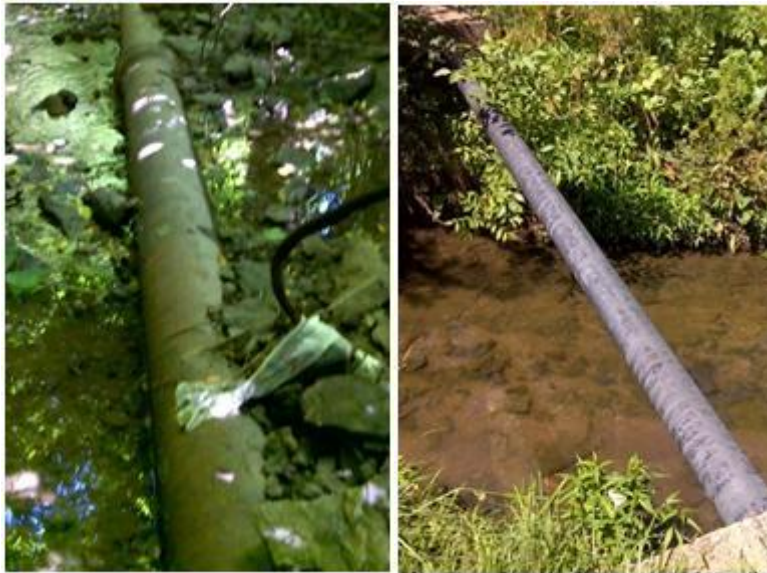
Figure 36. Sanitary sewer crossing

In addition to finding pipes that discharge into the stream, the students were also asked to locate and mark GPS points for the pipes that cross the streams, most of which were sanitary sewer pipes (Figure 36). Some were also assumed to be utility lines crossing the stream (Figure 37).

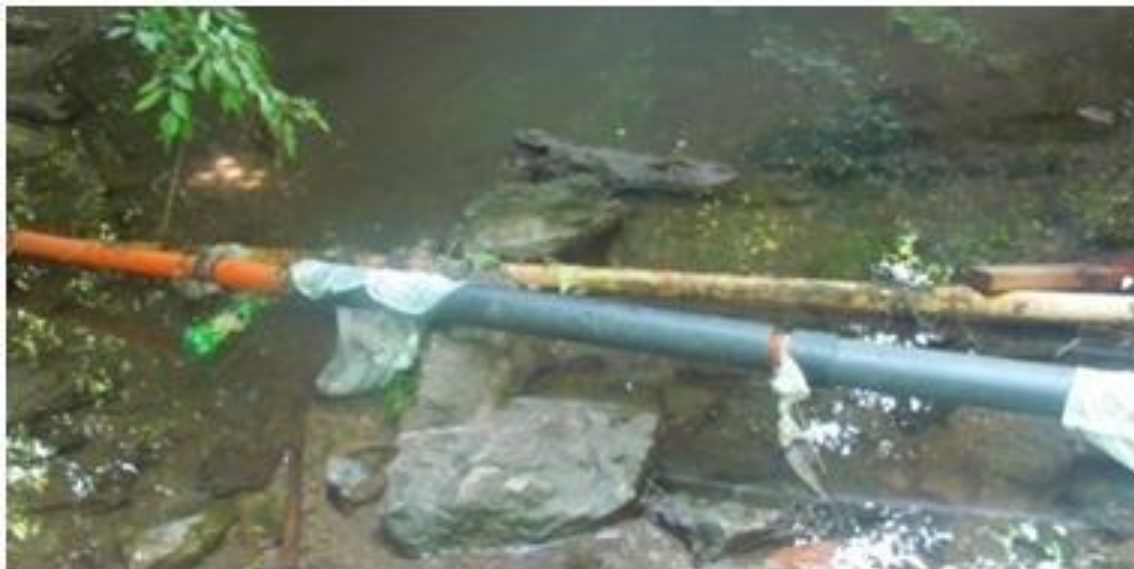
Figure 37. Utility line crossing stream

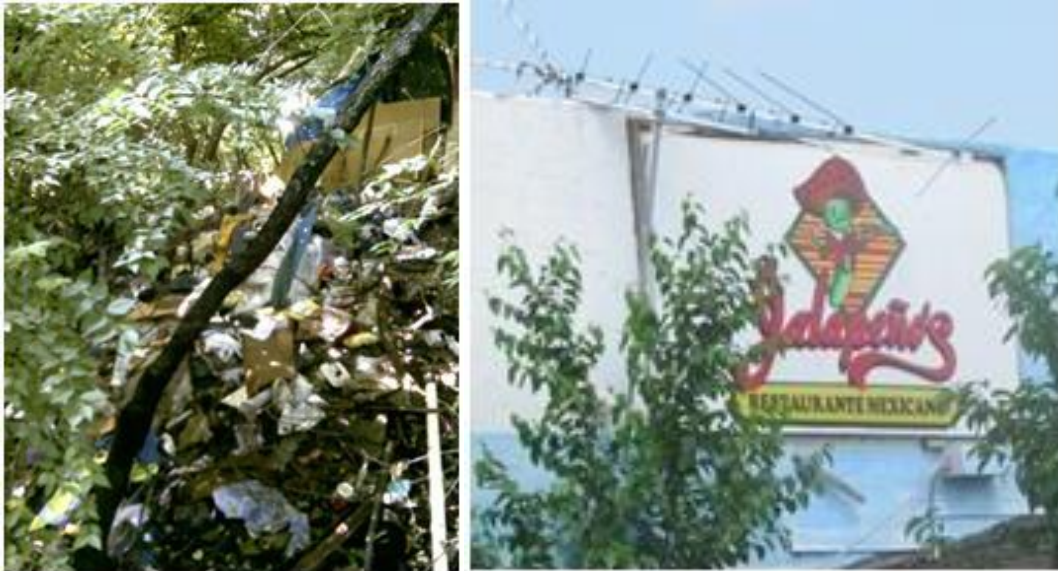
Figure 38. Trash near stream by homeless encampment; Area where a major source of trash was found

In all of the areas that were inspected, the dumping of trash, debris, and large items in the stream is a large problem. Trash can be found in every part of the watershed, especially in the urban areas. Many of the worst spots for trash occurred near homeless camps. During their exploration of the streams, the students found many locations where homeless people live near the streams. The worst one was in the West Loudon Avenue area, near the railroad track (Figure 38). Another major source of trash is located behind Jalapeño's Mexican Restaurant off of New Circle Rd (Figure 38).

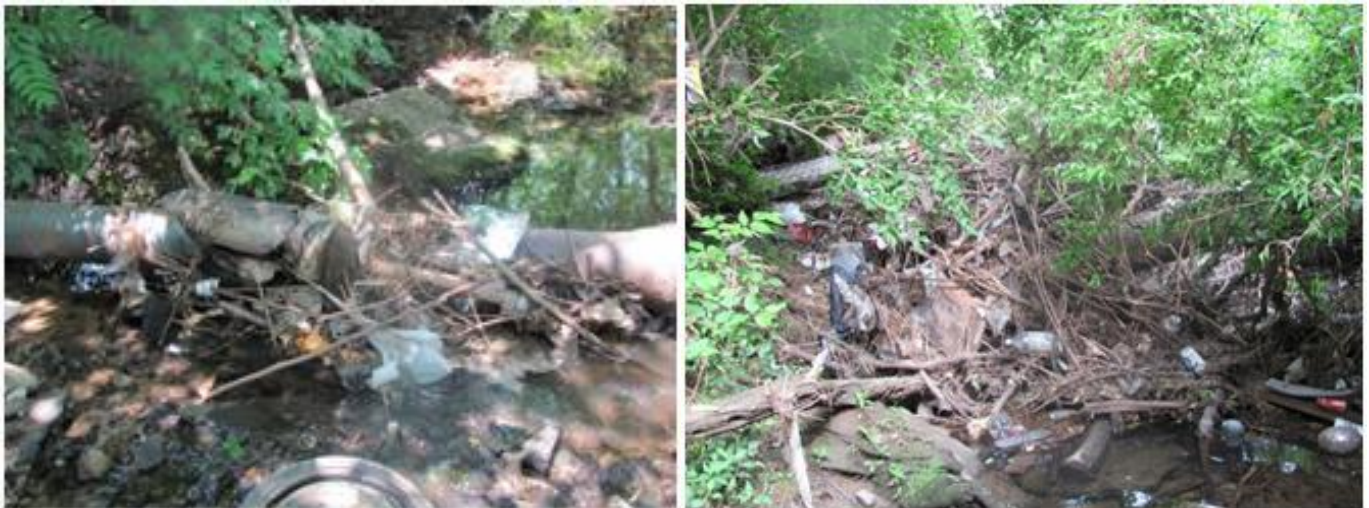
The students found several locations where debris was clogged in the streams and underneath aerial pipes that crossed the streams (Figure 39). In several locations the stream was impassable, and the students were forced to climb out of the stream and bypass the obstruction (Figure 39).

Figure 39. Debris clogging around pipes; Possible area for LFUCG and UK Fusion Cleanups

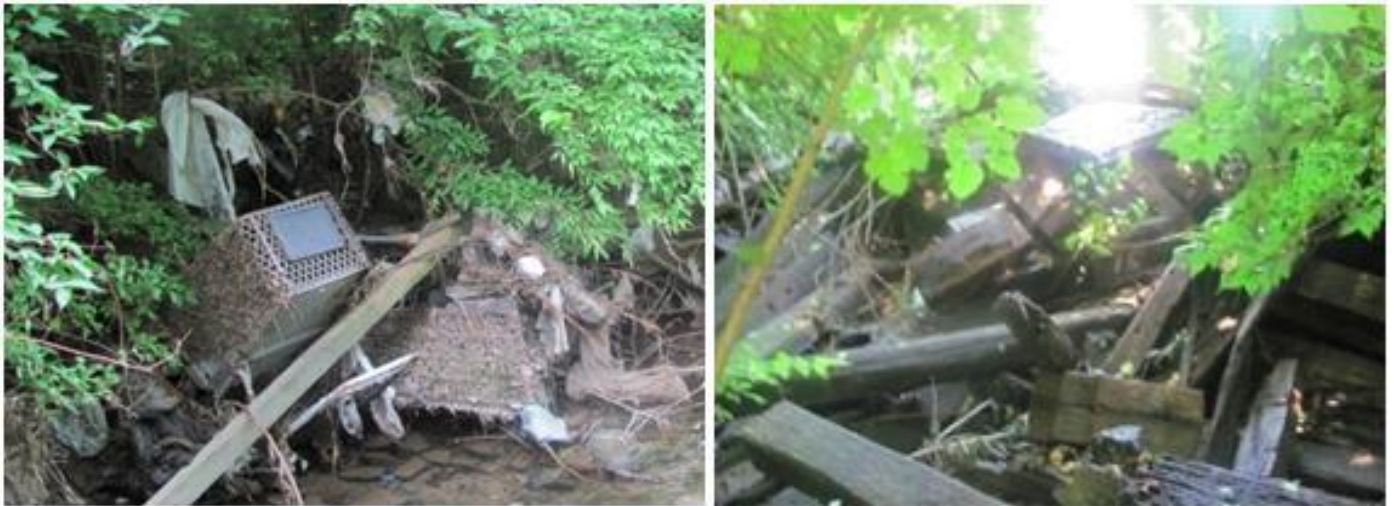
Figure 40. One of many shopping carts; Railroad debris

Several additional dumping locations were also found. The students found shopping carts, refrigerators, lawn mowers, a moped, and excess railroad supplies dumped into the stream. Approximately 15 shopping carts were found on the bank of the stream behind the Family Dollar on New Circle Road (Figure 40). Another major dumping site was found near the railroad tracks in the West Loudon Avenue area, near the homeless camp, where a significant amount of excess railroad materials had been dumped (Figure 40).

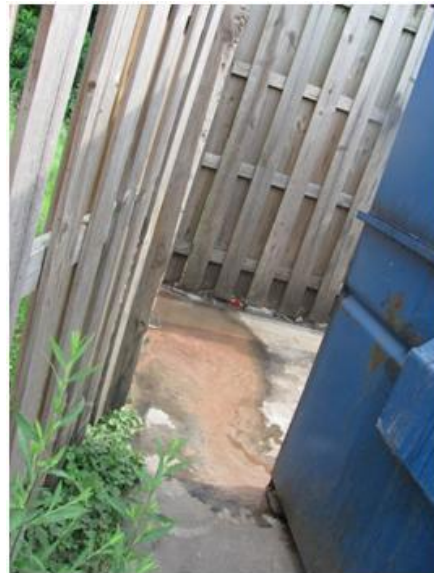
In addition to these sources of pollution, the students found that dumpsters located near the streams posed a problem. In the stream located off of Nandino Boulevard, a large amount of trash and tires were found in one site. The students followed the trash up the bank to the source: a dumpster. Another dumpster that appeared to be a problem is located off New Circle Road behind the strip mall where Family Dollar is located. This dumpster was leaking a foul smelling, brown liquid that was running into the stream (Figure 41).

Figure 41. Leaking dumpster

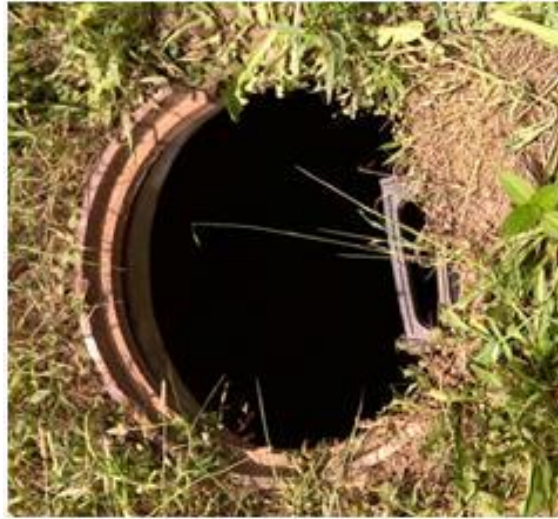
in, and upon examining the hole, it seemed to be some sort of a tank that the students could not identify. The tank held about 1 foot of water, and the lid could be seen in the bottom. The hole was at the entrance of a gate and could be hazardous to anyone who is walking or driving by. This was reported to LFUCG and UK, and the problem was fixed.

Figure 42. Manhole without cover

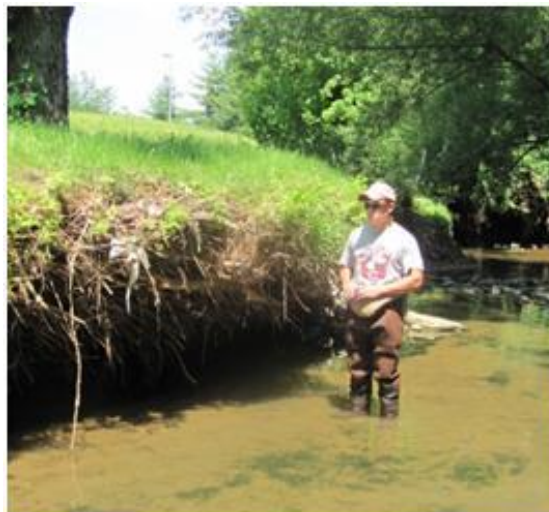
Although many problems of trash found in the streams were created as a result of direct human behavior, some problems, such as bank erosion, were occurring simply because of increased stormwater runoff caused by urbanization and impervious cover. In all sections of the streams, the students found areas of significant bank erosion. In many cases the erosion was so severe that the banks are overhanging (Figure 43). This photograph was taken in Shadybrook Park, which is located on Lexmark's property.

Figure 43. Bank erosion

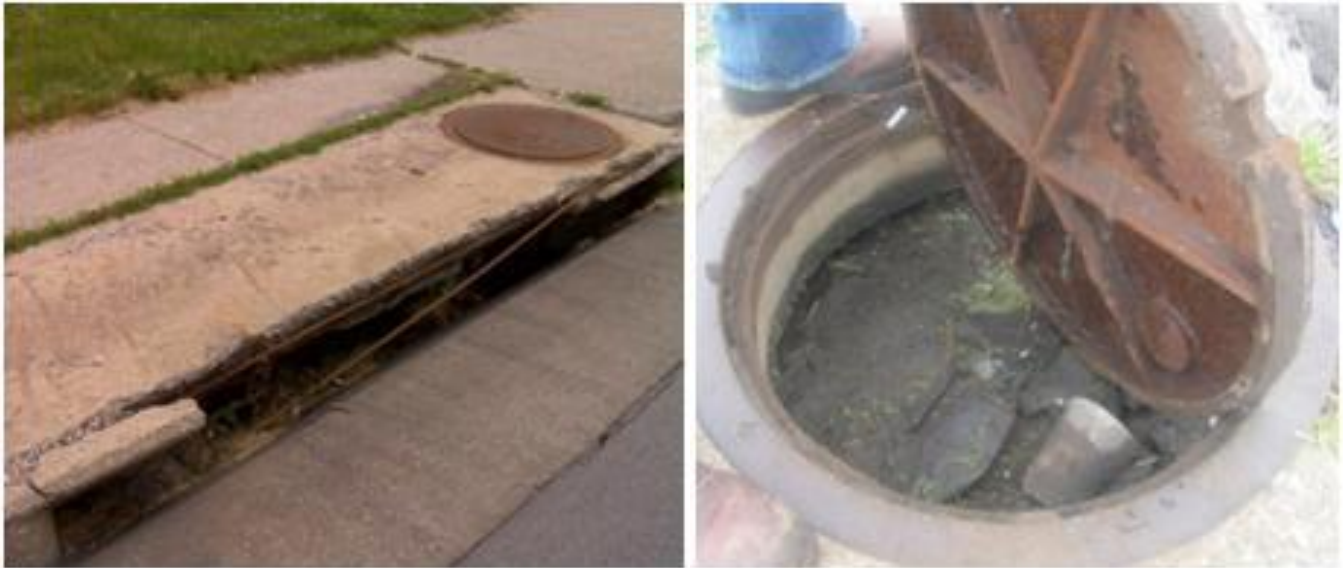
After walking all of the streams, the students began checking curb inlets, storm sewer manholes, and drainage grates in parking lots. Several problems were found with curb inlets, especially in the New Circle Road and Russell Cave Road areas. Numerous broken curb inlets were found on Russell Cave Rd (Figure 44). One curb inlet was completely filled in with sediments, trash, and other debris (Figure 44). In all areas, trash could be seen in the curb inlets, but most did not contain a significant amount.

Figure 44. Broken curb inlet; Sediment-filled inlet

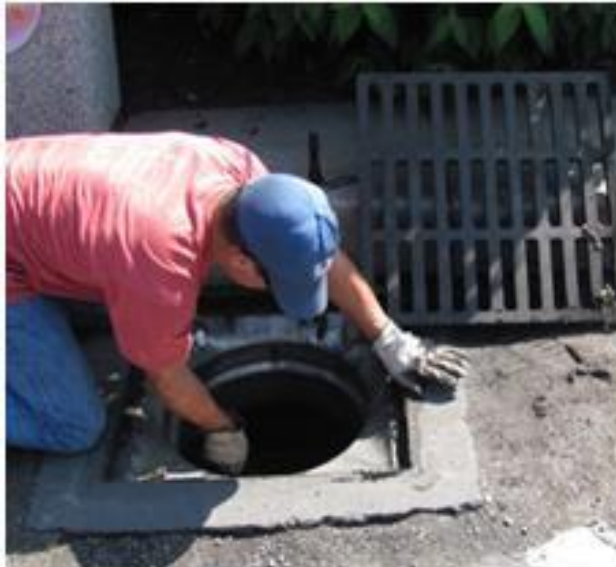
Figure 45. Source of foul odor

When beginning to look at storm drains, the students decided to focus on the businesses off of New Circle Road. This area is very congested and receives a lot of traffic on a daily basis. Upon checking the storm drains in the McDonald's parking lot, the students smelled a very foul odor coming from a drainage grate. The grate was pulled up, revealing water that had collected in the bottom of the grate (Figure 45). The students were unable to test the water because it was so deep. The students contacted LFUCG, who called the streets and roads department, who stated that it was a state line and not their responsibility. The next week the environmental inspector went out to look at the storm water drain to get a water sample. The water contained low levels of ammonia, no *E. coli*, and very high levels of fecal coliforms. This indicated to the inspector that it was just run-off from the parking lot and not a sewer leak; therefore, nothing else was done about this storm drain.

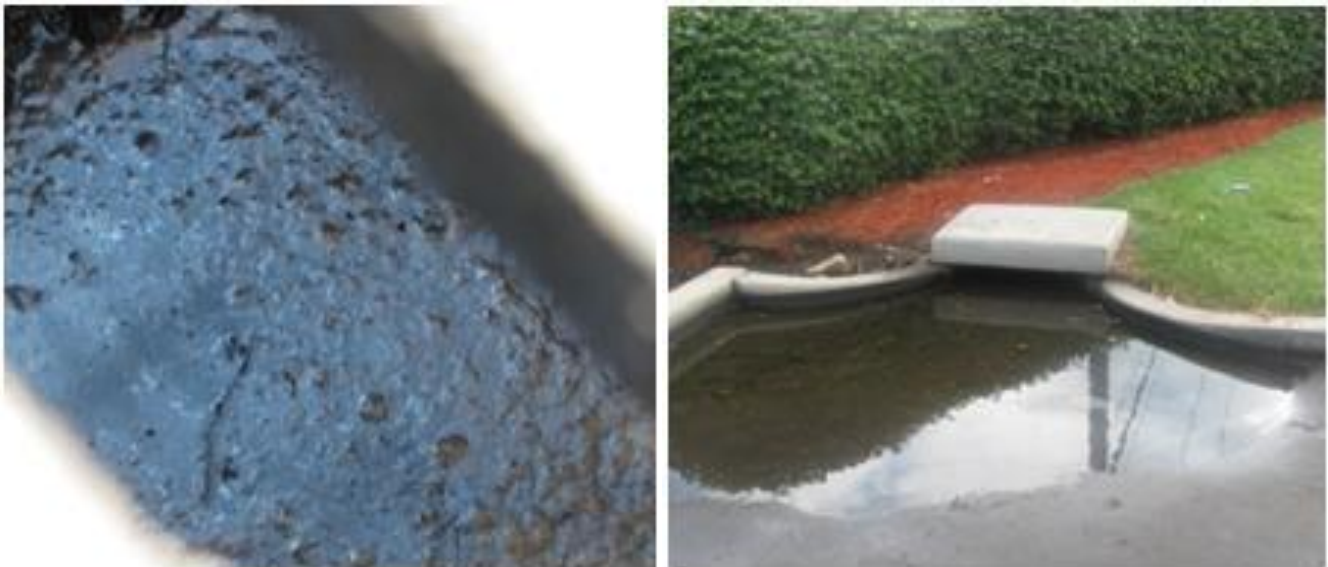
Just down the street from McDonald's the drainage grate in the Dairy Queen parking lot contained suspicious looking water. The water had a sheen and brown foam around the edges (Figure 46). Another problem was discovered in the Taco Bell parking lot on the corner of New Circle Road and Russell Cave Road. The students found water pooling around the drainage structure the day after a rainfall and assumed the drain was clogged up (Figure 46).

Figure 46. Water with sheen and brown foam; Water pooling around drain

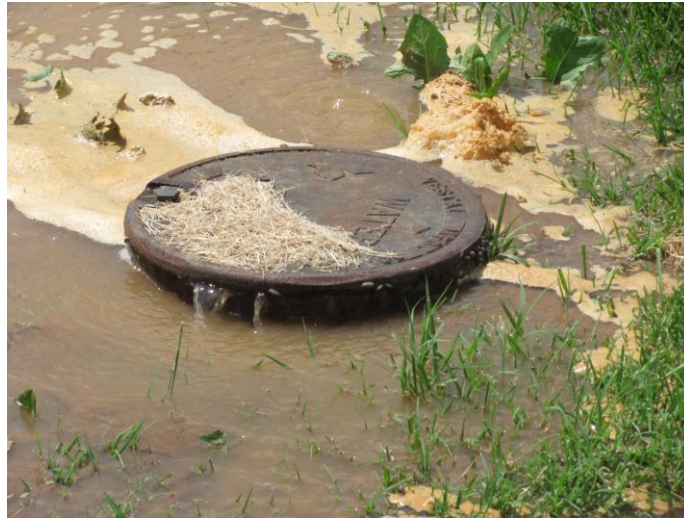
On another corner of the same intersection by the old Hollywood Video building, the students discovered a pipe with water flowing out and flooding the nearby area (Figure 47). LFUCG was contacted and informed the students that it was a waterline clean-out. The pipe was inspected and fixed later on that same day.

Figure 47. Water overflowing

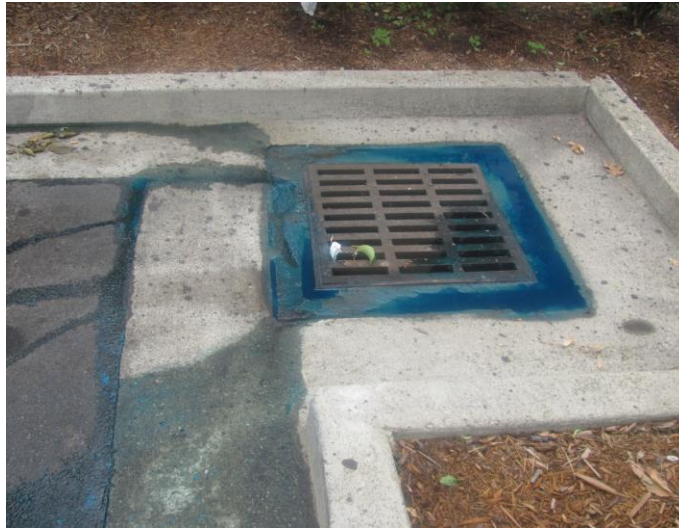
Upon checking storm drains in the Russell Cave and New Circle Road area, the students noticed a blue substance pooled up and draining into a storm drain in the Marathon gas station parking lot (Figure 48). The gas station employees were unable to identify the substance but claimed that it had leaked out of the back of a garbage truck that had been emptying the dumpster. LFUCG was notified about the substance but proposed that the gas station employees wash the rest of the substance down the storm drain because they did not have the tools or a quick enough response time to deal with the substance. Pictures of the spill were collected by the students. The blue substance smelled highly of some type of detergent.

Figure 48. Blue substance entering drain

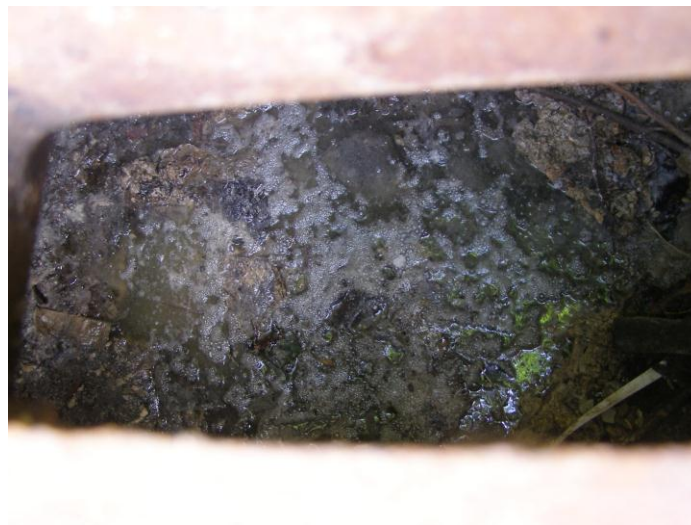
Figure 49. Nasty water

Another storm drain that posed a major problem was found in the back parking lot of Golden Corral on New Circle Road. When arriving at that storm drain the students noticed a very foul odor and realized it was coming from the storm drain. As Figure 49 shows, the water in the storm drain was sudsy, thick, and very unpleasant looking. The Environmental Inspector from LFUCG was called, and he came out and checked the storm drain. Grease was leaking from a dumpster directly into the storm drain. The students were informed later on that the problem had been fixed.

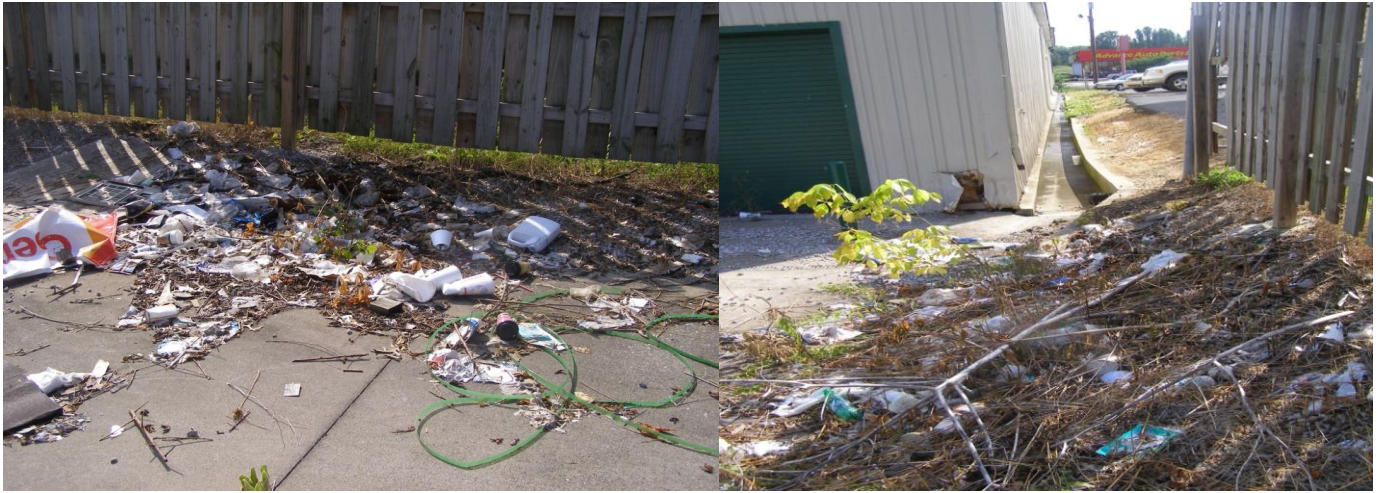
Another major source of pollution to the storm drains was found behind O'Reilly's Auto Parts on New Circle Road. A significant amount of trash had been left in the parking lot (Figure 50), and when a large rainfall

event occurred, the trash would be washed directly into the storm drain, which flows directly to the stream (Figure 50).

Figure 50. Trash in parking lot; Trash transported by large rainfall events

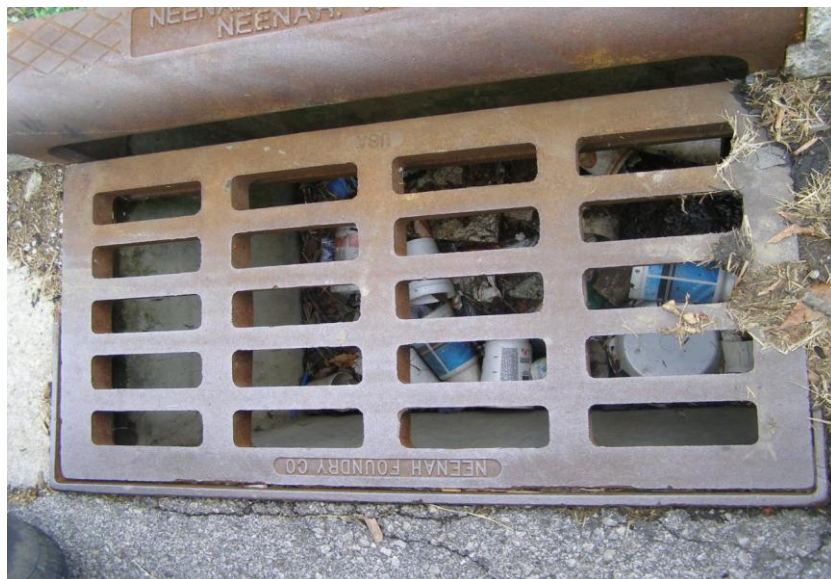
In several other locations, the students found storm drains that were completely filled with trash. Many of these storm drains were curb inlets located along the sides of the roads rather than in parking lots. Figure 51 shows a curb inlet off of New Circle Road.

Figure 51. Trash-filled drain

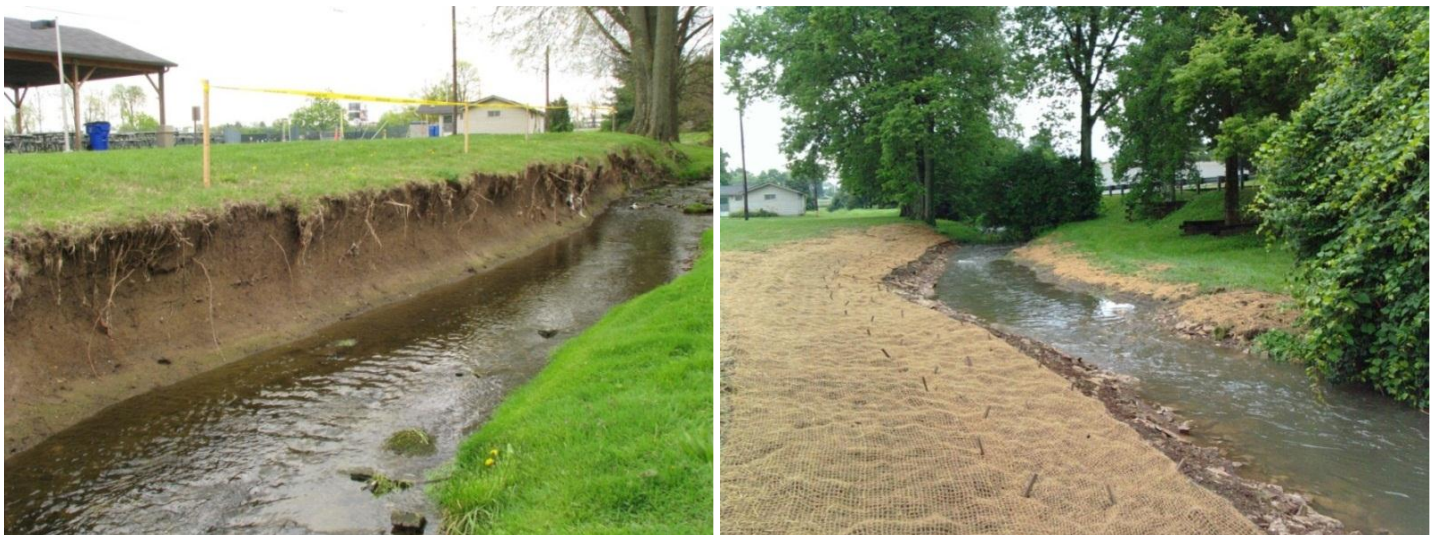
Figure 78. Cane Run tributary before Lexmark restoration; Cane Run tributary after Lexmark restoration

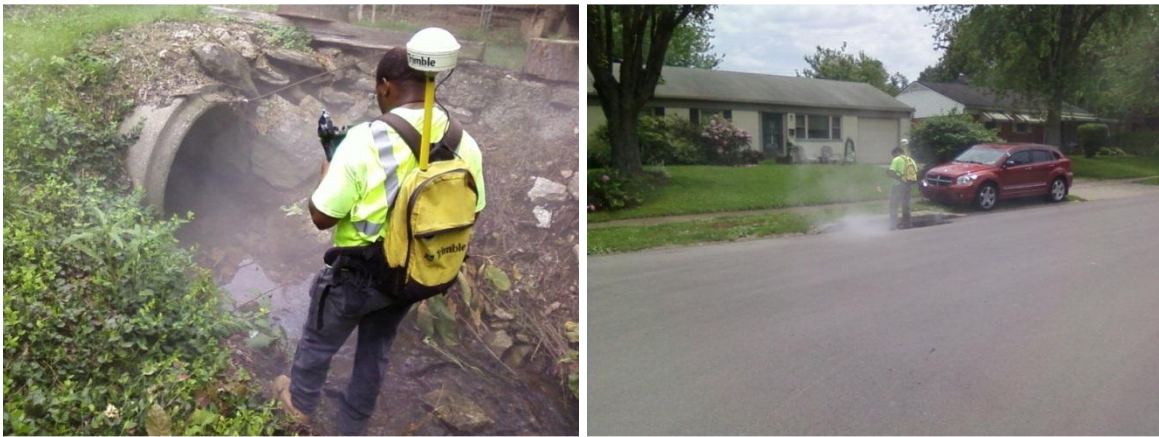
Figure 83. LFUCG sanitary sewer smoke testing coming out of storm sewer

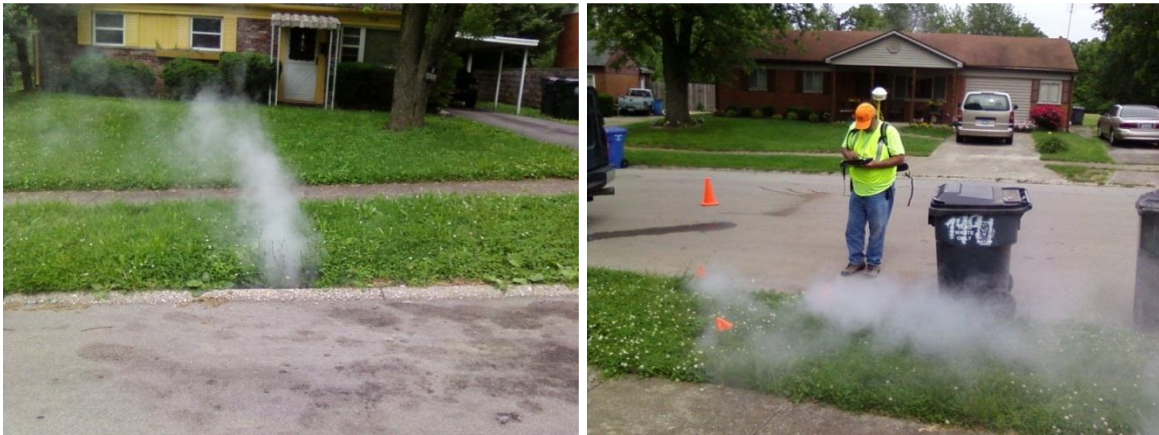
Figure 84. LFUCG sanitary sewer smoke testing coming out of storm sewer

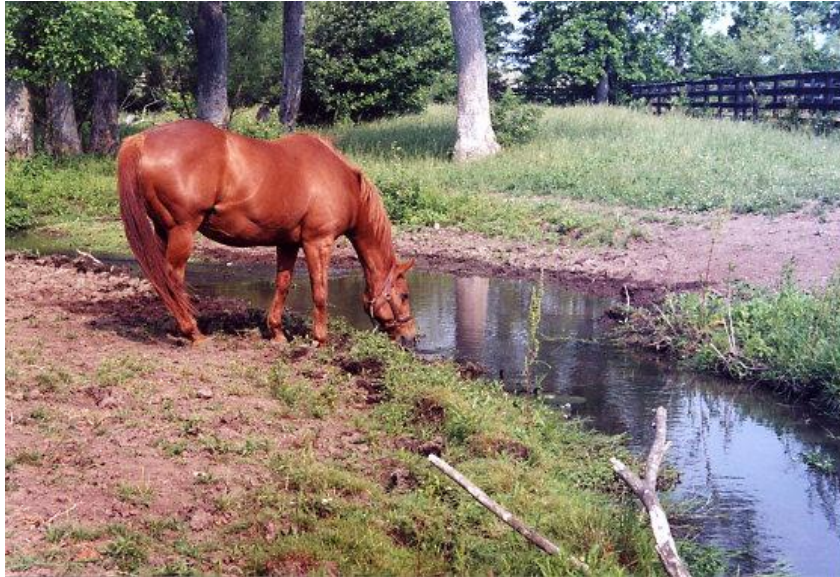
Figure 109. Horses with full access to the creek

Before the implementation of this BMP in 2007, horses along this section had full access to the creek, and at that time, their only source of water was the creek that ran through the paddock (Figure 109). By fencing horses out of the stream, providing them with a city waterer, and leaving a substantial buffer between pasture and stream, nutrient and bacteria deposition near the stream was eliminated and the project described below could be pursued.
