Cane Run and Royal Spring Watershed-Based Plan

EPA Project Number: C9994861-06

Prepared by:

Executive Summary

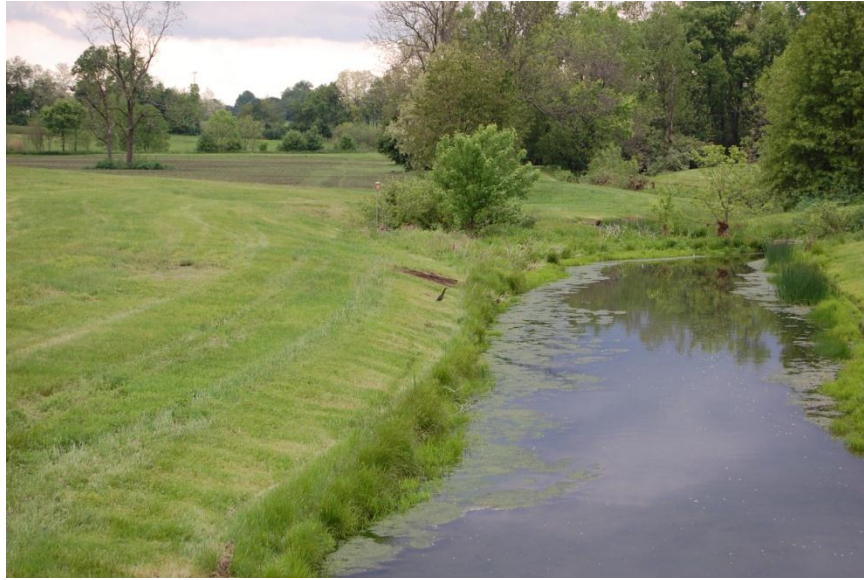
Figure 111. Example of stream before the installation of the no-mow zone policy

No-mow zones are areas adjacent to water bodies that are left un-mowed by maintenance crews. Formerly these riparian areas were mowed to the water's edge (Figure 111), but the installation of a no-mow zone allows vegetation to grow without restriction, which provides a vegetative buffer between pollutants such as sediment, nutrients, and bacteria and the water. It is common to believe that no-mow zones are improper on the Experiment Station because they make the farm look unkempt; however, no-mow zones are valuable features that control and trap pollutants before they reach surface waters. It is also a cost effective practice. Equipment can be damaged while mowing riparian slopes, and not mowing these areas saves fuel, equipment, and labor. In addition, many of these sections are wet areas where equipment can easily become stuck in the mud.

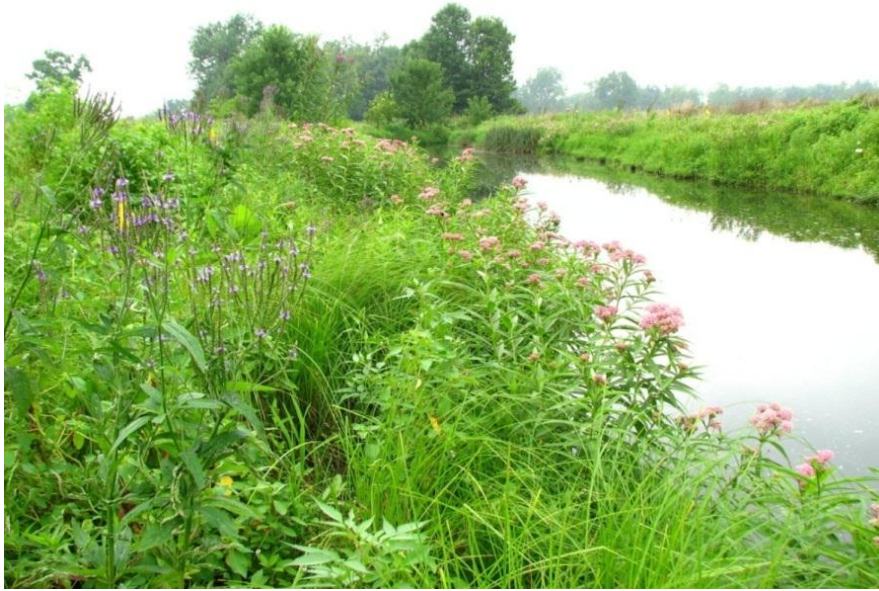
Figure 112. A Cane Run no-mow zone one year after implementation

No-mow zones have been established along all streams and water bodies across the entire farm, with the exception of several small stream sections and Lake Mildred (Figure 112 and Figure 113). These buffers are approximately 50-feet wide on each side of the water body and add up to a cumulative 27 acres of land on the Experiment Station. As a result of this stewardship, original populations of riparian flora such as Great Blue Lobelia, Swamp Milkweed, sedges, Woodland Sunflower, and Arrow Arum are being revived. In 2010, signs and markers were posted to help delineate no-mow zones and conservation buffer areas and to help describe the practices to users and visitors of the farm (Figure 113).

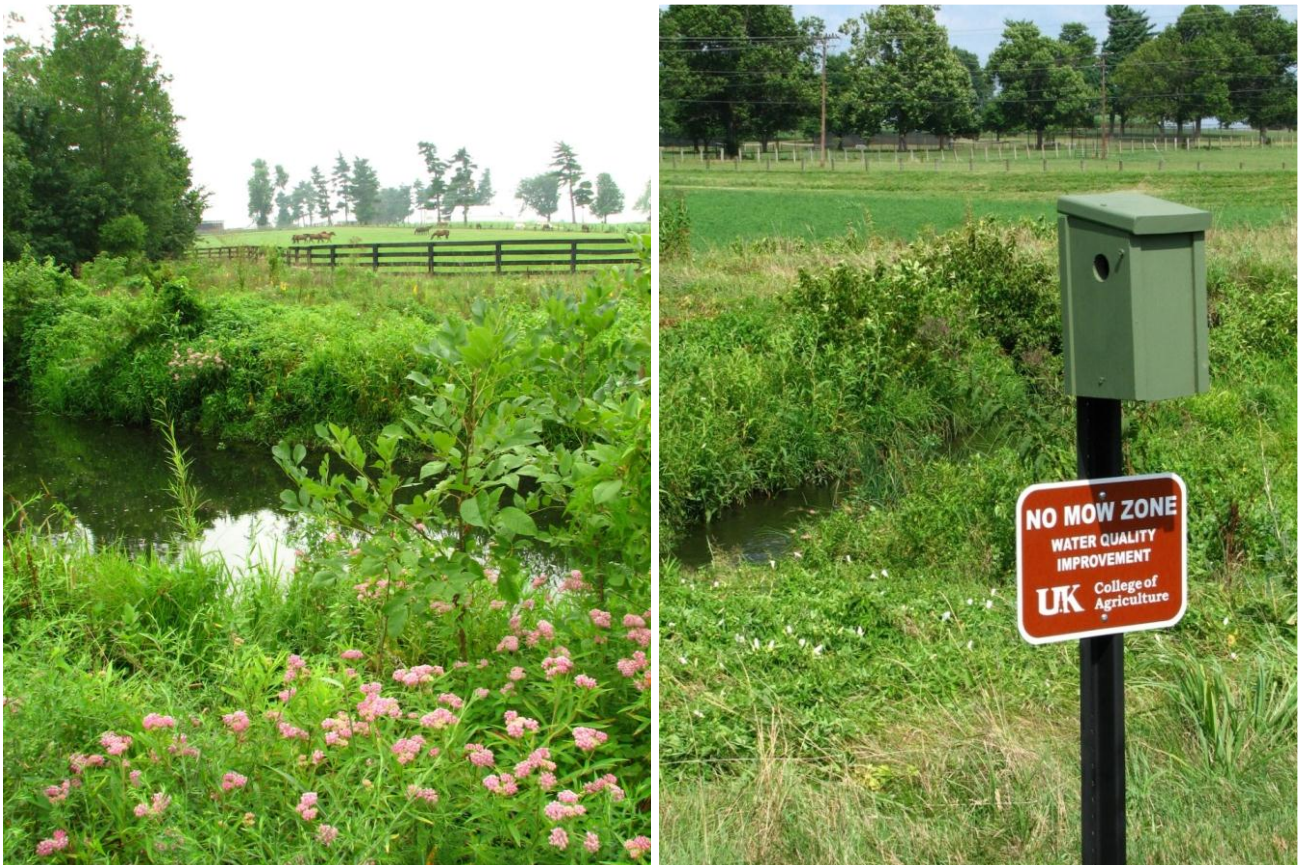
Figure 113. This early no-mow zone provided an example for the entire Experiment Station; No-mow sign with bluebird house to delineate riparian buffer zone

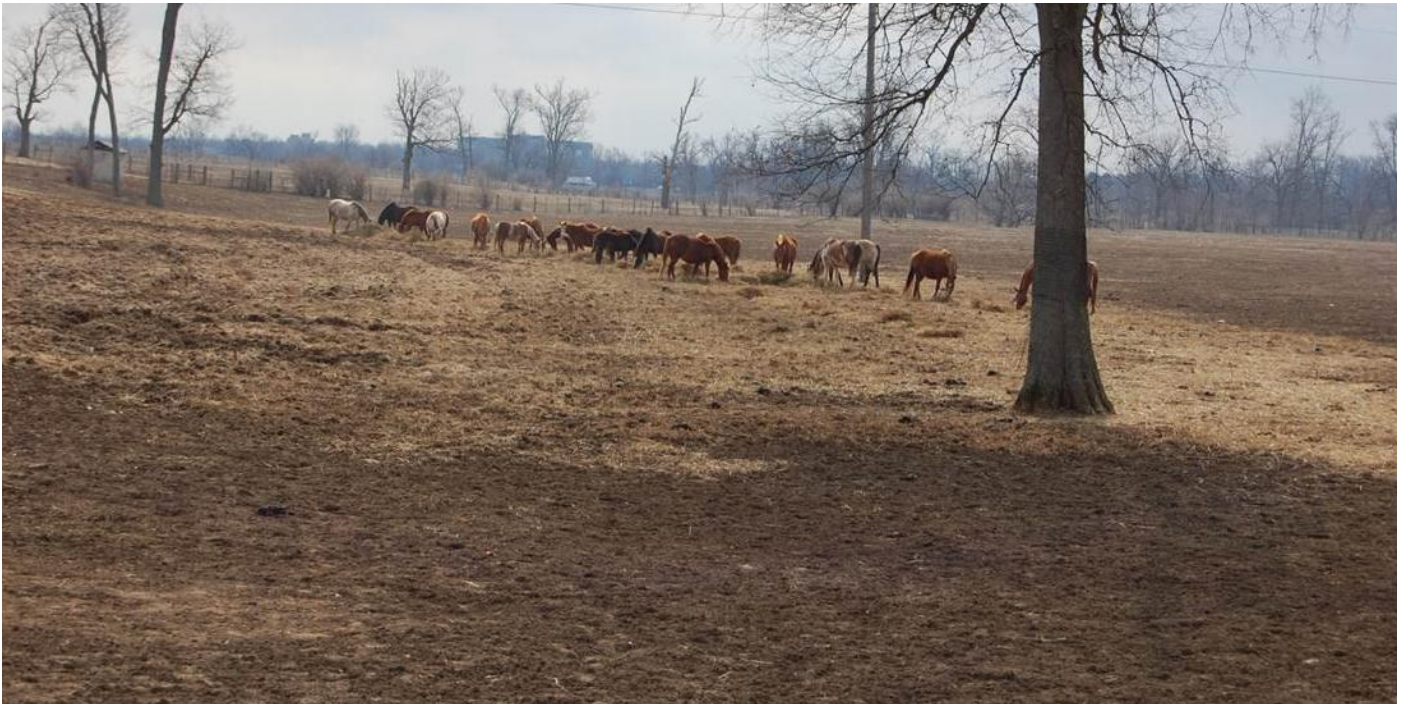
Figure 118. Overgrazing produces large unvegetated areas that can contribute to sediment pollution in surface waters.

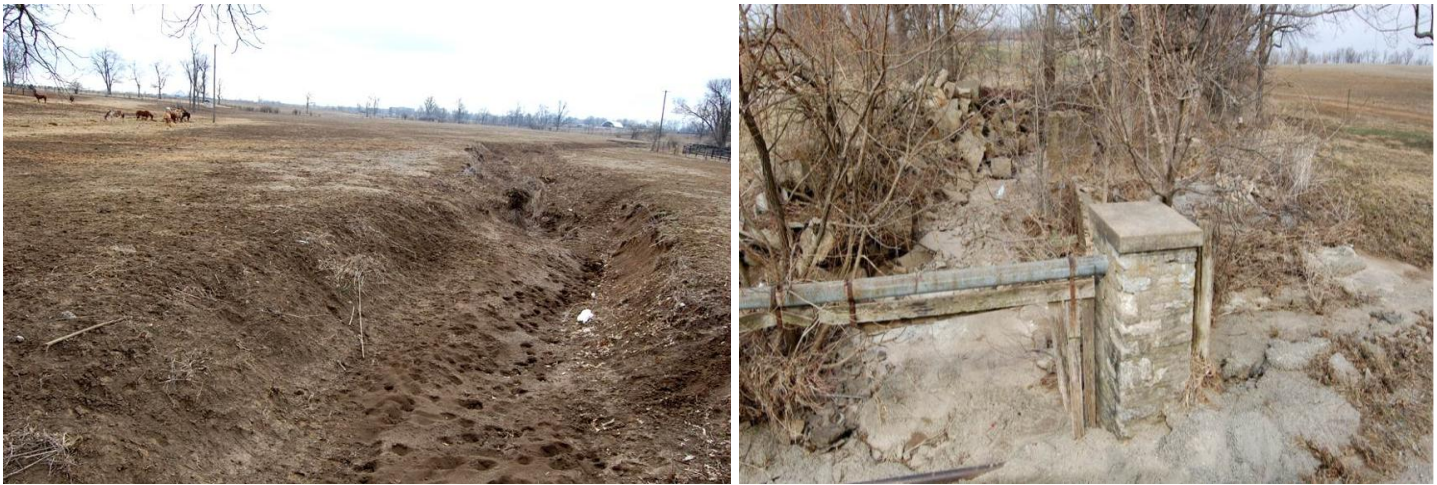
Figure 119. Erosion caused by a low water bridge; Concrete used to prevent erosion near low water bridge

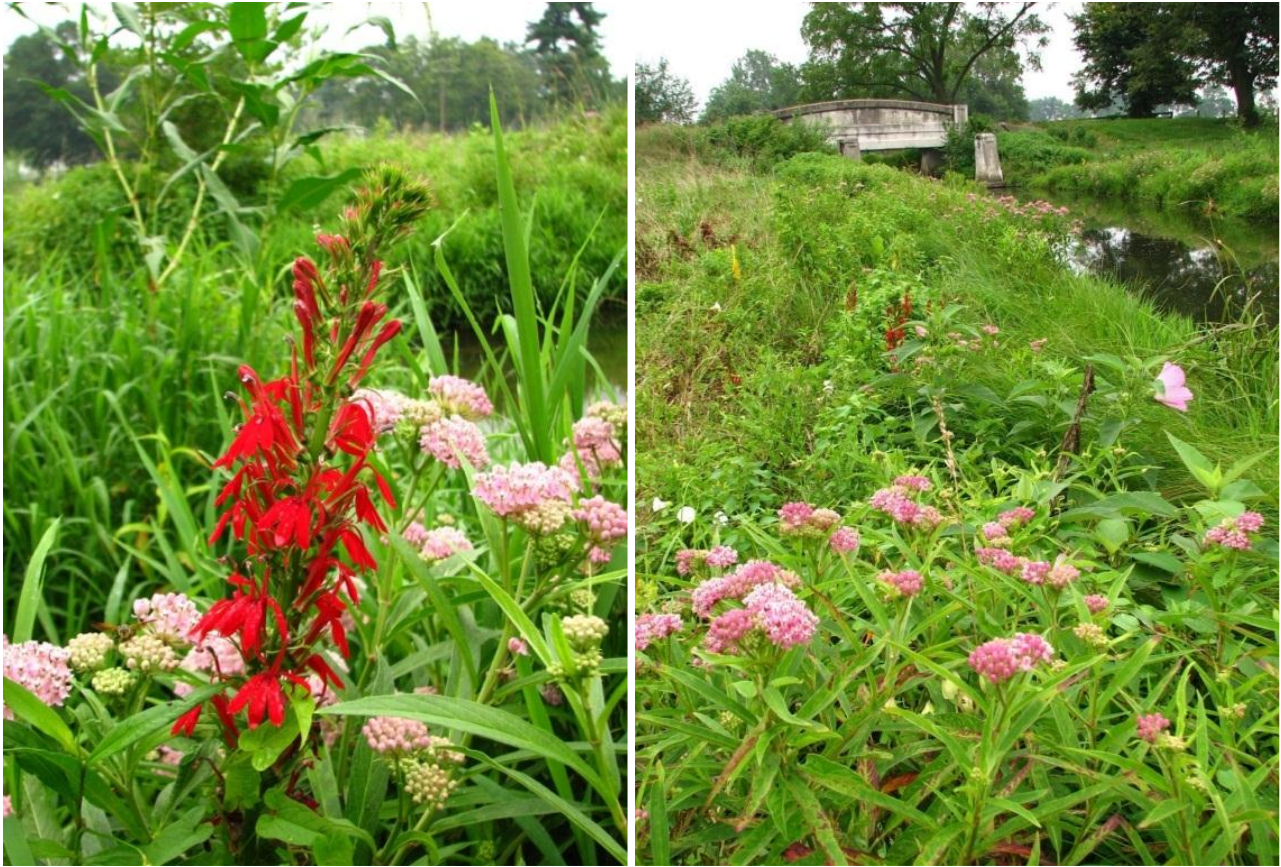
Figure 132. Cardinal Flower and Swamp Milkweed planted within a no-mow zone; Plantings of Cardinal Flower and Rose Mallow increase biodiversity

In the fall of 2010, approximately 1,600 Kentucky native perennials and grasses were planted within a 3,800 ft² section of the riparian buffer along the main tributary that runs through the University's North Farm (Figure 132). This will not only to improve aesthetics and acceptance of the no-mow buffer, which filters pollutants in runoff such as nutrients, bacteria, and sediment, but also will increase natural biodiversity and restore plants that would typically be found along a Central Kentucky stream corridor. Many of these plants will provide food and habitat for birds, butterflies, pollinators and aquatic organisms.

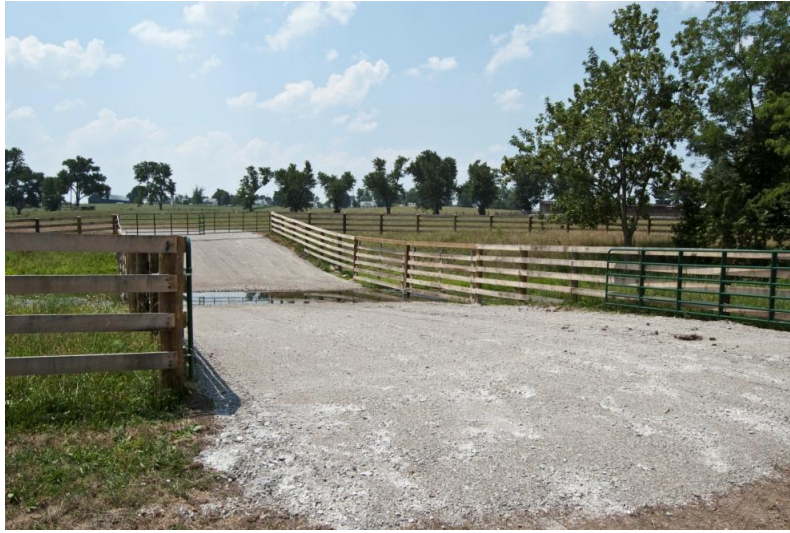
Figure 134. This hardened stream crossing prevents damage from livestock crossing

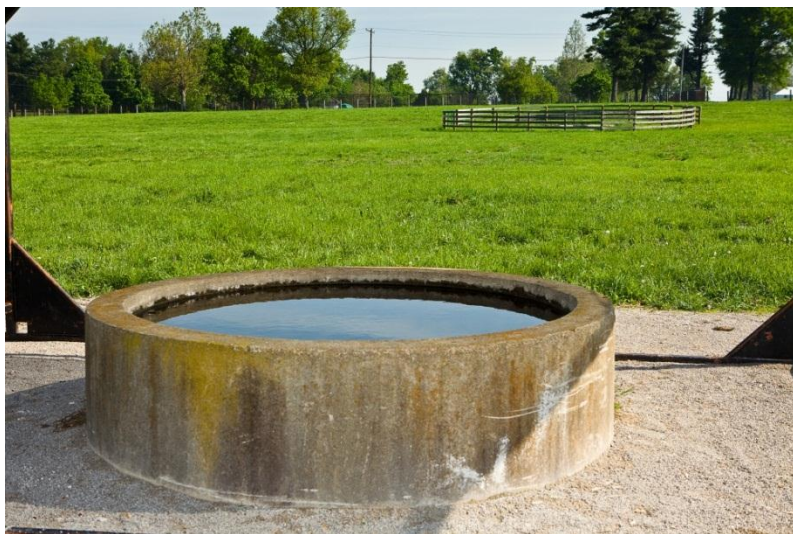
Figure 135. This watering tank is fed by the fenced developed spring in the background.

A developed spring was installed in a veterinary sciences paddock on UK's Experiment Station in 2008 and 2009 (Figure 135). Developing a spring as an alternative water source allows livestock to be excluded from the creek, which decreases bacteria, sediment, and nutrient loading, while still using a local, low-cost water source. Development of a spring can also remove excess water from a saturated area within the pasture, allowing the area to be safely grazed by livestock while also providing drinking water for the livestock. Spring developments may also improve the ability to implement rotational grazing, which can increase overall pasture productivity and conserve soil resources. The developed spring and several other implemented BMPs in this catchment can be seen in Figure 136.

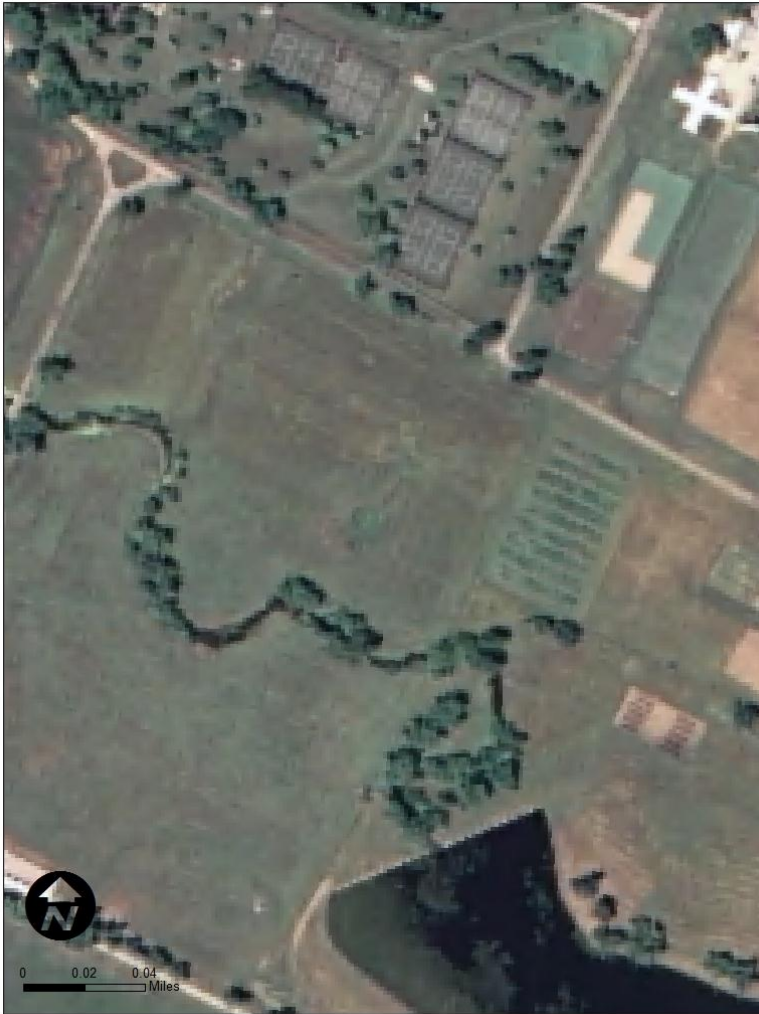
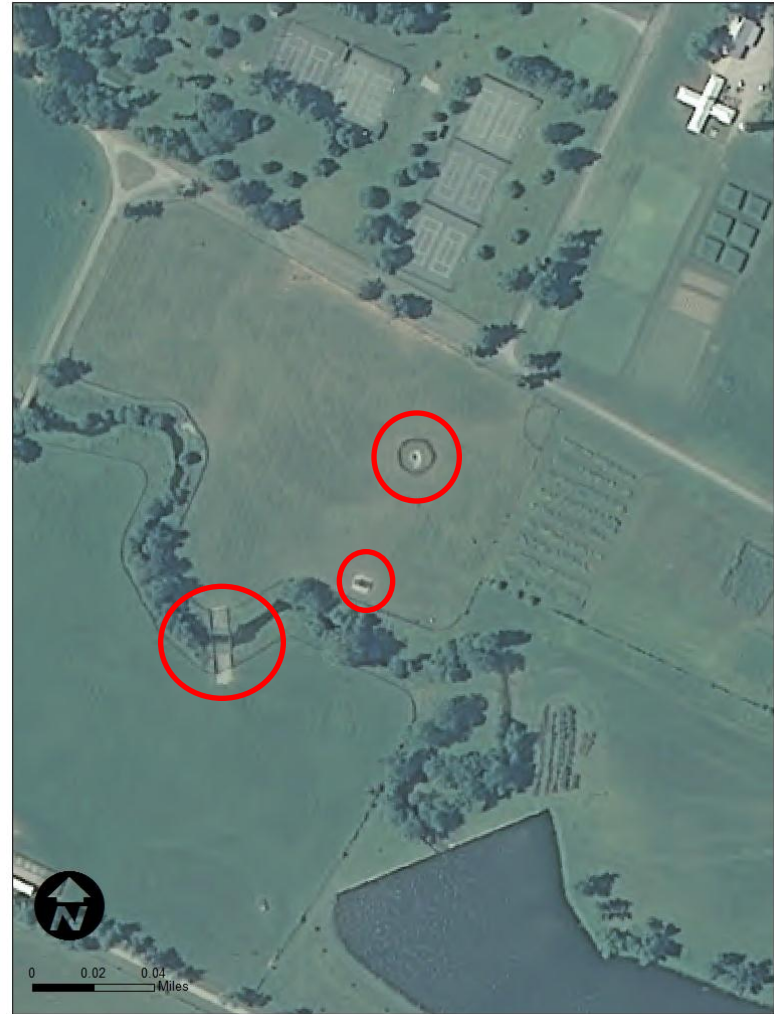
Figure 136. This comparison of 2006 (left) and 2010 (right) shows the implementation of a stream crossing, livestock exclusion, and spring development.

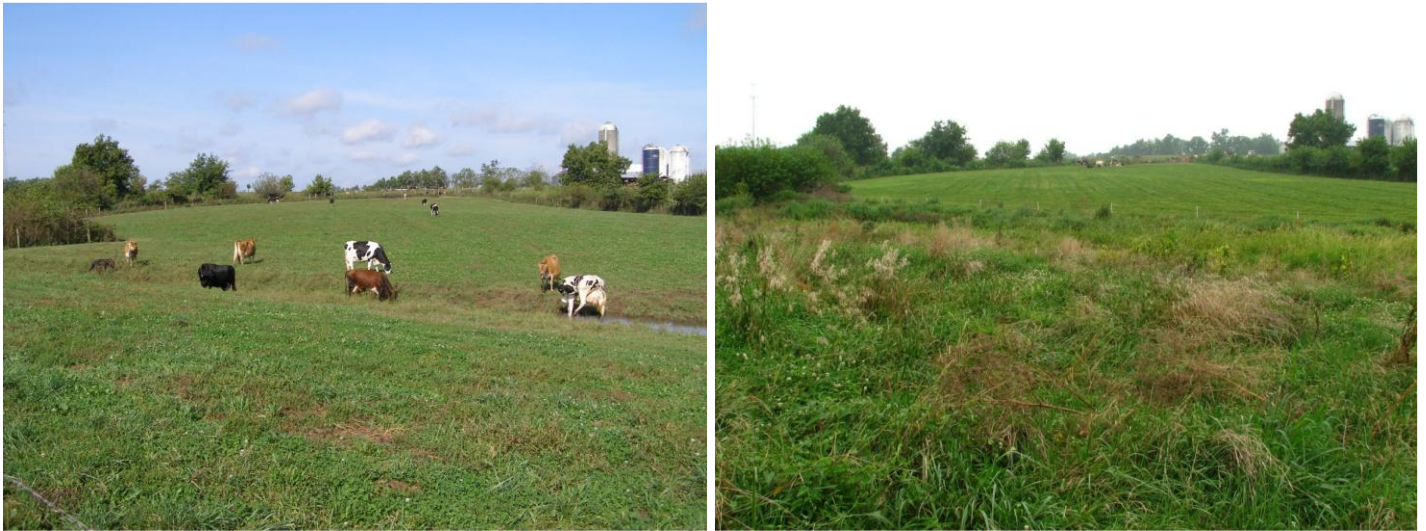
Figure 137. Livestock grazing in creek before exclusion; Enhanced riparian area after removal of livestock

In February 2010, dairy cows were restricted from a creek section running through their paddock, to which they had previously enjoyed full access, and a 30-foot riparian buffer was created (Figure 137). Shortly afterwards, ponies in a paddock controlled by Veterinary Sciences, were restricted from a creek section. In the spring of 2010, the dairy cows were fenced off from a tributary of the Cane Run. The restricted area includes a thirty-foot buffer that will be maintained in vegetation. All together, these projects totaled about 6,000 feet of protected stream bank, and considering that cattle like to loaf in the stream, this practice will greatly reduce the bacteria, nutrient, and sediment loading that was occurring on this stream section.

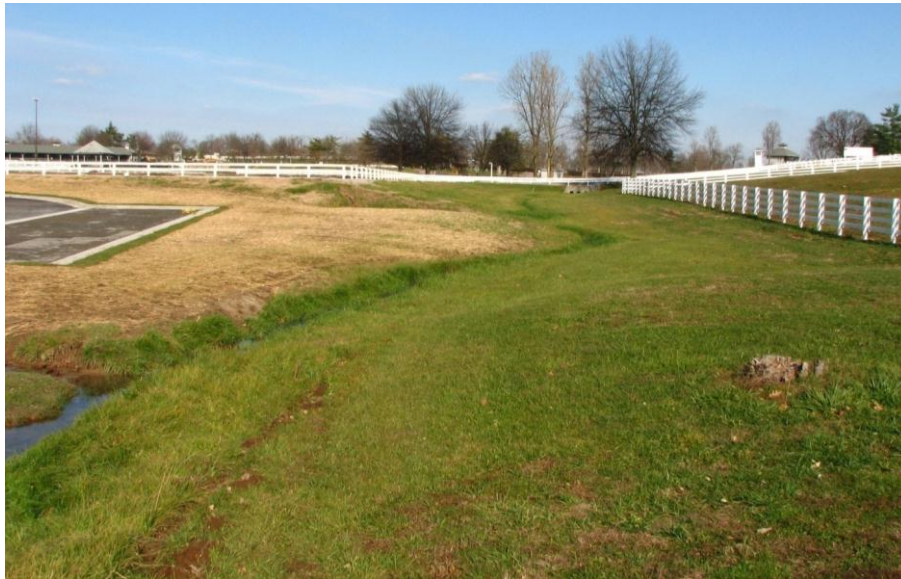
Figure 149. A Cane Run tributary before the installation of a vegetated riparian buffer

In the spring of 2010, a streamside vegetative buffer was planted along an unnamed tributary of Cane Run on Kentucky Horse Park property that was previously mowed to the banks (Figure 149). Streamside vegetation, including trees, grasses, and wildflowers, was established in order to prevent bank erosion and reduce the nutrient, bacteria, and sediment run-off from adjacent horse paddocks and the parking lot. All plants that were planted are native to Kentucky. In addition to the plants, a path along the stream was constructed, and educational signs were placed along the path.

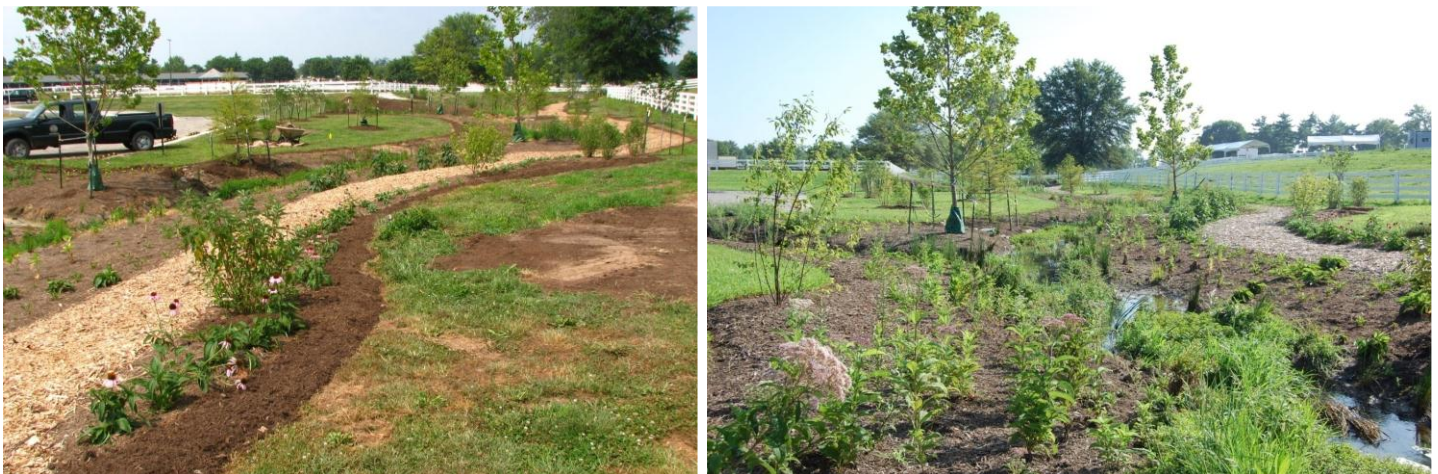
Figure 150. The streamside vegetated buffer along a tributary of the Cane Run under construction and completed

This project uses trees, shrubs, and wildflowers along the stream to filter out sediment and trash from roads, parking areas and arenas, as well as reduce some of the excessive nutrients in the tributary from manure (Figure 150). This planting will also have additional water quality benefits. The dense root systems will hold soil in place to reduce bank erosion. Increased tree and shrub canopy along the banks will help shade and cool waterways to increase dissolved oxygen for aquatic organisms. The native planting will reduce mowing as well as provide a food source and breeding habitat for birds, butterflies, essential pollinators and aquatic organisms.

The installation of the Kentucky Horse Park streamside vegetative buffer strip consisted of planting over 9,000 ft² with 39 trees, over 100 willow stakes, 77 shrubs and 4,000 wildflowers, grasses, rushes and sedges. On May 10, 2010, planting of the wildflowers was undertaken with 25 volunteers from a variety of organizations

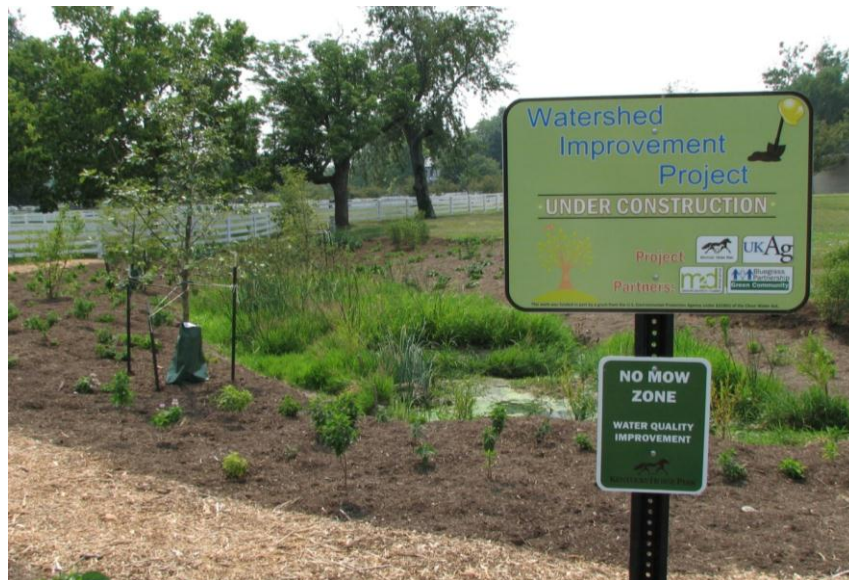
Figure 151. Educational signage placed at the KHP streamside vegetated buffer

In addition to the attractive plants, the project includes a path through the buffer, interpretative signs, and brochures about the project (Figure 151). The literature available at the project site will not only help inform the general public, but also will help horse owners learn how they can create their own streamside plantings. Robinson Scholars also toured the project as part of their watershed training. The education and outreach potential of this site will have some of the highest visibility for years to come. For more information about the education and outreach conducted at this site, see Chapter IX.

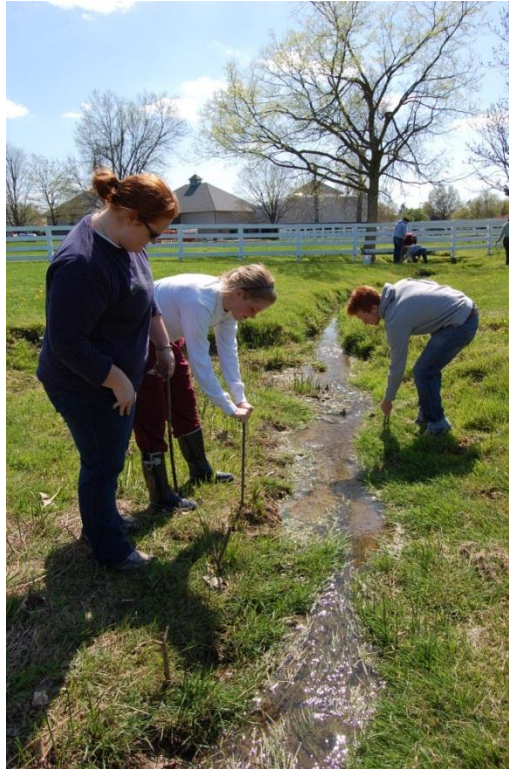
Figure 177. Students in a UK service fraternity planting willow stakes

- In March and April 2010, UK employees associated with the Cane Run Watershed Project worked with KY Horse Park and M2D Designers on education/outreach component of the stream vegetation project at the Horse Park.
- UK employees associated with the Cane Run Watershed Project hosted students from UK's Alpha Phi Omega service fraternity at the Kentucky Horse Park. Students installed willow stakes at the riparian buffer vegetation project site April 9, 2010 (Figure 177).

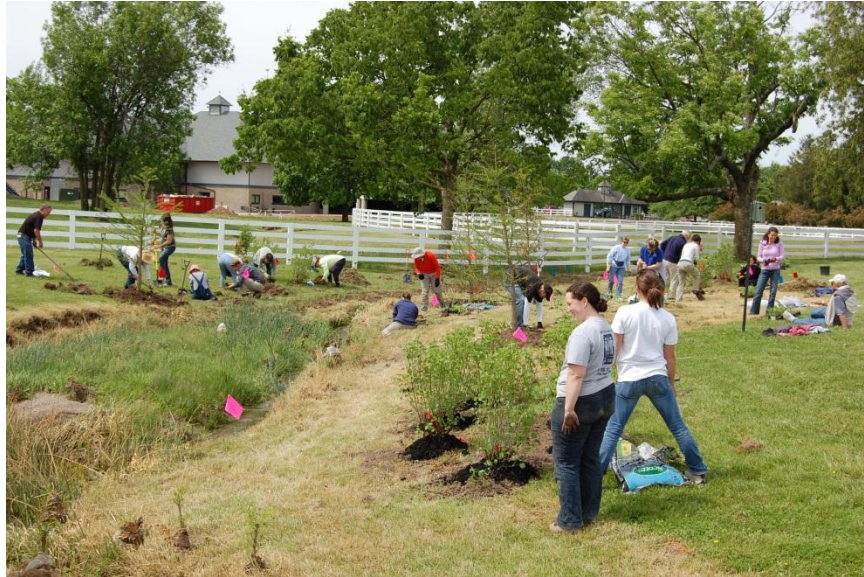
Figure 178. Volunteers planting a riparian buffer at the Kentucky Horse Park

- UK employees associated with the Cane Run Watershed Project conducted a volunteer planting event for the stream vegetation project at the Kentucky Horse Park on May 10, 2010 (Figure 178).

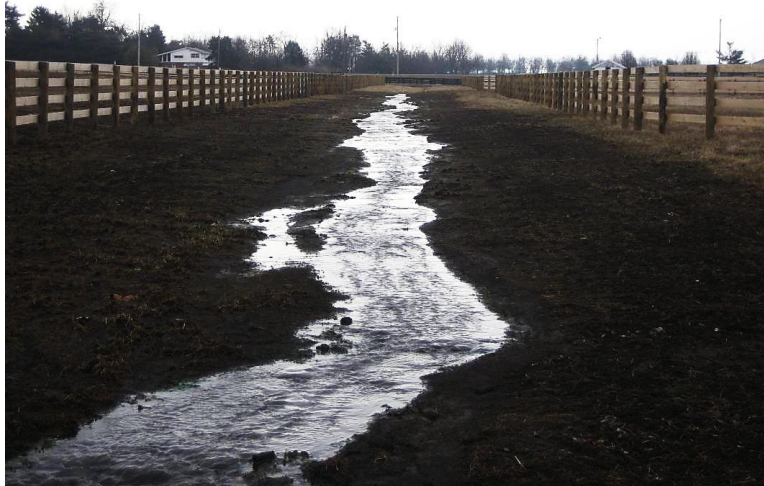
Figure 182. This stream on UK's Experiment Station will be restored as part of research.

A project titled “Examining the Effects of Stream Restoration and Riparian Buffer Development on Water Quality of a Small Spring-Fed Stream” will begin on the Experiment Station. The objective of this project is to evaluate the effect of restoring a small spring-fed channel (drainage area of 0.2 mi²), which was degraded by intensive horse-grazing and farm machinery traffic, on water quality (Figure 182). This project is being funded through a NRCS earmark project titled “Development and Implementation of Stream Restoration and Riparian Corridor Techniques for Enhancing Water Quality in the Cane Run Watershed.”
