Memo from Mountain Studies Institute

Continued 416 Fire water quality monitoring results from Hermosa Creek and Animas River

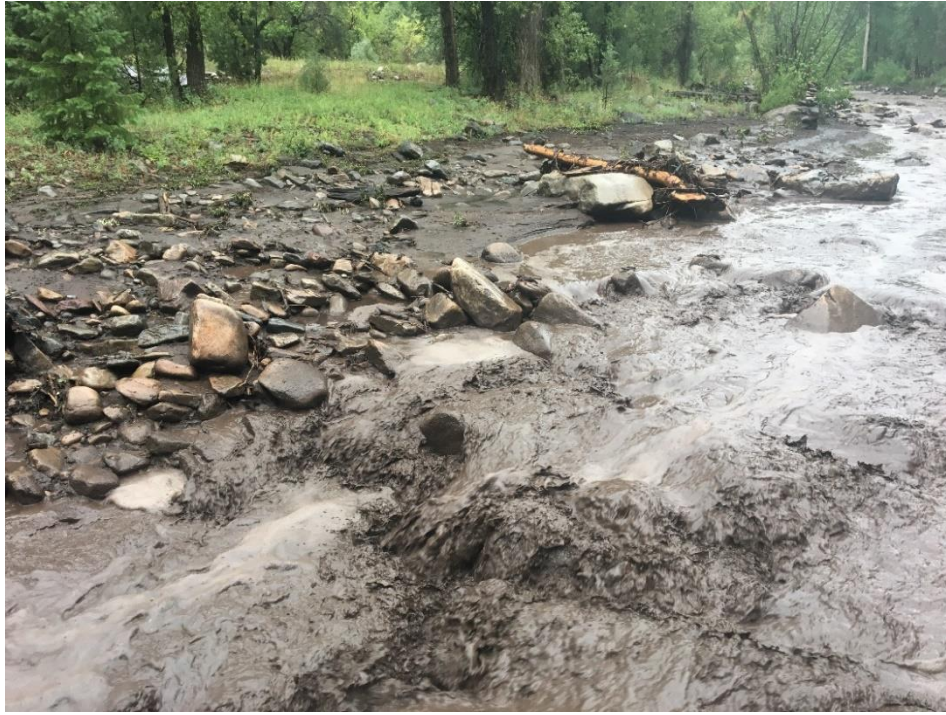
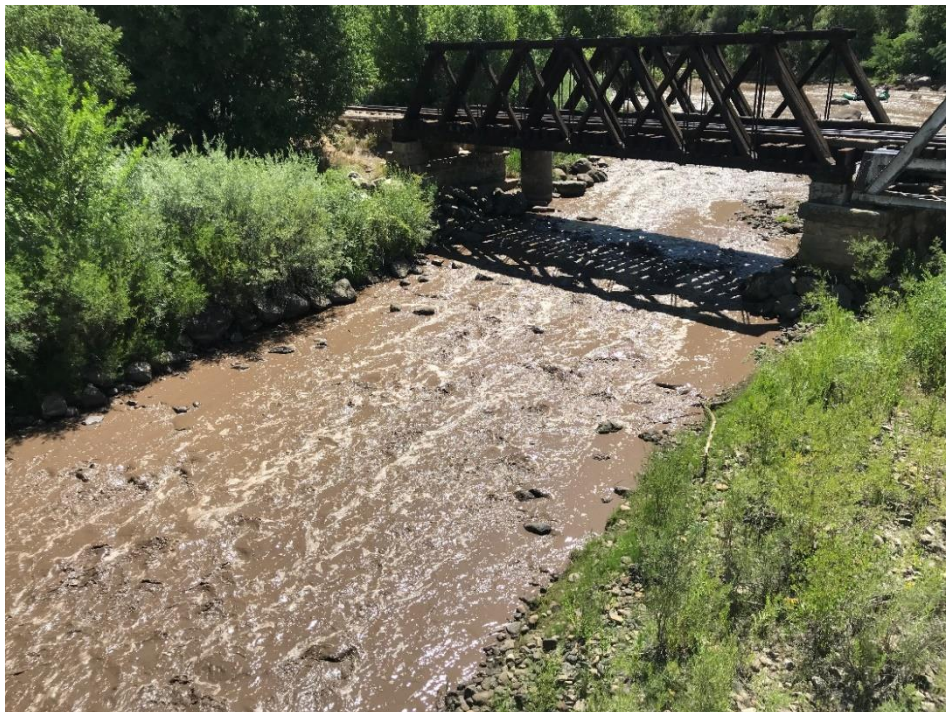
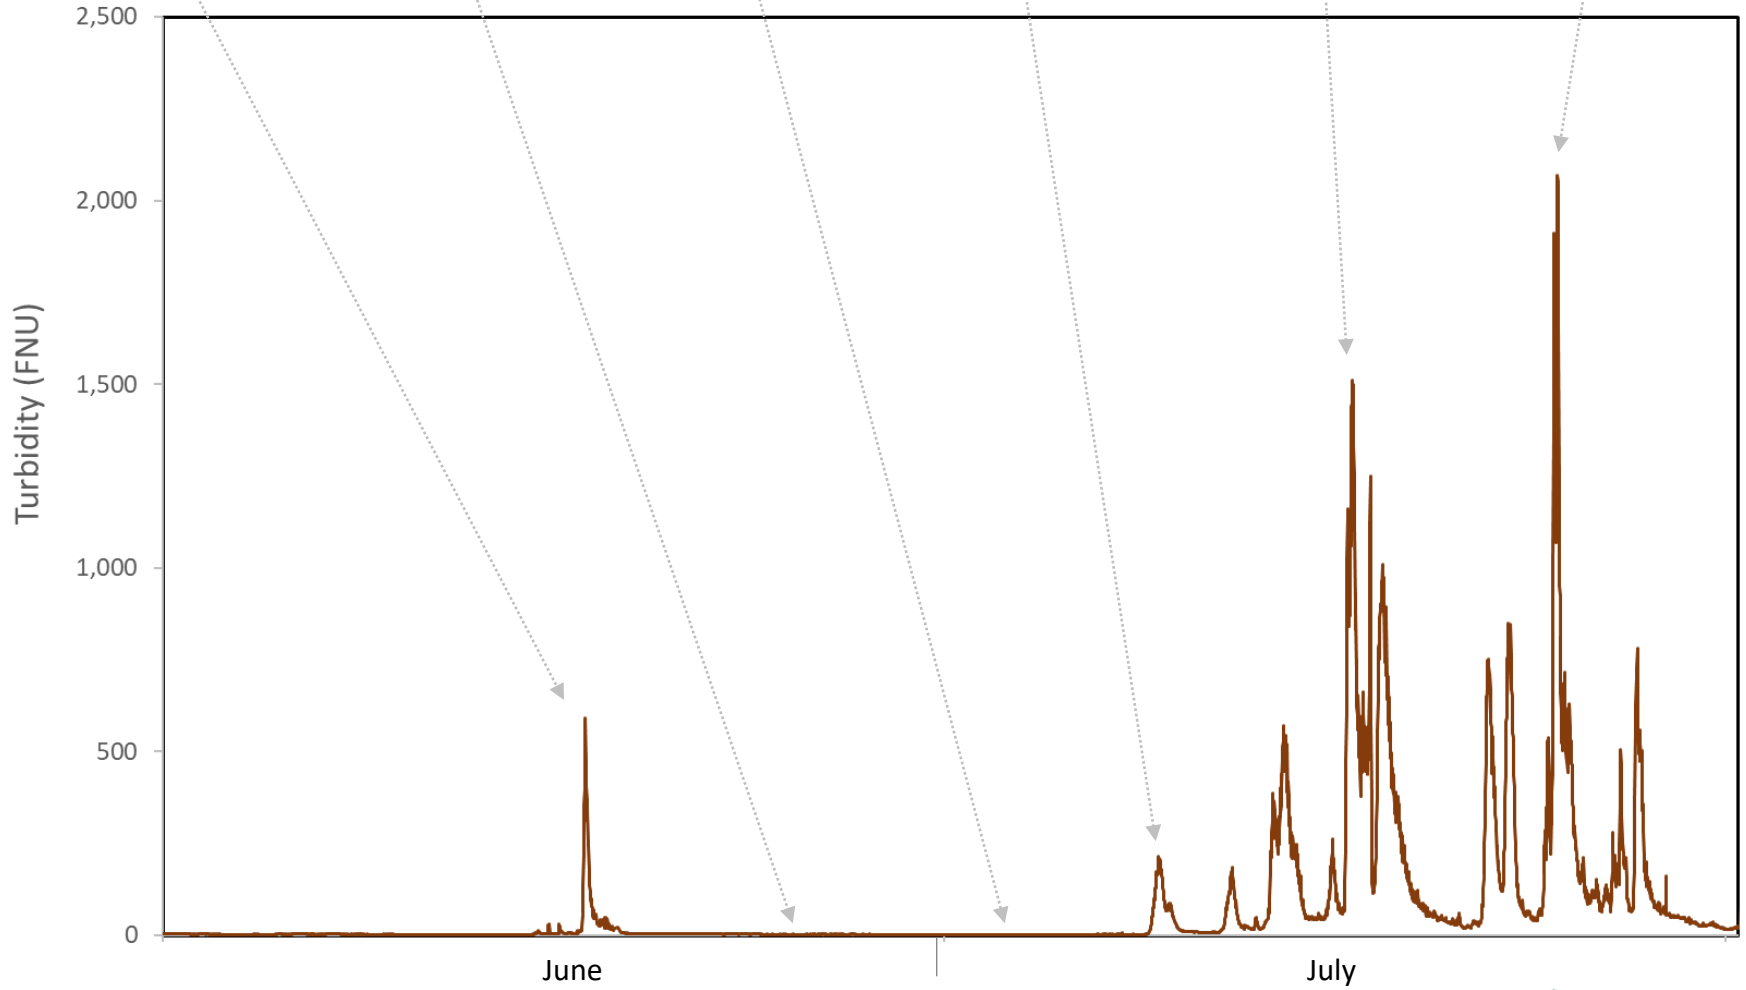
Figure 1

Hermosa Creek on July 24, 2018

Animas River at Rotary Park on July 25, 2018

Turbidity, Animas River at Durango, CO (USGS): June-July, 2018 and photos illustrating a subset of MSI sampling dates

- The highest concentration of nearly every water quality parameter was observed at Hermosa Creek after precipitation events that occurred on 7/16 and 7/24. These events caused debris flows, flooding, and closure of local roads.

- For example, the concentration of total aluminum observed in the Animas River at Rotary Park on July 25th was 37 times higher than the acute standard set to protect aquatic life from brief, short-term exposure and 260 times higher than the chronic standard set to protect aquatic life from persistent, long-term exposure.

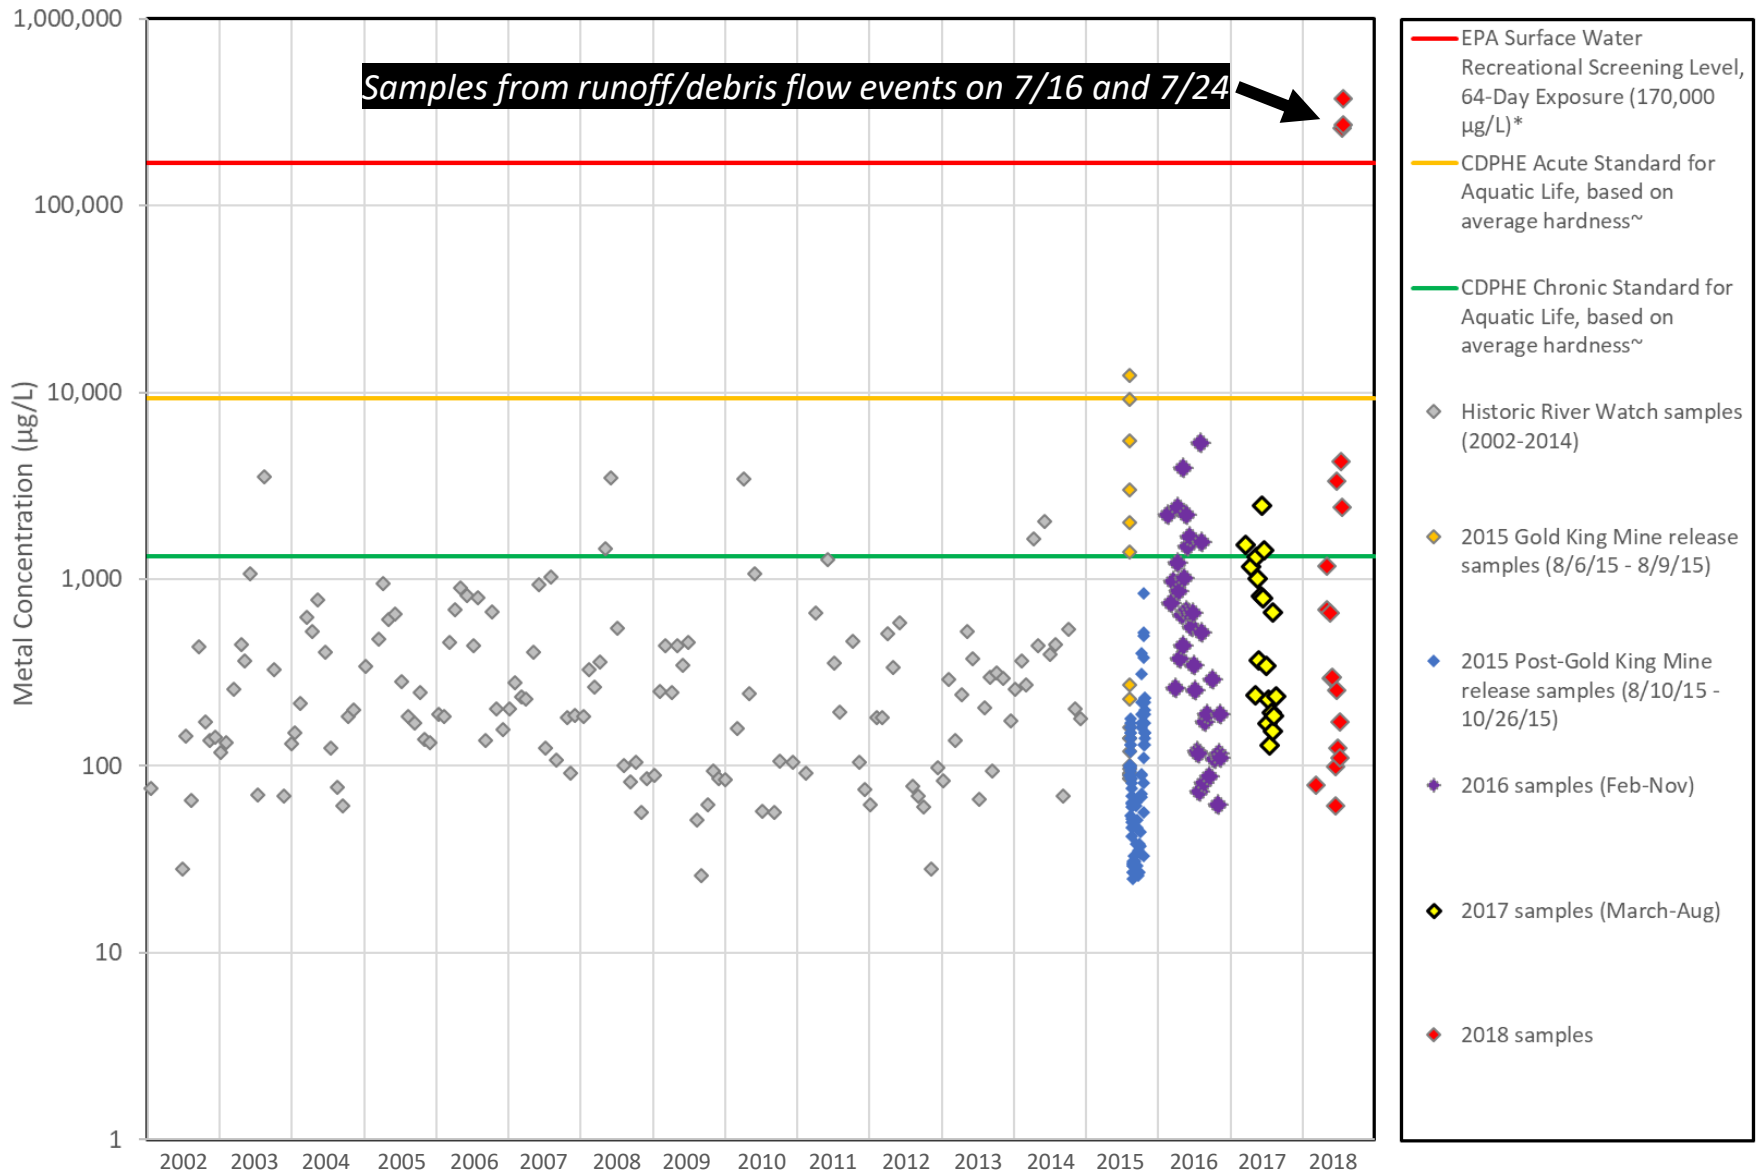
Total Aluminum, Animas River at Durango, CO: 2002-2018

~Colorado Department of Public Health and the Environment (CDPHE) standards based on Colorado surface water quality classifications and Reg. 31 and 34. Standards vary with water hardness and are plotted here using an average water hardness of the Animas River at this location, 208 mg/L.

Note: 2002 - 2014 data is River Watch data from the Animas River at the fish hatchery in Durango, CO. 2015-18 data is Mountain Studies Institute data from the Animas River at Rotary Park in Durango, CO

- Were the observed post-416 water quality parameters levels unprecedented for Hermosa Creek and the Animas River? Our ability to answer this question is reliant on the existence of water quality data collected in previous years prior to the 416 Fire. There is limited historical storm event water quality data available from Hermosa Creek, and thus, it is difficult to know if the post-fire conditions were unprecedented. For the Animas River at Rotary Park, we can compare the post-fire levels of aluminum, iron, lead, and manganese to historical observations over the past decade from MSI and the Colorado River Watch program. Although we do not have enough post-416 Fire data yet to conduct statistical analysis, it is clear that during storm events following the 416 Fire, we have documented unprecedently high levels of aluminum, iron, and manganese in the Animas River at Rotary Park (Appendix A).

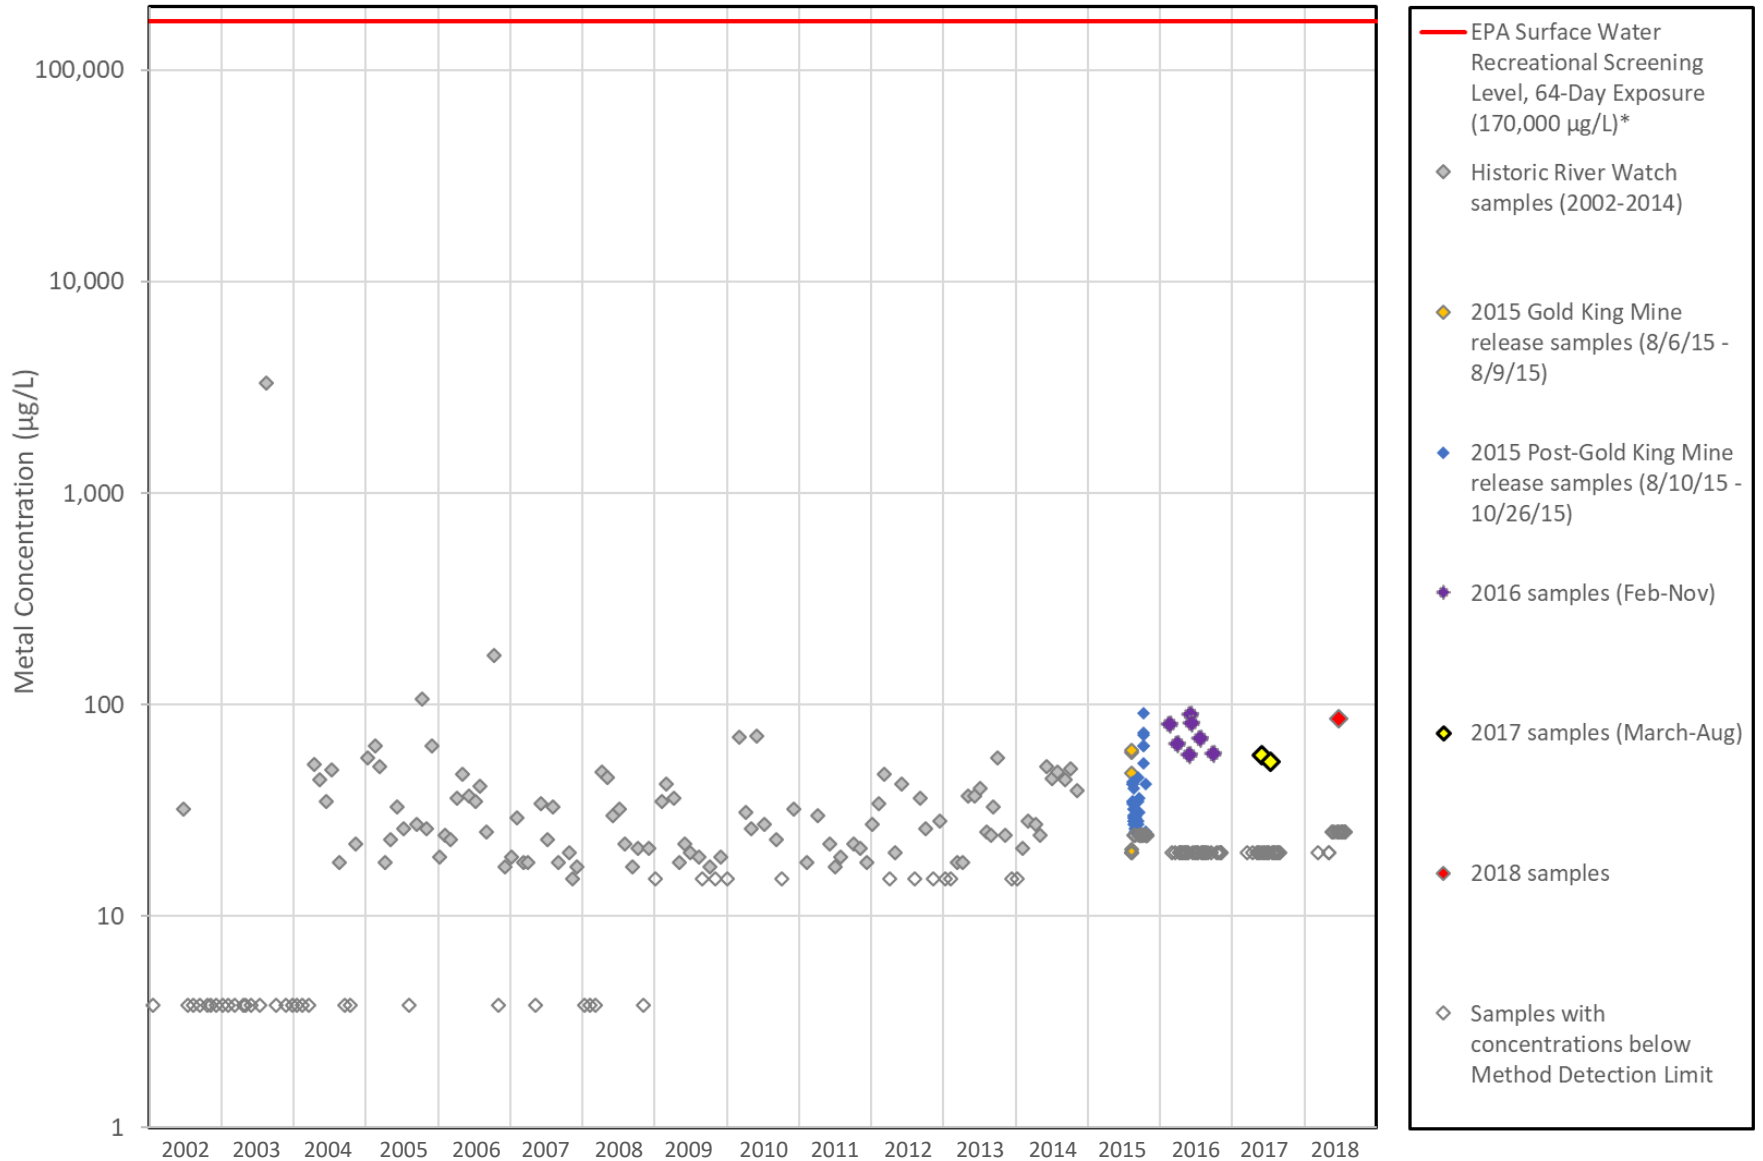
Dissolved Aluminum, Animas River at Durango, CO: 2002-2018

* The recreational screening level represents the level at which no adverse health effects are expected to occur in humans consuming 2L of water per day, from the Animas, orally, for 64 days each year for a total of 30 years.
 Note: 2002 - 2014 data is River Watch data from the Animas River at the fish hatchery in Durango, CO. 2015-18 data is Mountain Studies Institute data from the Animas River at Rotary Park in Durango, CO

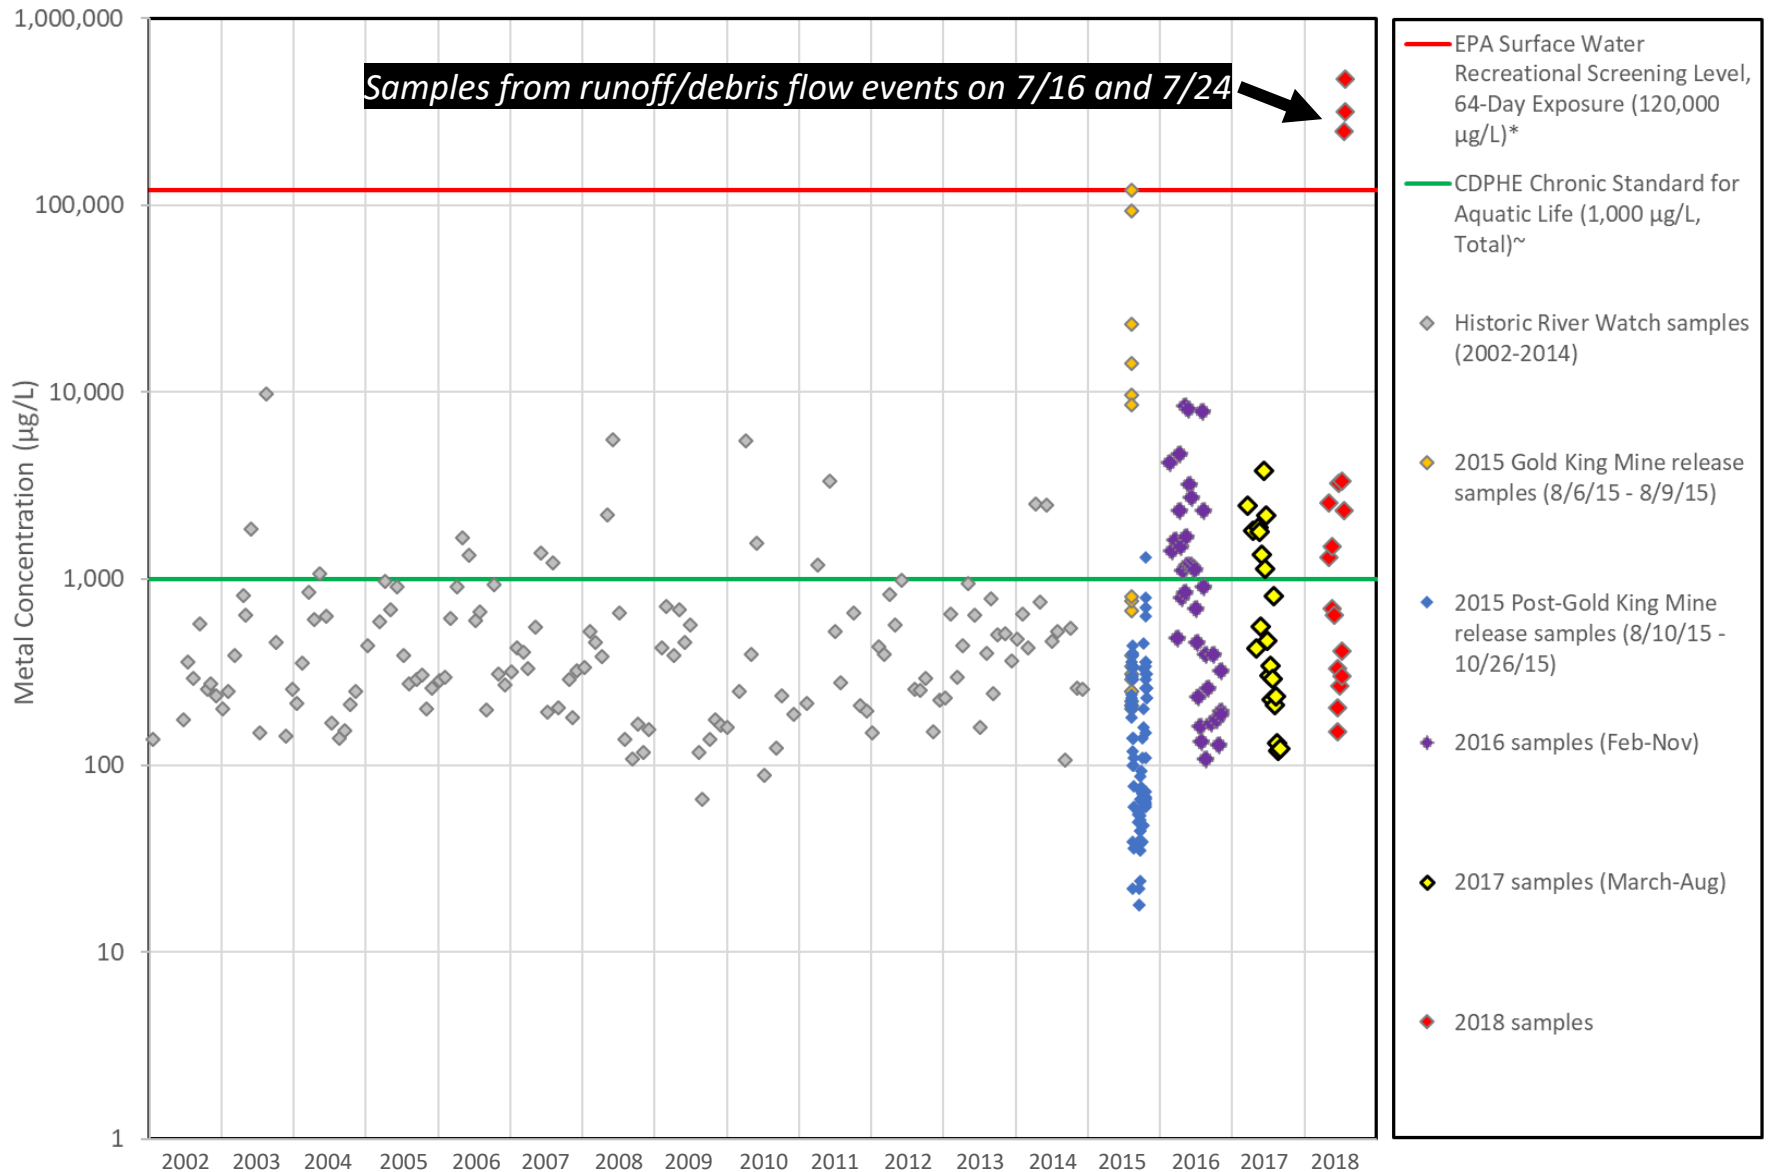
Total Iron, Animas River at Durango, CO: 2002-2018

~Colorado Department of Public Health and the Environment (CDPHE) standards based on Colorado surface water quality classifications and Reg. 31 and 34.

Note: 2002 - 2014 data is River Watch data from the Animas River at the fish hatchery in Durango, CO. 2015-18 data is Mountain Studies Institute data from the Animas River at Rotary Park in Durango, CO

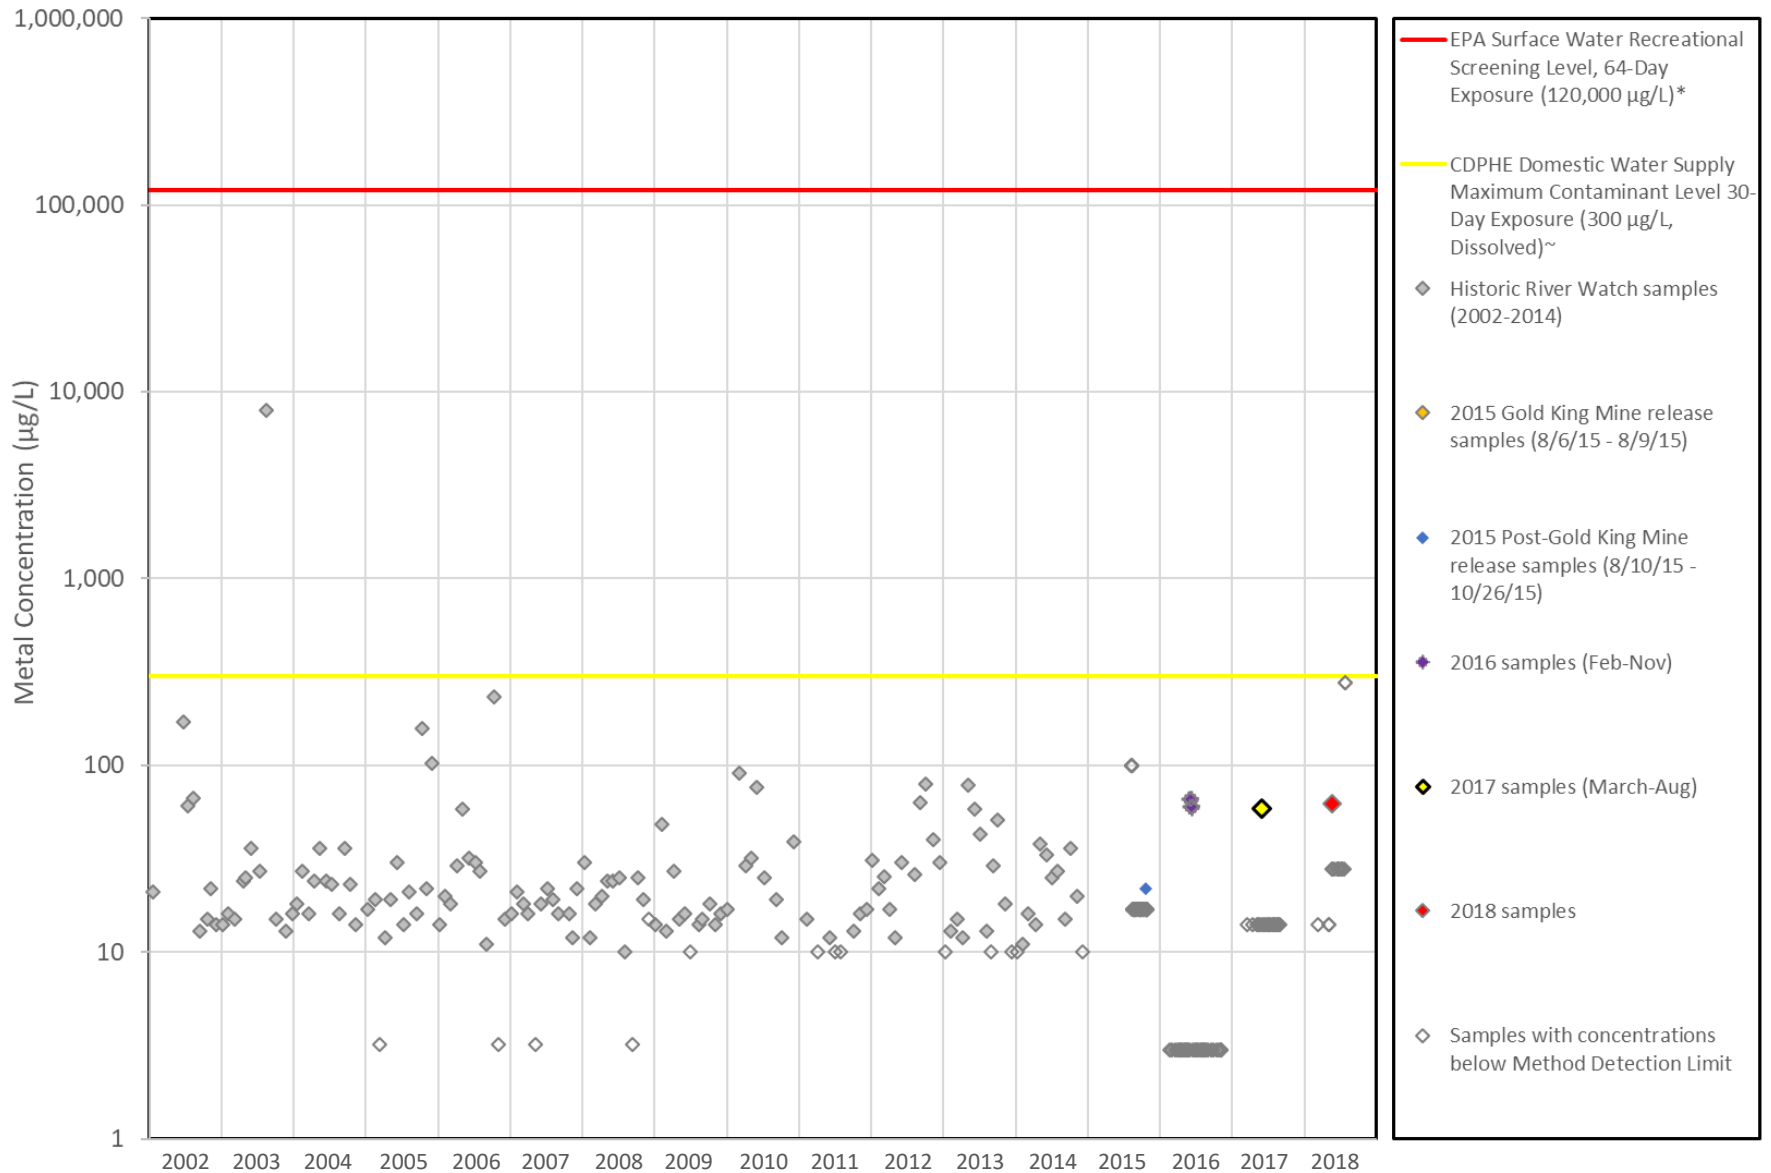
Dissolved Iron, Animas River at Durango, CO: 2002-2018

* The recreational screening level represents the level at which no adverse health effects are expected to occur in humans consuming 2L of water per day, from the Animas, orally, for 64 days each year for a total of 30 years.
 ~Colorado Department of Public Health and the Environment (CDPHE) standards based on Colorado surface water quality classifications and Reg. 31 and 34.
 Note: 2002 - 2014 data is River Watch data from the Animas River at the fish hatchery in Durango, CO. 2015-18 data is Mountain Studies Institute data from the Animas River at Rotary Park in Durango, CO

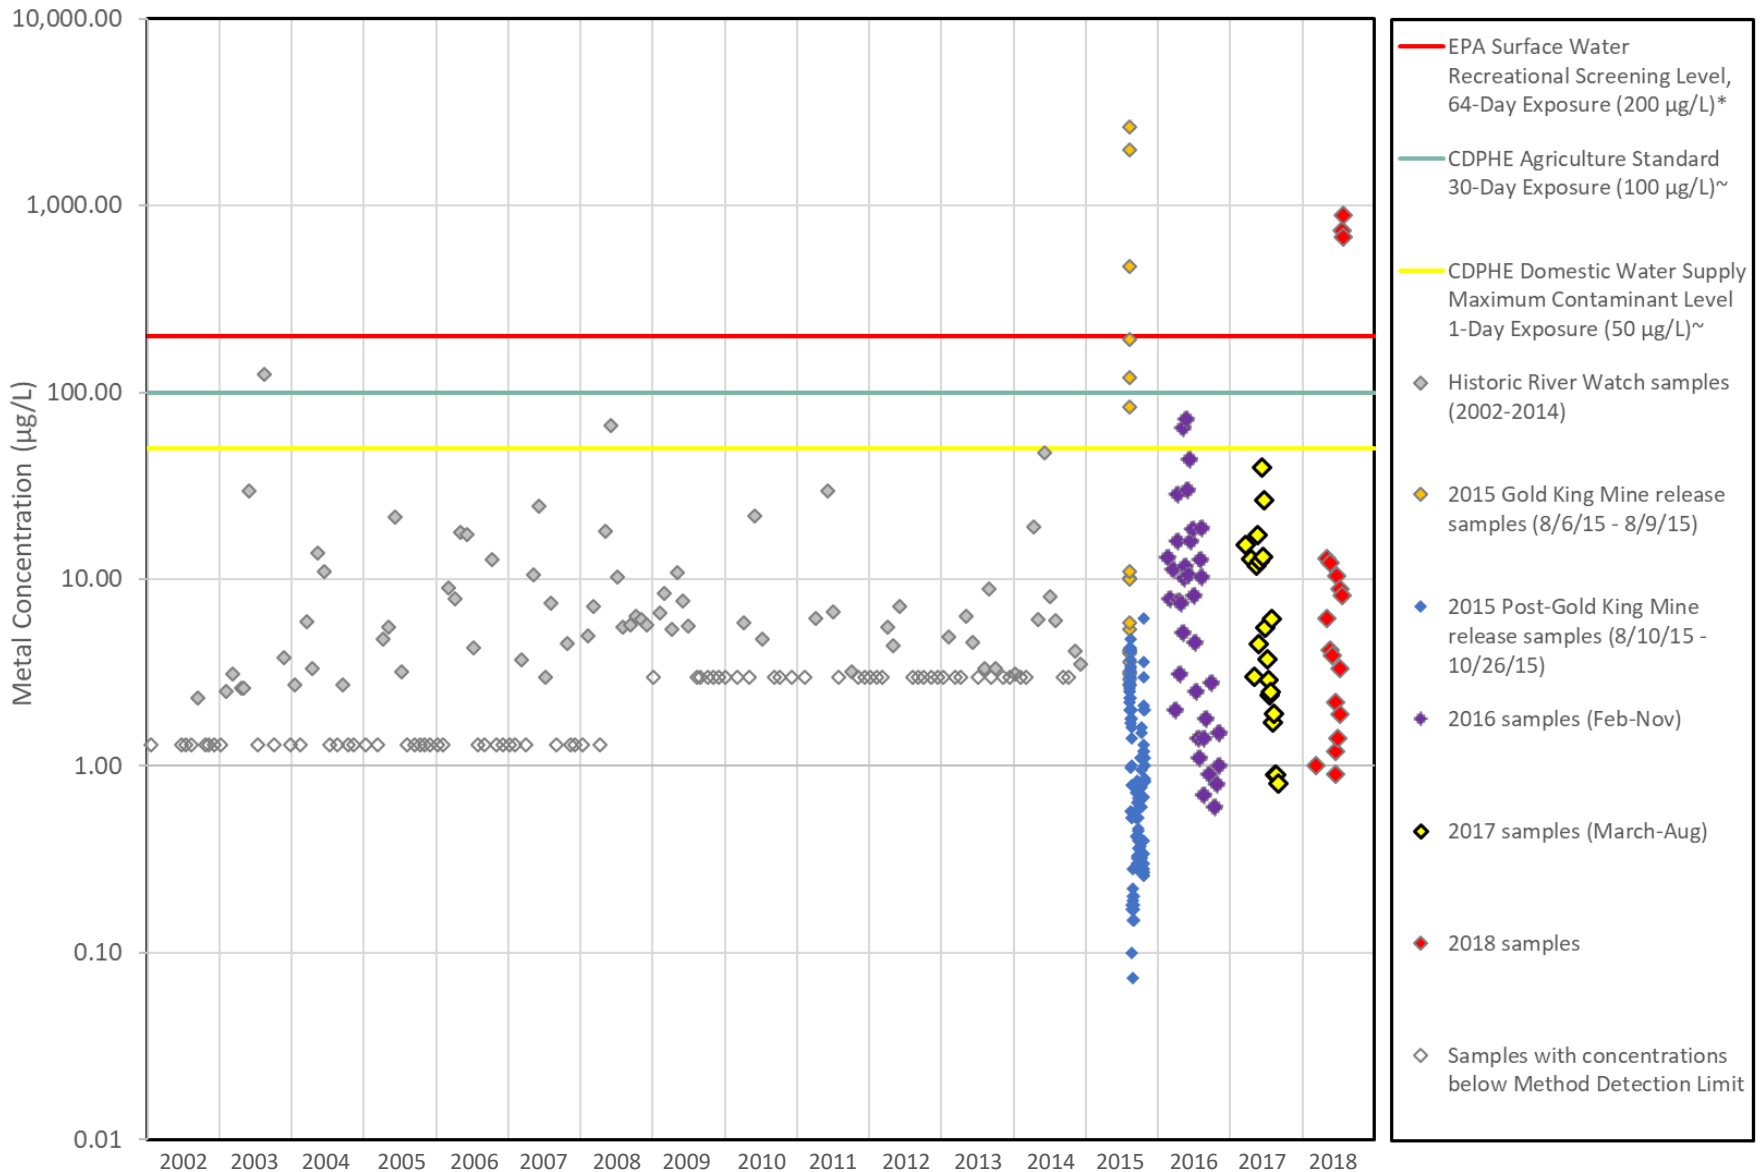
Total Lead, Animas River at Durango, CO: 2002-2018

~Colorado Department of Public Health and the Environment (CDPHE) standards based on Colorado surface water quality classifications and Reg. 31 and 34.

Note: 2002 - 2014 data is River Watch data from the Animas River at the fish hatchery in Durango, CO. 2015-18 data is Mountain Studies Institute data from the Animas River at Rotary Park in Durango, CO

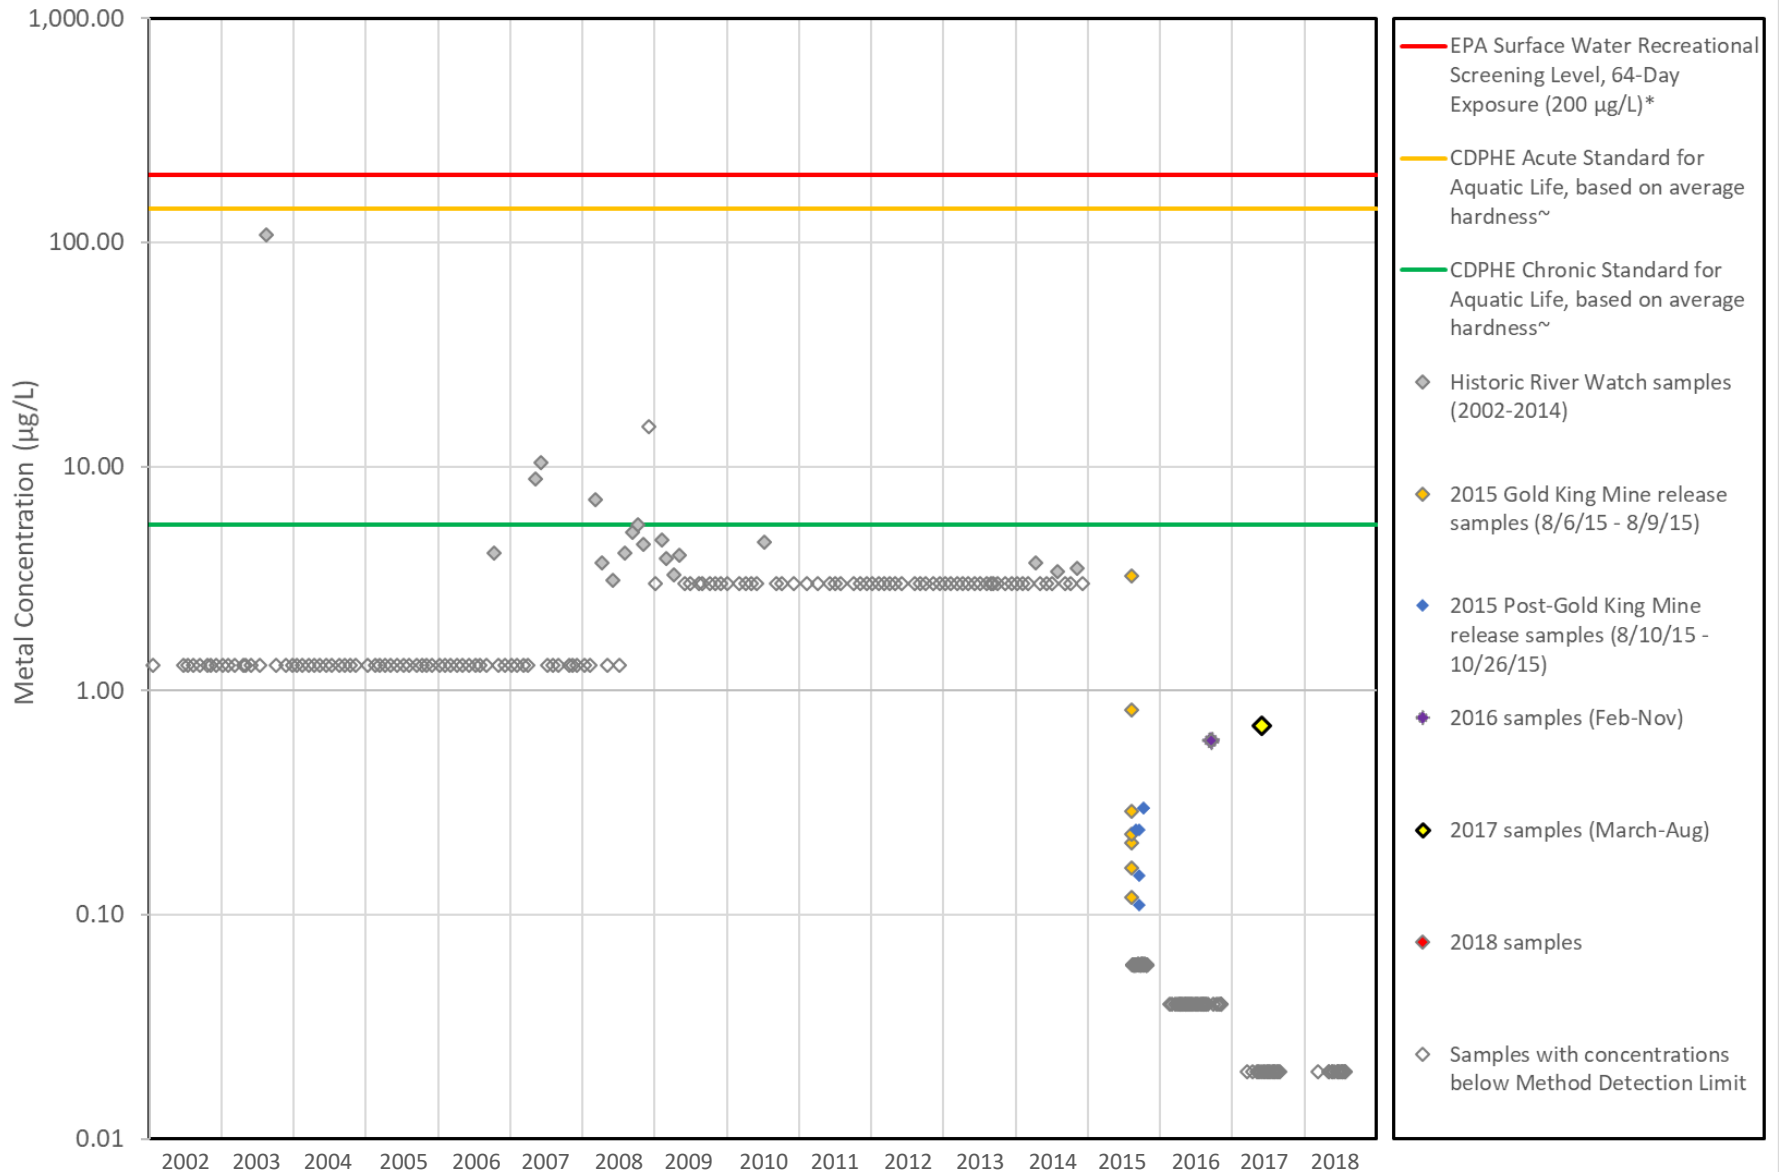
Dissolved Lead, Animas River at Durango, CO: 2002-2018

~Colorado Department of Public Health and the Environment (CDPHE) standards based on Colorado surface water quality classifications and Reg. 31 and 34. Standards vary with water hardness and are plotted here using an average water hardness of the Animas River at this location, 208 mg/L.

Note: 2002 - 2014 data is River Watch data from the Animas River at the fish hatchery in Durango, CO. 2015-18 data is Mountain Studies Institute data from the Animas River at Rotary Park in Durango, CO

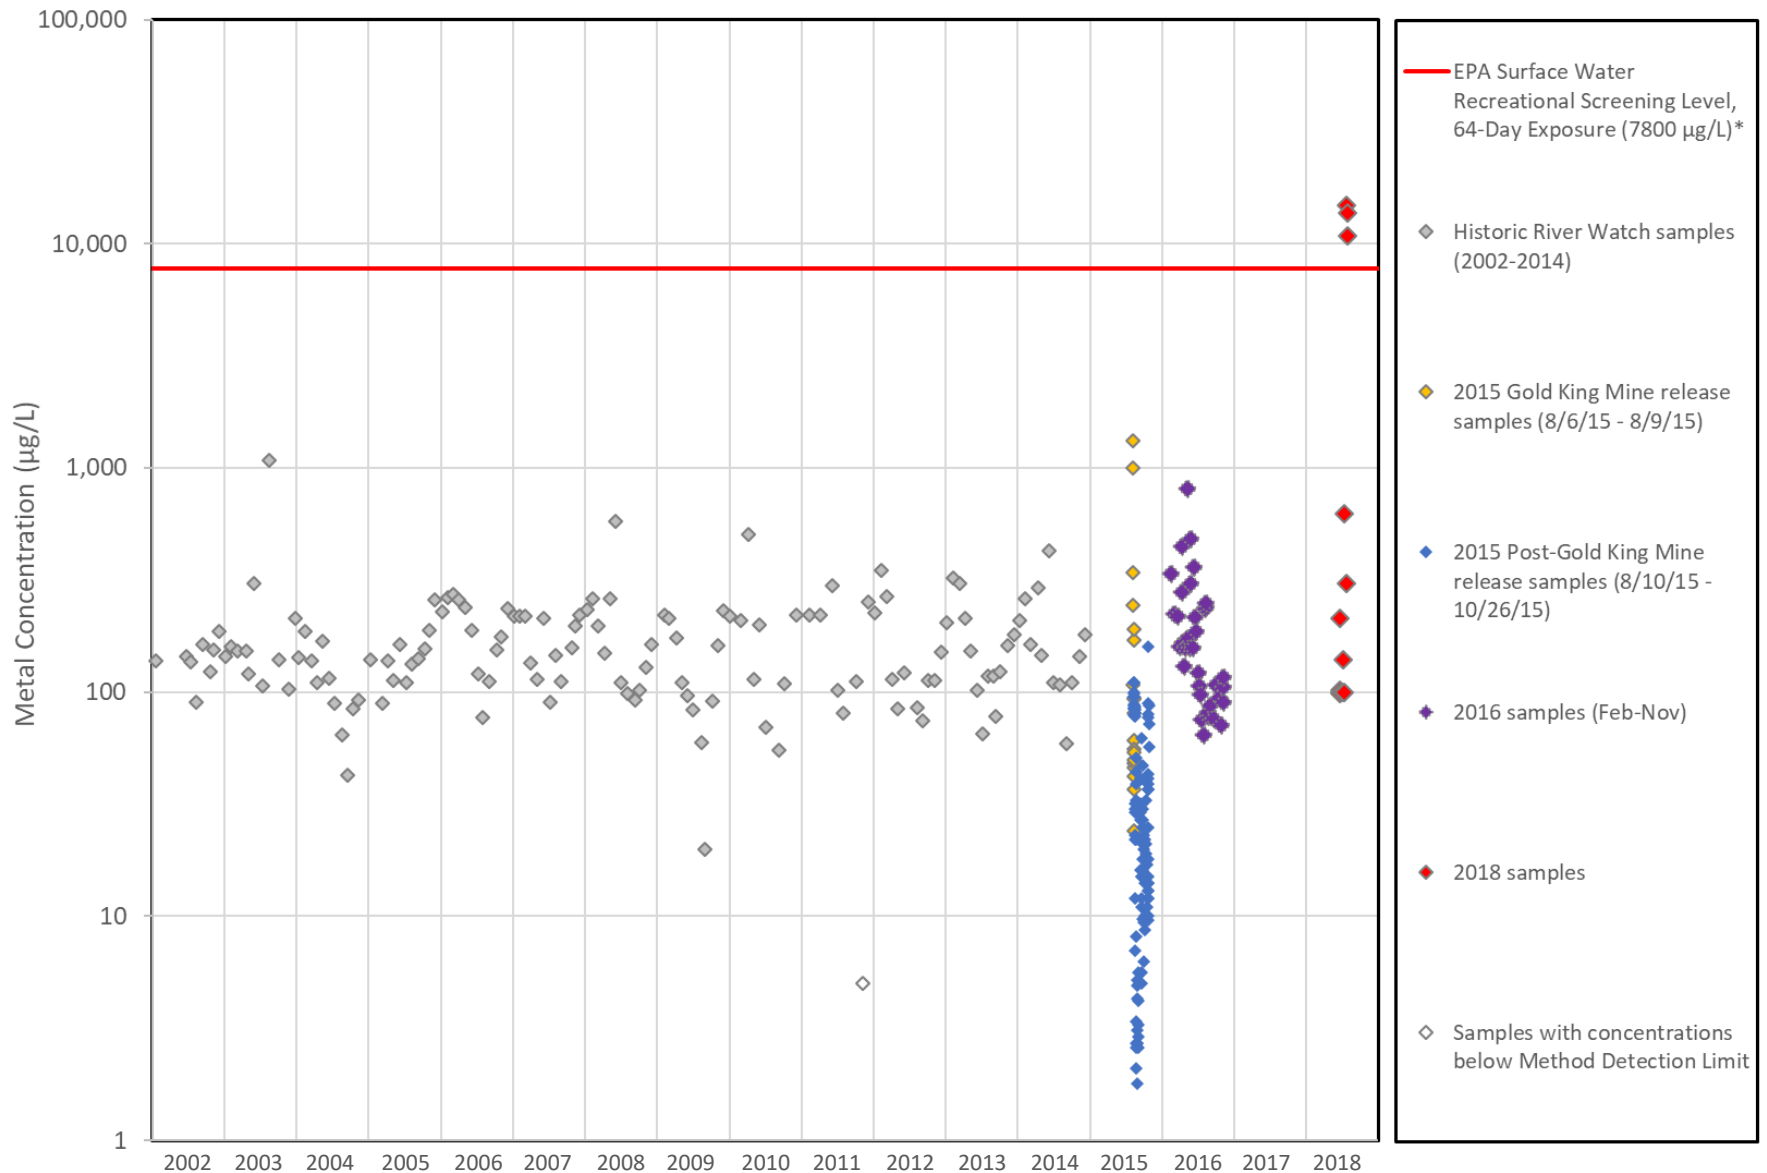
Total Manganese, Animas River at Durango, CO: 2002-2018

* The recreational screening level represents the level at which no adverse health effects are expected to occur in humans consuming 2L of water per day, from the Animas, orally, for 64 days each year for a total of 30 years.
 ~Colorado Department of Public Health and the Environment (CDPHE) standards based on Colorado surface water quality classifications and Reg. 31 and 34.
 Note: 2002 - 2014 data is River Watch data from the Animas River at the fish hatchery in Durango, CO. 2015-18 data is Mountain Studies Institute data from the Animas River at Rotary Park in Durango, CO

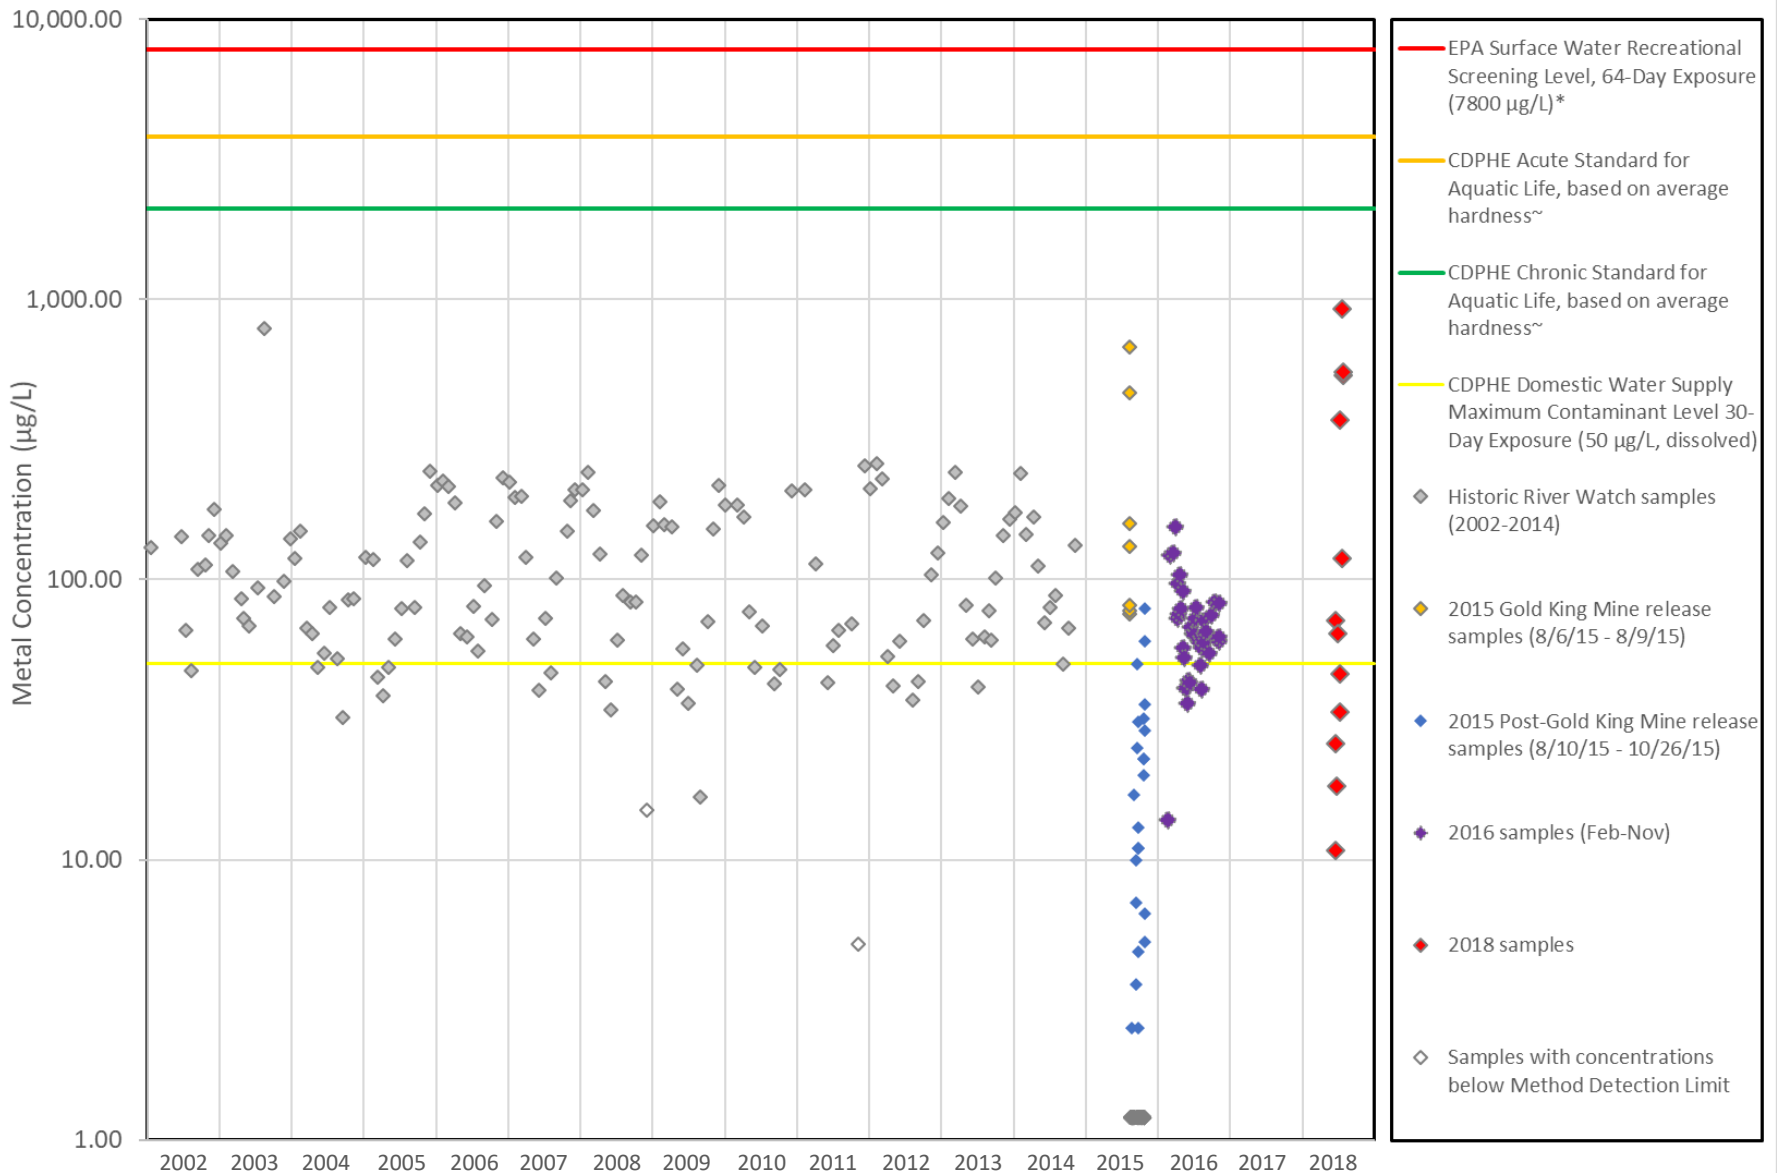
Dissolved Manganese, Animas River at Durango, CO: 2002-2018

~Colorado Department of Public Health and the Environment (CDPHE) standards based on Colorado surface water quality classifications and Reg. 31 and 34. Standards vary with water hardness and are plotted here using an average water hardness of the Animas River at this location, 208 mg/L.

Note: 2002 - 2014 data is River Watch data from the Animas River at the fish hatchery in Durango, CO. 2015-18 data is Mountain Studies Institute data from the Animas River at Rotary Park in Durango, CO
