Memo from Mountain Studies Institute

Continued 416 Fire water quality monitoring results from Hermosa Creek and Animas River

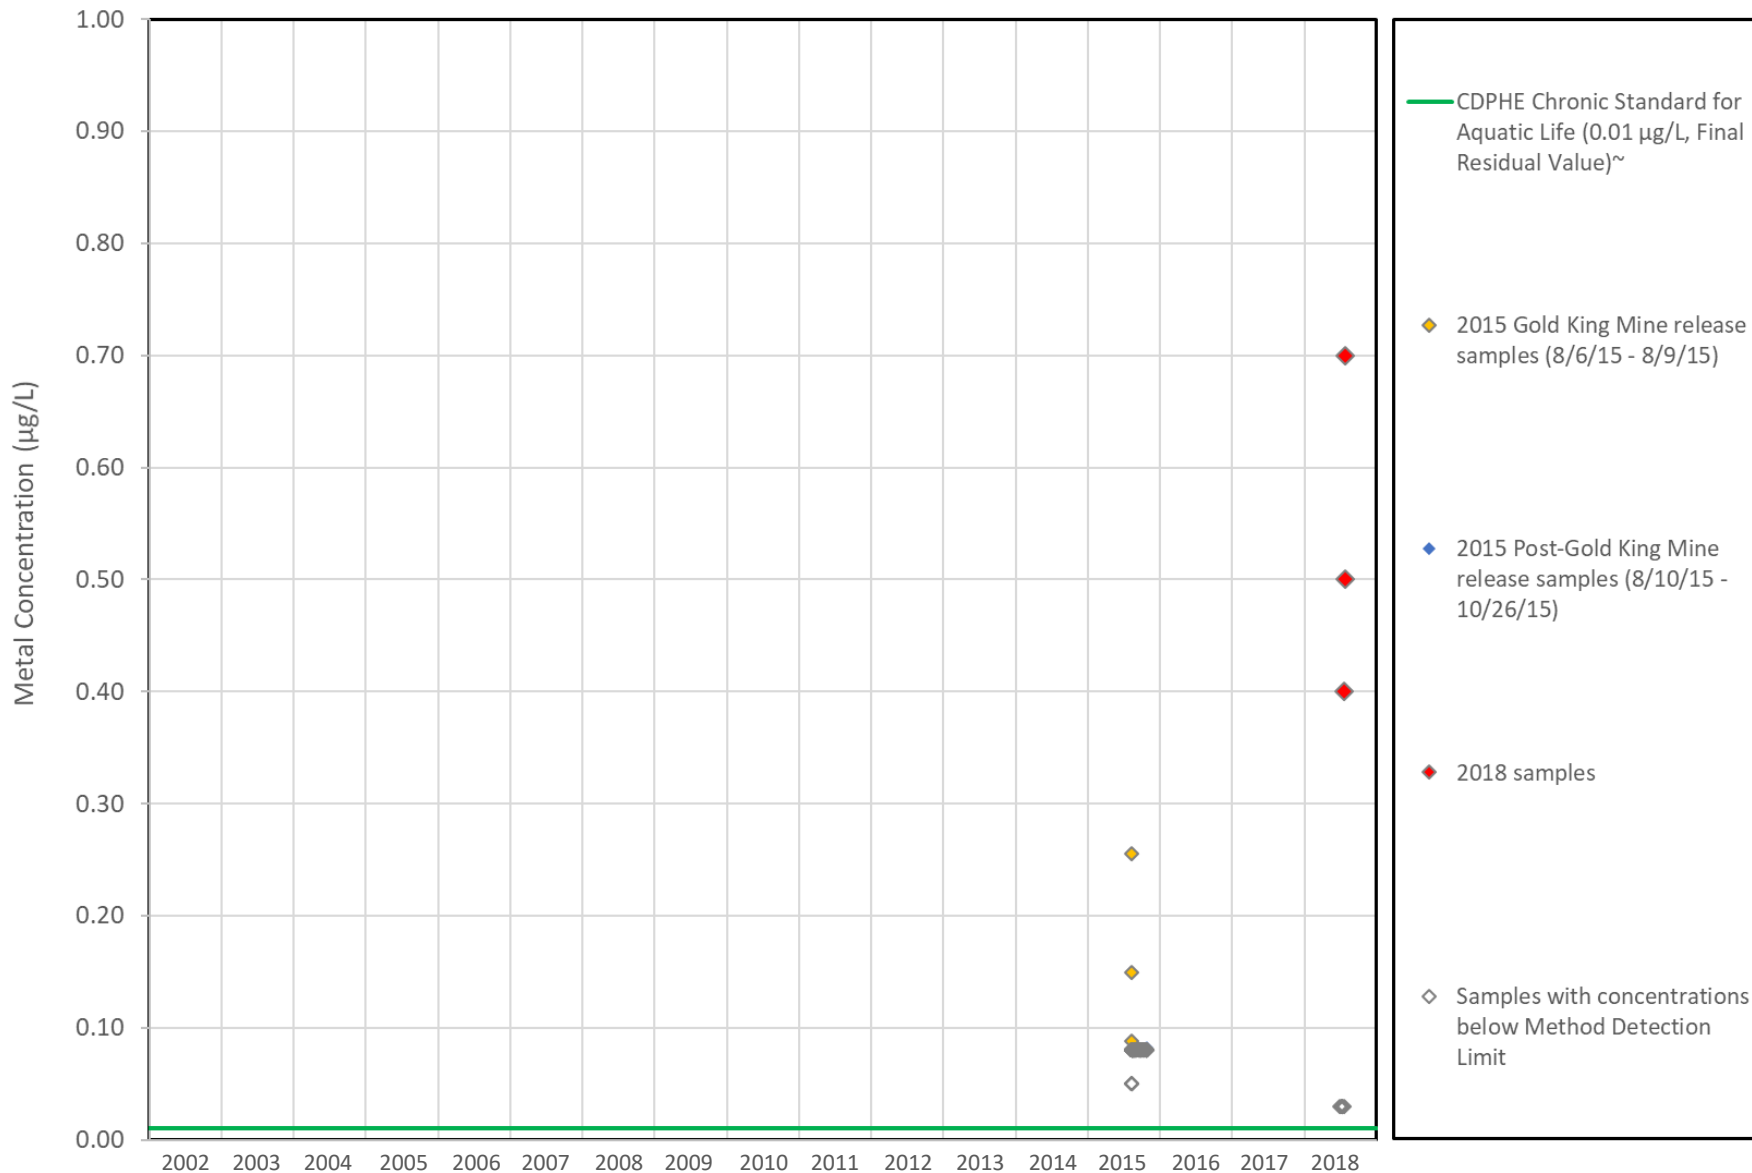
Total Mercury, Animas River at Durango, CO: 2002-2018

~Colorado Department of Public Health and the Environment (CDPHE) standards based on Colorado surface water quality classifications and Reg. 31 and 34. The mercury chronic standard for aquatic life is based on the final residue value (FRV) of 0.01 µg/L, which is the maximum allowed concentration of total mercury in the water that will present bioaccumulation of methylmercury in edible fish tissue. In waters supporting fish with a potential for human consumption, the chronic standard for mercury can be assessed as a 30-day average.

Note: River Watch data does not include mercury as a water quality parameter, so 2002 - 2014 data is unavailable. 2015-18 data is Mountain Studies Institute data from the Animas River at Rotary Park in Durango, CO.

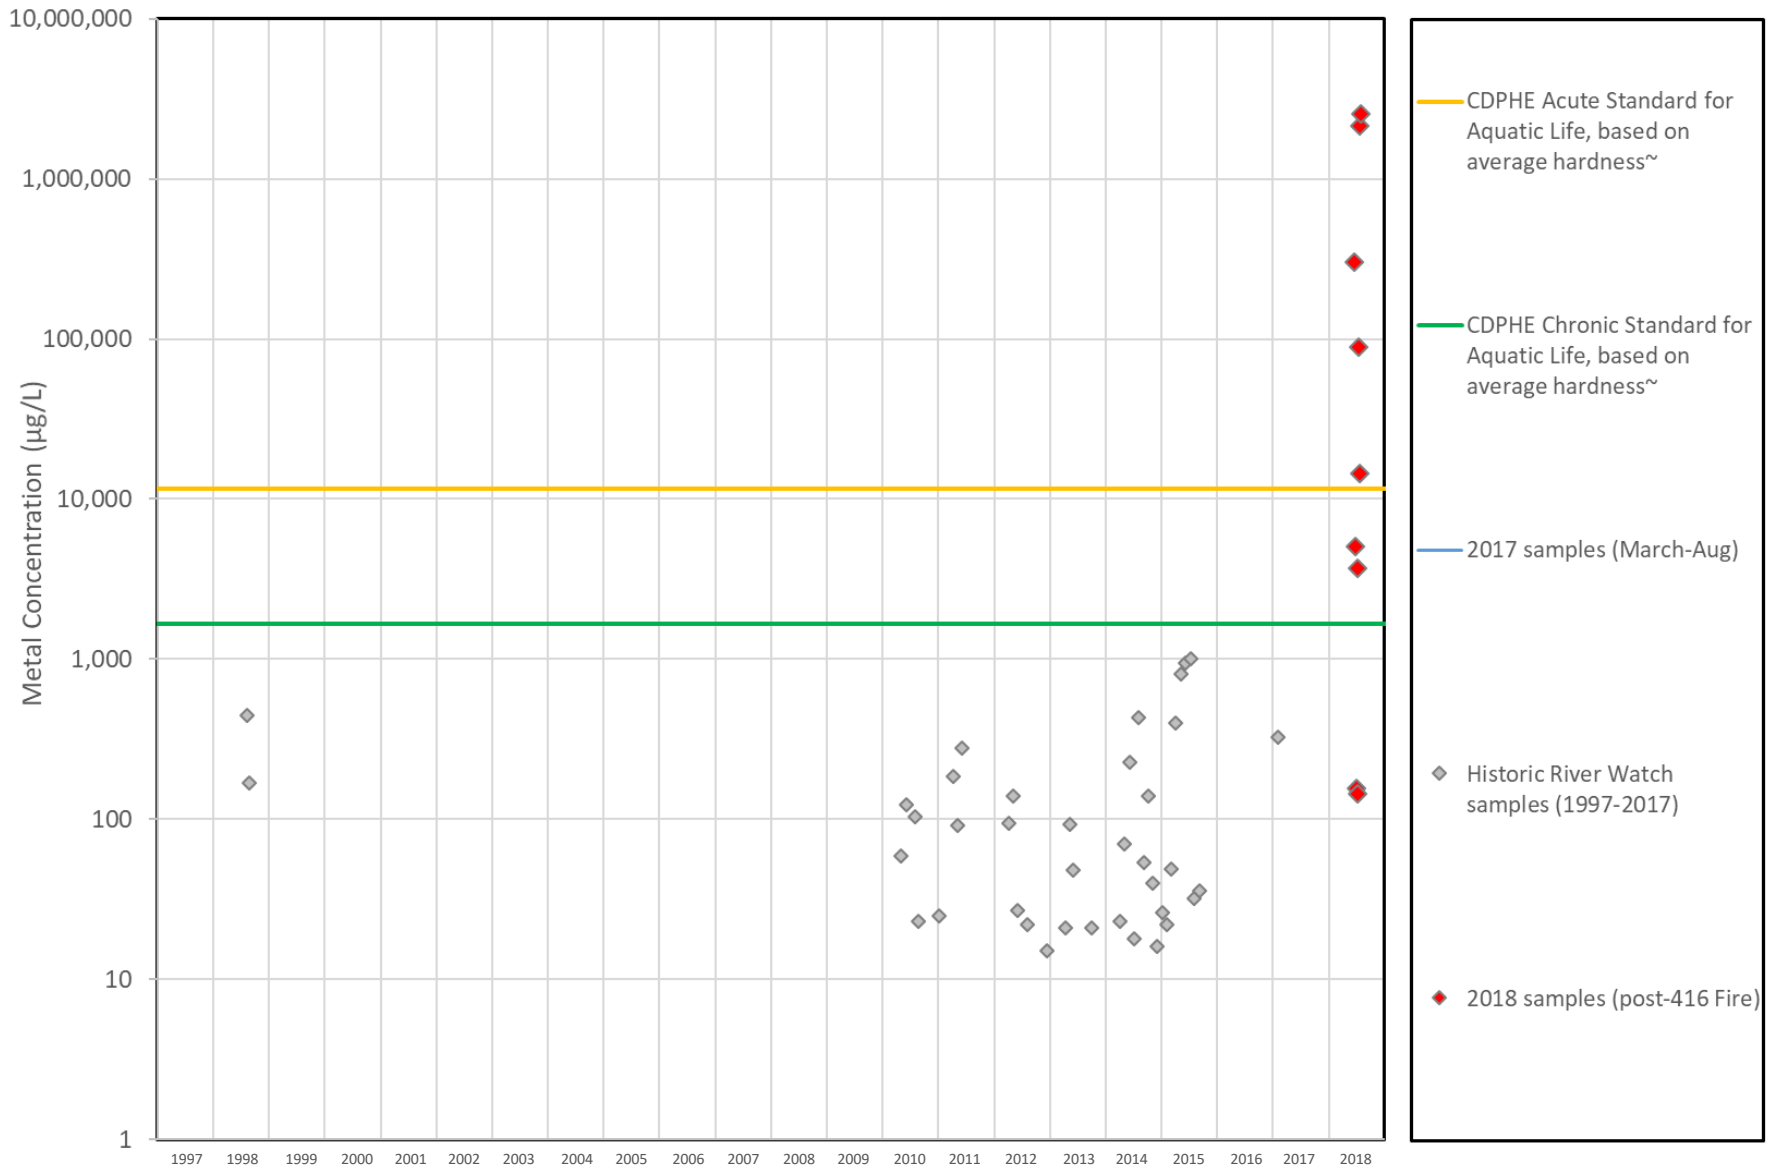
Total Aluminum, Hermosa Creek: 1997-2018

~Colorado Department of Public Health and the Environment (CDPHE) standards based on Colorado surface water quality classifications and Reg. 31 and 34. Standards vary with water hardness and are plotted here using an average water hardness of Hermosa Creek at this location, 245 mg/L.

Note: 1997-2017 data is River Watch data from Hermosa Creek. 2018 data is Mountain Studies Institute data.

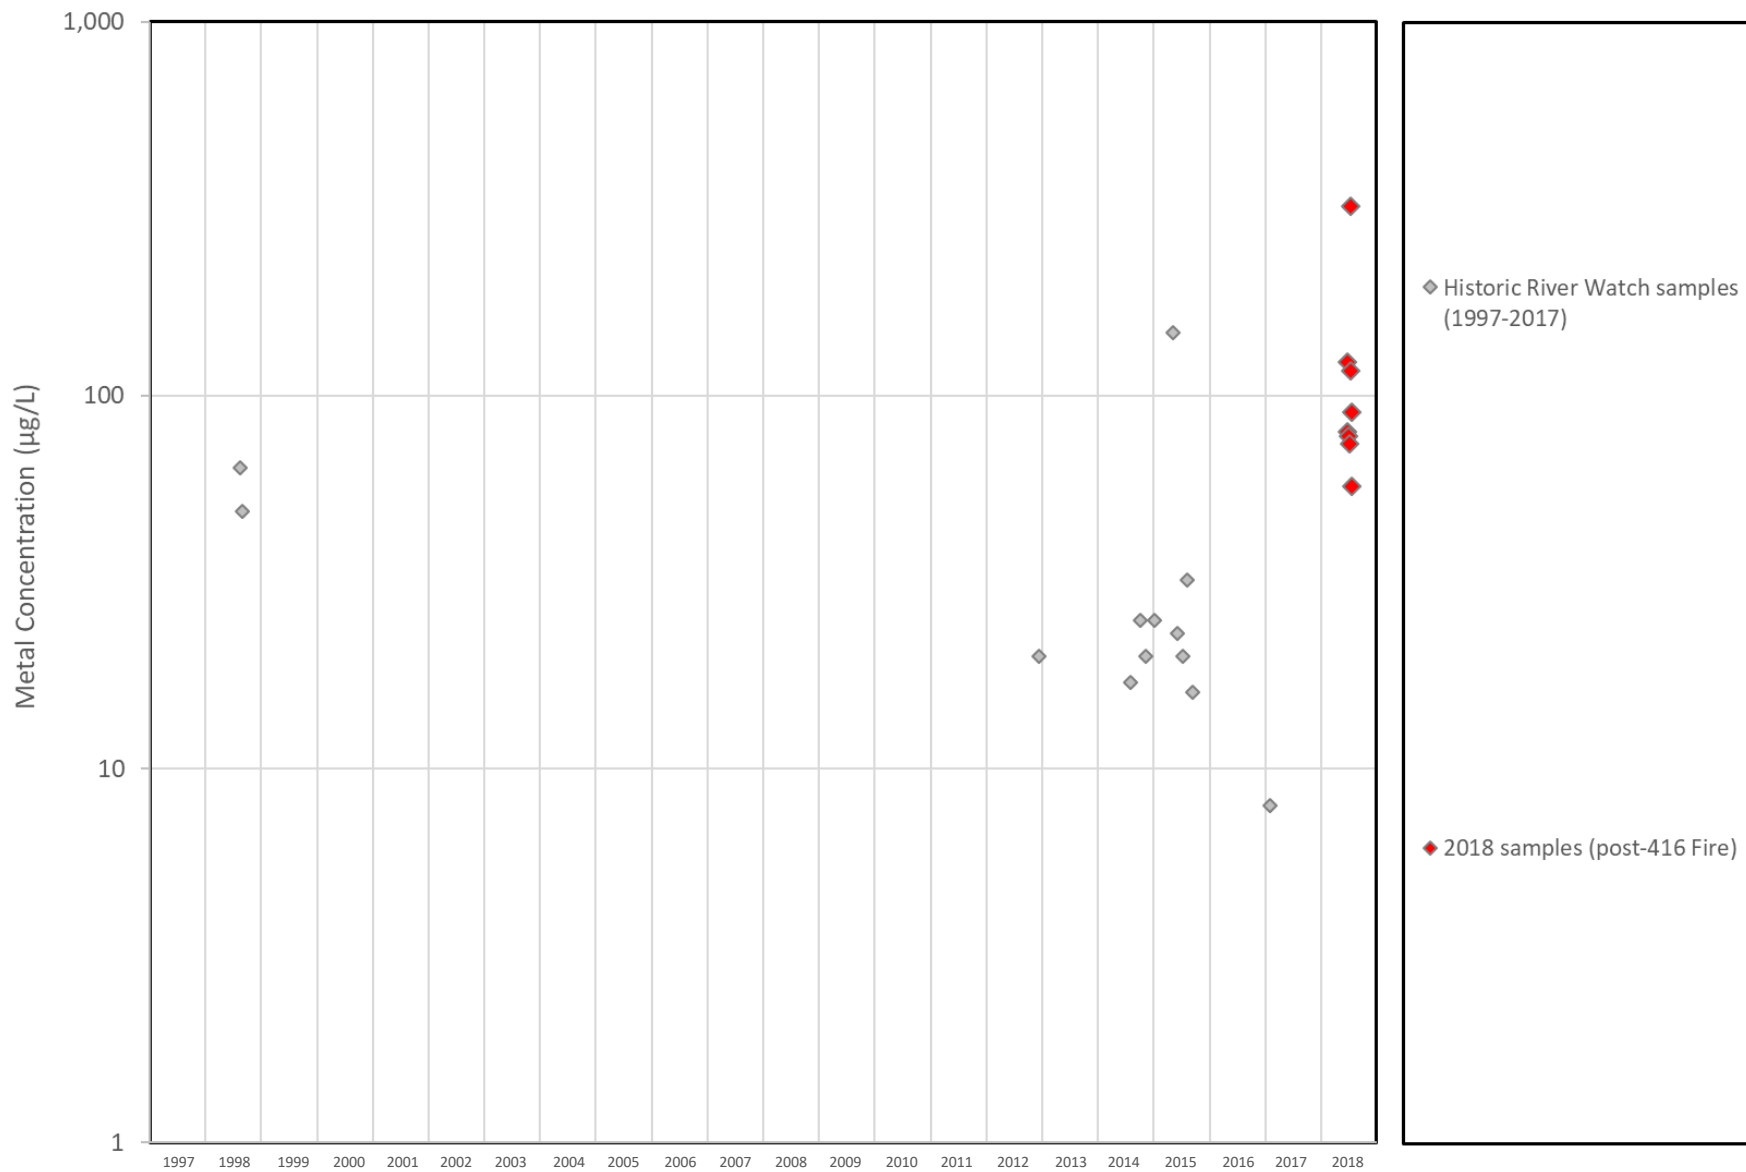
Dissolved Aluminum, Hermosa Creek: 1997-2018

Note: 1997-2017 data is River Watch data from Hermosa Creek. 2018 data is Mountain Studies Institute data.

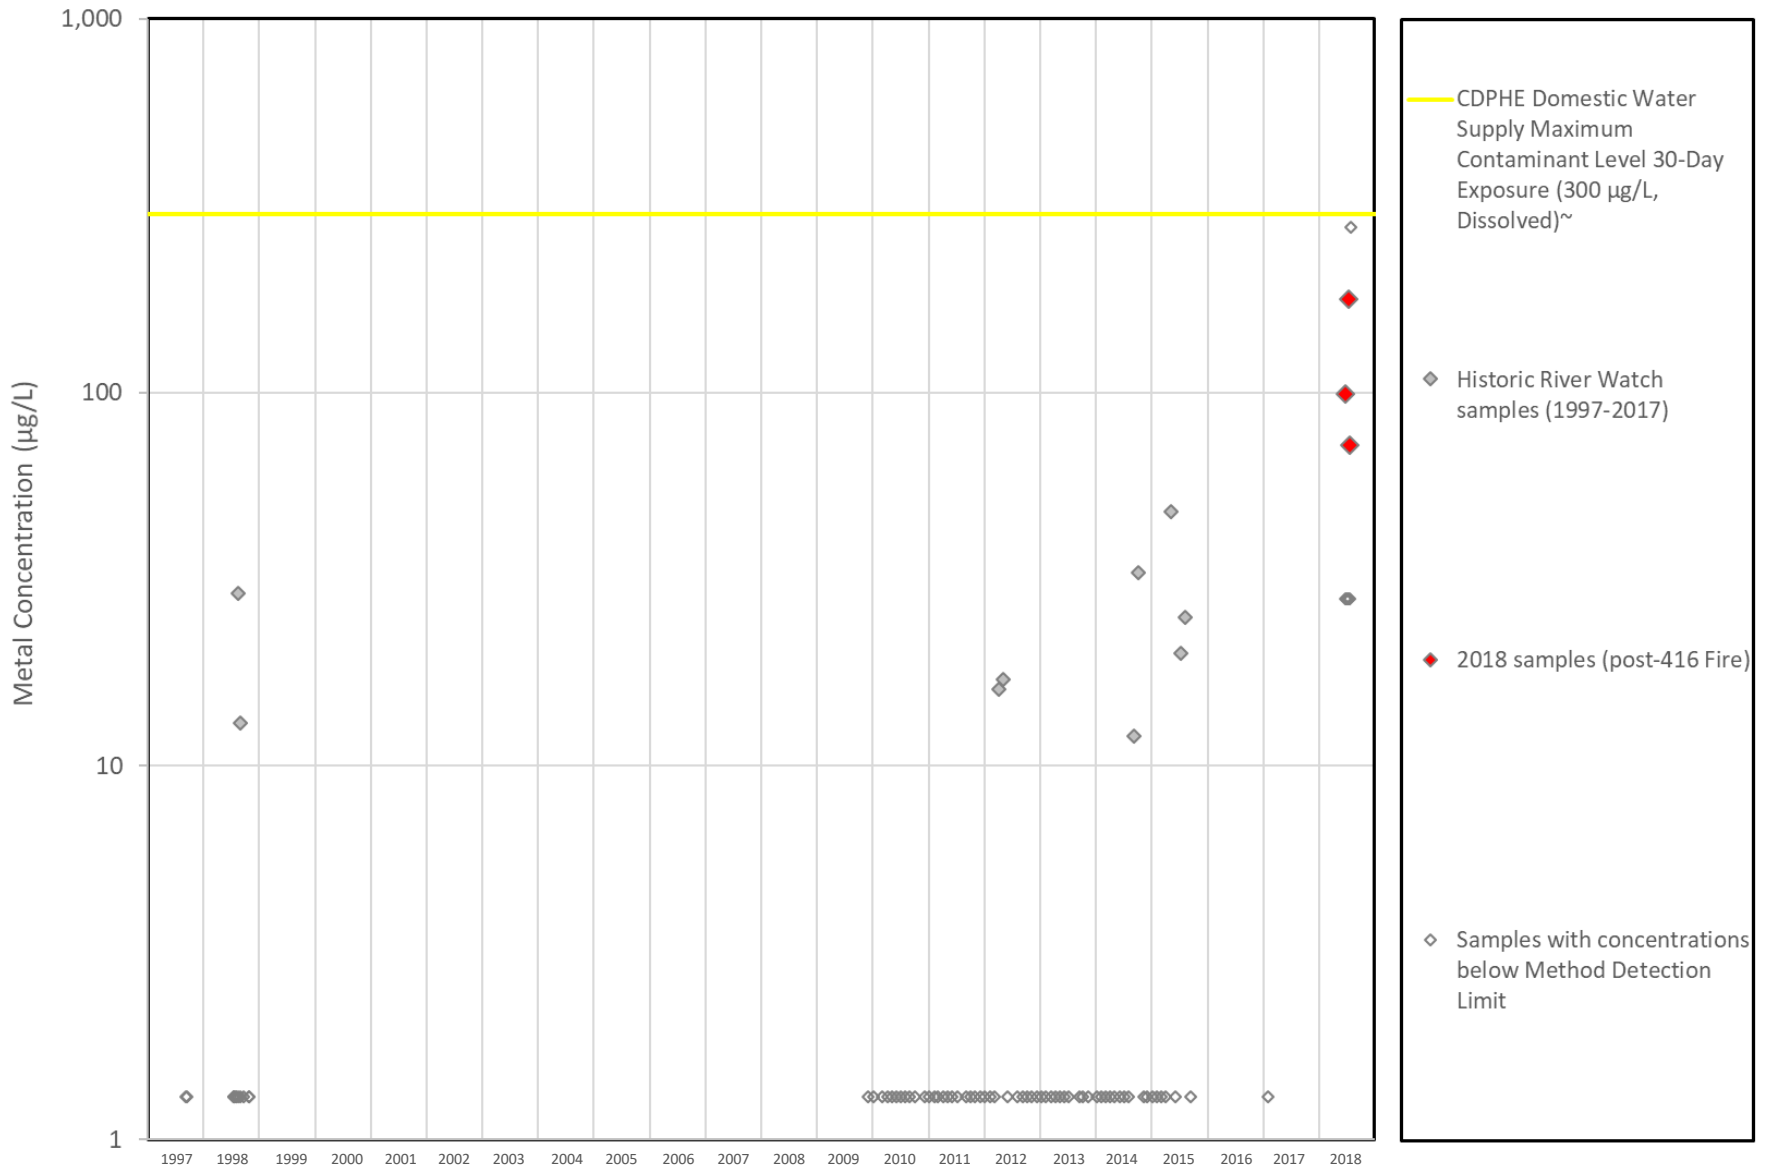
Dissolved Iron, Hermosa Creek: 1997-2018

Note: 1997-2017 data is River Watch data from Hermosa Creek. 2018 data is Mountain Studies Institute data.

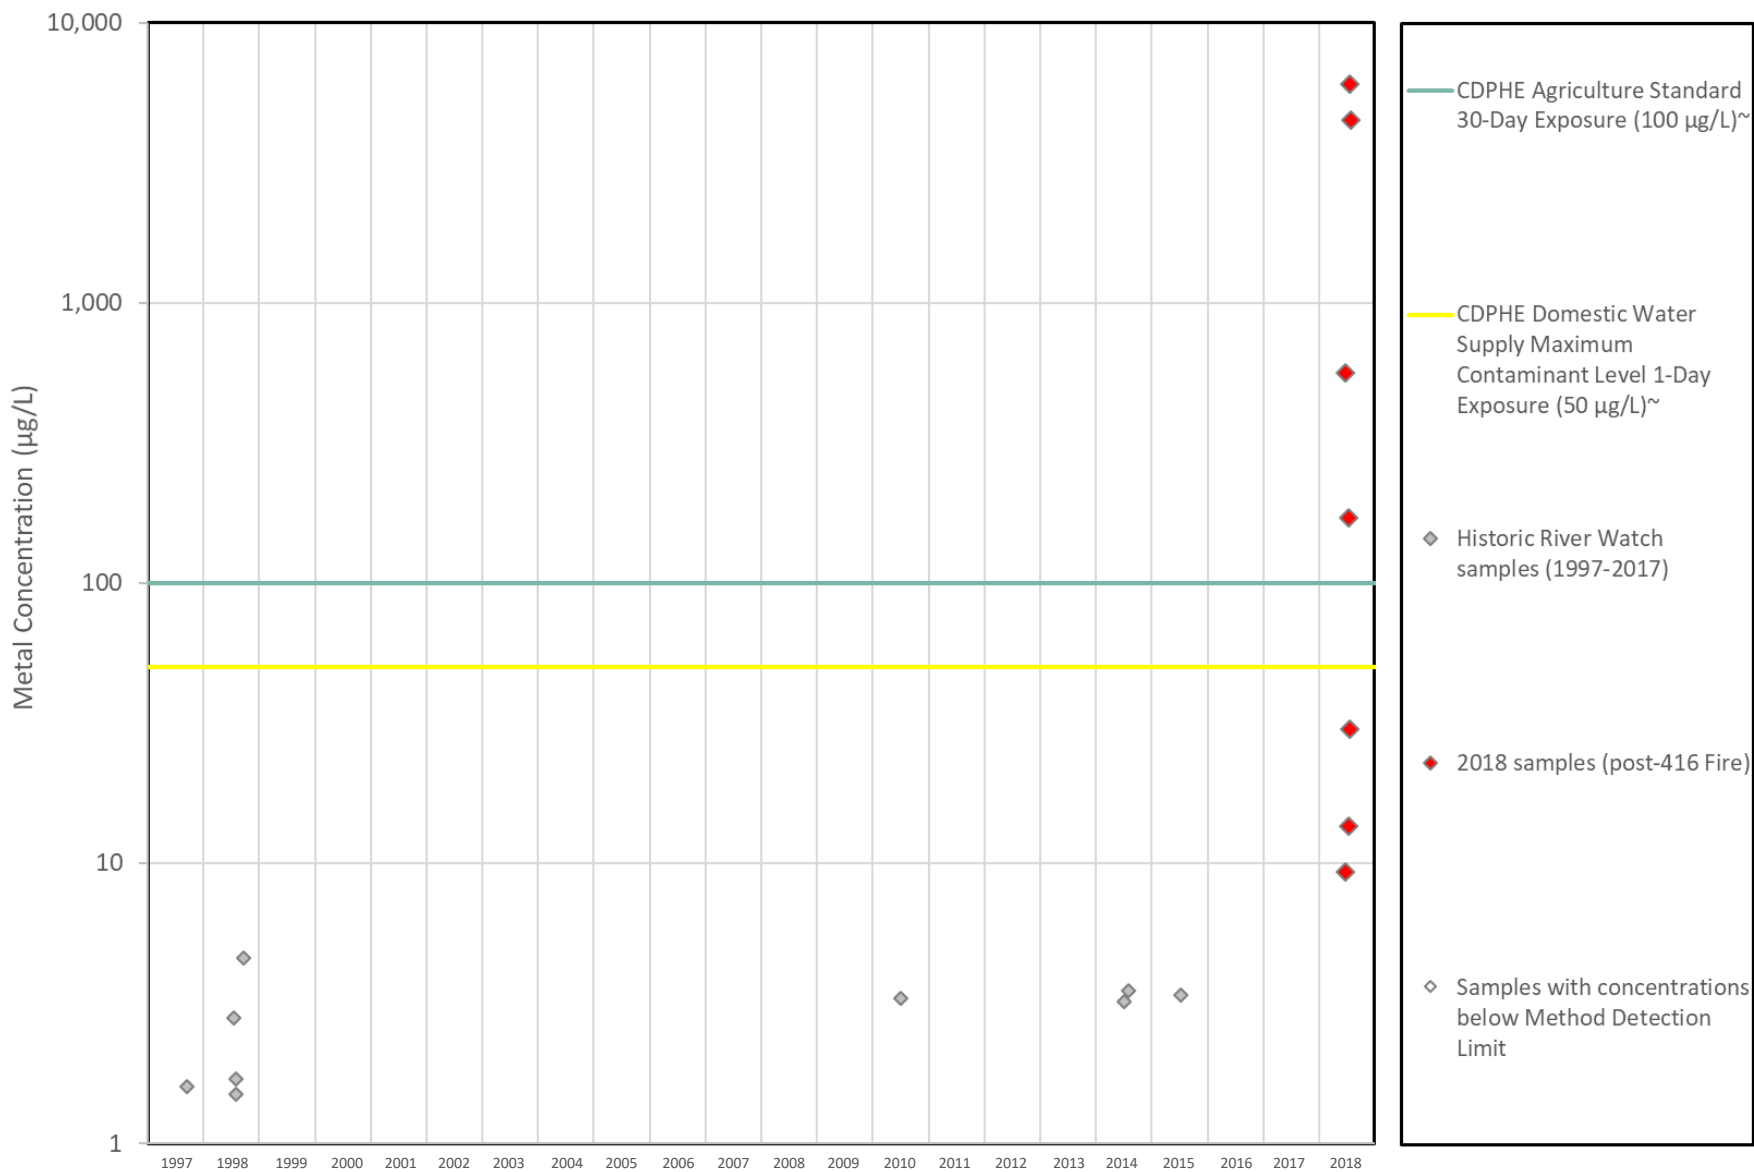
Total Lead, Hermosa Creek: 1997-2018

~Colorado Department of Public Health and the Environment (CDPHE) standards based on Colorado surface water quality classifications and Reg. 31 and 34.
 Note: 1997-2017 data is River Watch data from Hermosa Creek. 2018 data is Mountain Studies Institute data.

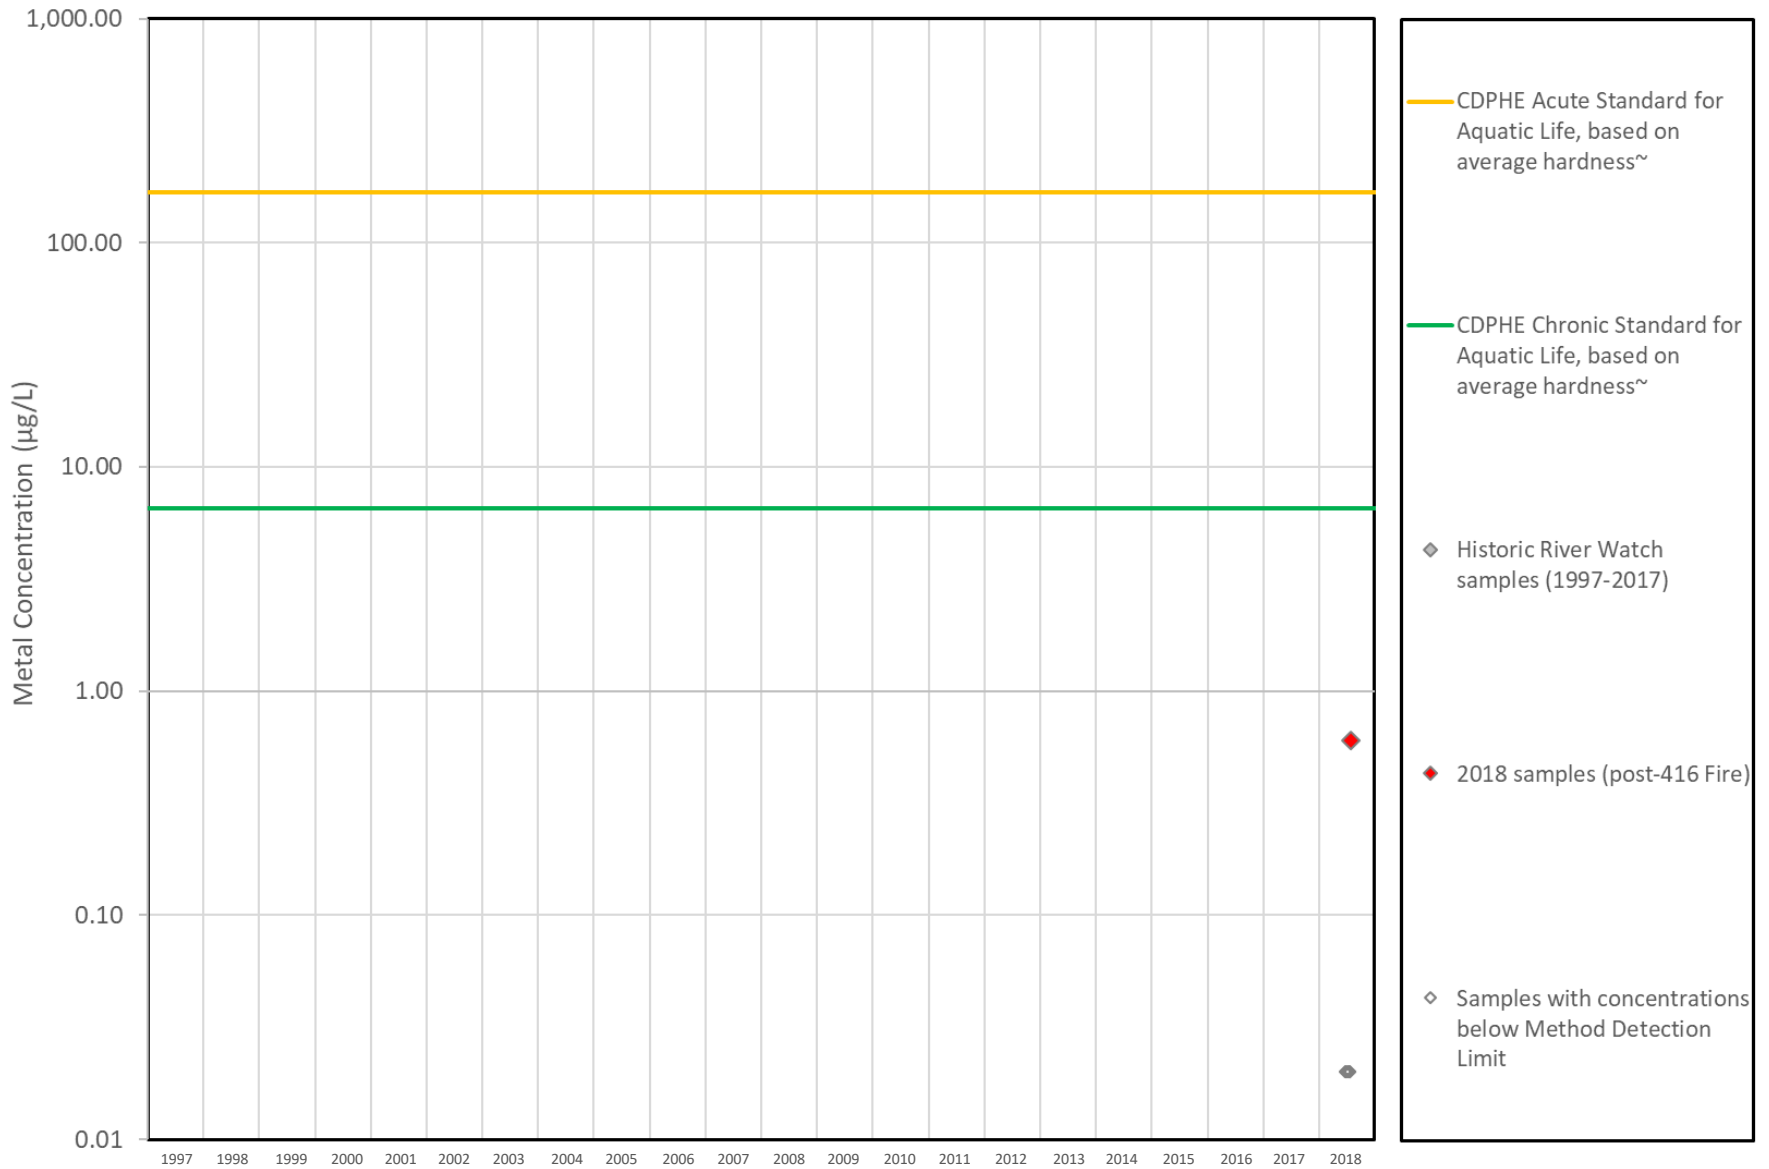
Dissolved Lead, Hermosa Creek: 1997-2018

~Colorado Department of Public Health and the Environment (CDPHE) standards based on Colorado surface water quality classifications and Reg. 31 and 34. Standards vary with water hardness and are plotted here using an average water hardness of Hermosa Creek at this location, 245 mg/L.

Note: 1997-2017 data is River Watch data from Hermosa Creek. 2018 data is Mountain Studies Institute data.

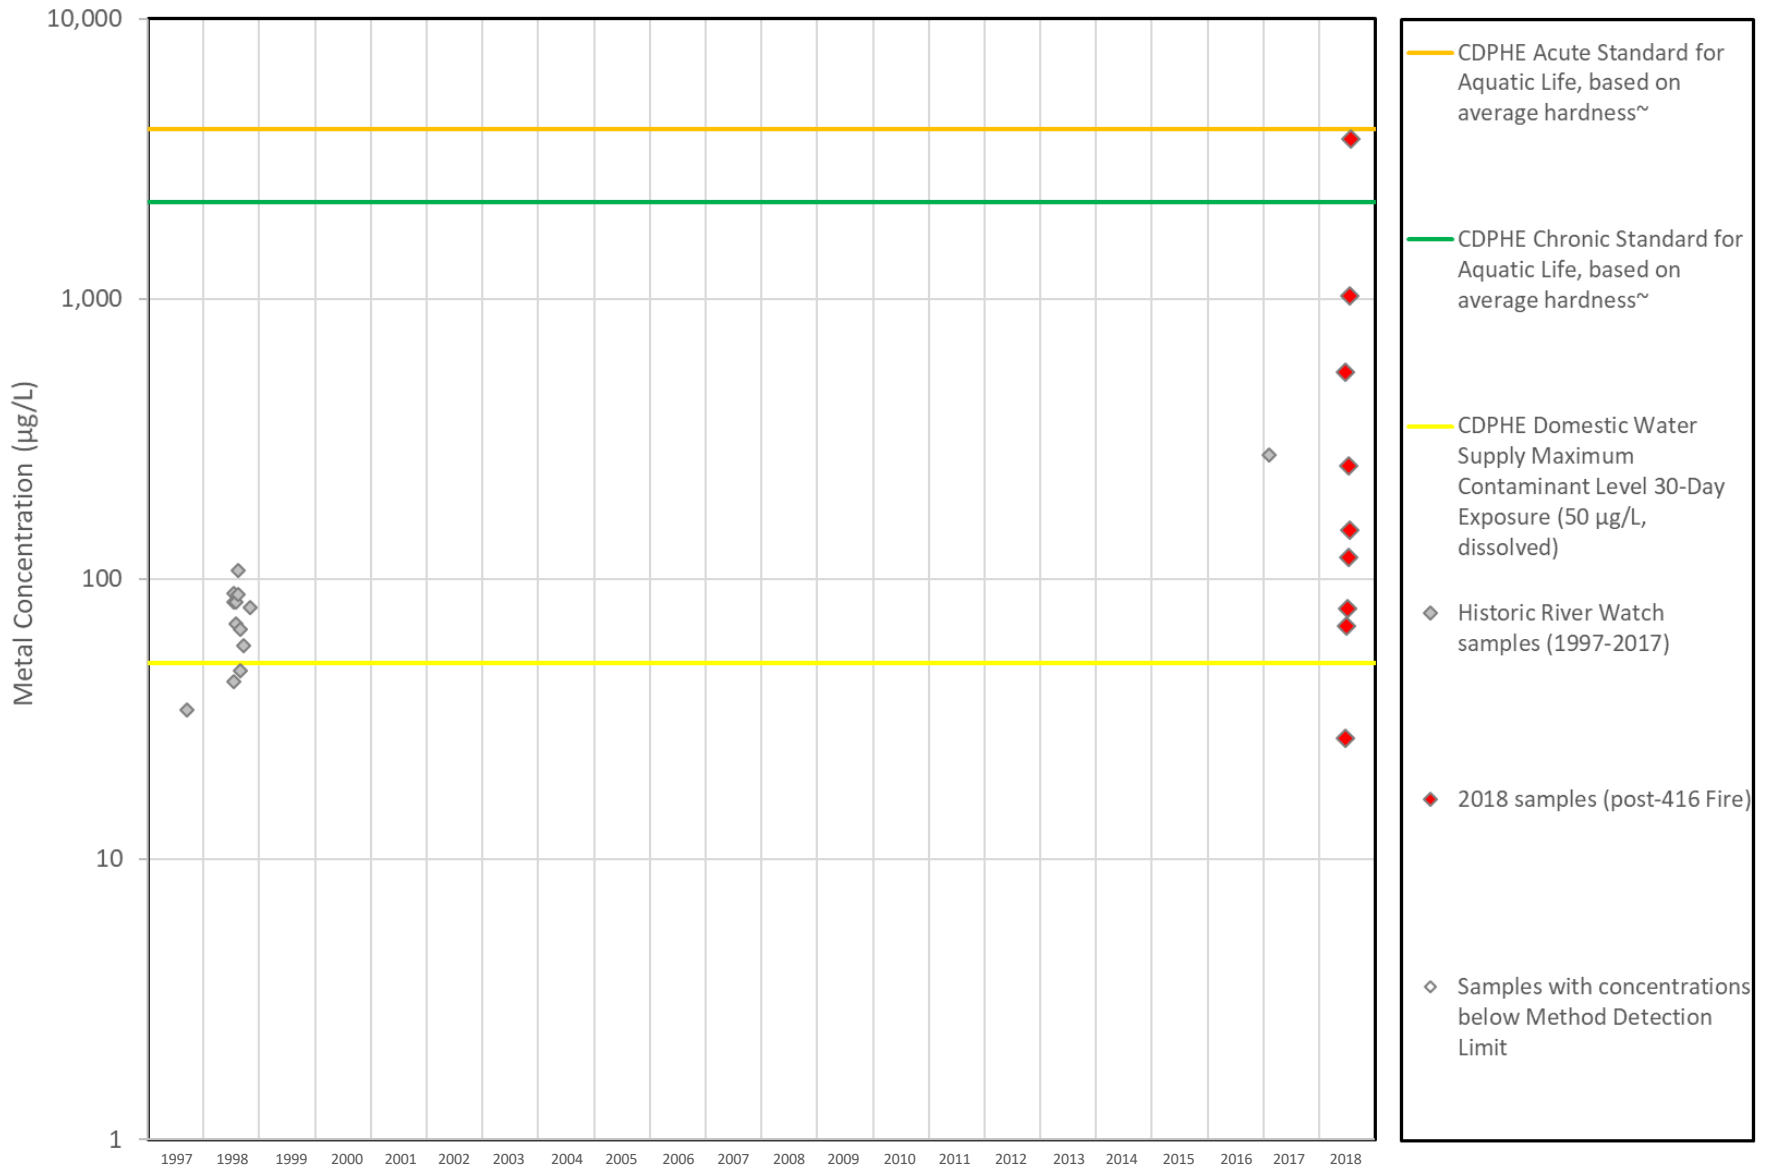
Dissolved Manganese, Hermosa Creek: 1997-2018

~Colorado Department of Public Health and the Environment (CDPHE) standards based on Colorado surface water quality classifications and Reg. 31 and 34. Standards vary with water hardness and are plotted here using an average water hardness of Hermosa Creek at this location, 245 mg/L.

Note: 1997-2017 data is River Watch data from Hermosa Creek. 2018 data is Mountain Studies Institute data.

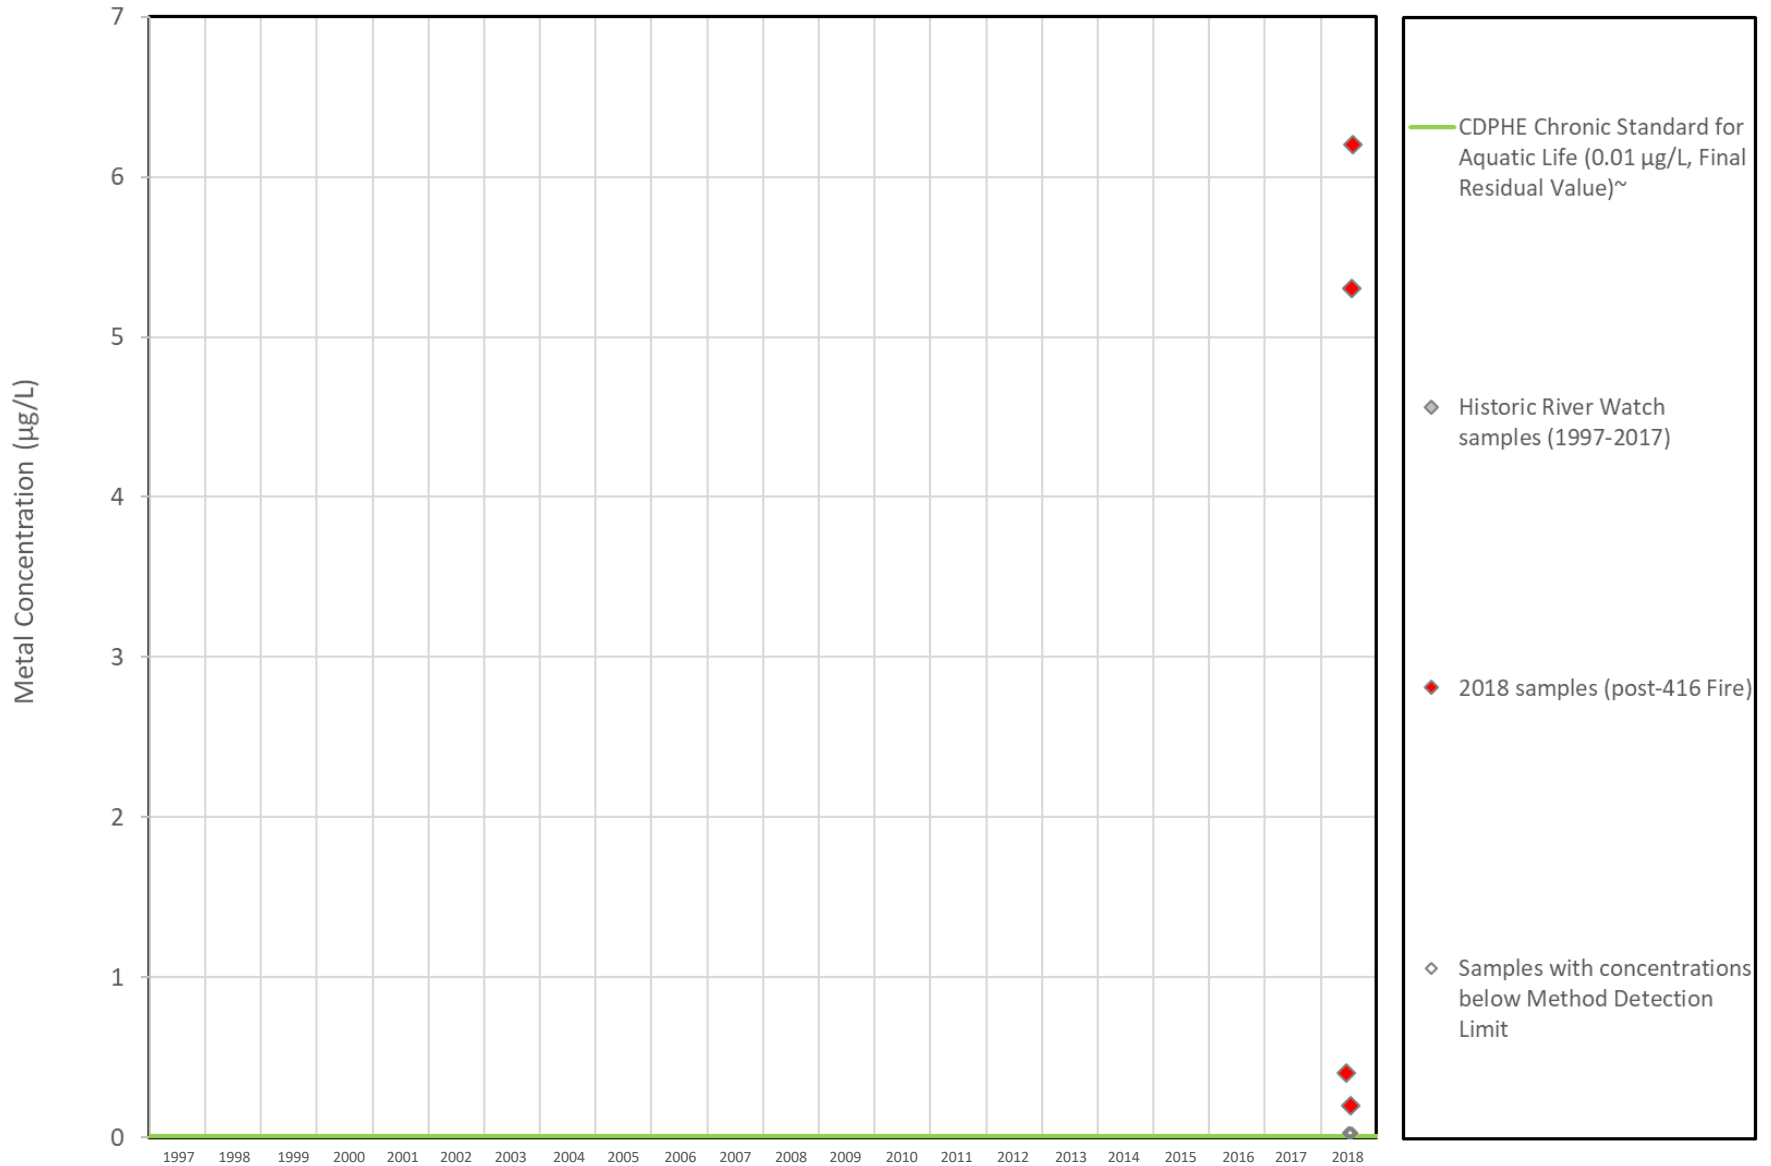
Total Mercury, Hermosa Creek: 1997-2018

[~]Colorado Department of Public Health and the Environment (CDPHE) standards based on Colorado surface water quality classifications and Reg. 31 and 34. The mercury chronic standard for aquatic life is based on the final residue value (FRV) of 0.01 $\mu\text{g/L}$, which is the maximum allowed concentration of total mercury in the water that will present bioaccumulation of methylmercury in edible fish tissue. In waters supporting fish with a potential for human consumption, the chronic standard for mercury can be assessed as a 30-day average.

Note: River Watch data does not include mercury as a water quality parameter, so 1997 - 2017 data is unavailable. 2018 data is Mountain Studies Institute data.
