# Arcing on Space Solar Arrays

11<sup>th</sup> Spacecraft Charging Technology Conference

**P. Leung, J. Scott, S. Seki and J.A. Schwartz**  
**Boeing Space and Intelligence Systems**  
**The Boeing Company**

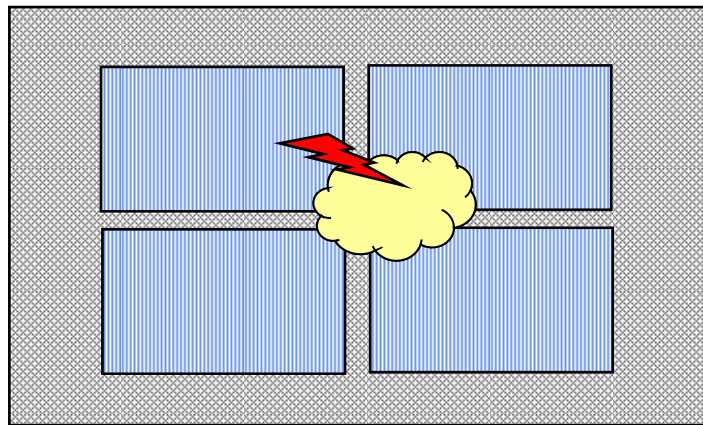
~80 V between adjacent solar cell strings

Trigger arc caused by differential charging of coverglass

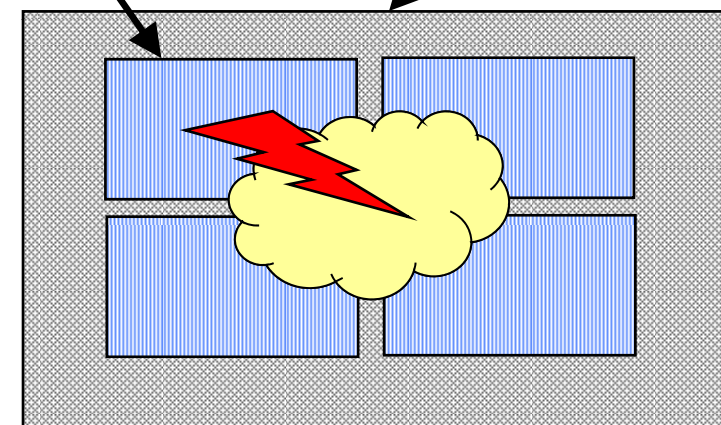
Solar cell  
Panel substrate

Sustained arc driven by solar array circuit

- Arcing resulted in pyrolyzed insulation and permanent shorting of solar array circuits on satellites in orbit

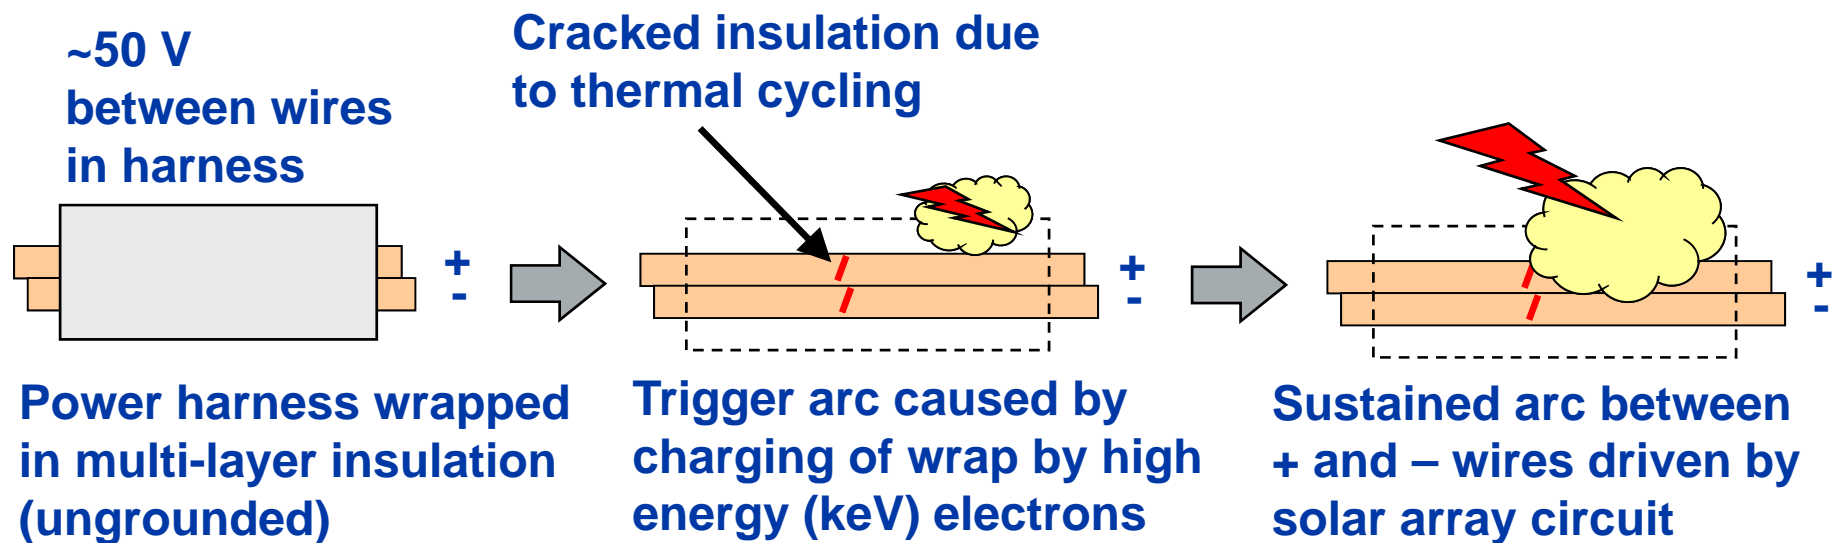
- Satellite passed through auroral region when high energy (keV) flux was 2 orders of magnitude higher than normal resulting in significant charging of multi-layer insulation
- Arcing resulted in pyrolyzed wires, destruction of wire harness and significant loss of power

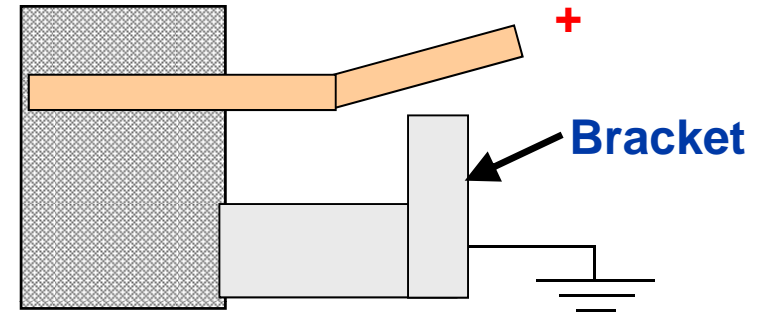
**Positive wire close to a metallic bracket or structure**

**Insulation damaged during manufacturing or due to space environmental effects**

- Positive and negative wires in close proximity
- Potential difference between wires and panel substrate

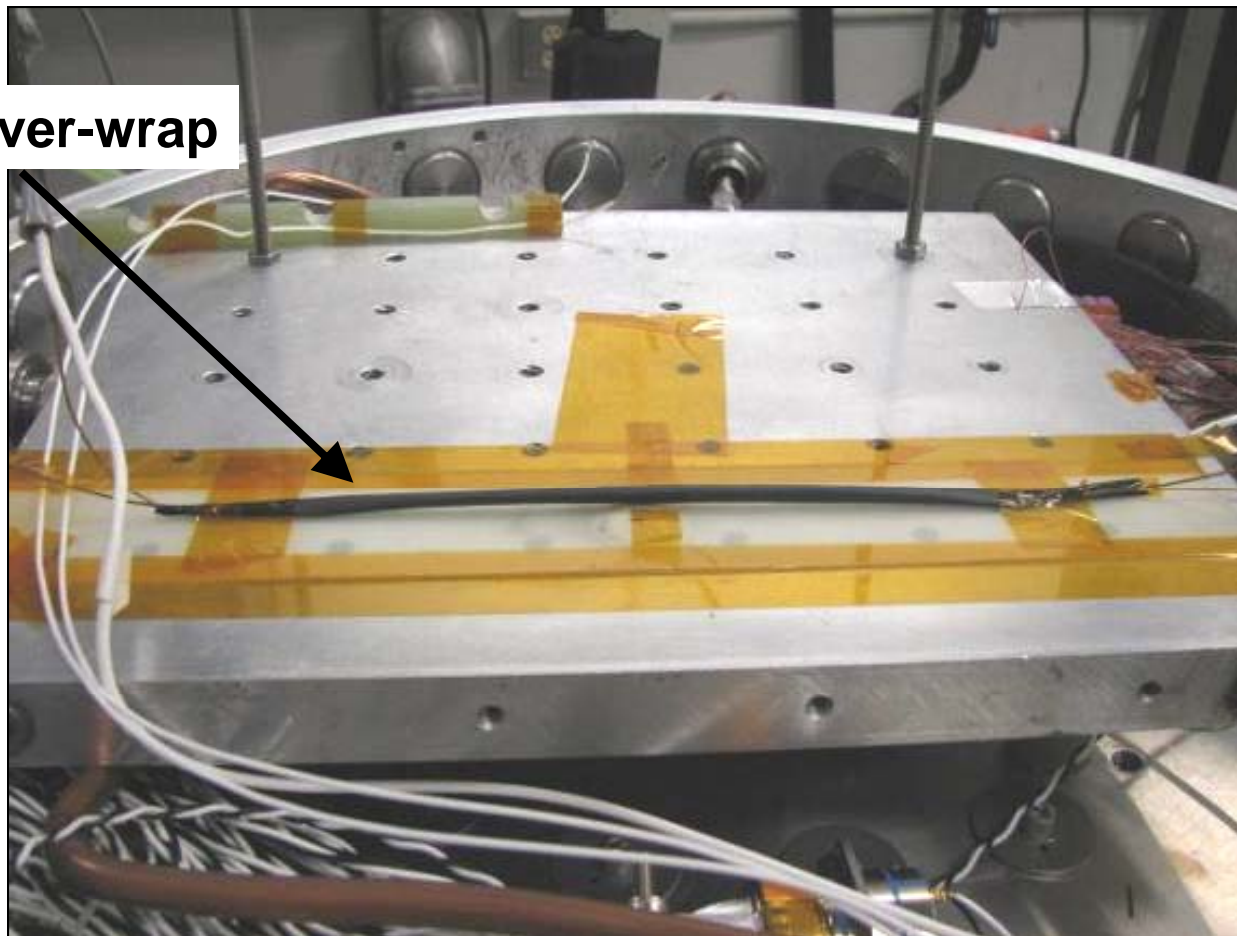
## Experiment #1: Set-Up using Wrapped Wires

Kapton over-wrap

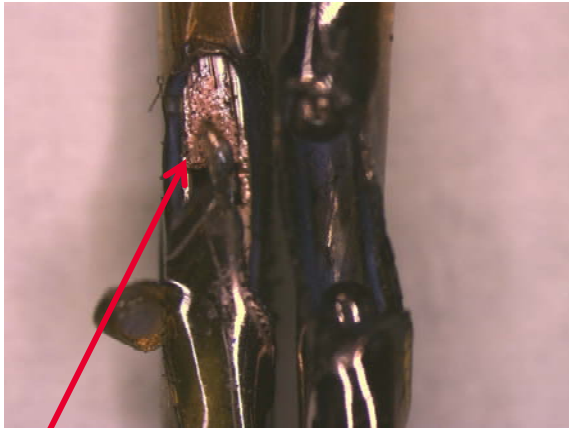
Insulation was damaged and copper material was ejected during the arcing event

- **First arcing event observed in experiment #1**
  - Arcing initiated with intentionally damaged insulation and strand of wire bridging gap between conductors
  - Significant damage, mass ejection and arc tracking along wires observed

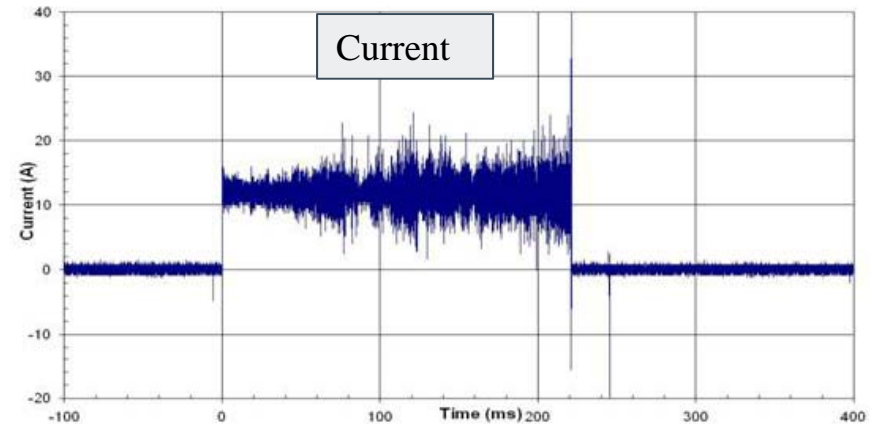
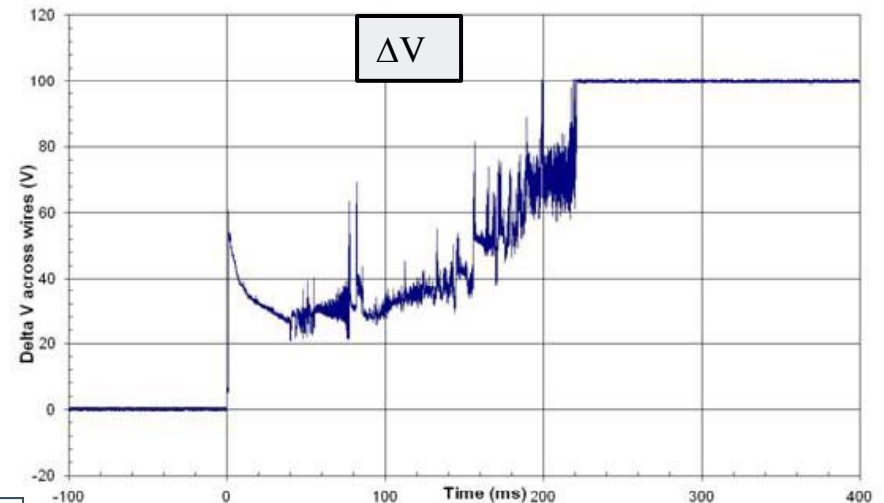
Current and Voltage waveforms

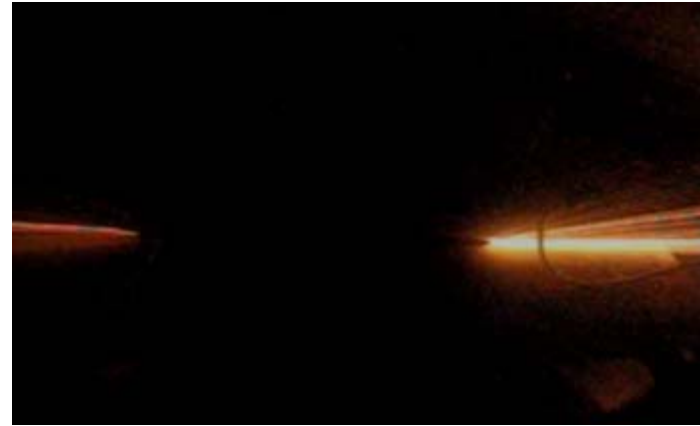
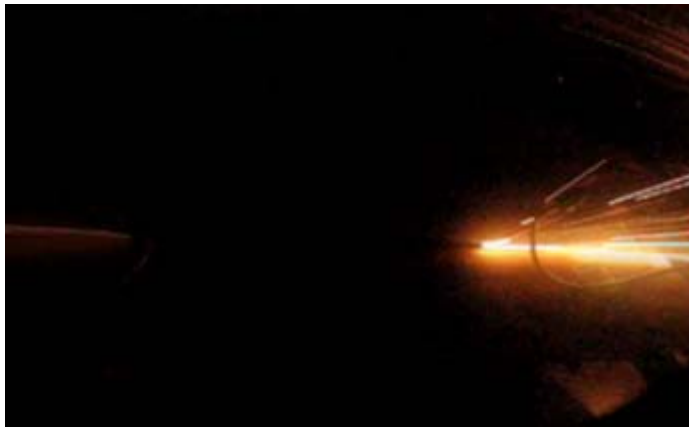
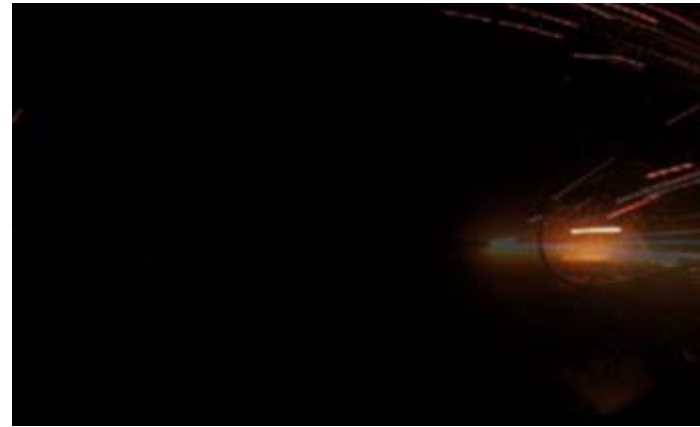
# Experiment #1: Arcing with Wrapped Wires

***Arcing resulted in highly directional mass ejection.***

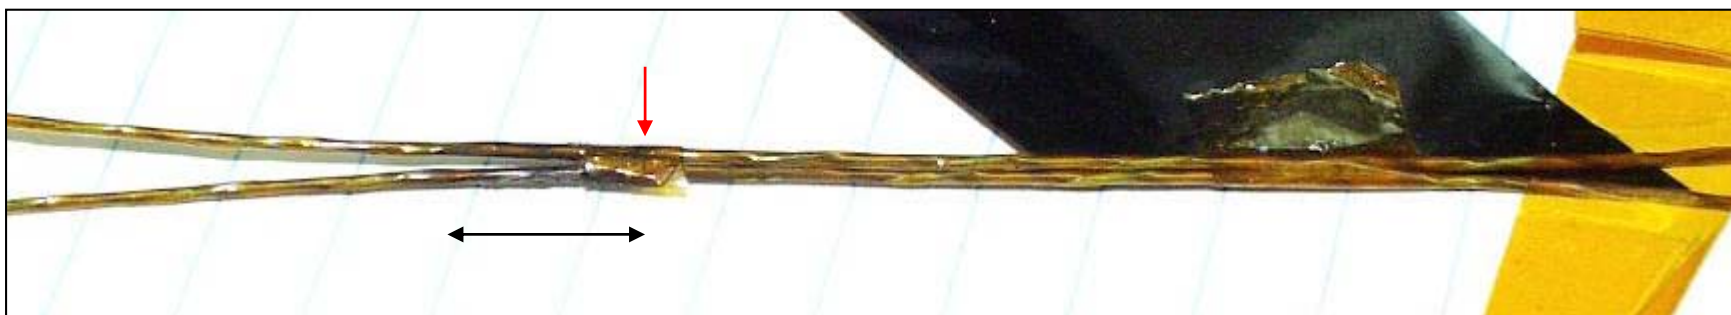
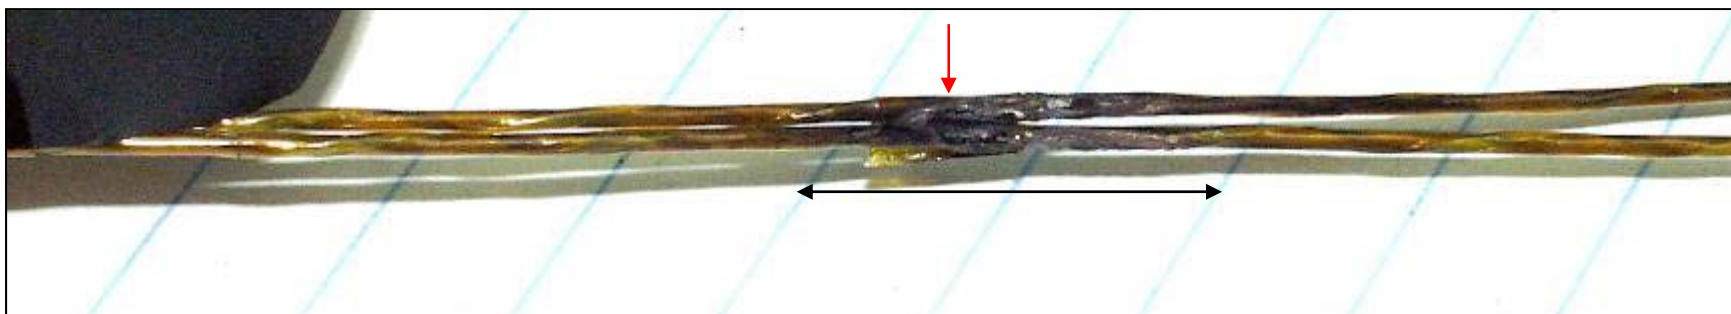
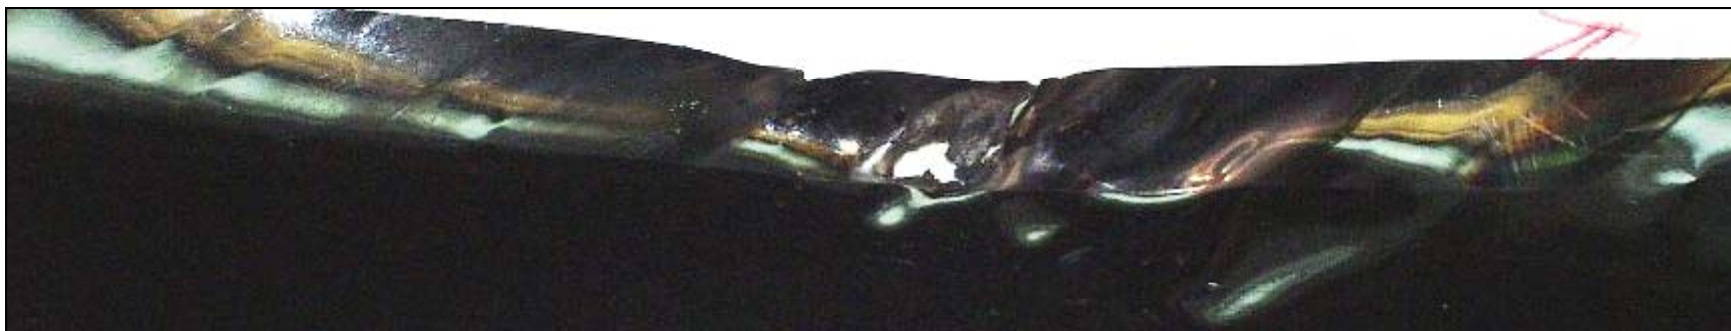
## Experiment #1: Damage to Wrapped Wires due to Arcing

***Insulation was pyrolyzed during the arcing event.***

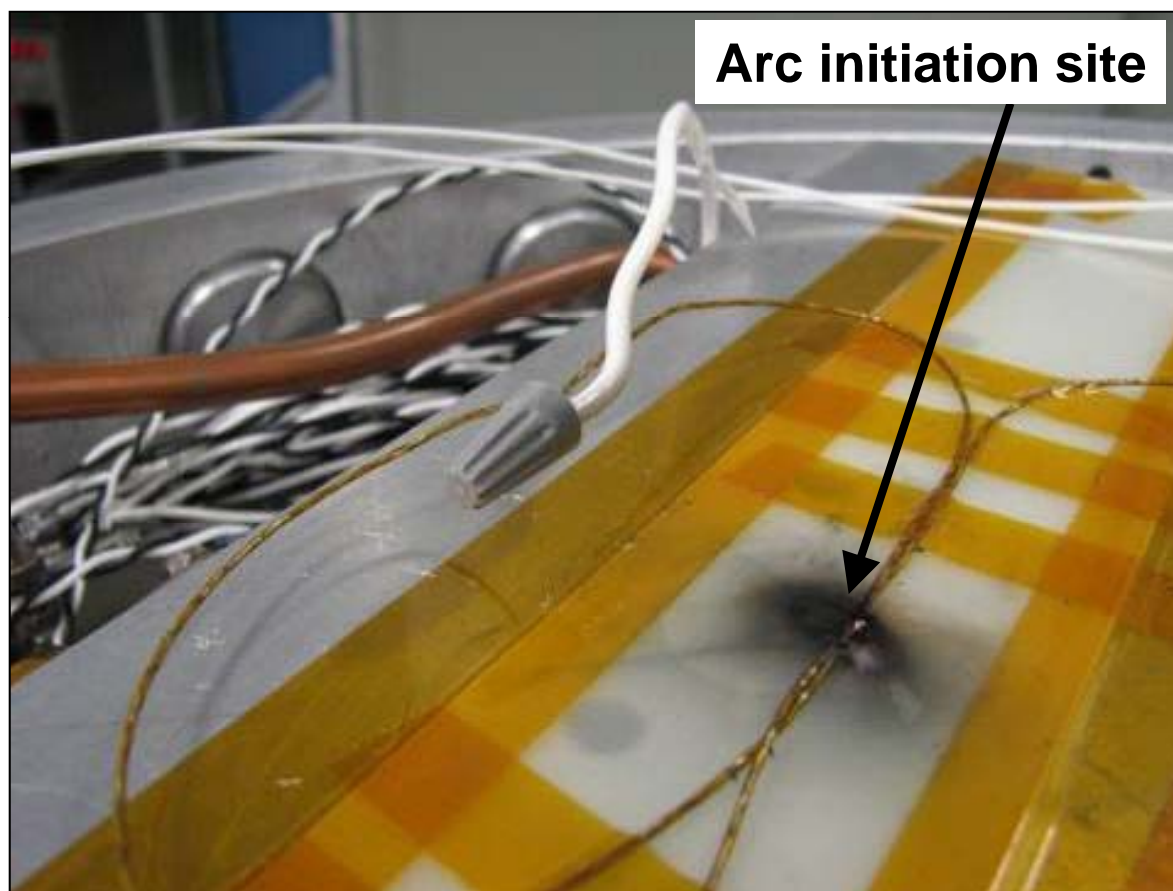
## Experiment #1: Set-Up using Twisted Wires and Pyrolyzed Insulation Defect

***The longest and most powerful arcing events were observed when a portion of the insulation was already pyrolyzed.***

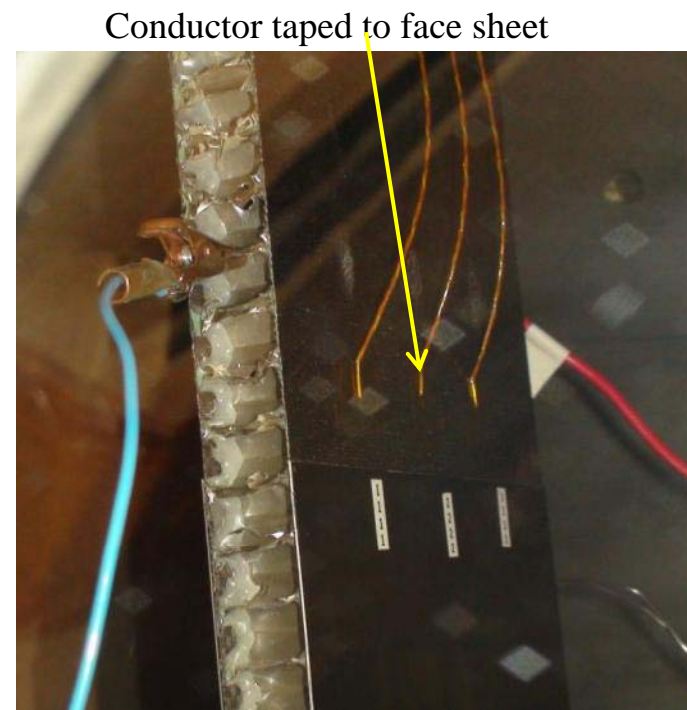
Test article

- Exposed wire conductor
- Tape the conductor to a conductive face sheet
- Apply a 100 V bias using an SAS
- Monitor the current
  - Transient and steady current (if applicable)

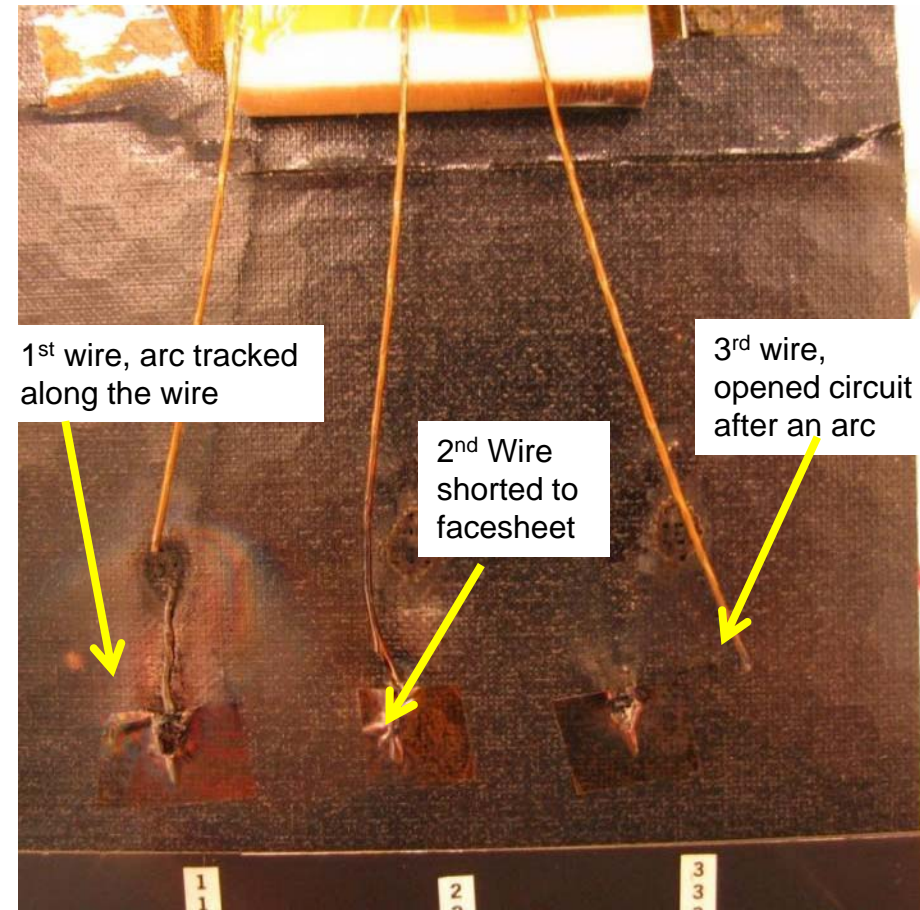
- **1<sup>st</sup> wire – arc track along the wire**
  - Open circuit at end of test
- **2<sup>nd</sup> wire – wire conductor shorted to face sheet**
  - Visible glow at point of contact
  - Continuously material release as witness by the increase in the chamber pressure from  $10^{-6}$  torr to  $10^{-4}$  torr
  - Short to face sheet at end of test
- **3<sup>rd</sup> wire – short duration arc**
  - Conductor detached from face sheet
  - Open circuit at end of test

Short between wire and panel could result in different arcing scenarios

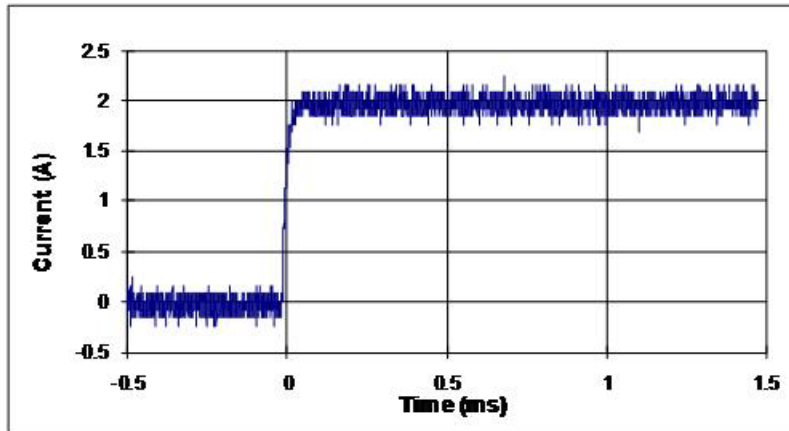
Initial current was ~ 2A

Interaction of arc current with face sheet material could cause a change in arc impedance

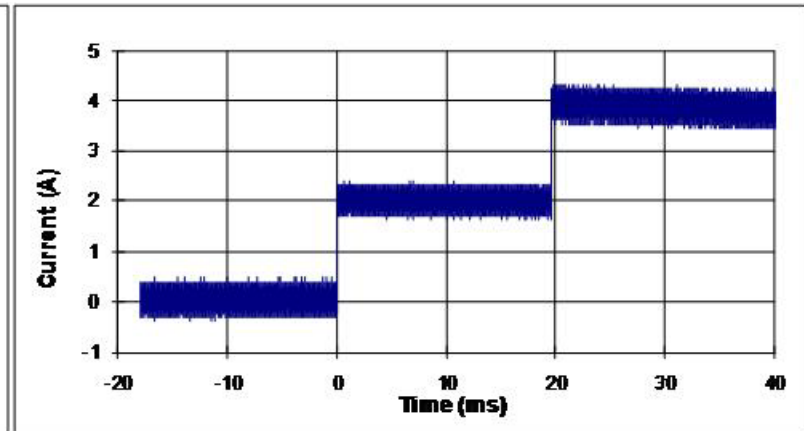
Current jumped to ~4 A after ~20 ms

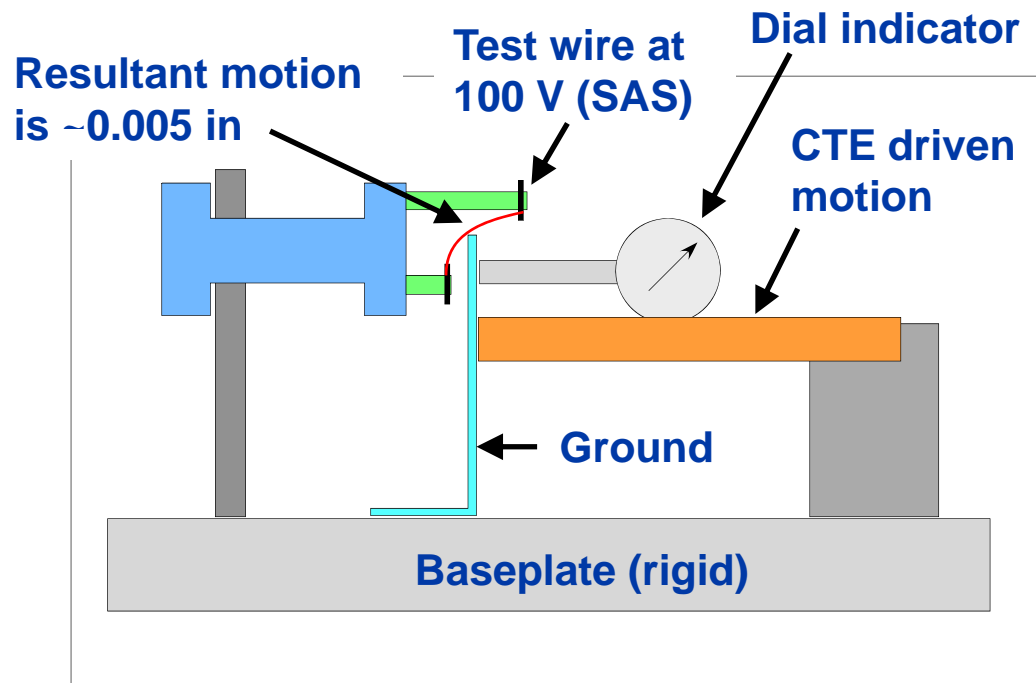
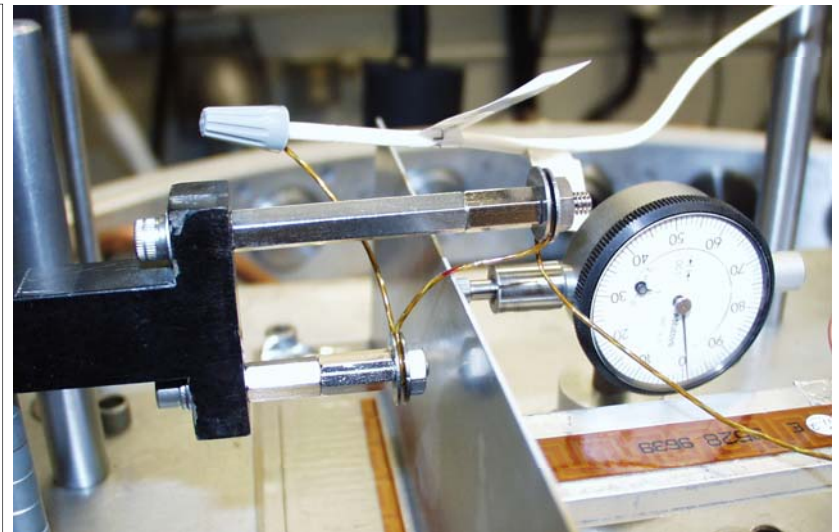
- Determine whether exposed conductors will arc to metallic bracket.
- Include motion of wire against and away from bracket, due to thermal expansion and contraction.
- Assess damage due to arcing (if applicable).

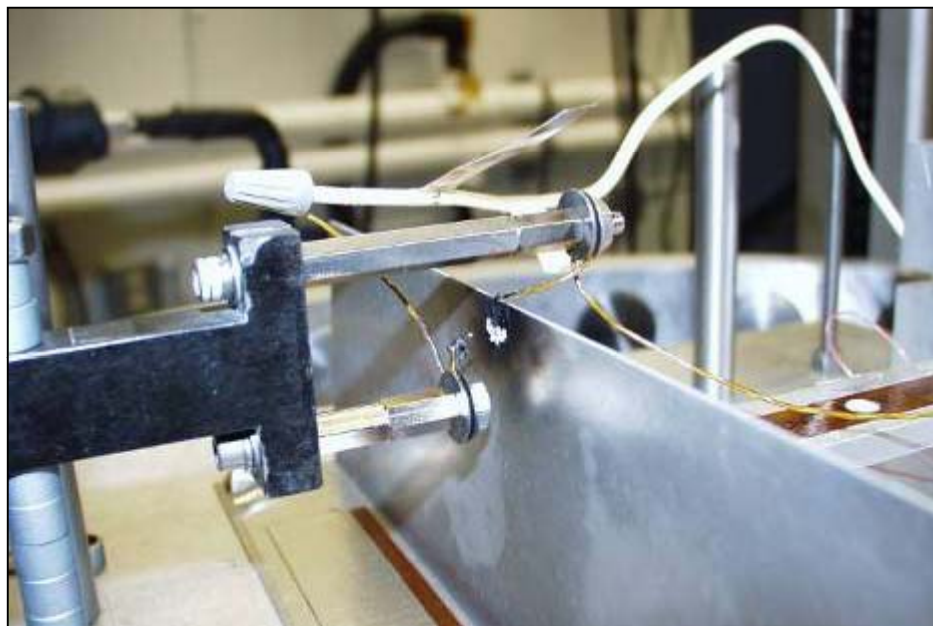
- **Typical result**
  - Arcing occurred when motion breaks contact between conductor and bracket.
  - Wire was vaporized
  - Resulted in open-circuit condition

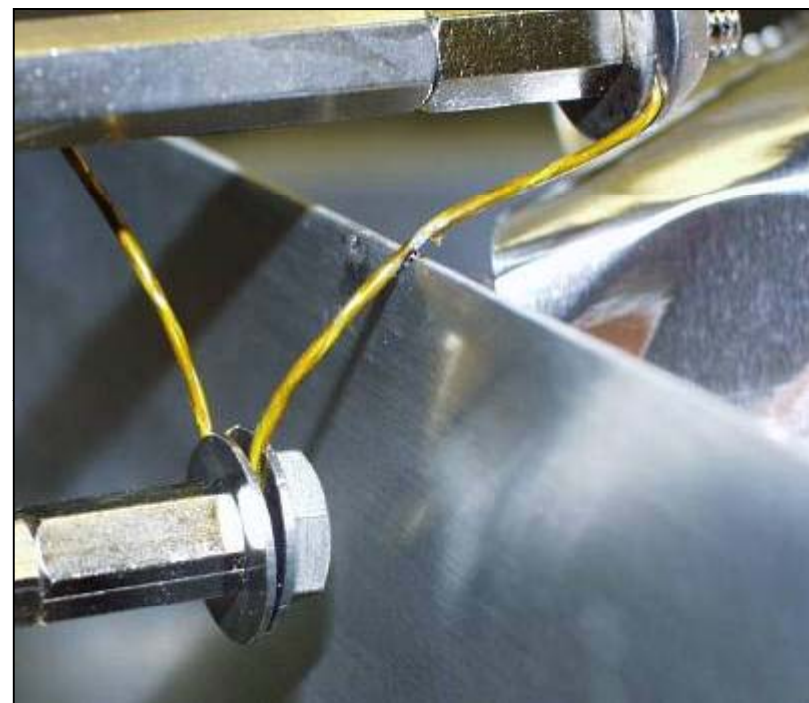
- **Singular result (observed once)**
  - Conductor welded to bracket
  - Resulted in short between wire and bracket
  - Weld broke after subsequent handling

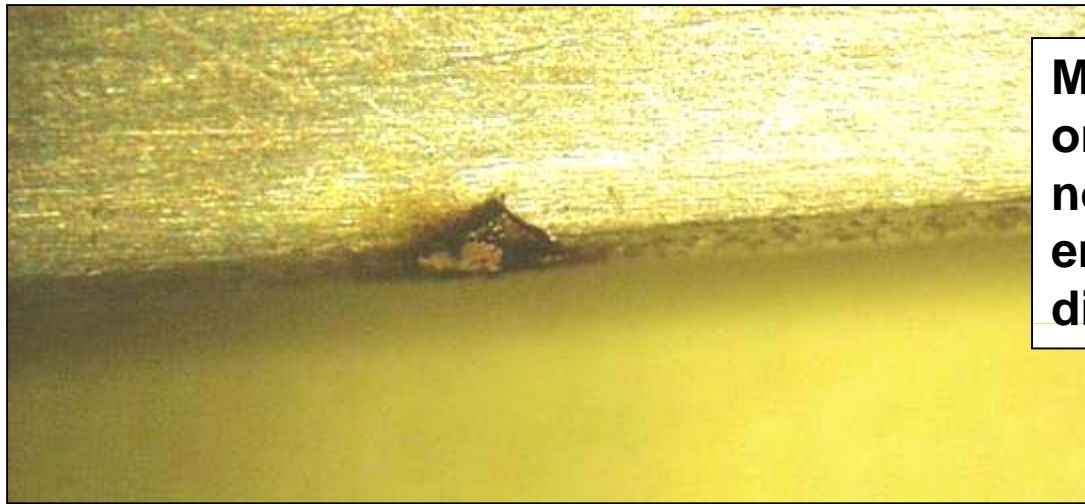
## Inspection after shorting event

**Metallic transfer of copper on to aluminum plate is noted. Weld was intact at end of test. Broke during disassembly.**
