Kuigmek: one who watches the river

January, 2018

**Alaska-Pacific
River Forecast Center
6930 Sand Lake Road
Anchorage, AK 99502-1845
907-266-5160
1-800-847-1739
<http://weather.gov/aprfc>**

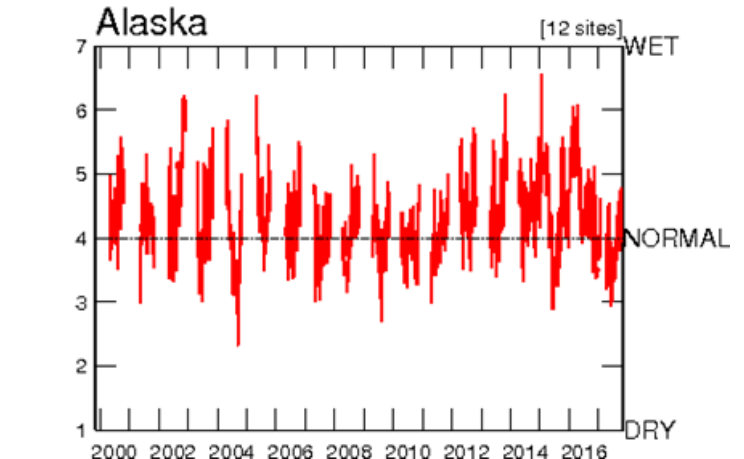
Explanation - Percentile classes							
Low	<10	10-24	25-75	76-90	>90	High	No Data
	Much below normal	Below normal	Normal	Above normal	Much above normal

Average Streamflow Percentile and Index at 12 primary USGS Gages in Alaska. Images: USGS (waterwatch.usgs.gov).

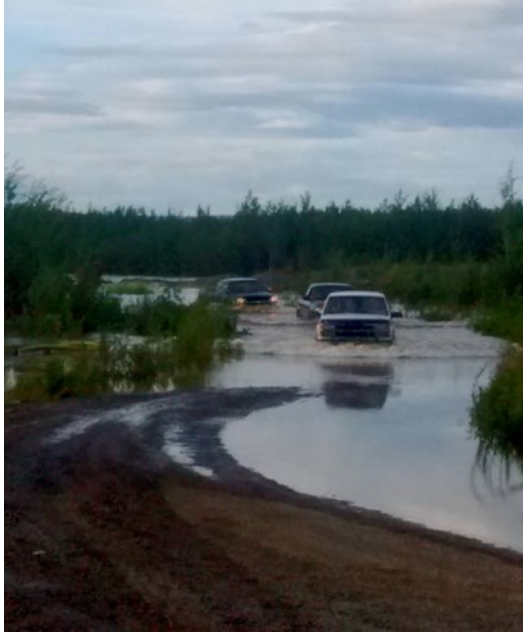
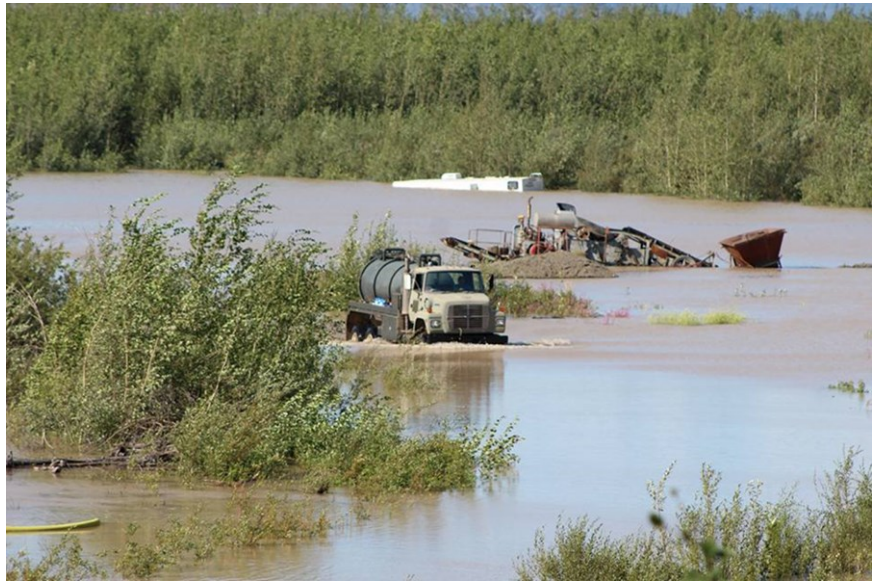
Photos: Tetlin Road flooding from Tanana River. Credit: Paul Kelley, used with permission.

Late in July, we got word that the road out to Tetlin was flooded and impassable. With help from local observers, the Fairbanks Civil Air Patrol, and satellite imagery, we were able to determine the source of the flood water as a breach in the Tanana River. The summer in the upstream watersheds—the Nabesna and Chisana Rivers—was anomalously warm and wet. Rain and snowmelt contributed to high water on the Tanana, which eroded a narrow natural levy between the river and an historic floodplain. Eventually, that water crossed the Tetlin Road and disrupted travel to village residents and commercial use well into mid-August.

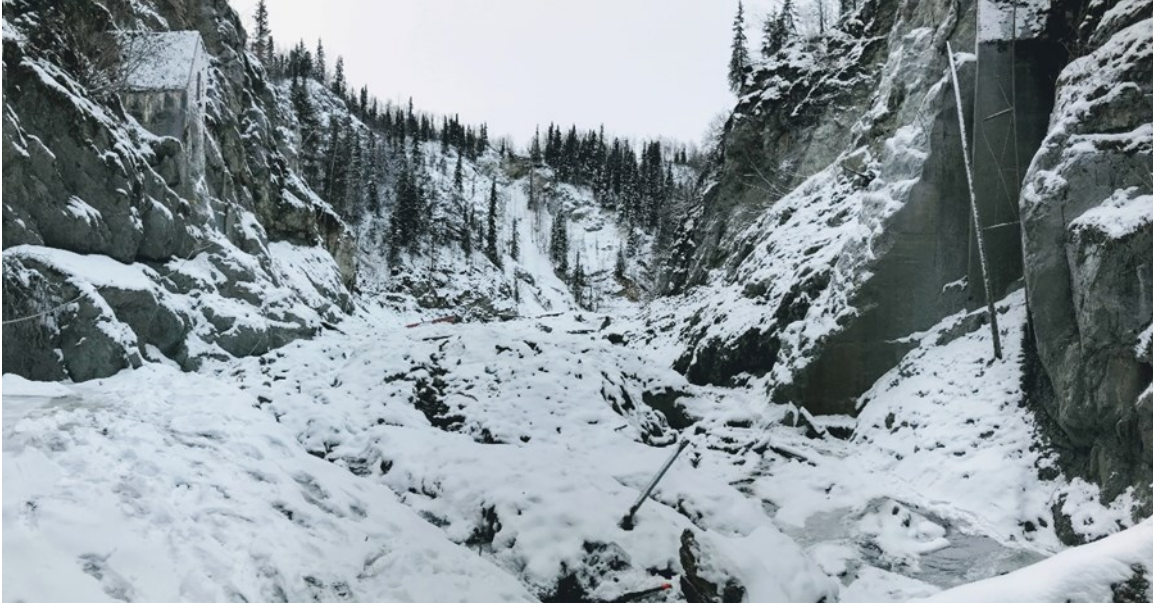
Photo: Looking upstream at remnants of the lower Eklutna Dam. Demolition of this concrete arch dam is ongoing. Credit: Crane Johnson, APRFC/NWS.

A series of strong storms, beginning in late August, washed out the Power Creek Road in Cordova and caused subsequent power supply changes. Smaller precipitation events contributed to runway flooding in Seward, several times this summer. In the Anchorage area, another hydrologic side note was the ongoing removal of the Eklutna dam this summer. In mid-September, Kobuk experienced minor flooding from heavy and persistent rain.

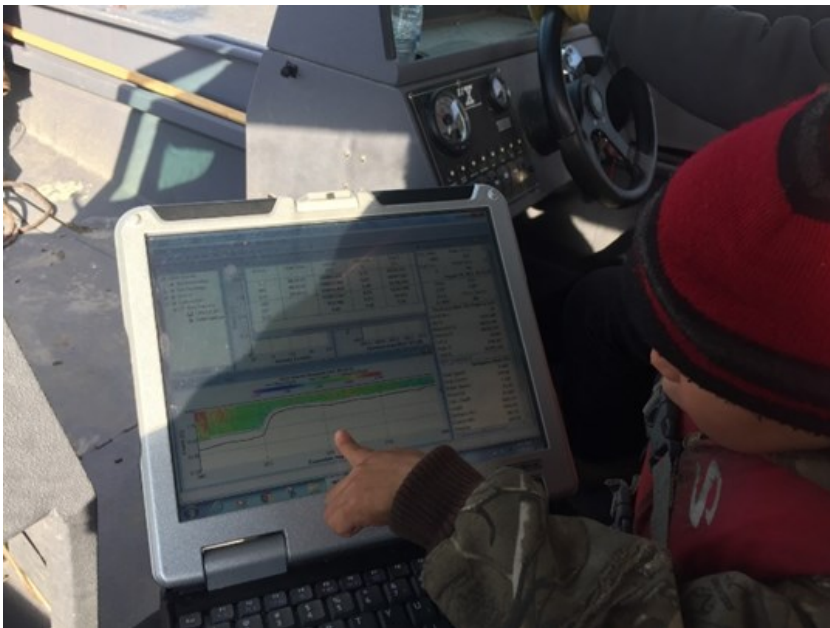
(Left) APRFC Hydrologist Celine van Breukelen (taking picture) explains the ADCP measurement profile to the boat-driver's grandson. (Right) Anchorage NWS Service Hydrologist Andrew Dixon uses pine needles deposited by flood water to determine the high water level near Cooper Landing, Kenai after the Snow GDL outburst. Photo credit: Jessica Cherry, APRFC/NWS.

We don't have room to describe all of our fieldwork this summer, but during August, APRFC forecasters Celine van Breukelen and Eric Holloway traveled to the Yukon River communities of Galena, Ruby, and Circle to measure discharge, re-survey gages, and meet with observers. We typically measure discharge using an Acoustic Doppler Current Profiler (ADCP). The relationship between this discharge and the height of the water is called the *rating curve*, and it's important to have a good estimate of this relationship for accurate flood forecasts. Both our manual and automated gages only measure the height of the water (*stage*), so we compute the discharge based on that rating curve. Another important aspect of our fieldwork is working alongside and talking with our river observers. We want to hear how the rivers may be changing and, in case of a flood event, we want to have strong, existing relationships and communication lines in each affected community.
