Assessment of a Post-Fire Debris Flow Impacting El Capitan Watershed, Santa Barbara County, California, U.S.A.

JONATHAN YONNI SCHWARTZ*

Key Terms: *Debris Flows, Post-Fire, Sherpa Fire, Wildfire, Transverse Ranges, Santa Ynez Mountains*

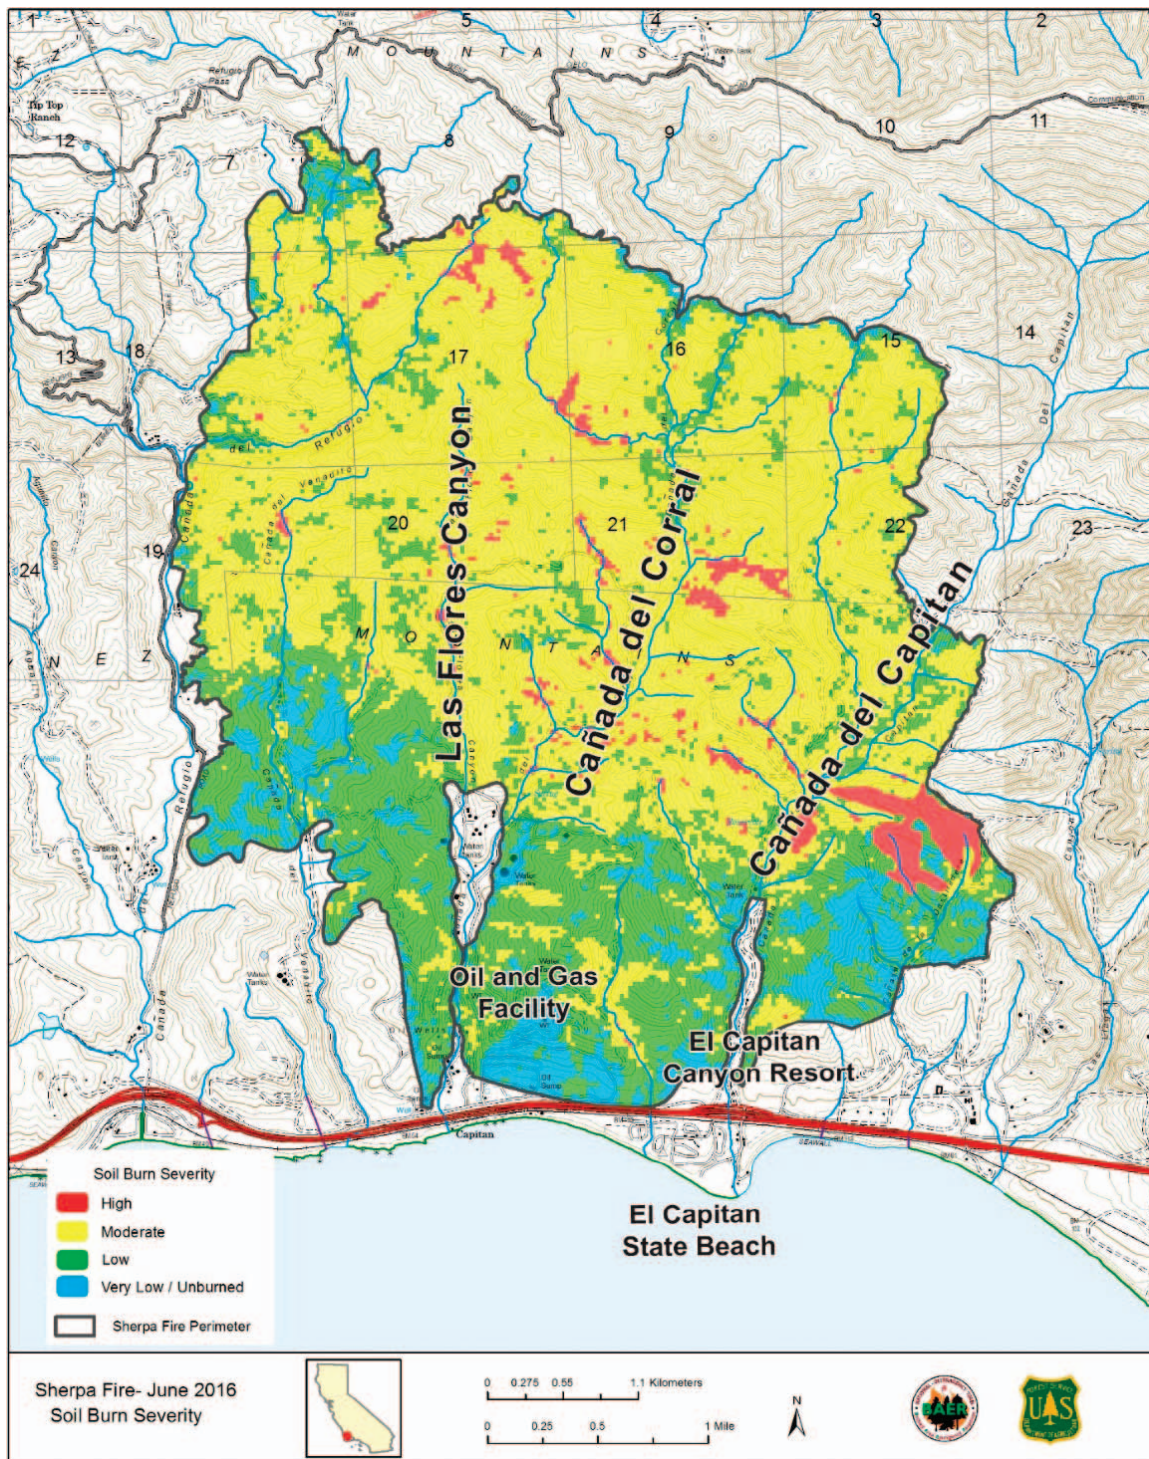
Figure 2. A Sherpa Fire soil burn severity map showing the watersheds impacted by the 20 January 2017 rainstorm event, Santa Barbara County, CA.

The area drained by the Cañada del Capitan watershed is 15.8 km², out of which 6.42 km² (41 percent) were burned in the Sherpa Fire. Of the area burned, 3.6 percent (0.23 km²) burned at high SBS and 67.9 percent (4.36 km²) burned at moderate SBS, amounting to 71.5 percent of moderate and high SBS (Figure 2). During the post-fire Burned Area Emergency Response (BAER) assessment conducted by the U.S. Forest Service, a majority of the soils were identified as soil Hydrologic Group D, indicating soils that are shallow and prone to runoff, especially when vegetation is removed. In addition, hydrophobicity testing in numerous plots revealed subsurface hydrophobic layers 2–5 mm thick with moderate to strong hydrophobic severity, lasting 1–5 minutes (Nicita, 2016).

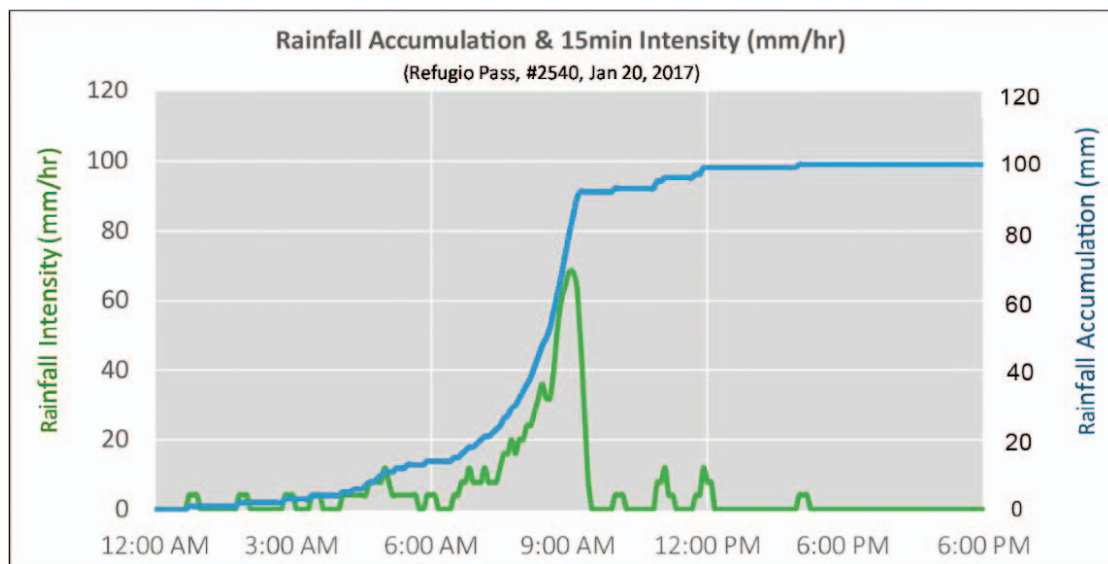
Rainfall in this storm event began at the Refugio Pass rain gage (Figure 1), which best represents the upper El Capitan watershed, at 0:45 a.m. PST. By 11:55 a.m. PST, 98 mm of rain had fallen, with a maximum 1-hour rainfall accumulation of 52 mm occurring between 8:10 and 9:10 a.m. PST and a peak 15-minute rainfall accumulation of 19 mm occurring between 8:53 and 9:08 a.m. PST, representing a 76 mm/hr rate (Figure 4). Based on NOAA Atlas 14 (NOAA, 2016) using the methods described by Staley et al. (2020), the peak 15-minute accumulation was calculated to an average precipitation return interval frequency of 15.8 years. Kean et al. (2011) and Staley et al. (2013) found that rainfall intensities measured over durations of 60 minutes or less are best correlated with post-fire debris flow initiation. Moreover, the 15-minute duration provides the most accurate prediction of post-fire debris flow generation (Staley et al., 2017).

Figure 4. Rainfall accumulation (blue line) and 15-minute intensities (green line) for the storm on 20 January 2017. The peak 15-minute intensity was 76 mm/hr.

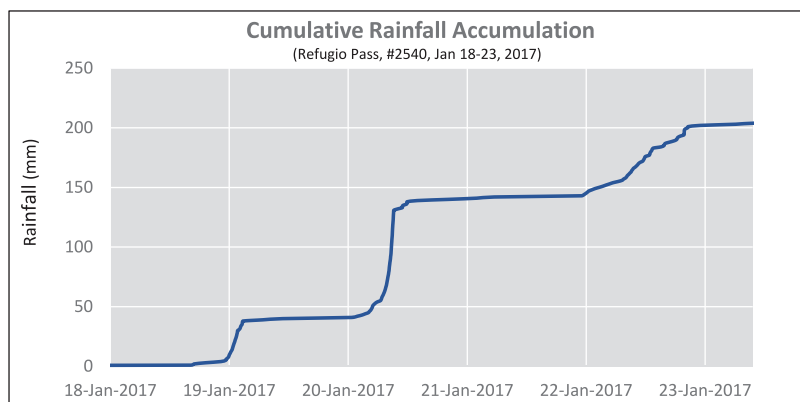
This triggering event was the second rainfall event in 2 days at this location (Figure 5), following the 19 January rainstorm event that produced 32 mm over a period of 2:45 hours at the Refugio Pass rain gage. The 20 January rainstorm event started 22 hours after the 19 January rainstorm ended. The average annual rainfall (1958–2020) at the Refugio Pass rain gage is 711 mm/yr. From the start of Water Year 2017 (October 1), this rain gage had received 470 mm of

Figure 5. Cumulative rainfall accumulations for the three rainfall events that occurred over a 4-day period, 19–23 January 2017 at Refugio Pass Raingage Station. The El Capitan debris flows occurred during the second consecutive storm on 20 January 2017.

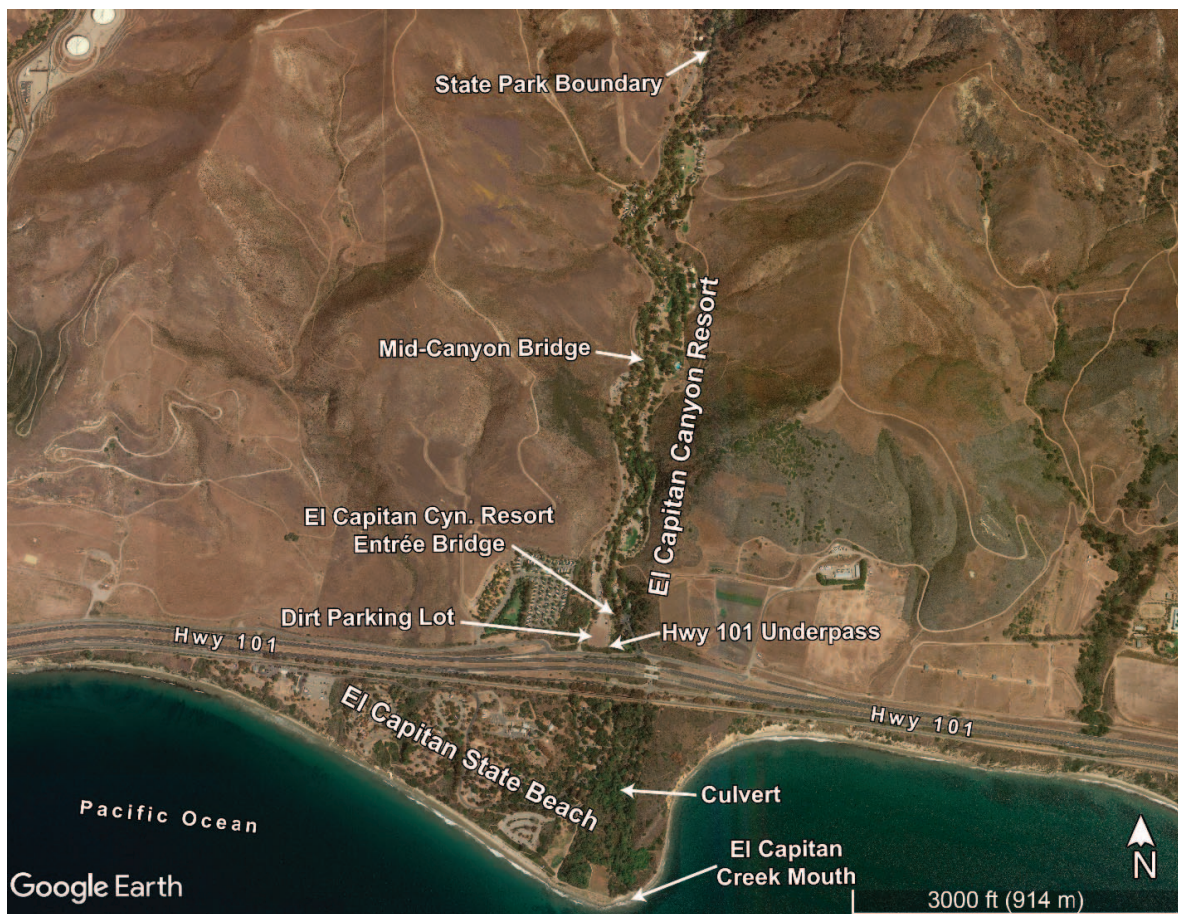
Field observations along the stretch of El Capitan Creek between the State Park boundary (upper end of the El Capitan Canyon Resort) and the Mid-Canyon Bridge (Figure 7) revealed that some segments of the stream experienced channel incision and scour depths ranging from 1.2 to 1.5 m. Other segments of the creek, mostly below the Mid-Canyon Bridge, accrued boulders and finer sediment deposition up to 4 m in depth. Lateral bank erosion occurred mostly on the outer banks at channel bends, exposing unsorted, non-stratified, matrix-supported alluvial channel and older debris flow deposits (Figure 8a). Since the field observation for this study began 24 January 2017 after the third consecutive rainstorm in a 4-day period (Figure 5), it is difficult to determine the exact time the scour and deposition took place along these segments of the stream channel. Along segments of the creek that experienced deposition, elongated boulder fields ranging in size from ~60 m to 140 m long, 10 m to 20 m wide were documented in the channel and were comprised of sub-angular to sub-rounded sandstone boulders ranging from 0.3 m to more than 2.5 m in diameter (Figure 9).

Figure 7. A map showing the El Capitan Canyon Resort and El Capitan State Beach locations with scale.

Resort Entrée Bridge. As these bridges were completely plugged, the flood was diverted out of the channel and into a large soil-surfaced parking lot (approximately 100 m by 60 m) located below and to the west of the El Capitan Canyon Resort Entrée Bridge and adjacent to Hwy 101 (Figure 7). As debris and flows avulsed the channel, flooding the parking lot area, flows continued toward the Hwy 101 underpass. At this stage, in addition to large amounts of woody debris, mud, rocks and boulders, the debris included cars and cabins that were swept away by the flows. As a result of debris plugging the Hwy 101 concrete underpass (3.6 m wide \times 4.6 m high), the large soil-surfaced parking lot turned into a debris catchment basin (Figure 11a). Based on the size of the parking lot and depth of debris estimated from photo documentation of the parking lot during the peak of the event, it is estimated

El Capitan Creek flows under Hwy 101 and continues ~0.75 km before reaching its mouth at El Capitan Beach. On its way to the ocean, the creek flows under a large arch culvert (4.5 m wide × 3.6 m high) located under the entrance road to the State Beach (Figure 7). Reports from staff occupying the State Beach entrance kiosk indicate that at approximately 9:45 a.m. PST, as the surge front of debris came down the creek, large amounts of debris plugged the arch culvert, causing the flows to avulse and divert down the road toward the kiosk. This diversion of the flow persisted for approximately 10 to 15 minutes. Once pressure on the debris plugging the culvert broke through, flows and debris resumed their natural flow path down the creek to the ocean.
