**Tornado Damage in Tuscaloosa, Alabama,  
December 16, 2000**

A report prepared by  
**Larry J. Tanner, P.E.**

Submitted to NIST  
**May 22, 2001**

Wind Science and Engineering Research Center  
Texas Tech University  
Lubbock, Texas

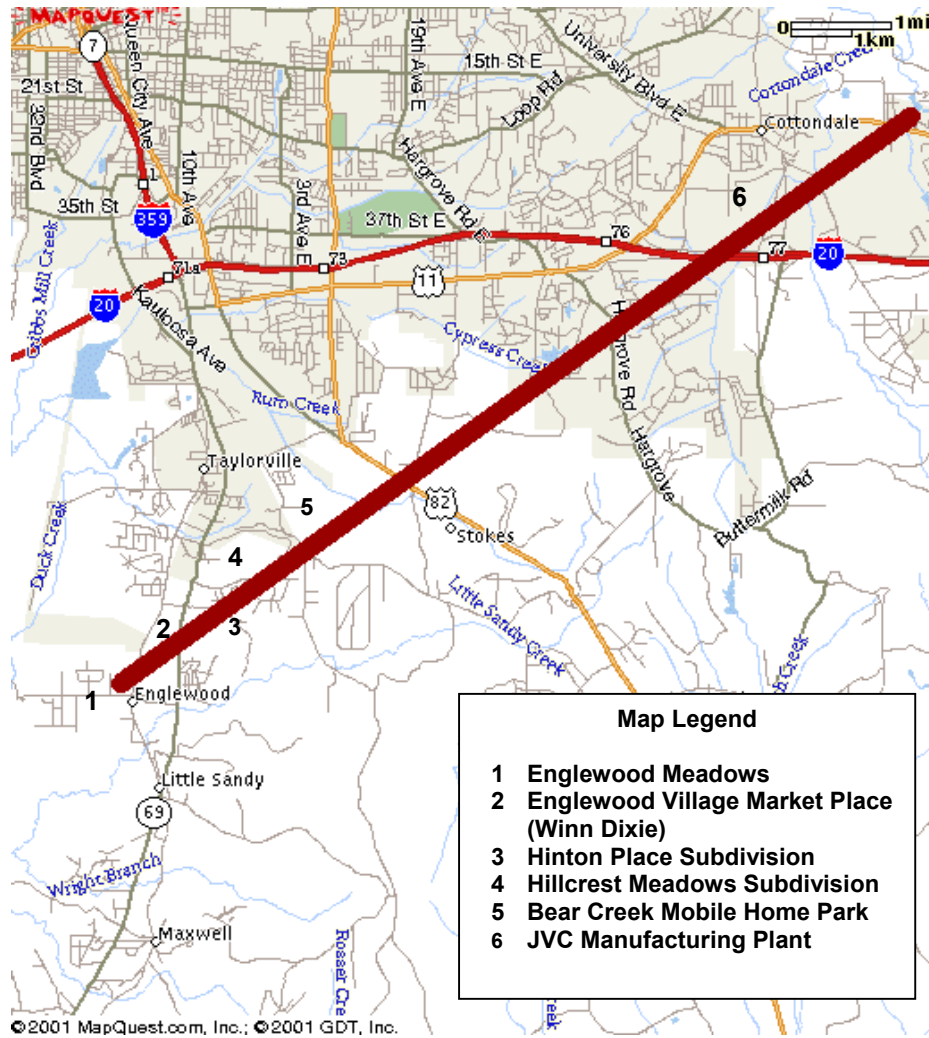
Figure 1. Storm Path

Figure 1 depicts the storm's path. The initial tornado touched down in Englewood Meadows, where a mobile home was overturned and several homes were damaged.
