Sinking of US Cargo Vessel SS *El Faro*  
Atlantic Ocean, Northeast of Acklins and Crooked Island,  
Bahamas  
October 1, 2015

NTSB/MAR-17/01  
PB2018-100342

NTSB/MAR-17/01  
PB2018-100342  
Notation 57238  
Adopted December 12, 2017

# Marine Accident Report

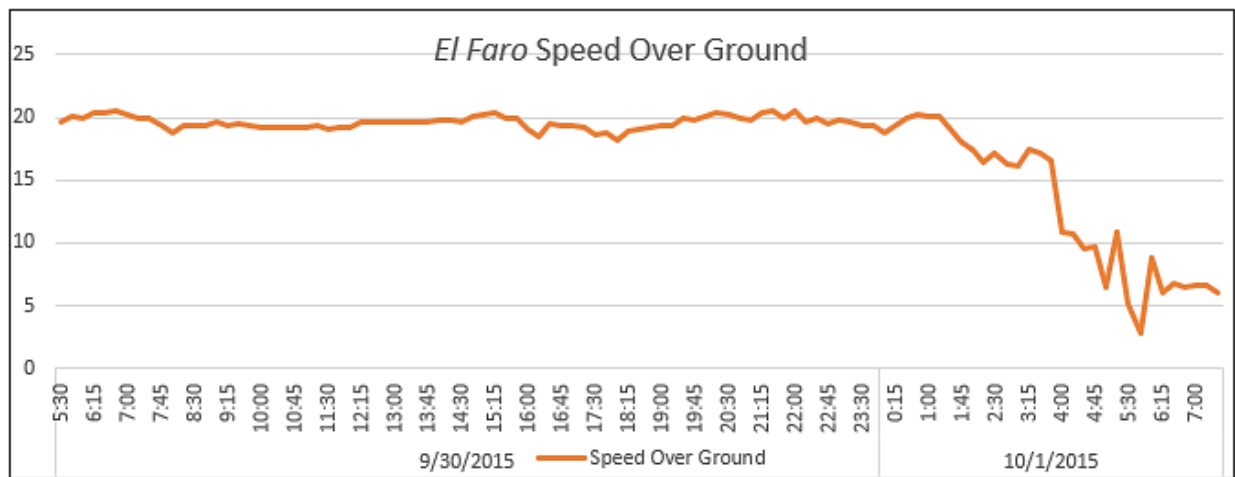
Figure 7 plots the ship’s speed over ground, which is the ship’s motion relative to the earth’s surface, as measured by GPS. The VDR recorded this information from the morning of September 30 to the time of the sinking. On October 1, as shown in the figure, the ship’s speed over ground slowly decreased after 0100, then dropped precipitously about 0400.

**Figure 7.** Vessel’s speed over ground from 0530 on September 30 until sinking. (Based on VDR parametric data)

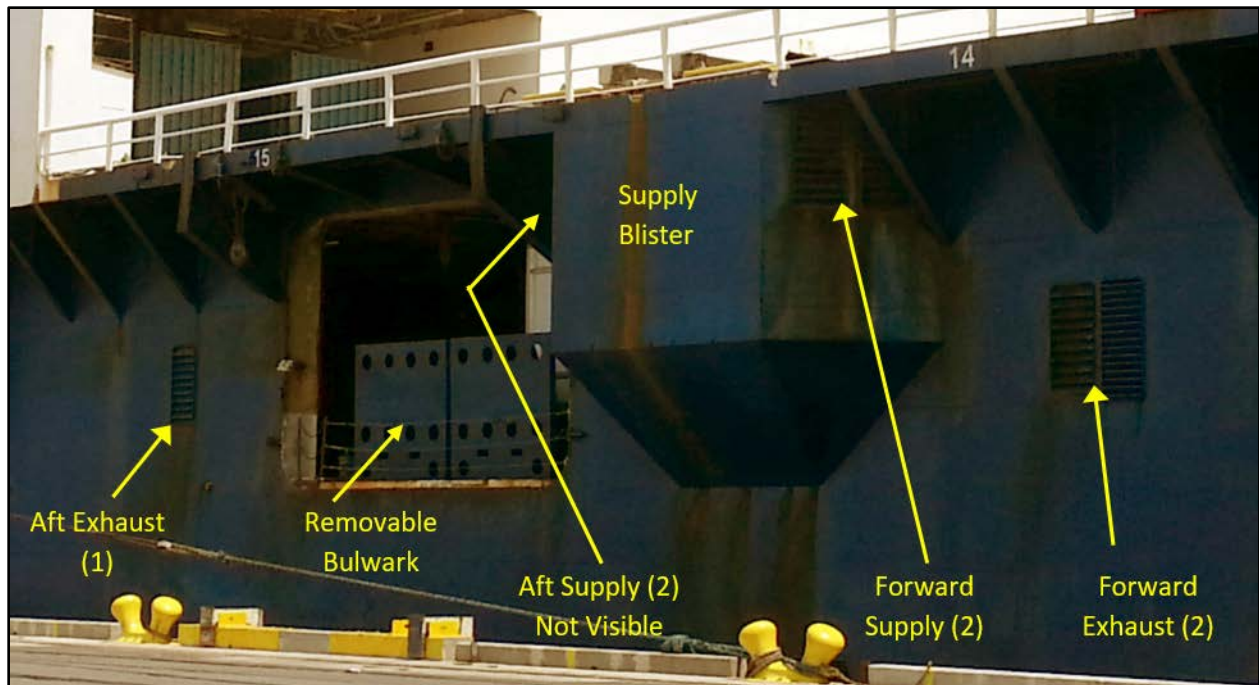
All cargo holds had two supply trunks (port and starboard) and at least two exhaust trunks. The supply trunks were fitted with electrically driven fans mounted port and starboard (directly opposed) on the enclosed part of the second deck. The supply fans were in “blisters” that bulged out from the hull below the overhanging main deck (figure 10). The fans pulled air through four sets of rectangular louvers mounted on the forward and aft sides of the three-sided blister shell plate, then drew it into the fan bellmouth. The fans pushed supply air through the fire dampers into a single trunk that passed through the tween holds and into the lower holds at the tanktop. There the trunk split into horizontal runs mounted longitudinally against the sides of the hold. The lower horizontal supply ventilation trunks in the cargo holds were fitted with downward-facing registers, measured as 12 inches above the tanktop.

**Figure 10.** Starboard side of *El Faro* showing supply and exhaust ventilation openings to cargo hold 3. (Photo by Herbert Engineering)

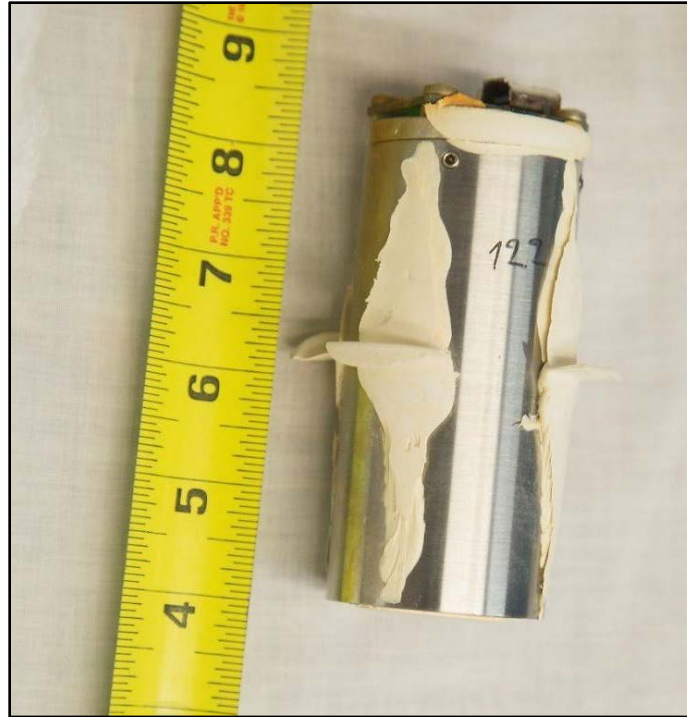
The VDR data were stored on a flash memory chip inside a protective capsule. On August 8, 2016, after the capsule was recovered from *El Faro*'s wreckage, it was submerged in a bath of distilled water aboard the Navy vessel *Apache*, then disassembled and inspected for possible damage to the internal recording medium. Inside the capsule, layers of protective materials housed an inner capsule containing the circuit board assembly that stored the nonvolatile memory (figure 16).<sup>82</sup> The circuit board assembly was inspected for visible signs of damage or corrosion (figure 17) before being transported to the NTSB laboratory in Washington, DC, on August 12.

**Figure 16.** Inner VDR capsule assembly after removal from outer capsule.

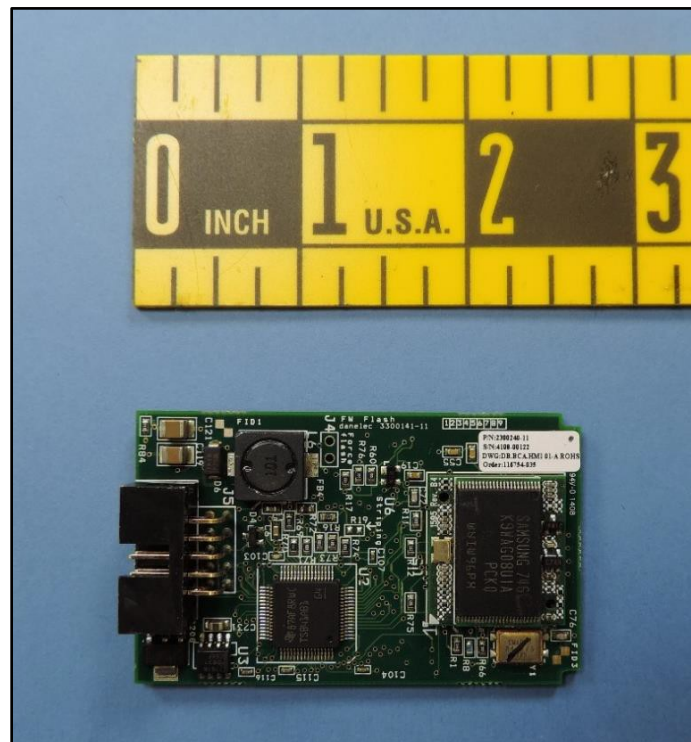
**Figure 17.** Circuit board assembly from inner VDR capsule.

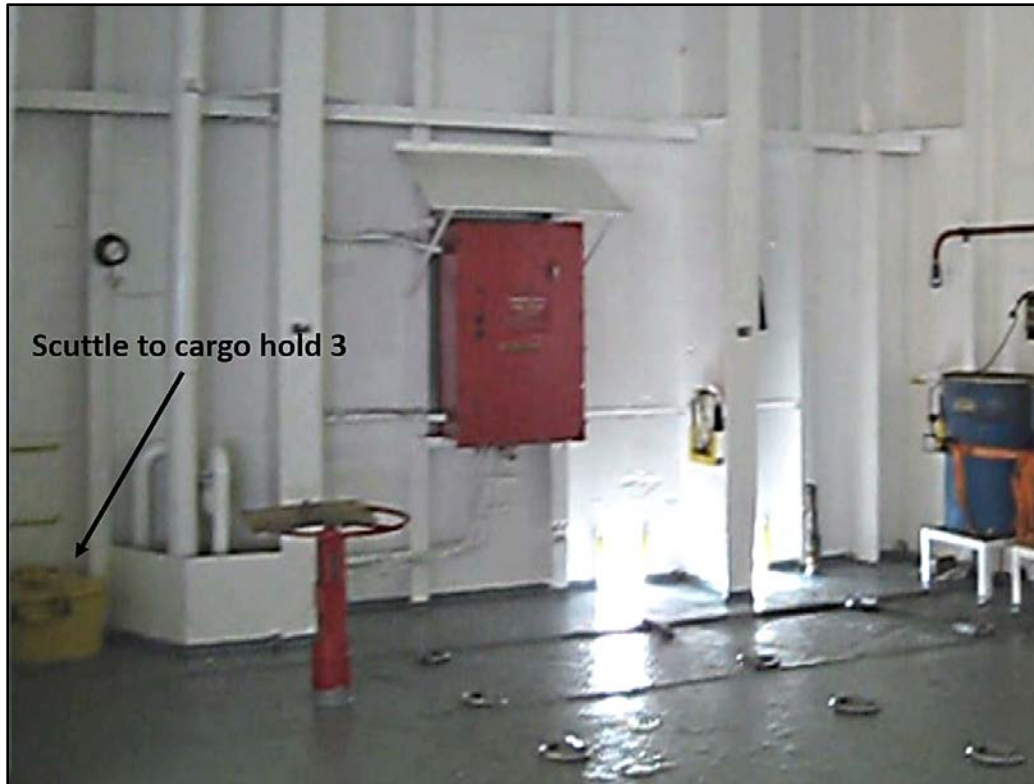
To achieve watertight integrity, a scuttle was secured by closing the steel cover (which had a gasket) and turning a wheel. Through a linkage system, the wheel moved four steel pegs (dogs) to seal the scuttle tight and prevent water from entering the hold. A former *El Faro* boatswain testified that a person could not tell by looking at a closed scuttle whether the wheel had been turned to engage the dogs and seal the hatch. A past chief mate and captain of *El Faro* stated, "You would have to grab the handle of it and see if it was locked or unlocked."

**Figure 57.** Second deck scuttle to hold 3. (Photo by former *El Faro* second mate)

The steel plates or covers to the scuttles were characterized by crew and officers as being heavy and hard to open. A former *El Faro* chief mate and captain stated that he had “never seen one pop open on its own.” Another former captain of *El Faro*, who had nearly 27 years’ experience as captain or chief mate on that ship and other vessels of the *Ponce* class, stated, “I don’t see a wave getting in there and lifting [a scuttle]. Even if it was not dogged.”
