Takata Inflator Rupture Root Cause Summary Report

Submitted by:
Orbital ATK for the Independent Testing Coalition

Submitted to:
National Highway Traffic Safety Administration

September 2016

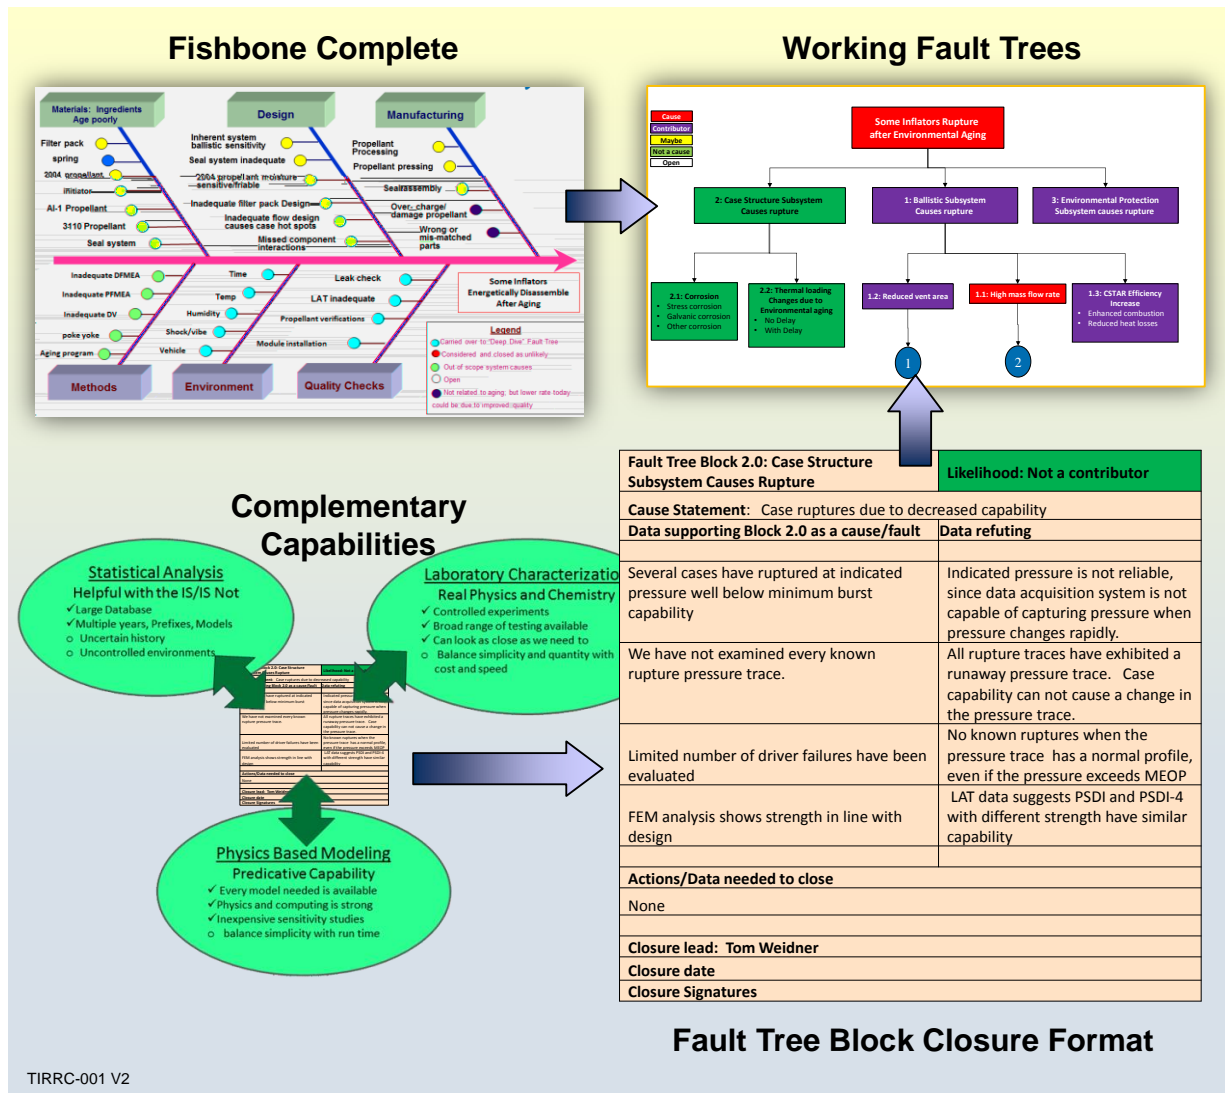
Figure 1. Overarching Project Process.

The disciplined process for root cause started with an industry-standard fishbone which was used to populate an extensive fault tree. A multi-disciplinary approach serves as checks on each other to reduce probability of errors. Full documentation of the fault tree including a formal closure process will provide a complete record for future reference.

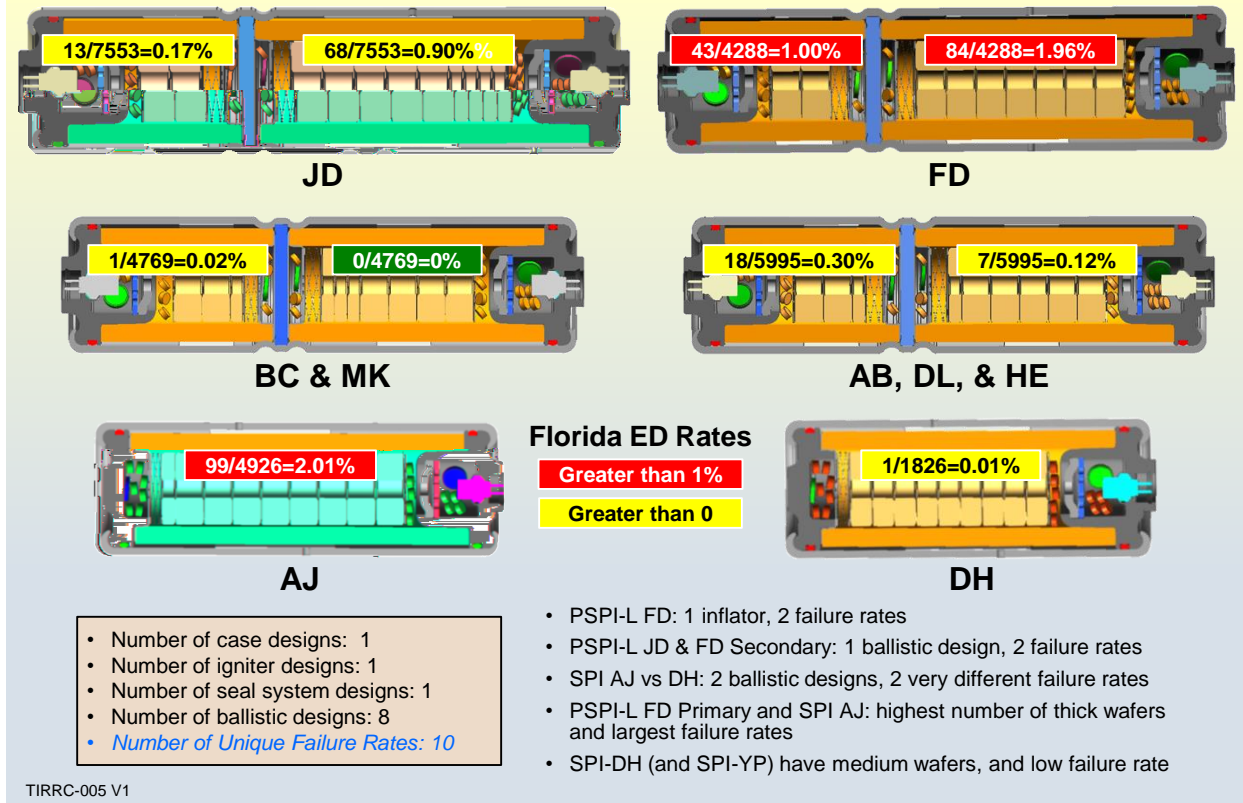
Figure 4. Summary of Similarities and Differences for Passenger Inflators.

These summaries guide where more detailed engineering analysis and testing will be most likely to identify root causes and contributors. The rupture rate on field return tests is shown for each inflator chamber superimposed on that chamber.

Analysis of the passenger branch showed a common case design, seal system design and igniter design with eight unique ballistic designs. Since the main hardware designs are the same but ballistic designs are different, this suggests a focus on ballistic differences will help to understand differences in energetic disassembly (ED), or rupture rate. This analysis shows that designs that superficially appear similar can be quite different in the ED rate. Detailed analysis is yielding insights on these differences. Each of these points is a clue in understanding the root cause.

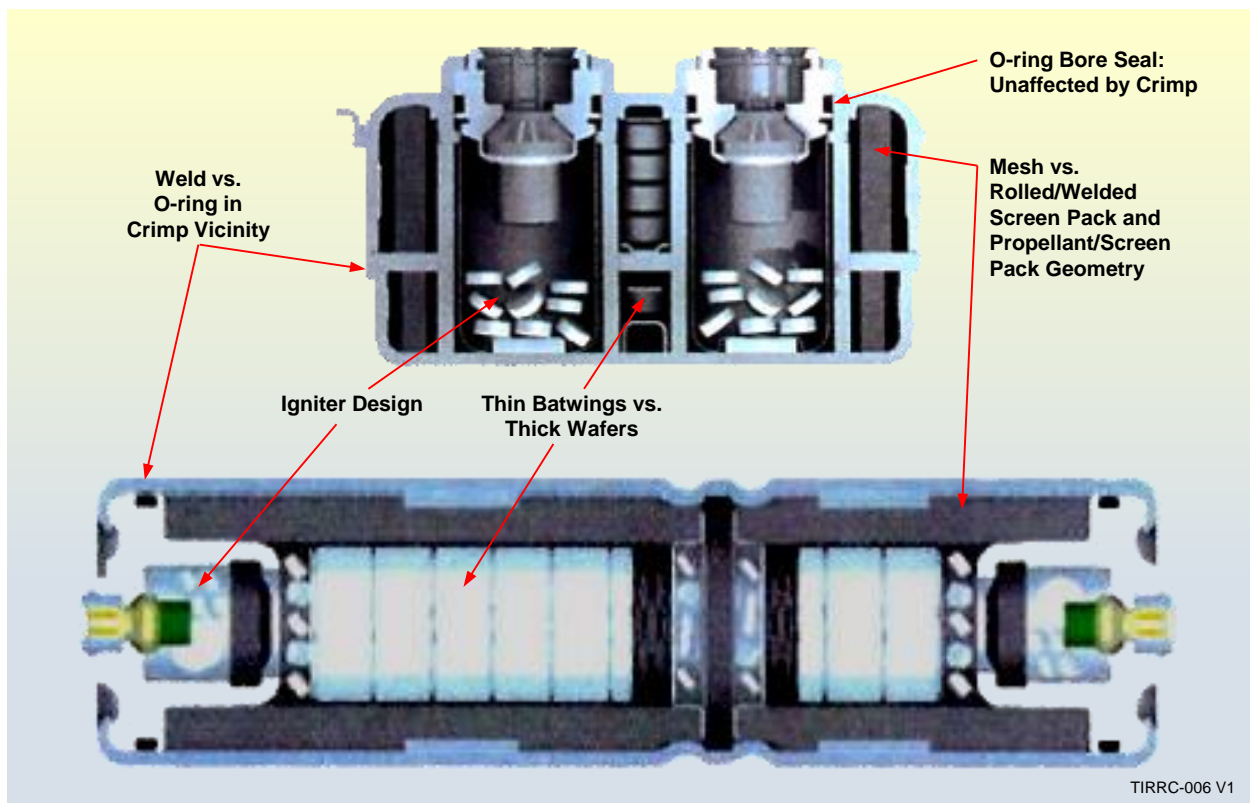
Figure 5. Comparison and Contrast of Major Design Differences in Takata Driver and Passenger Dual Chamber Inflators.

Detailed design analysis and comparison was also done for the driver branch of inflators. This allowed us to examine the driver and passenger designs for similarities and differences (Figure 5) that could account for the order of magnitude higher passenger-branch failure rate. Key differences include: 2004 propellant geometry, igniter closure seal design, igniter design and screen pack design.

While functionally similar (see Figure 7), understanding these differences is relevant to understanding differences in ED rates.

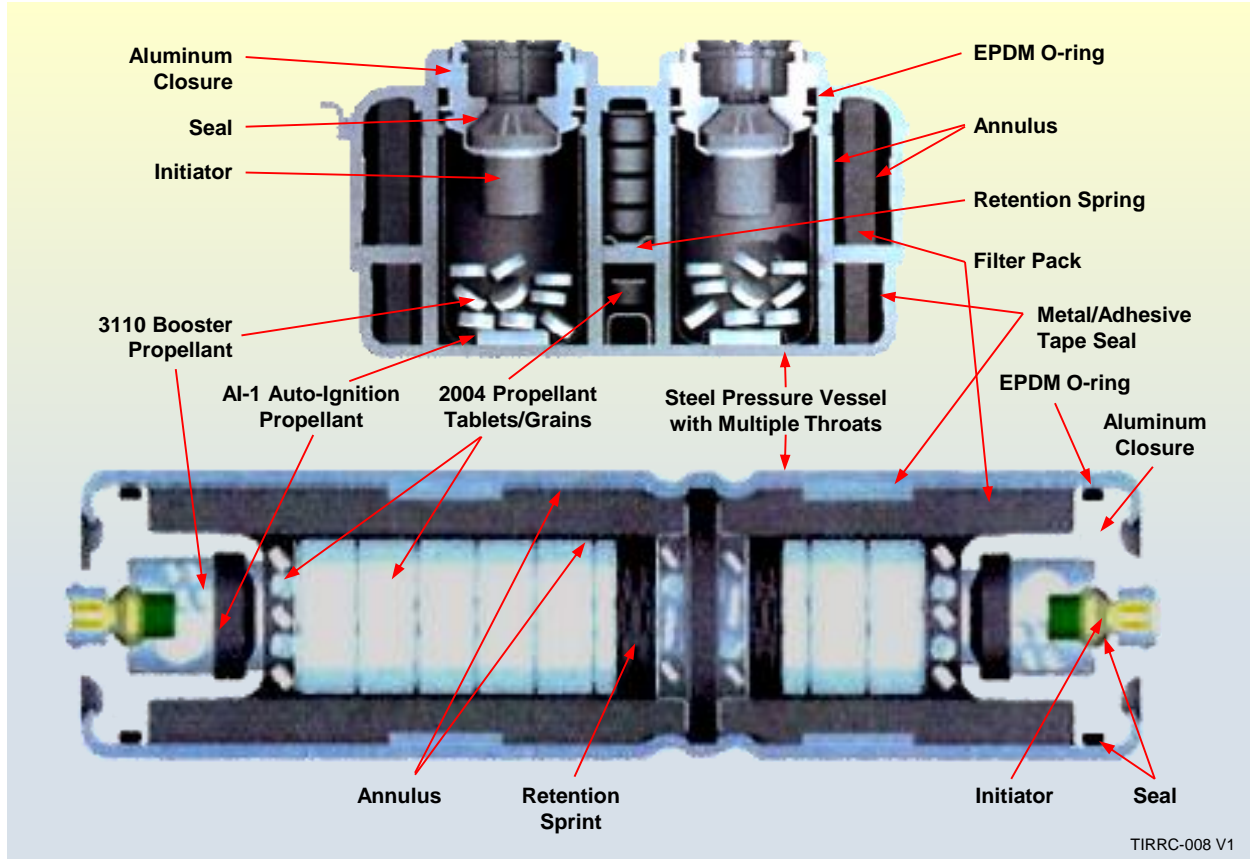
Figure 7. Similarities in Operating Features of Takata Driver and Passenger Inflators.

While there are certain differences (Figure 5), there are many similarities in propellants, materials and designs for the inflators under recall. These similarities allow conclusions regarding both designs to be reached on several key parameters.

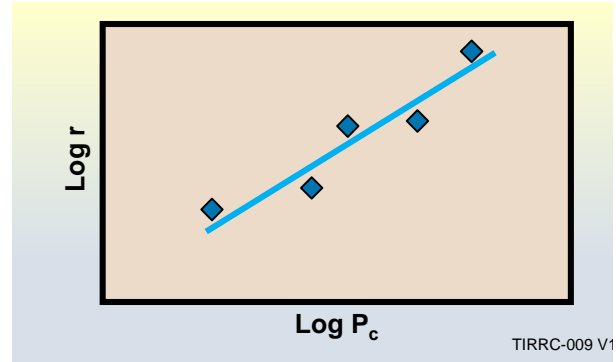
Figure 8. Schematic Representation of Burn Rate and Pressure Plot.

Propellants combust following an exponential relationship of pressure and burn rate. With a high slope of the line, burn rate rises rapidly with increasing pressure. Such propellants exhibit larger changes in burn rate and gas production than those with lower slopes.
