BUILDING PERFORMANCE ASSESSMENT REPORT

**OKLAHOMA AND
KANSAS**

Midwest Tornadoes of May 3, 1999

**OBSERVATIONS, RECOMMENDATIONS,
AND TECHNICAL GUIDANCE**

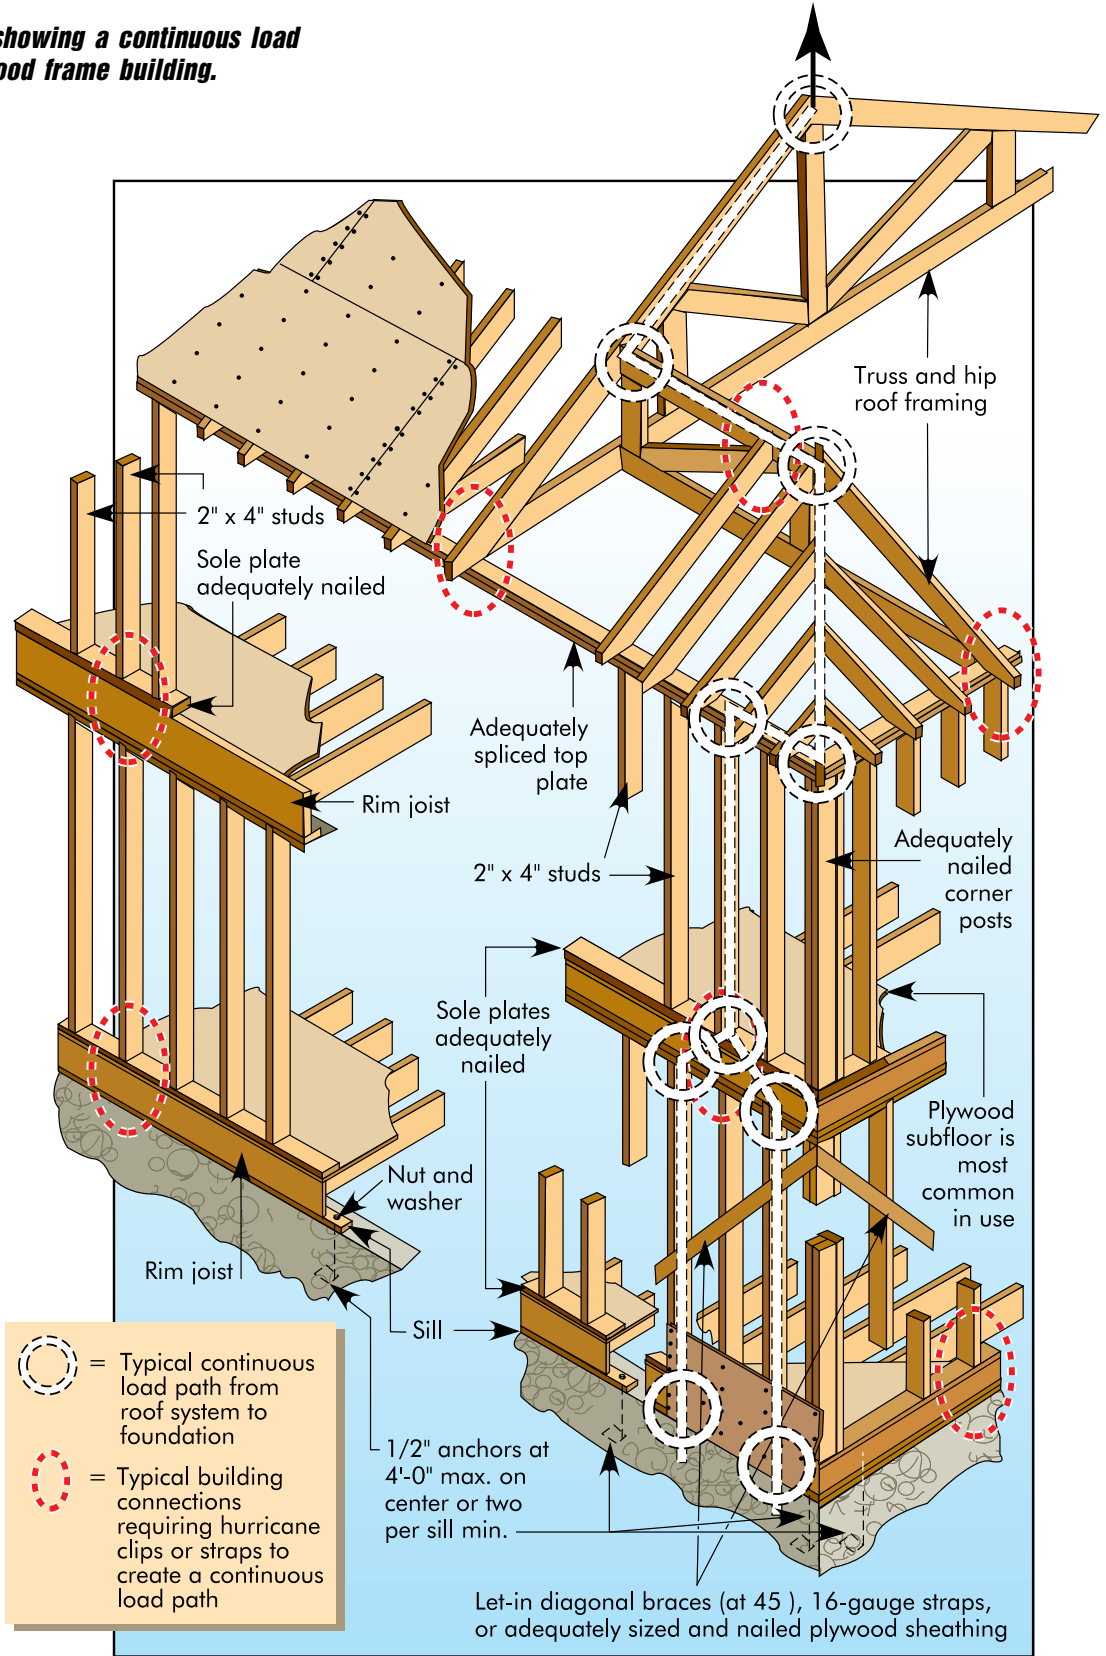
FIGURE 3-2: Diagram showing a continuous load path for a two-story wood frame building.

Primary structural systems are those that support the building against all lateral and vertical loads. Many buildings inspected had structural systems capable of providing a continuous load path for gravity loads, but were unable to provide a continuous load path for the lateral and vertical uplift forces generated by the tornado winds. The team looked at how this property damage could have been prevented or reduced in all areas of the windfield, with the exception of that directly under the vortex of violent tornadoes. Figure 3-2 shows a continuous load path in a wood frame (stick built) house.

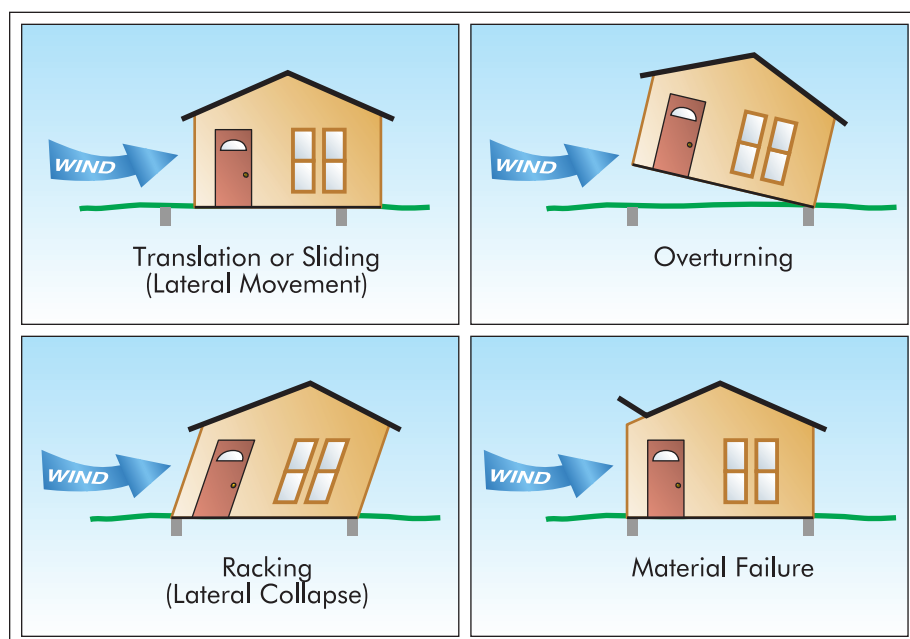
FIGURE 3-3: Building failure may occur in several ways.

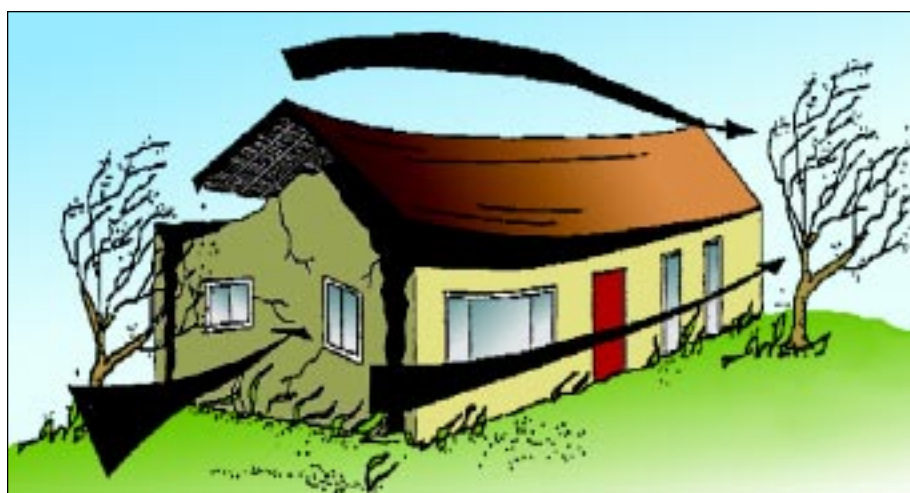
FIGURE 3-4: This building failure is the result of inward wind forces and uplift wind forces acting on a building during a high wind event.

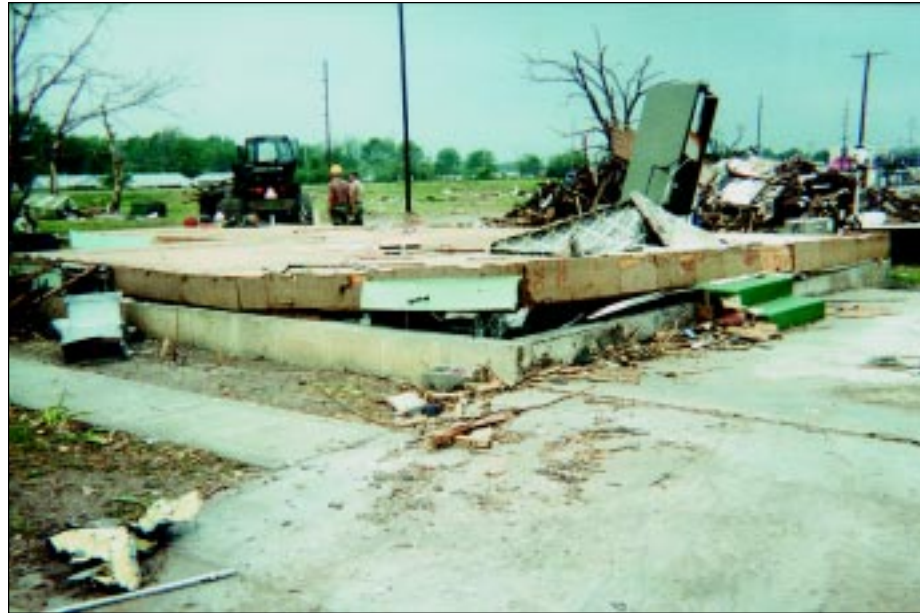
Winds moving around a building or structure will create uplift, overturning, and sliding forces that act on buildings (Figure 3-3). Uplift is the force caused by the wind accelerating around and over buildings and other structures (Figure 3-4). An example of uplift strong enough to move a house off its foundation is presented in Figure 3-5. This house was separated from its foundation when it experienced winds associated with a strong tornado that passed through the city of Haysville, Kansas. Although anchor bolts extended from the concrete foundation into the wood floor framing, nuts and washers were not attached to the bolts to provide a continuous load path at the connection points. The use of nuts and washers in combination with anchor bolts is essential for this connection to provide a continuous load path that would have resisted the uplift forces. This type of deficiency was observed at more than just this one house.

FIGURE 3-5: Wind uplift acting on this house in Haysville, Kansas, resulted in this corner of the building being lifted off its foundation.

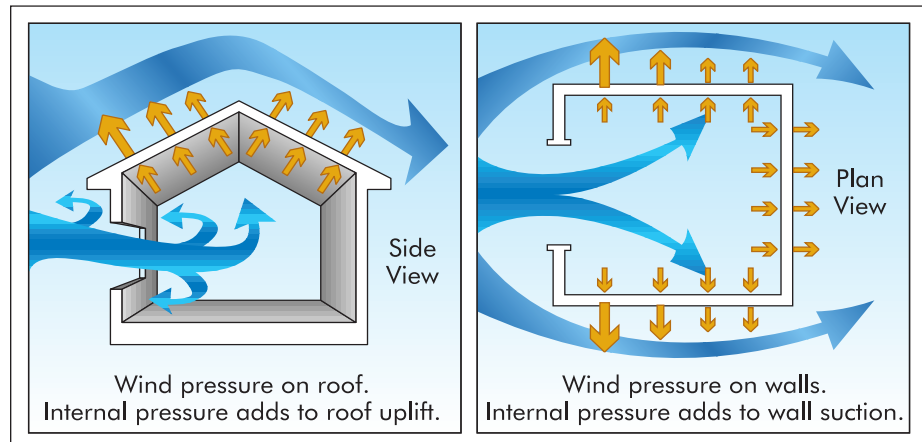
Depending on factors such as building size, number of interior rooms, number of stories, and size of the building envelope breach, laboratory tests in wind tunnels indicate that, when wind can enter the building, the uplift forces on the roof system can be doubled during extreme wind conditions.

Figure 3-6: Increased loads on roof and walls due to breach in envelope.

in effect partially enclosed buildings and are subject to wind load increases. The failure of openings, such as windows and doors, causes greatly increased air pressures in buildings. In areas not prone to hurricane force winds (such as the tornado prone areas of Oklahoma and Kansas), houses are not normally designed for these increased pressures, which can result in structural failure.

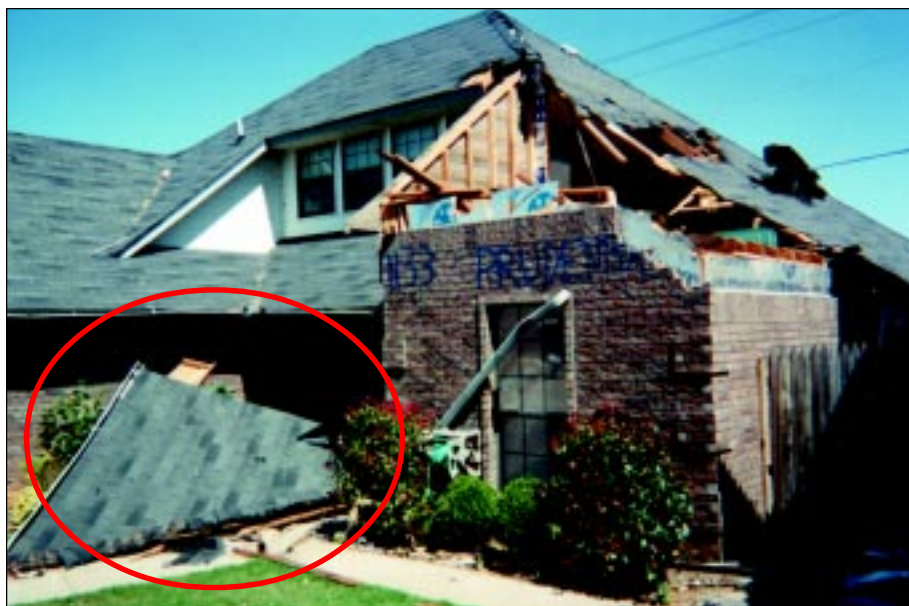
Failures due to combined internal pressures and leeward roof pressures, failure due to leeward suction pressures only, and failures due to internal pressurization only are presented in Figures 3-7, 3-8, and 3-9, respectively. These failures were typical of wind induced failures observed along the inflow wind areas of violent and strong tornadoes.

FIGURE 3-7: Failure of hip roof due to internal pressures and leeward roof (uplift) wind forces acting together. This house, which was exposed to inflow winds on the periphery of a violent tornado, is located in a suburb of Oklahoma City, Oklahoma.

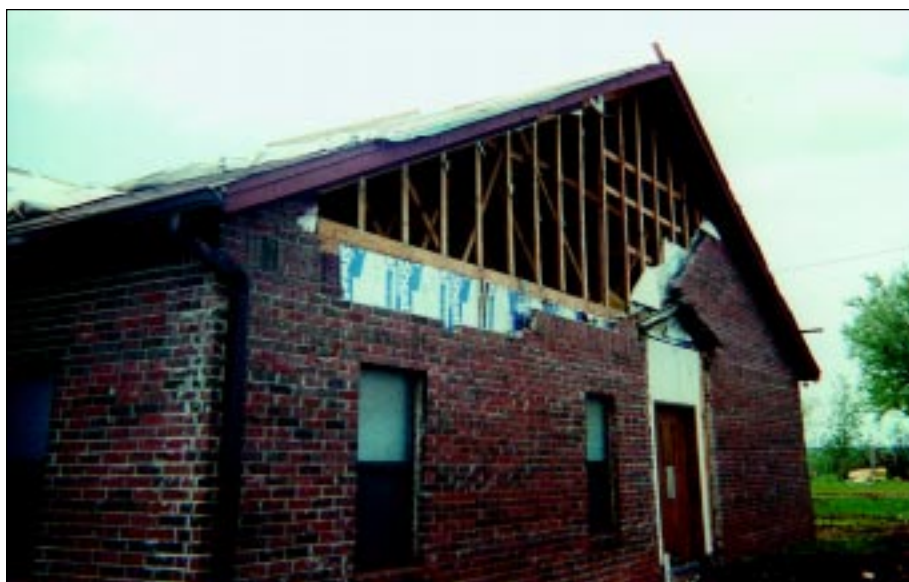
FIGURE 3-8: Failure of this gable wall section was due to wind suction forces on the leeward wall. This church was on the outer edge of a violent tornado path.

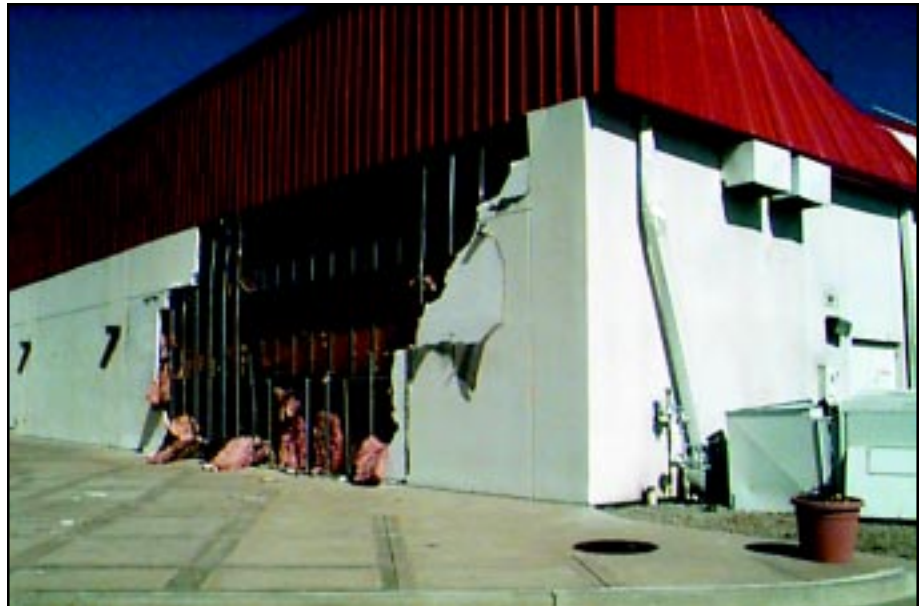
FIGURE 3-10: EIFS and metal fascia damage at the regional outlet mall in Stroud, Oklahoma. This is a typical example of a components and cladding failure.

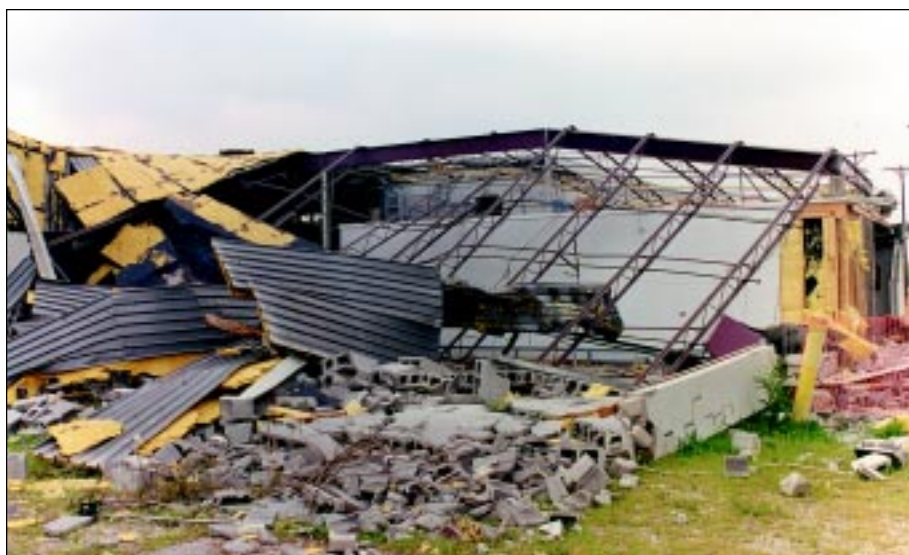
FIGURE 3-11: *This un-reinforced masonry (URM) wall failed when inflow winds from a strong tornado acted on this building in Wichita, Kansas.*

breached. Figure 3-11 was a building with load bearing masonry walls and a steel joist roof system. Figure 3-12 is a steel frame building with masonry infill walls.

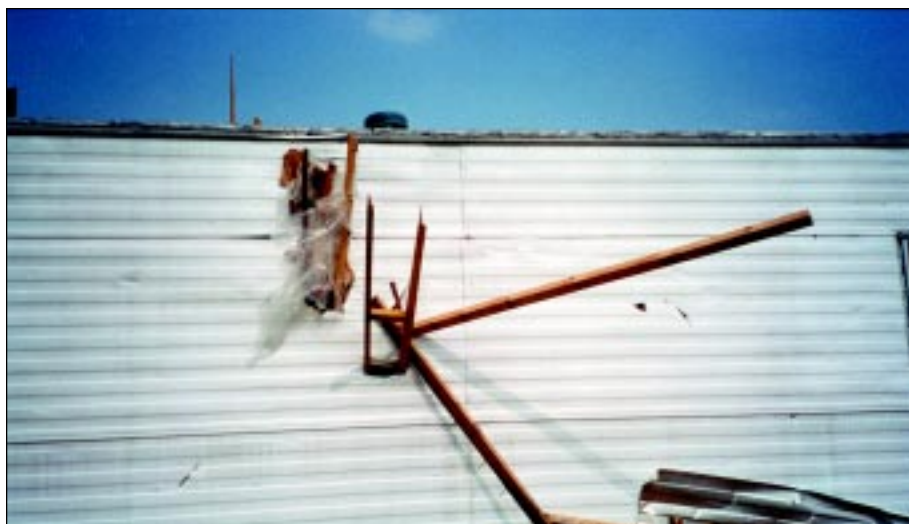
FIGURE 3-14: *These medium sized missiles struck and remained embedded within this manufactured home in Wichita, Kansas.*

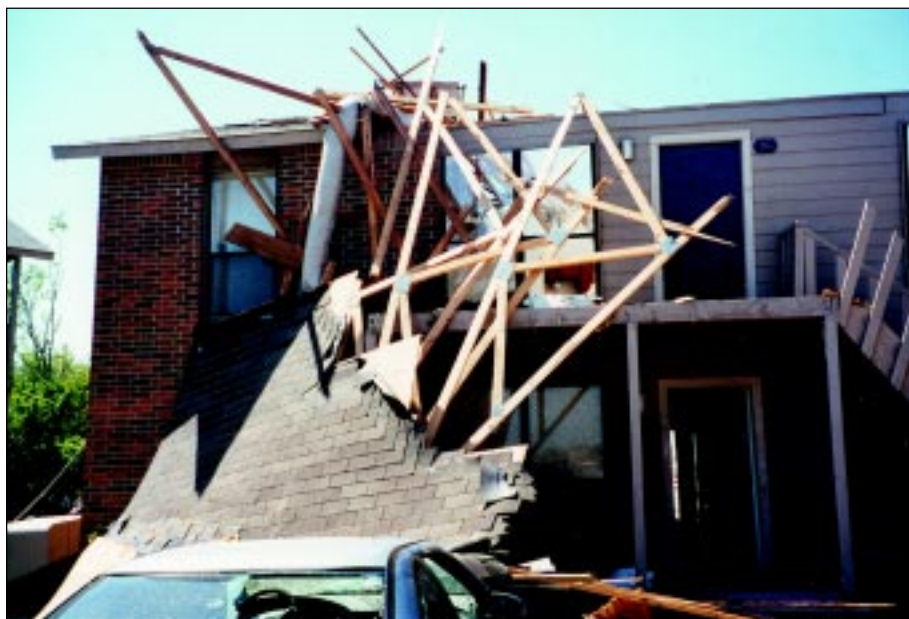
FIGURE 3-15: *These trusses and roof covering (still attached to the roof sheathing) were displaced by the winds of a violent tornado and are capable of becoming large, windborne missiles. These trusses were originally attached to this apartment building.*

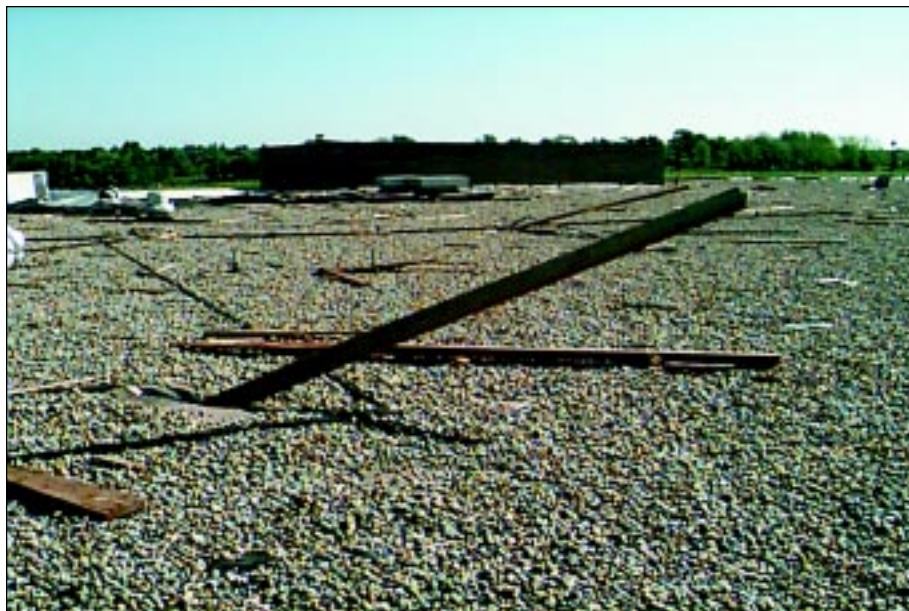
Figure 3-16 shows missile impacts on the roof of Westmoore High School in Moore, Oklahoma. The missile sticking out of the roof surface in the foreground is a double 2-in by 6-in. The portion sticking out of the roof is 13 feet long. It penetrated a ballasted ethylene propylene diene monomer (EPDM) membrane, approximately 3-in of polyisocyanurate roof insulation and the steel roof deck. The missile laying on the roof just beyond it is a 2-in by 10-in wood member that is 16 feet long. The missile in the background that penetrated the roof deck is a 2-in by 6-in that had a total length of 16 feet. The source of missiles was not determined, hence the distance to their origin is unknown. However, because this school building was located within 100 yards of a violent tornado, it is likely that they traveled at least a few hundred feet from a subdivision of wood-frame houses that were in the direct path of the tornado.

FIGURE 3-16: *Medium and small missiles through and on Westmoore High School's roof, Moore, Oklahoma*

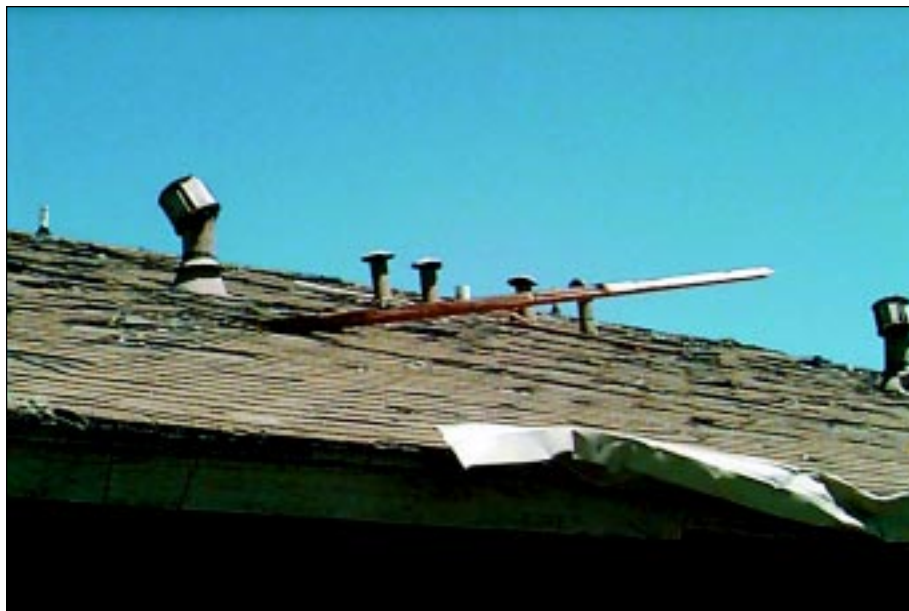
FIGURE 3-17: *This missile struck a house located in Moore, Oklahoma.*

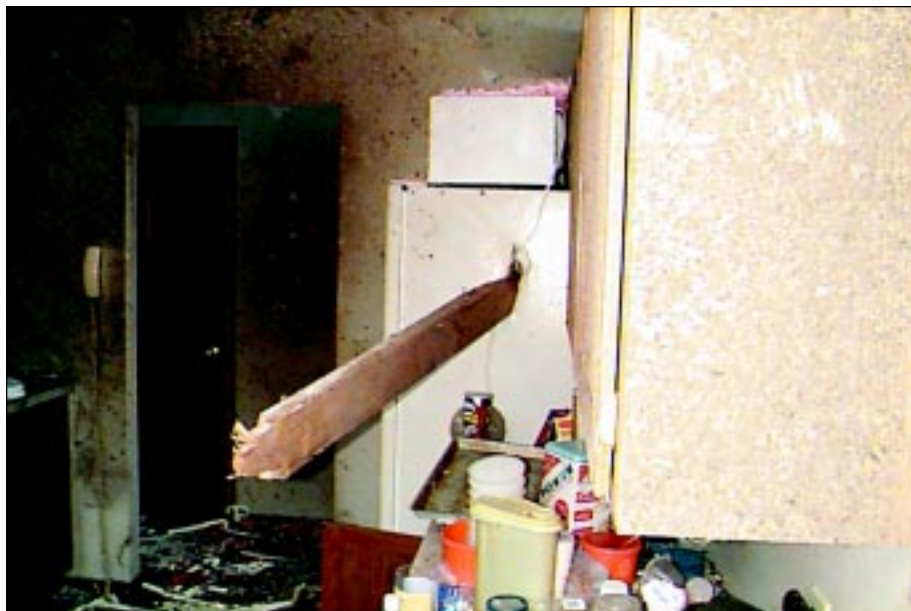
FIGURE 3-20: A 2-in by 6-in missile penetrating a refrigerator located inside a home in the Country Place subdivision outside Oklahoma City, Oklahoma.

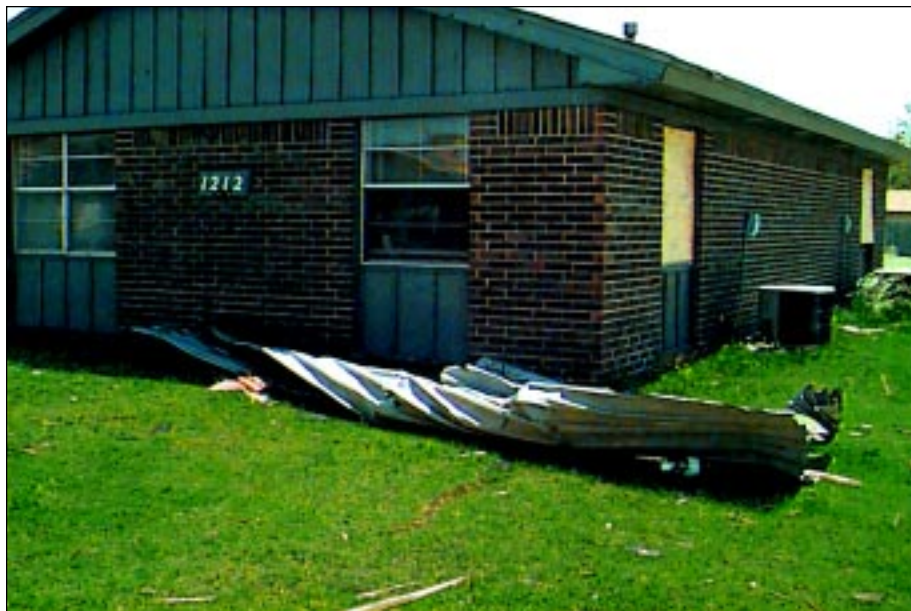
FIGURE 3-21: This piece of steel deck landed at the periphery of a violent tornado damage area in Moore, Oklahoma. The building it likely came off of was a few hundred feet away.

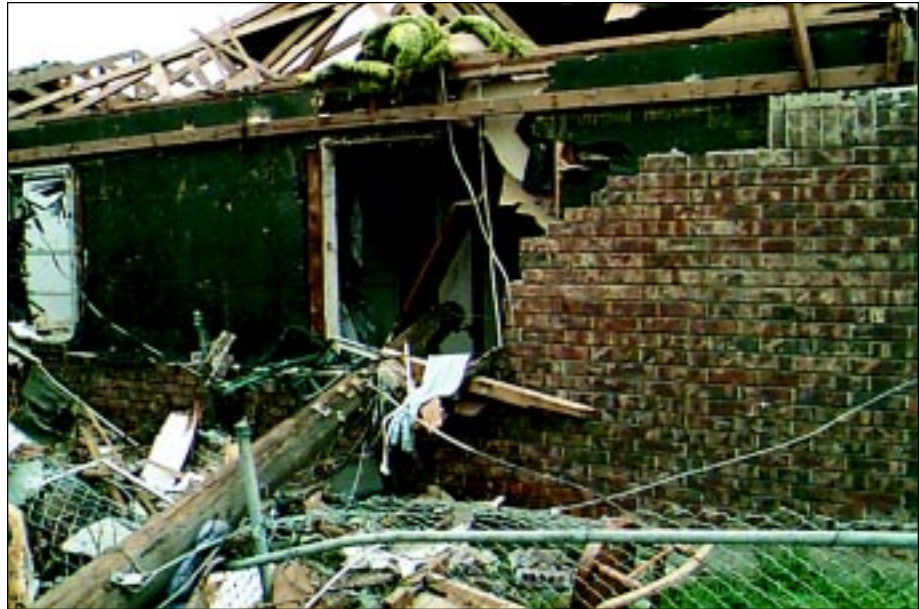
FIGURE 3-22: This power pole penetrated a window and extended several feet into the house after traveling approximately 40 feet from its original location. This home was located in Moore, Oklahoma, along the track of a violent tornado.

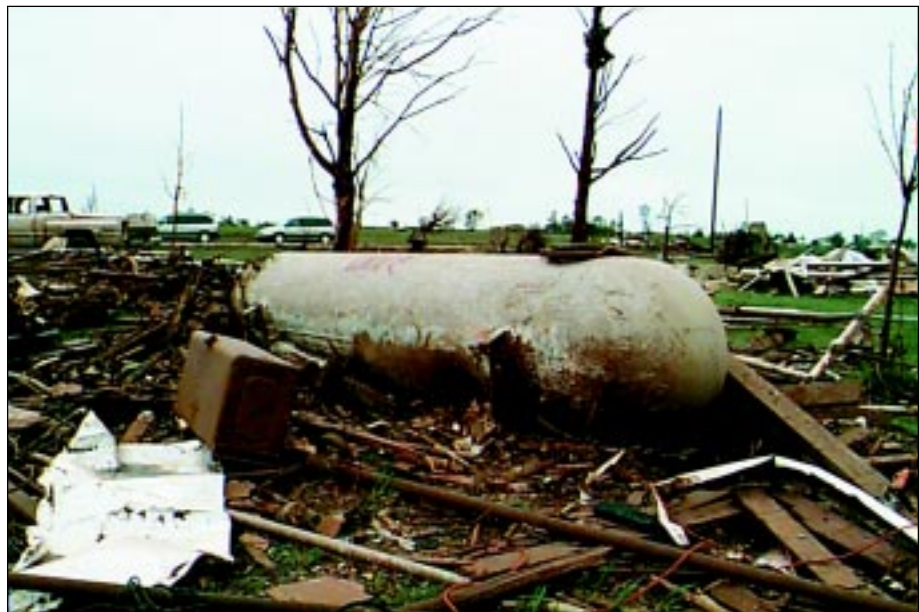
FIGURE 3-23: Wind displaced this very large propane tank in Bridge Creek, Oklahoma; its original location could not be determined. This area was hit by the vortex of a violent tornado.

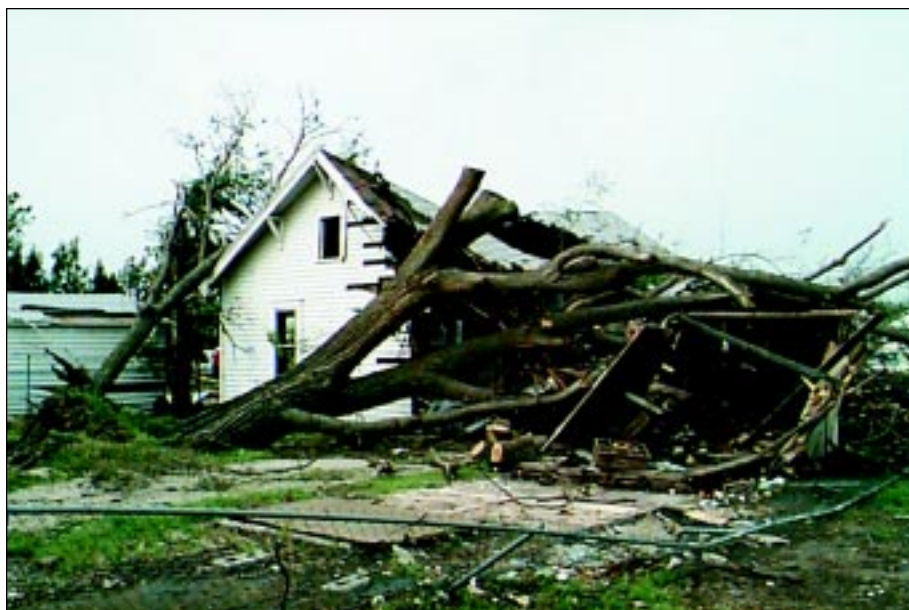
FIGURE 3-24: This building was on the periphery of a violent tornado damage area in Haysville, Kansas. One large tree fell near the corner of the house and collapsed a large portion of the roof and the corner walls. A smaller tree caused minor damage on the other corner of the house.

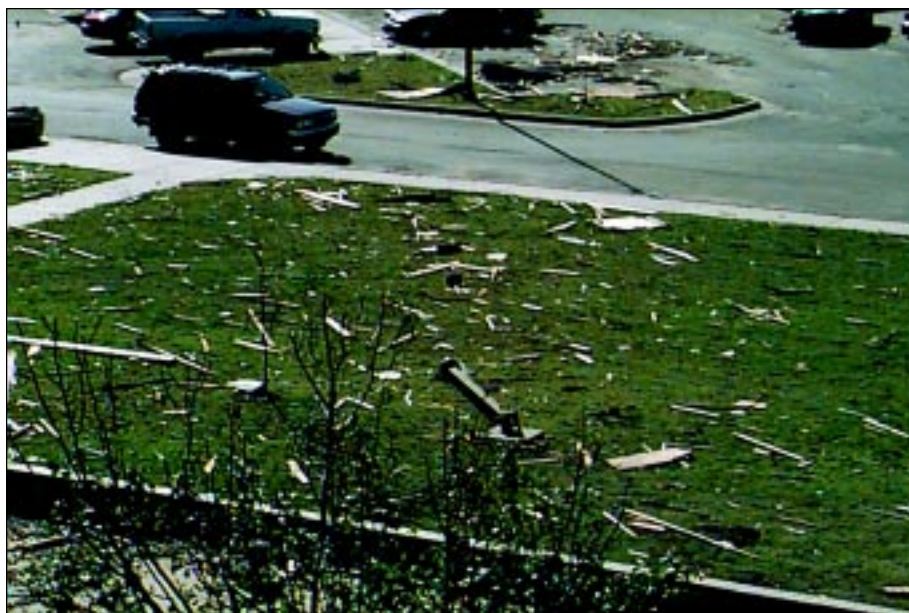
FIGURE 3-25: Wood framing members and plywood sheathing near the periphery of a violent tornado damage area in Moore, Oklahoma, displaying quantity of flying debris.

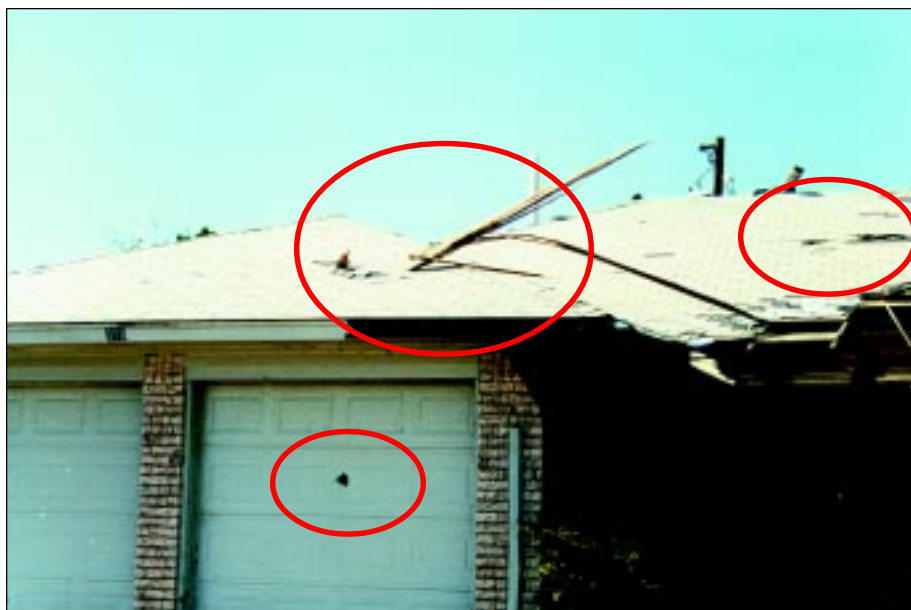
FIGURE 3-28: This house was on the periphery of a violent tornado damage area in Moore, Oklahoma. Two medium missiles are embedded this area of the roof and additional holes due to windborne missiles are also visible.

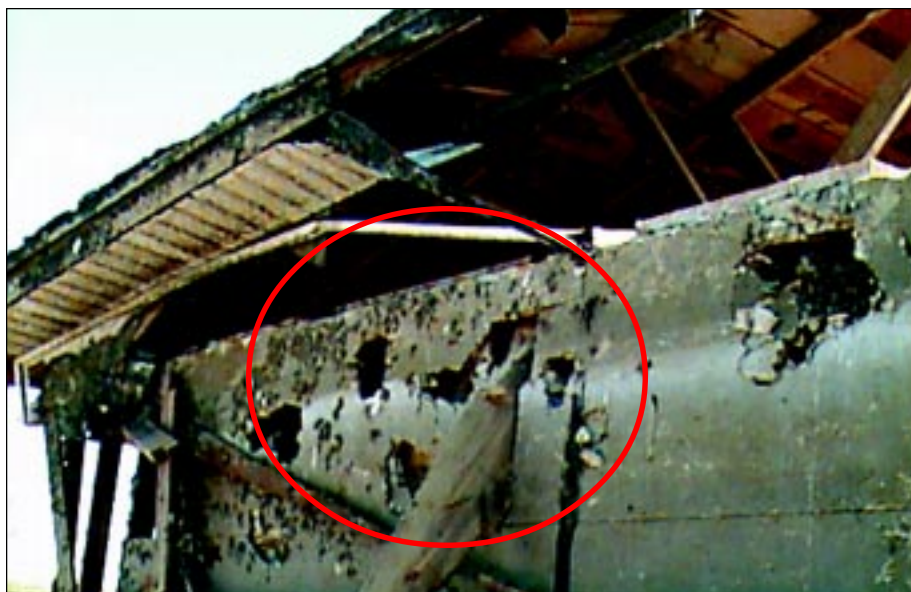
FIGURE 3-29: Several missiles struck the wall of this house in Del City, Oklahoma, including a medium sized piece of debris in the center of the photo.

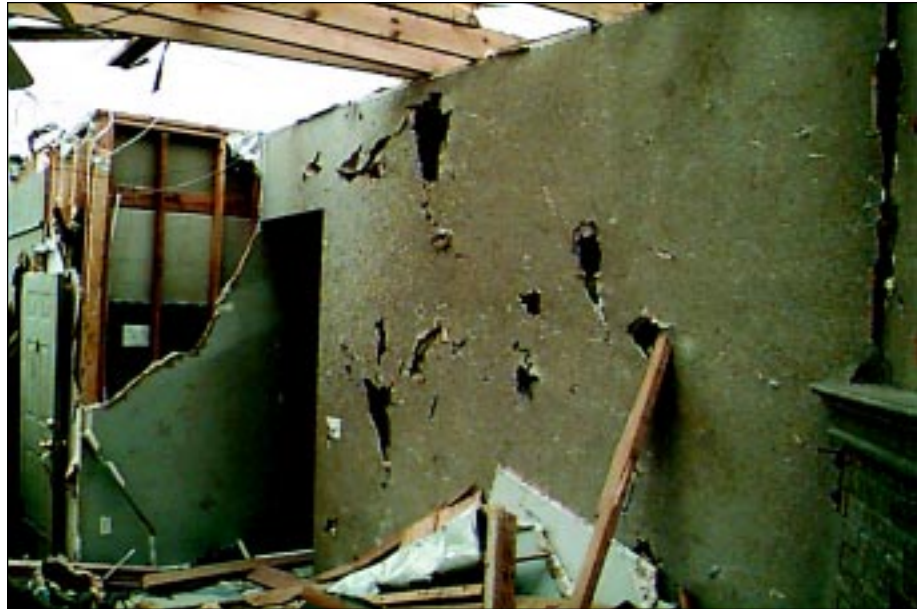
FIGURE 3-30: *Several missiles struck and perforated the interior wall of this house in Moore, Oklahoma.*

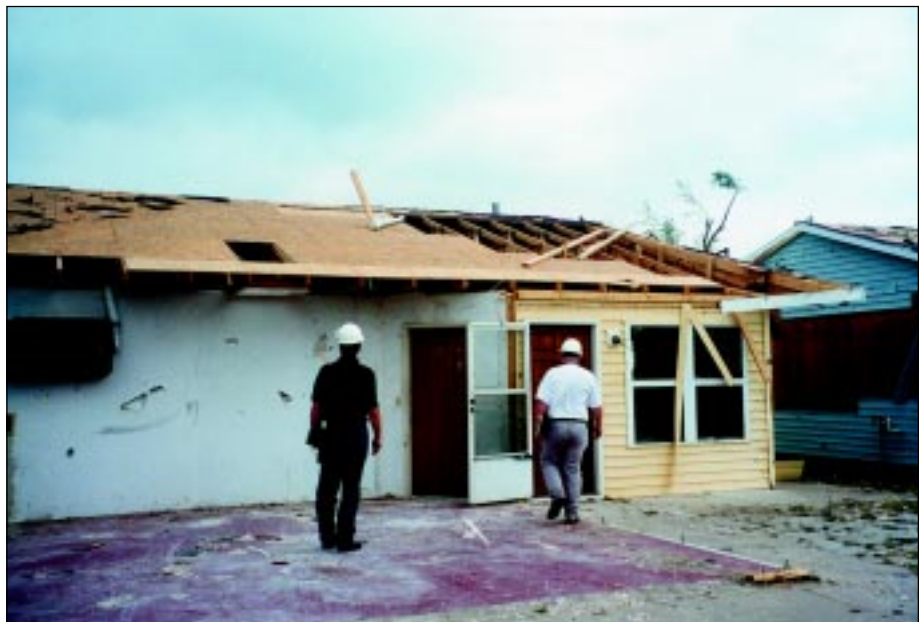
FIGURE 4-4: Although roof sheathing was lost at this Wichita, Kansas, home, code requirements of staggering joints in sheathing applications was observed. This house experienced inflow winds from a strong tornado.

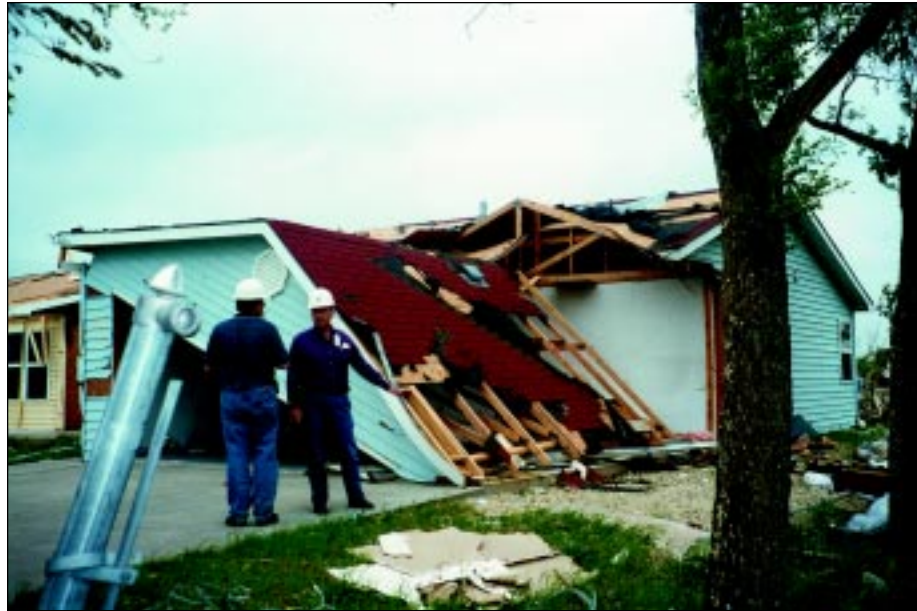
Wall sheathing observed consisted primarily of wood fiberboard or combination siding/sheathing. With the exception of garage end walls, it was difficult to ascertain any consistent failure of wall sheathing because it appeared the entire wall was either lifted or blown inward or outward as the result of windward pressure or a combination of windward/leeward pressure (Figure 4-6).

FIGURE 4-6: Wall failure due to inadequate lateral load resistance in Wichita, Kansas. The return wall at this garage was inadequate to carry wind loads and may have led to this failure.

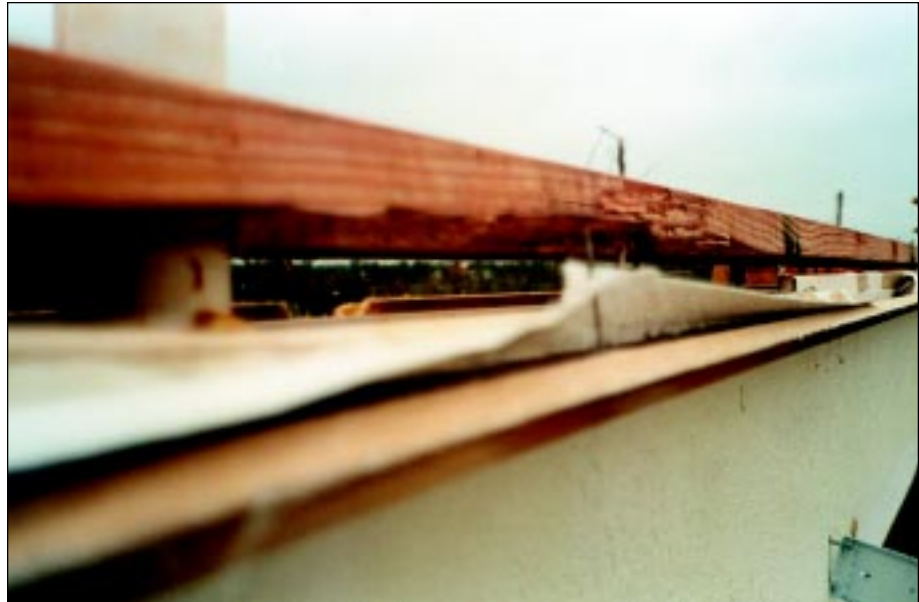
Figure 4-8 shows a seldom seen type of failure caused strictly by uplift of the roof truss attached to the double top-plate. There were few observed failures of the connection of the double-top-plate to the supporting studs below, although one example is shown in Figure 4-9.

FIGURE 4-8: Failure of a double top-plate. The uplift of the roof truss previously attached to this double top-plate caused separation of the two members that comprise this top-plate.

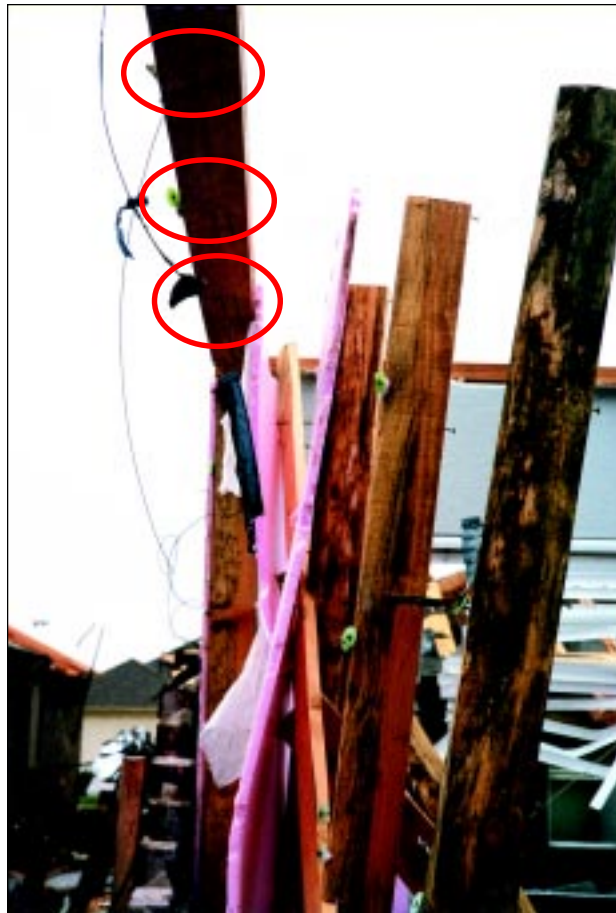
FIGURE 4-9: Failures of the connection of the double-top-plate to the supporting studs below at a home in Moore, Oklahoma. This home was located along the periphery of a violent tornado.

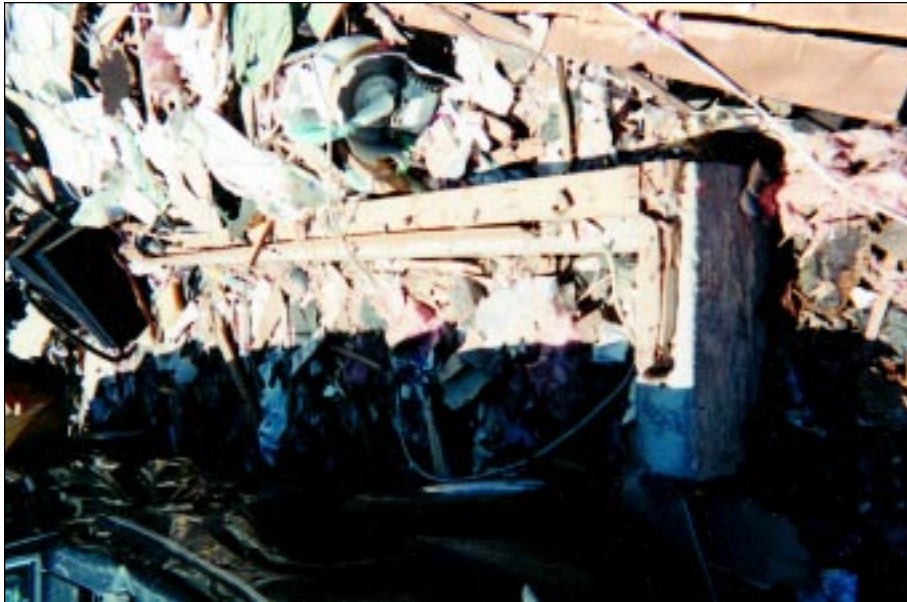
Once the wall is erected, the bottom plate should be connected to the foundation or to the floor. In Oklahoma, the foundation was typically a slab-on-grade foundation. In Kansas, basement and crawl space foundations were more common than slab-on-grade construction. Figure 4-10 represents one of many observed failures of the wall-to-bottom plate connection. In this instance, the bottom plate remained anchored to the foundation, but the toe-nailed or face-nailed connection of the studs to the bottom plate were inadequate to resist uplift loads from a violent tornado that struck this Oklahoma home.

FIGURE 4-10: Wall framing to bottom plate failure. This house in Del City, Oklahoma, experienced a direct hit from the vortex of a violent tornado.

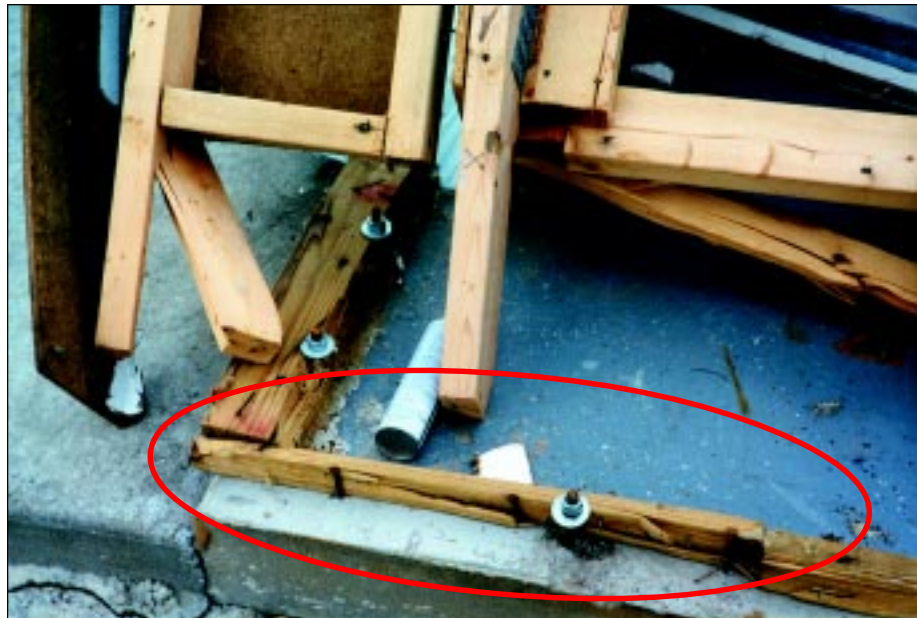
Another factor observed that contributed to failures of wall systems was that the bottom-plate (sole- or sill plate) was not integral with the siding or other means of transferring the force. The connection was weak as seen in Figure 4-12. In both Oklahoma and Kansas, bolts, nails, and epoxy anchors were observed securing bottom plates to foundations. In one instance in Oklahoma, straps from the foundation were observed securing the bottom plate to the foundation.

In the event adequate connections and structural elements are provided in the wall system and above, the bottom plate-to-foundation connection is one of the last links in the continuous load path chain that may fail. The BPAT saw many examples of failures at the connection to the foundation. Figures 4-12 and 4-13 highlight these weaknesses. Uplift, racking, and moderate windward forces combined to cause separation of this connection.

FIGURE 4-12: Failure at base of wall between wall studs and bottom plate. The bottom plate, which was connected to the foundation slab with anchor bolts and nails, has splintered.

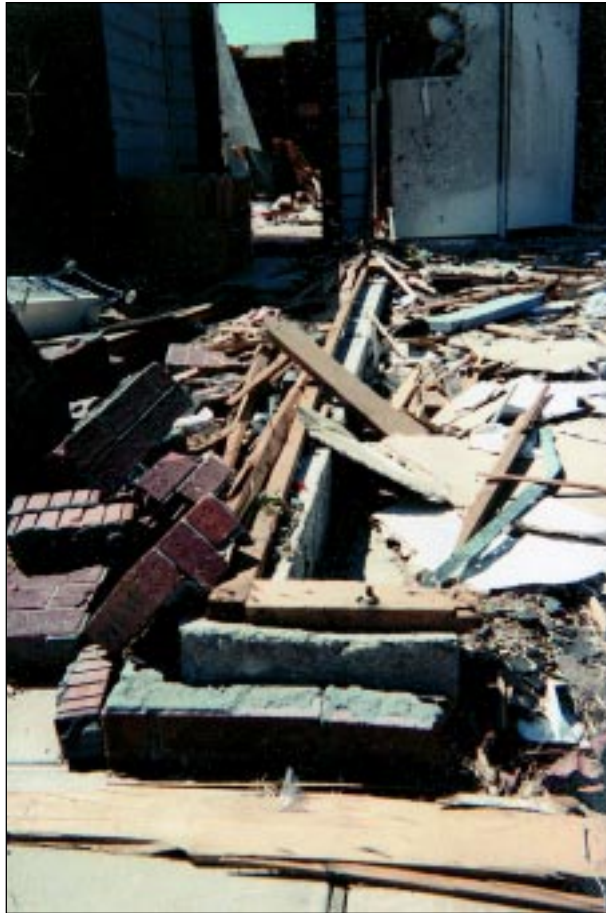
FIGURE 4-13: Failure of this bottom plate to wall stud connection occurred at this home outside Oklahoma City, Oklahoma. The vortex of a violent tornado passed very close to this home.

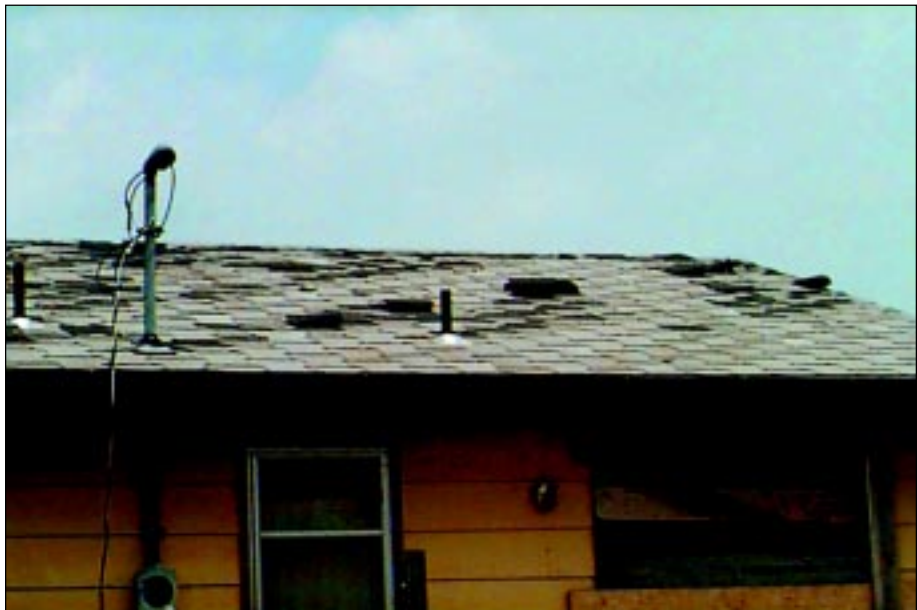
FIGURE 4-15: *Several T-lock shingles on this house were lifted and torn. This house was on the periphery of a weak tornado in Wichita, Kansas.*

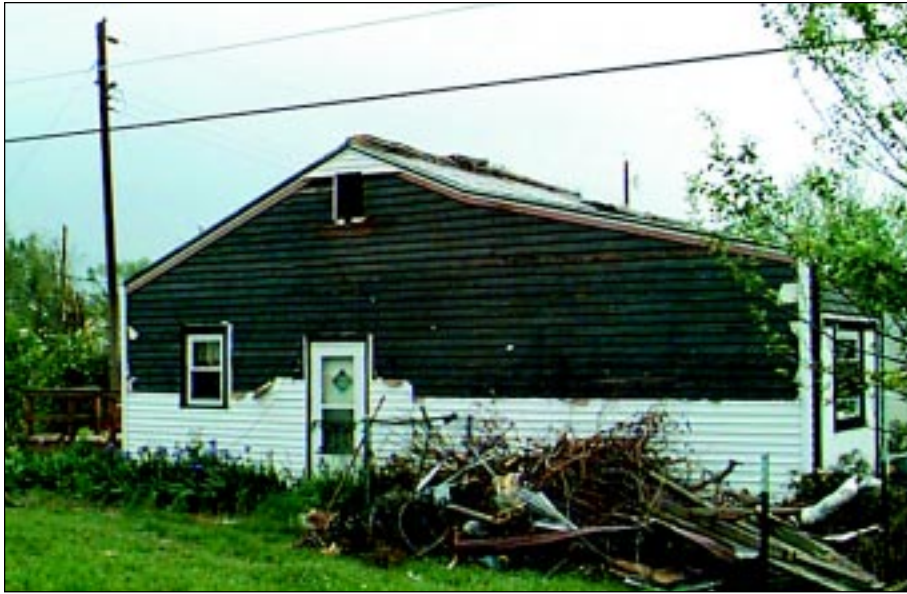
FIGURE 4-16: The vinyl (white) that was installed over wood siding experienced damage; however, the wood siding was undamaged. The home was located along the periphery of a violent tornado in Wichita, Kansas.

The siding of the home in Figure 4-16 was attached with roofing nails. In one area, the nails were 30-in and 21-in apart. The failure of the siding occurred when the vinyl pulled over the nailheads. Additionally, the home in Figure 4-16 suffered some asphalt shingle damage. Houses with vinyl siding that were closer to the vortex commonly had extensive missile damage (Figure 4-17). The siding on the home in Figure 4-17 was fastened with roofing nails placed at 13.5-in, 10-in, and 20-in along one length of siding. The vinyl pulled over the nailheads. Most of the siding failures observed were in areas that experienced straight inflow winds from the tornadoes that were likely at or slightly above the design wind speeds of the current building codes wind speeds (e.g., 70-80 mph, fastest mile or 90-mph 3-second peak gust).

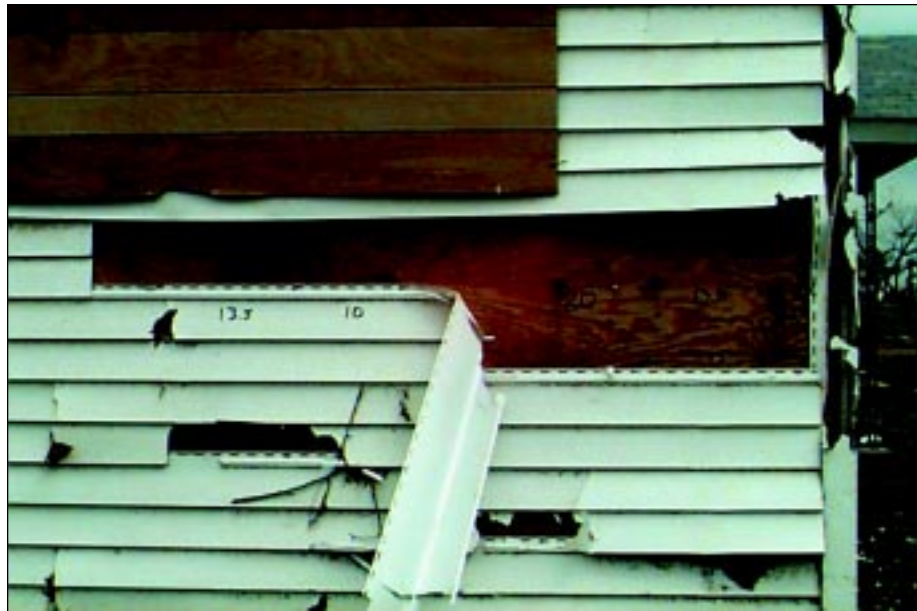
FIGURE 4-17: *Some pieces of vinyl siding were blown off and in other areas the siding was torn away by missiles. The home was located along the periphery of a violent tornado in Mullhall, Oklahoma.*
