BUILDING PERFORMANCE ASSESSMENT REPORT

**OKLAHOMA AND
KANSAS**

Midwest Tornadoes of May 3, 1999

**OBSERVATIONS, RECOMMENDATIONS,
AND TECHNICAL GUIDANCE**

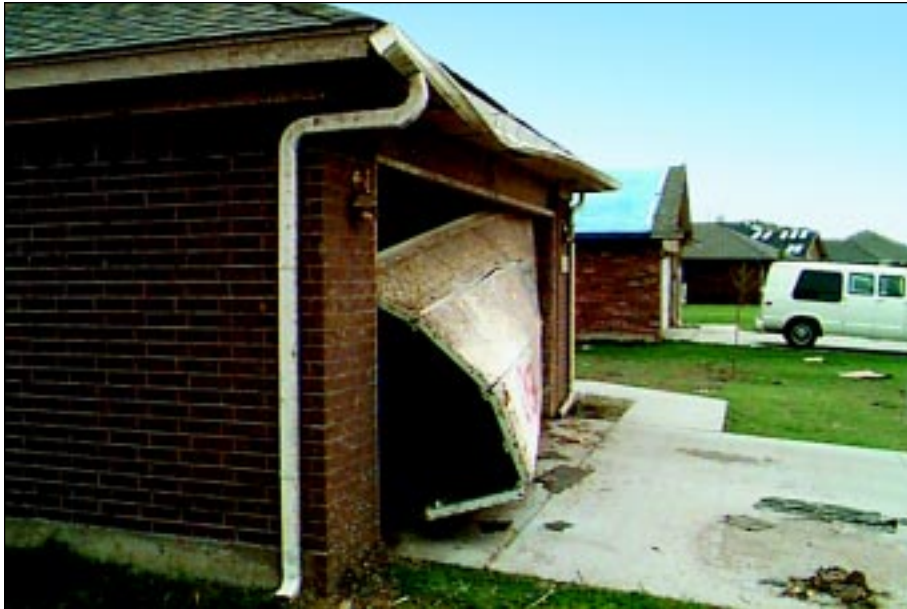
Along the track periphery, it was common to see residential garage door failures (Figure 4-18). The door in this figure likely had a laboratory tested positive load resistance of 12.5 psf, a common test pressure for doors of similar construction. The design load on this door would be 13 psf negative and 11 psf positive using UBC 1997 and 18 psf negative and 14 psf positive using ASCE 7-98. Hence using a 1.5 safety factor, the positive load derived from ASCE 7-98 is 68 percent higher than the resistance of the door. Had this door met the wind loading derived from ASCE 7-98, this failure may have been avoided. This observation is important because it highlights the advanced guidance given by engineering standards as opposed to the basic guidance given by the model building codes for components and cladding elements such as exterior wall systems, windows and doors, and garage doors.

The BPAT conducted an extensive assessment of garage door performance at Greenbriar Eastlake Estates in Oklahoma City. A violent tornado directly struck this subdivision and destroyed many homes. The house in Figure 4-18 was located approximately 1200 feet away from the vortex of the tornado as it moved from the southwest to the northeast of this neighborhood. A partial schematic map of the Greenbriar Eastlake Estates is shown in Figure 4-21. The rectangles represent the average dimensions of homes surveyed with

FIGURE 4-18: This double-width garage door failed under a suction load in Moore, Oklahoma.

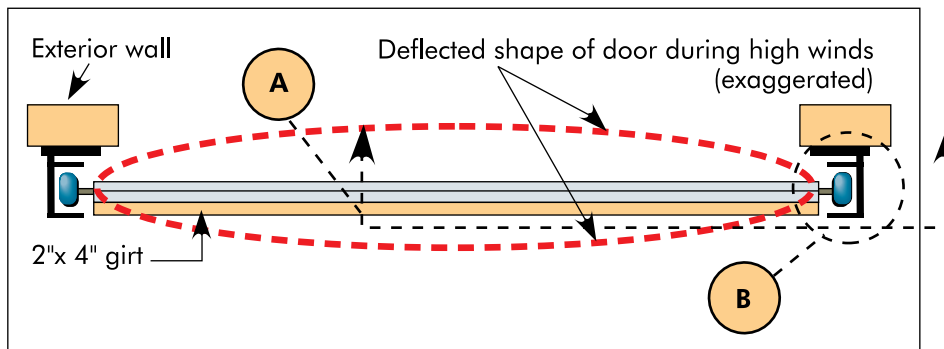
Most of the doors investigated were made of thin metal. Failures were typically caused by wind pressure, rather than by missiles. The most common failure mode observed was the door rollers disengaging from the door tracks, most likely caused by excessive door deformation (see Figures 4-19 and 4-20). Door failure resulted in increased load on the buildings.

FIGURE 4-19: Plan view of typical garage door shown in Figure 4-18.

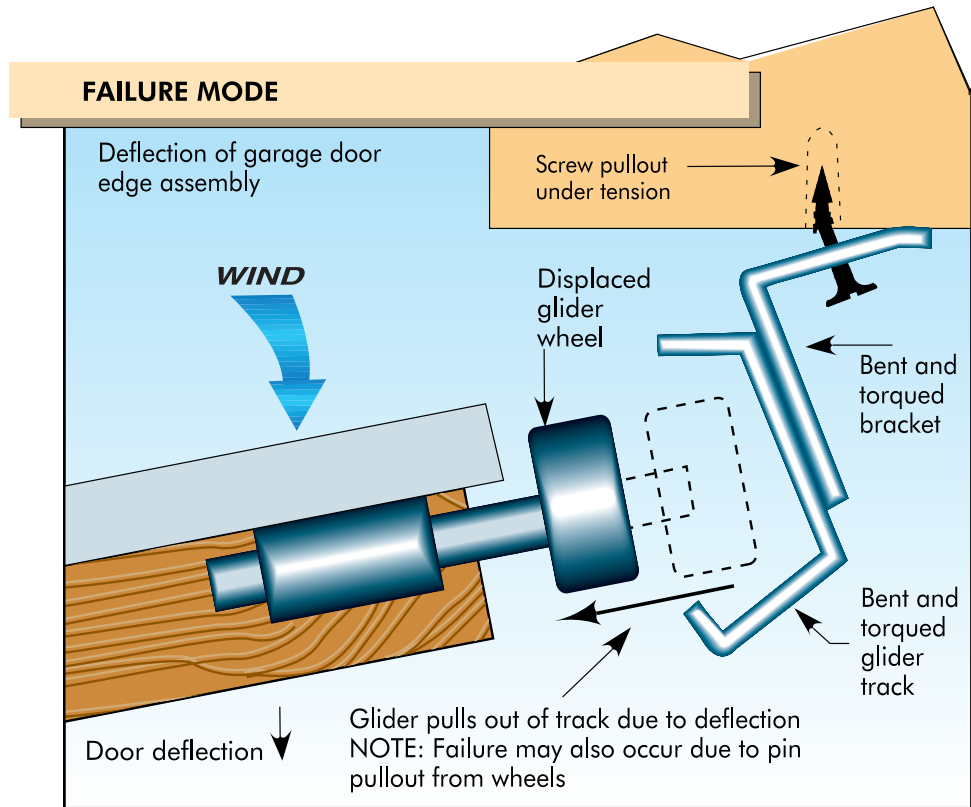
FIGURE 4-20: Detail B from Figures 4-19. Garage door failure at track and recommend assembly improvements.

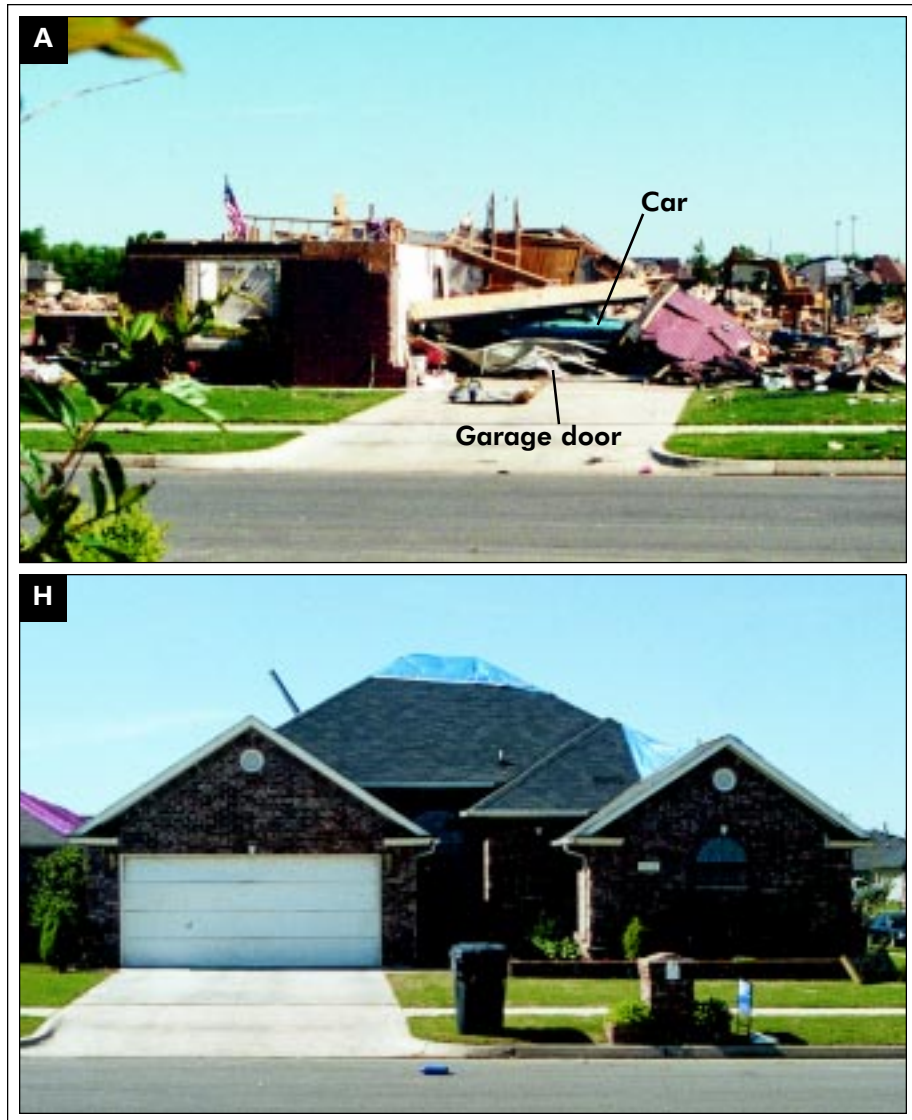
Homes located at H and A are shown in Figure 4-22. The damage states of the two homes are significantly different even though they are located directly across the street, approximately 95 feet apart, from one another and may have experienced relatively similar wind conditions based on the approximate track location (Figure 4-21). The home located at H had seven broken windows, primarily at the back of the home as a result of debris generated from a failed wooden fence. It also had one breached glass entry door, and lost approximately 60% of its roof covering. The home located at A lost its entire roof structure and several exterior walls. This was likely due to the failure of the garage door from inward wind forces. For the remaining houses, similar “across-the-street” damage gradients were observed between the homes, A through G and H through N, with the exceptions of the home at location F, which did not lose its entire roof structure, and the home at location G, which did not lose any roof structure, but did sustain severe roof framing damage due to uplift.

Several failed garage doors were observed lying at the back of the garage for many homes (A through G), indicating that the garage doors failed due to positive (inward) pressure. These failures of the garage doors are believed to have initiated or contributed to the catastrophic roof and exterior wall failures for homes A through G, a direct consequence of load increase due to a large breach in the building envelope. Examples of this may be seen in Figures 4-22 and 4-23. Note that the failed garage door in Figure 4-22 is crumpled up against the car, suggesting a door failure under positive pressure. A partial roof failure (house F) is depicted in Figure 4-23. In this case, the garage door was also found within the garage as shown in the picture inset. The observed location of the failed garage door and the localized roof damage suggests that the failed garage door may have initiated or played an important role in the roof failure. Many of the moderately to severely damaged homes observed had a significant amount of structural damage to the garage area and to the immediate surrounding area, but did not necessarily have the same magnitude of structural damage at the opposite side of the building where no garage was located.

FIGURE 4-22: Home in Moore, Oklahoma, with partial roof loss and garage door in place (H) vs. home with total roof loss due to garage door failure (A) under positive pressure.

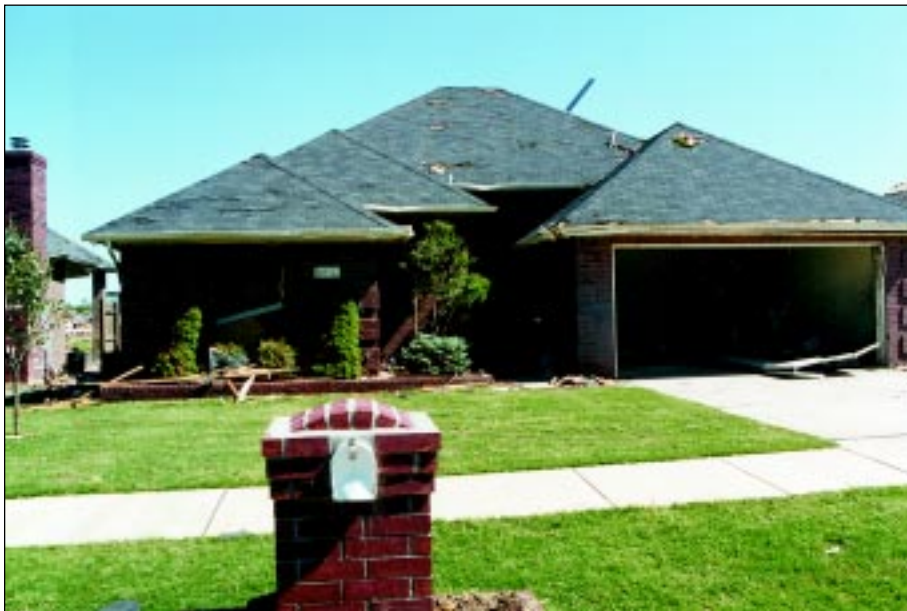
FIGURE 4-23: Garage door failure possibly resulting in the localized partial roof failure on the left side of this home located in Moore, Oklahoma.

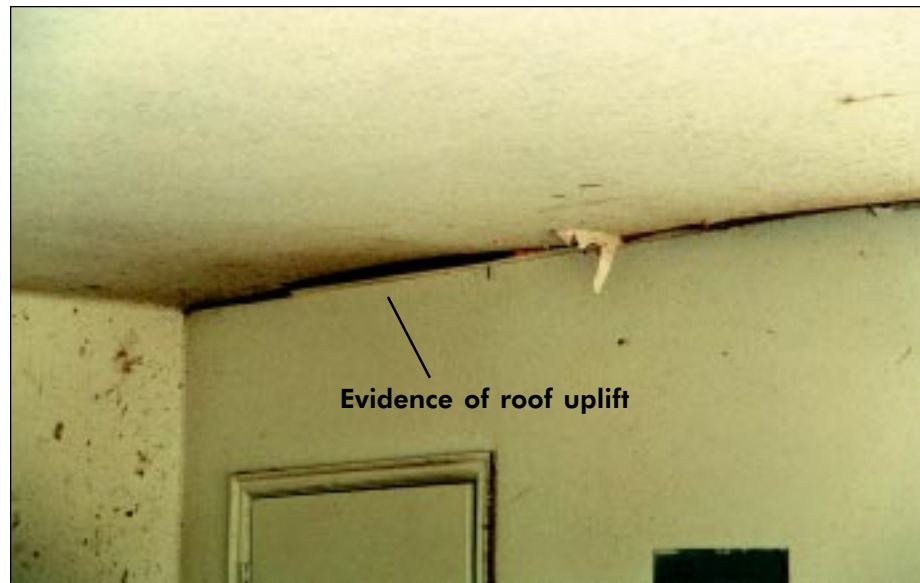
A final example of observed internal pressurization and roof uplift is shown in Figures 4-24 and 4-25 for the house located at G. The garage door failed by positive pressure and was found inside the garage. Figure 4-24 shows strong evidence of the early stages of roof uplift between the garage roof and exterior wall. The ceiling was observed to have pulled away from the exterior wall perimeter, indicating that the whole roof frame was lifted up. The space shown in Figure 4-25 was apparent along most of the perimeter of the garage ceiling. Figure 4-26 shows an exterior view of the roof and wall interface where the initiation of roof uplift was observed. Tension cracks in the brick veneer and a large gap along the length of the right exterior wall between the roof and top plate were also observed.

FIGURE 4-24: A view of home G with a garage door that failed due to positive (inward) acting wind loads.

FIGURE 4-25: *Roof uplift between garage ceiling/roof structure and exterior wall at home G.*

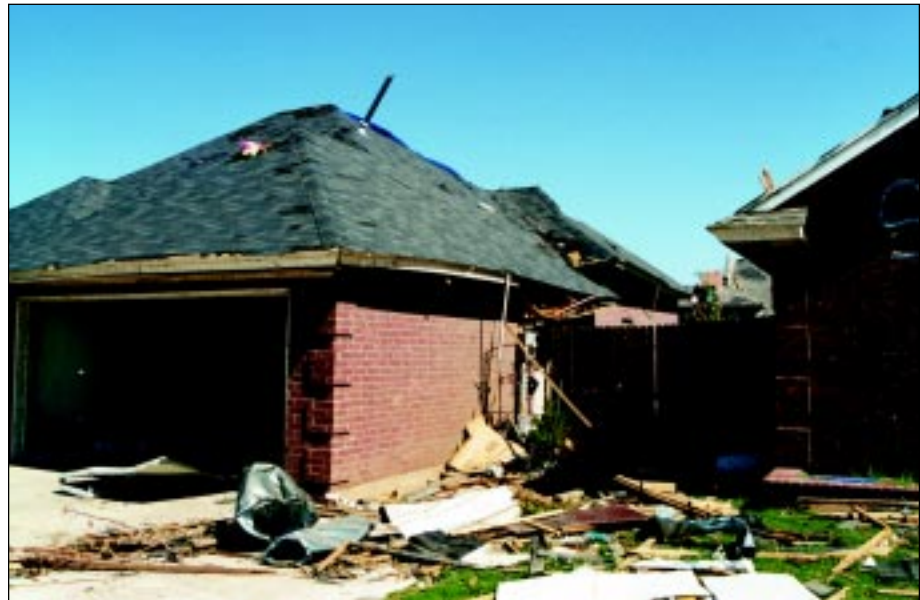
FIGURE 4-26: *A 2x4 member extends out of the gap that runs the length of this garage wall between the top of the wall and the roof framing.*

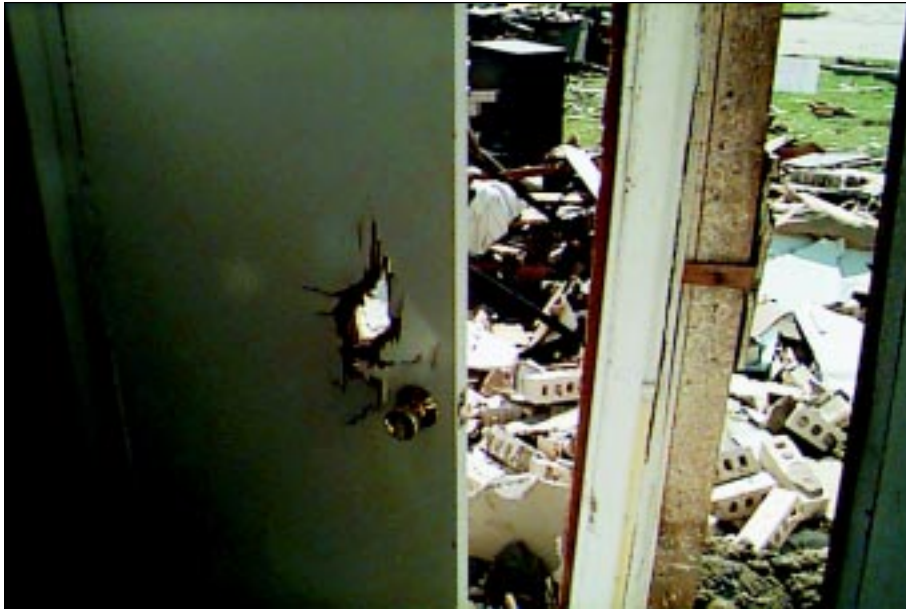
If the building envelope is breached (e.g., windows, wall and roof coverings), the building may experience rapid pressurization, which may well lead to structural failure (Figure 4-27). The failure of a door or window may start this process. Window failures were commonly observed because windows can be broken by both large and small missiles in addition to the wind pressure acting on the windows. Exterior doors and windows failed from the wind pressures of the tornadoes. Garage doors failed from both wind pressures and debris,

FIGURE 4-27: A missile penetrated this exterior door in Del City, Oklahoma. Interior hollow-core doors typically offer even less missile protection than common exterior doors.

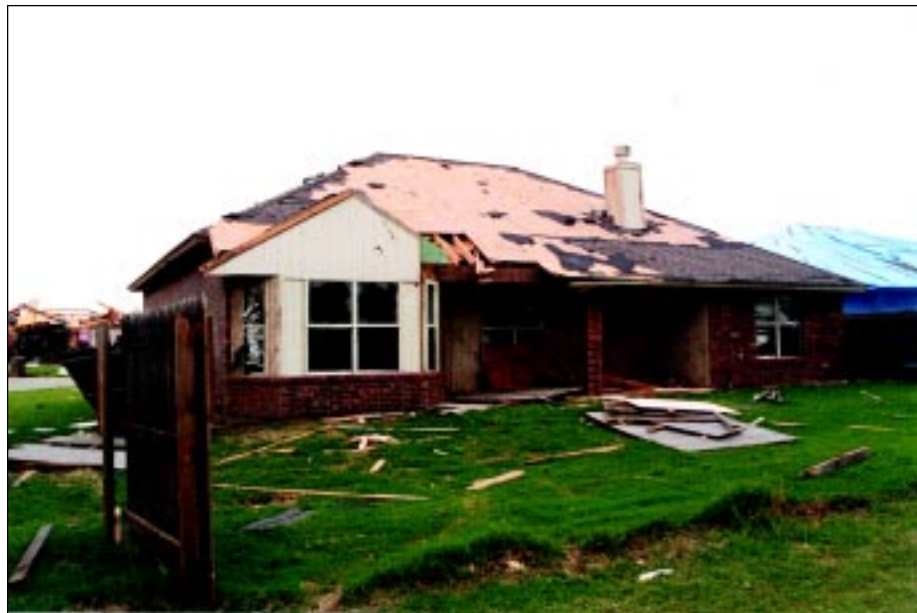
Several window failures at the back of the home located in Country Place, a subdivision of Oklahoma City, are shown in Figure 4-28. This home was located along the periphery of a violent tornado. Other than a small piece of sheathing missing from the roof edge, the roof damage in the back of the home is limited to the loss of roof covering material only. In contrast, several pieces of roof sheathing failed on the front portion of the roof as depicted in Figure 4-29. Note that no breaches to the front exterior wall were observed. Figure 4-30 shows a view of the interior of the same dwelling taken from outside the left-hand window breach seen in Figure 4-28. The photograph of the interior suggests the possibility that internal pressurization may have contributed to the roof sheathing loss. This is suggested by the holes in the ceiling, in particular the right-hand hole above the interior doorway. There was evidence to suggest that internal pressure may have pushed the ceiling away from the top of the interior wall where the ceiling drywall failed. Note that there was no evidence of drywall debris on the floor directly below the drywall failure, suggesting the drywall was ejected into the attic. Internal pressurization may have caused the ceiling drywall to fail between the roof structural members that led to the pressurization of the attic space and contributed to the

FIGURE 4-28: *Damage to back of home in the Country Place Subdivision in Oklahoma City, was limited to several window failures and roof covering damage. The home was located along the periphery of a violent tornado.*

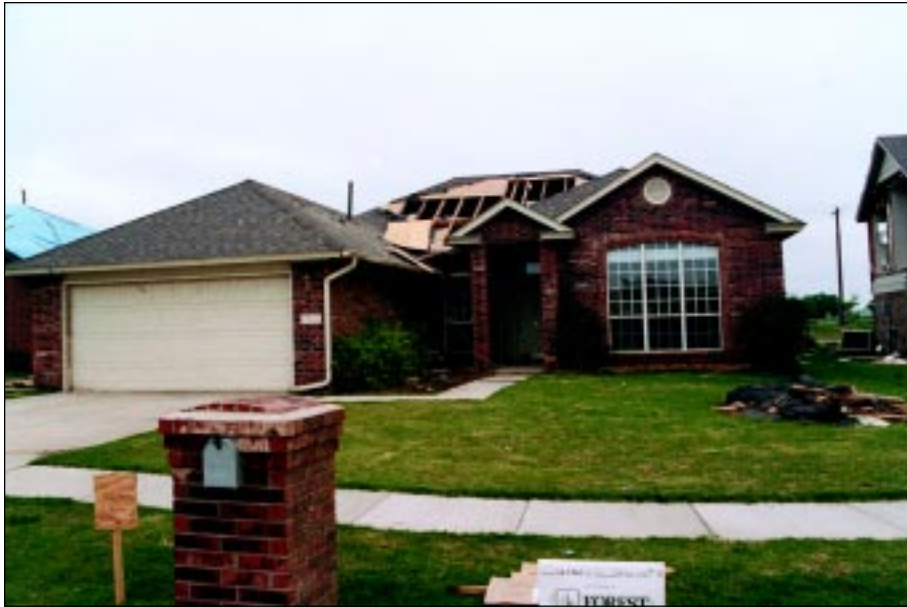
FIGURE 4-29: Front of home in Figure 4-28 where several pieces of roof sheathing failed.

sheathing failure shown in Figure 4-29. Drywall debris on the floor in front of the door belonged to the collapsed ceiling drywall to the left and was likely the result of rain water damage entering through the roof.

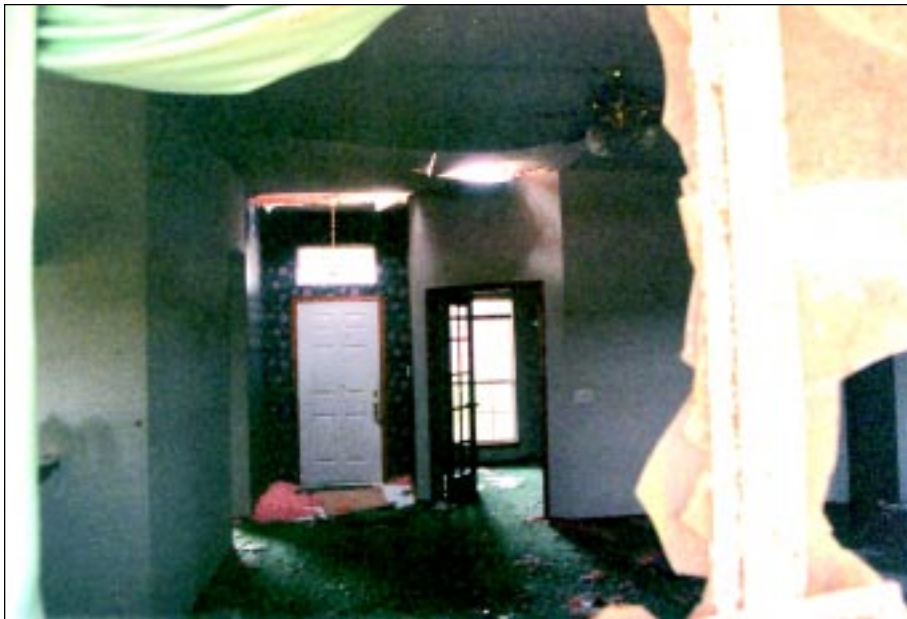
FIGURE 4-30: View of interior of the home shown in Figures 4-28 and 4-29.

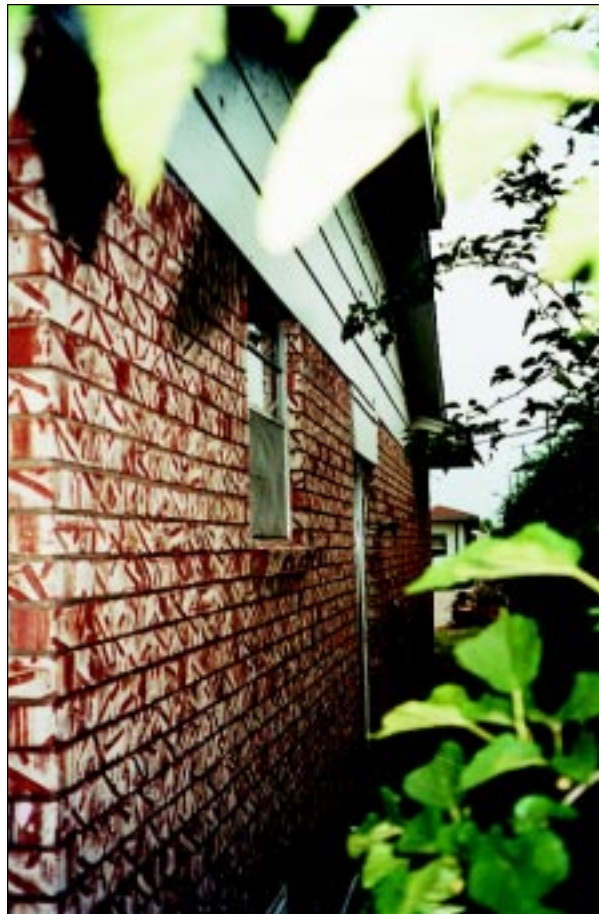
The BPAT observed brick masonry veneer construction and its failure from moderate wind loads at numerous locations throughout the inspected subdivisions of the Oklahoma City Metroplex and the Willow Lake Estates in Bridge Creek, Oklahoma. Brick veneer often appeared to have withstood the wind forces of the tornadoes, but closer inspection revealed the veneer on many homes, although still standing, was easily moved with light hand pressure (Figure 4-31). In Figure 4-32, the north wall of a house had been framed with 2-in by 6-in studs with 1-in by 4-in let-in corner bracing, covered with 1-in thick plastic foam insulation boards and brick veneer. Several studs remained upright, but the brick veneer lay on the ground. Corrugated metal brick ties remained fastened to the studs, and had pulled out of mortar joints. On-site evaluation indicated that much of the damage had been caused by straight

FIGURE 4-31: *This brick veneer appears to be undamaged but close inspection indicated that this wall could be deflected inward with only hand pressure.*

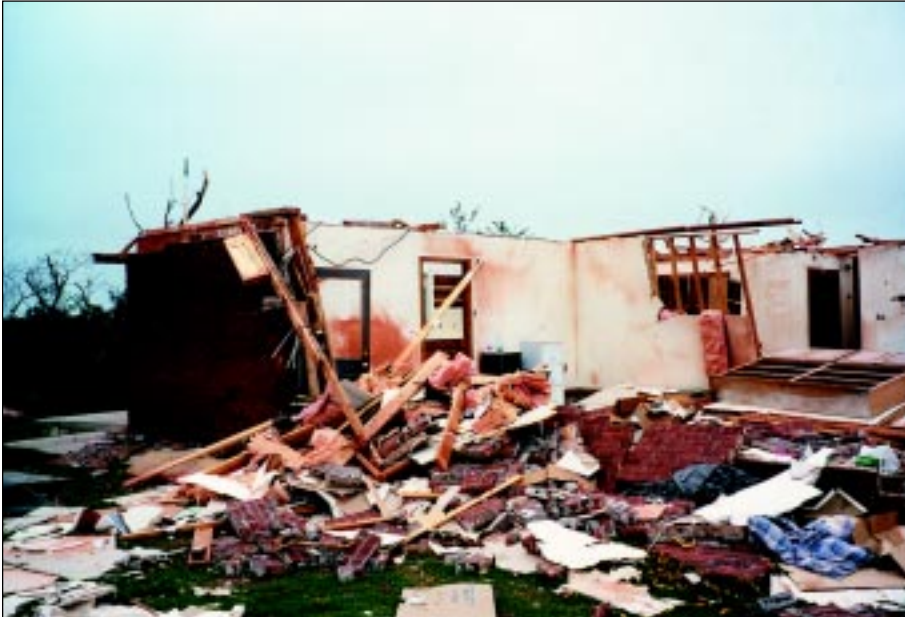
inflow winds associated with a strong tornado, similar to that experienced from severe thunderstorms or other typical design events, and not from a tornado vortex (Figures 4-32 and 4-33).

FIGURE 4-32: Failure of brick masonry veneer construction. The vortex of the strong tornado that caused the winds at this site passed approximately 300 feet from this building in Bridge Creek, Oklahoma.

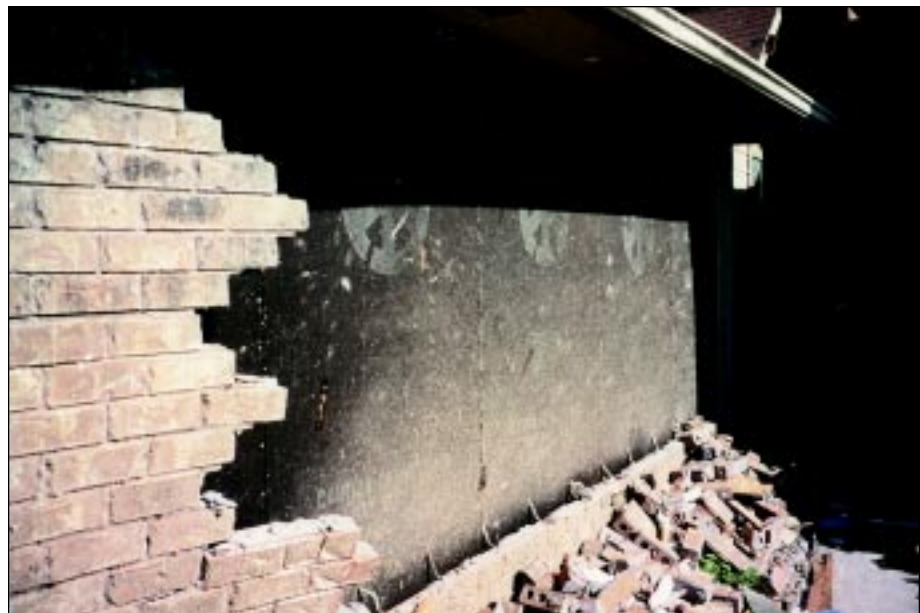
At Country Place and Eastlake Estates in the southwest suburbs of Oklahoma City, the BPAT observed a large number of 1- to 5-year-old homes with brick veneer failures. The wind speeds at these locations could not be determined. However, based on the team's observation of the damage and debris, including standing wood framed walls, it appeared that most homes with brick veneer failure were outside the vortex of a violent tornado (Figure 4-34).

FIGURE 4-34: Failure of masonry veneer wall of a home located along the periphery of a violent tornado near Moore, Oklahoma.

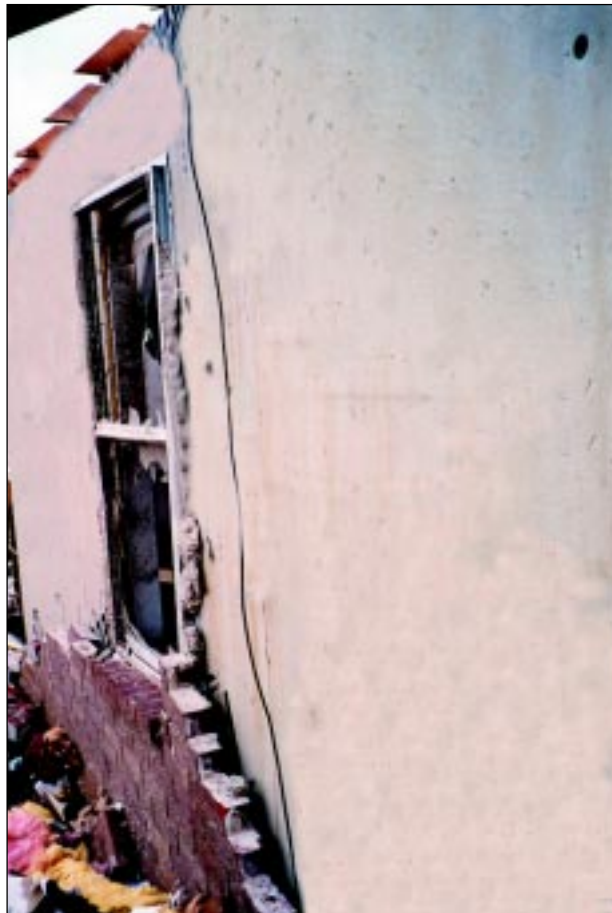
The BPAT also observed several problems that led to failure of the brick veneer, such as inadequate bonding of mortar to galvanized brick ties, inadequate bonding of mortar to brick, corroded brick ties, and nail pull-out at brick ties. The BPAT observed that brick veneer was generally constructed using 3-in brick. Location and number of brick ties varied considerably, from 16-in on center vertically and horizontally, to ties at top, midheight, and near bottom of walls. There were several walls with up to 1.5-in to 2.0-in gaps behind brick and with brick ties only inserted $\frac{3}{4}$ -in to 1.0-in into mortar joints. Most ties were fastened through plastic foam insulation sheathing into studs with one 6d common nail per tie.

In many cases, sections of brick veneer wall panels could be easily pulled loose by hand, and where brick veneer was left standing, it could easily be pushed in with hand pressure (Figures 4-35, 4-36, and 4-37). Walls with no visible failure could also be pushed over. This occurred when suction loads acting on the walls broke the bond with the ties, but did not result in brick veneer failure.

In Del City and Midwest City, and Oklahoma City, the BPAT observed several more examples of brick veneer (both clay and concrete brick) failure. Most of the failures appeared to have been caused by negative wind pressure (suction) on leeward and side walls (Figures 4-35, 4-36, and 4-37). These walls were also in an area that was in the inflow wind area of a violent tornado, but outside the vortex. The house in Figure 4-38 experienced only brick masonry and window damage when exposed to the winds on the periphery of a violent tornado.

FIGURE 4-35: *Inadequate bonding of mortar to galvanized brick ties contributed to this masonry failure at a home in Bridge Creek, Oklahoma.*

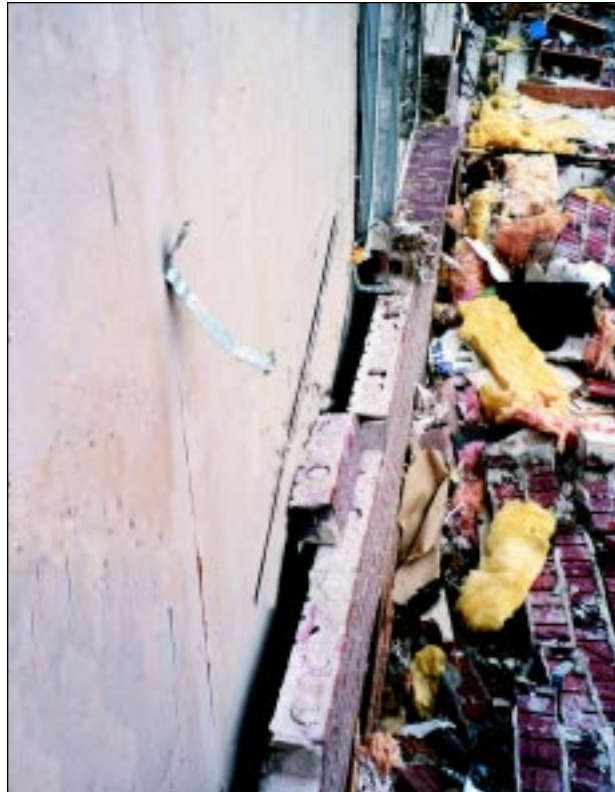
FIGURE 4-36: *Inadequate bonding of mortar to galvanized brick ties, Bridge Creek, Oklahoma.*

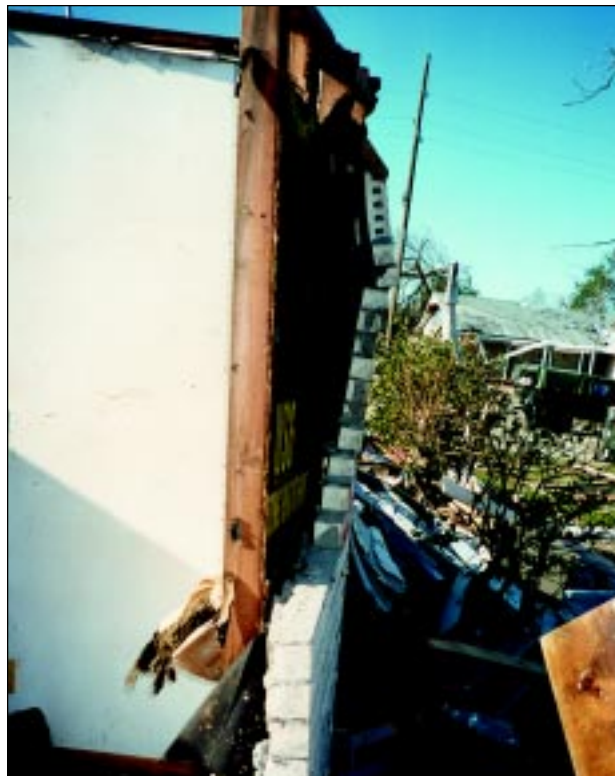
FIGURE 4-37: *Failure of brick veneer wall, Del City, Oklahoma.*

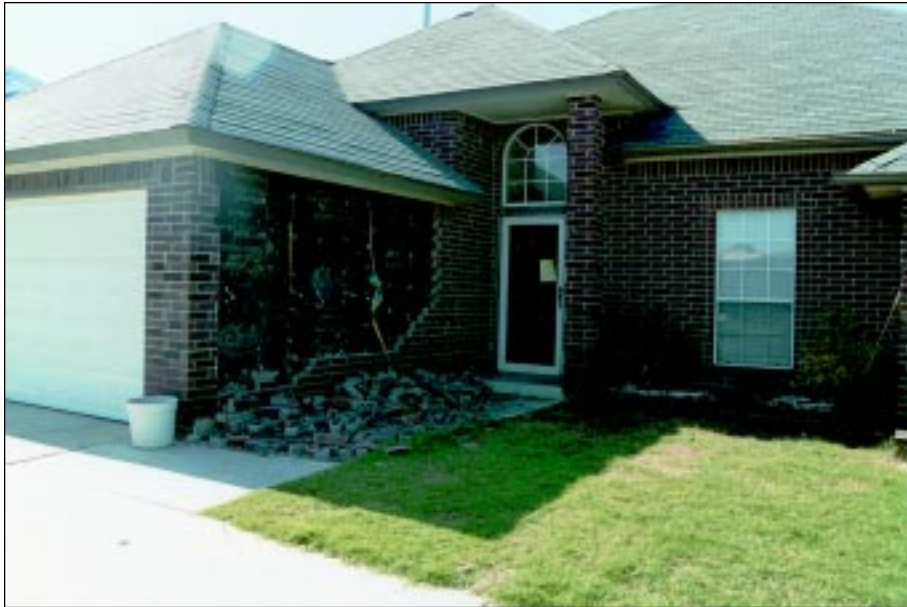
FIGURE 4-38: Failure of brick veneer wall, collapsed on the ground. This home, located outside Oklahoma City was on the periphery of a violent tornado.

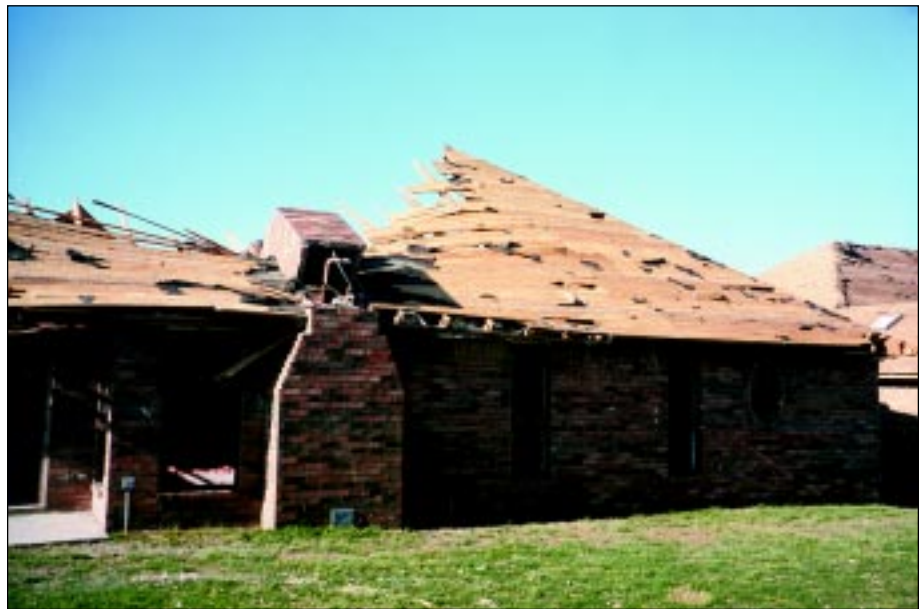
FIGURE 4-40: Failure of brick chimney onto roof of home located along the periphery of a violent tornado, Moore, Oklahoma.

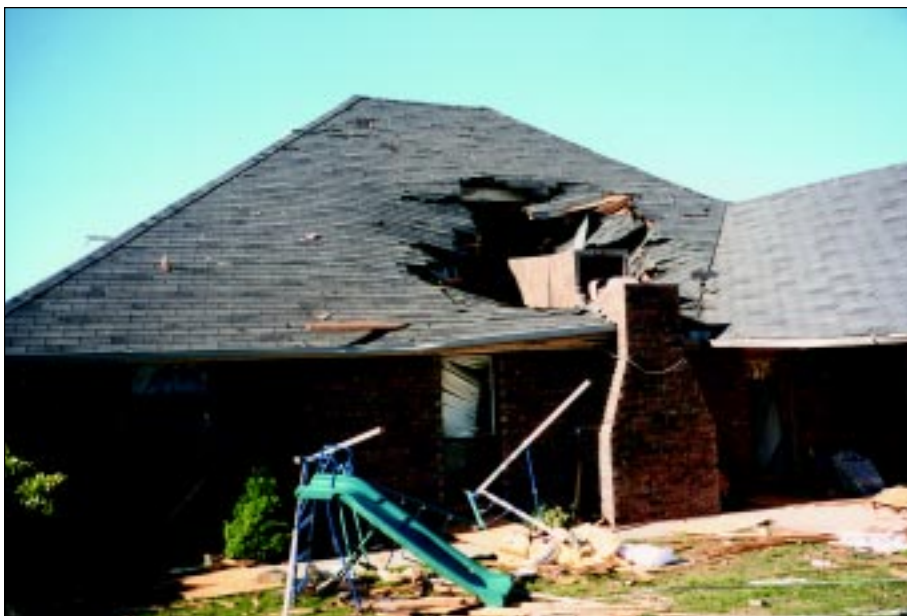
FIGURE 4-42: Failure of brick chimney onto top of home located along the periphery of a violent tornado, Moore, Oklahoma.

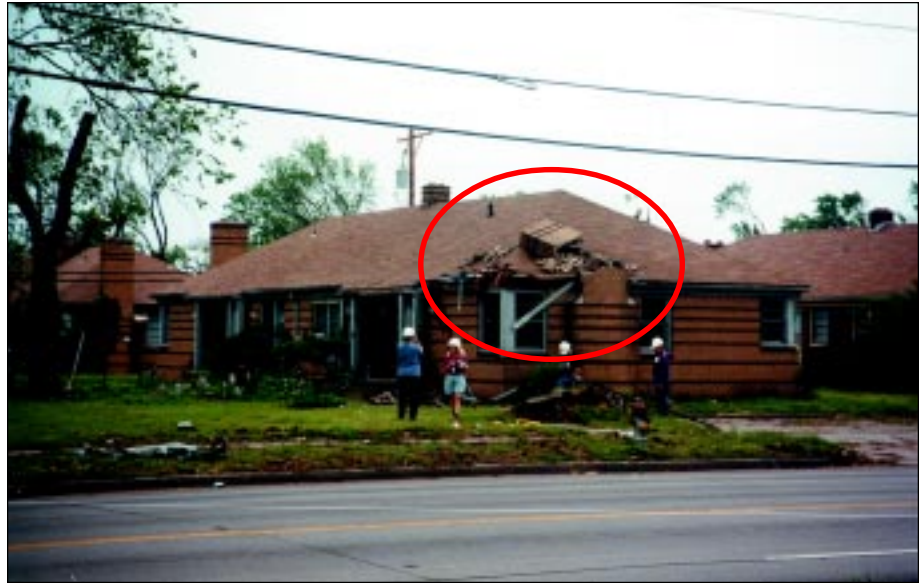
FIGURE 4-43: Chimney failure onto roof of single-family attached housing, Wichita, Kansas. This building was located along the periphery of a strong tornado.

was similar to the chimneys presented in Figures 4-43 and 4-44. These rectangular chimneys were calculated to have failed at wind speeds ranging from 75-85 mph (fastest mile). No reinforcing bars were observed in any of the chimneys in which calculations were performed.

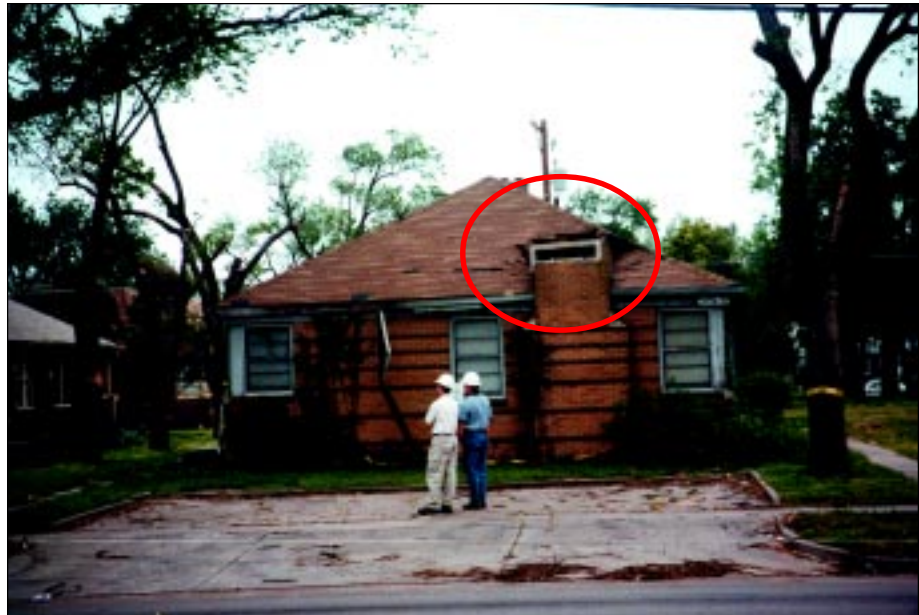
FIGURE 4-44: Chimney failure onto roof of single-family attached housing located along the periphery of a strong tornado, Wichita, Kansas.

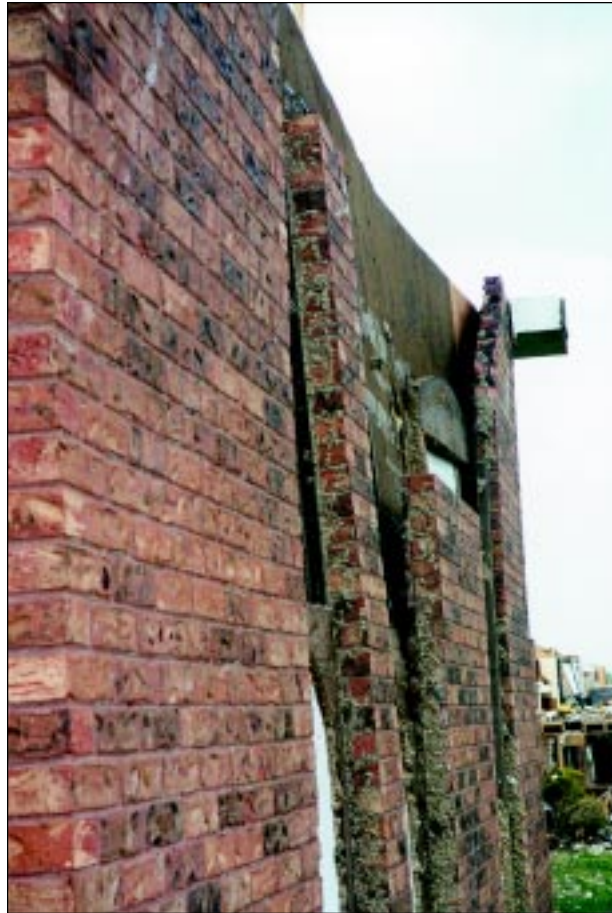
There were several two-story apartments in the Wichita, Kansas, area that also had extensive damage to roofs and brick veneer walls (Figures 4-45 and 4-46).

FIGURE 4-46: Failure of brick veneer in multi-family housing located along the periphery of a strong tornado, Wichita, Kansas.

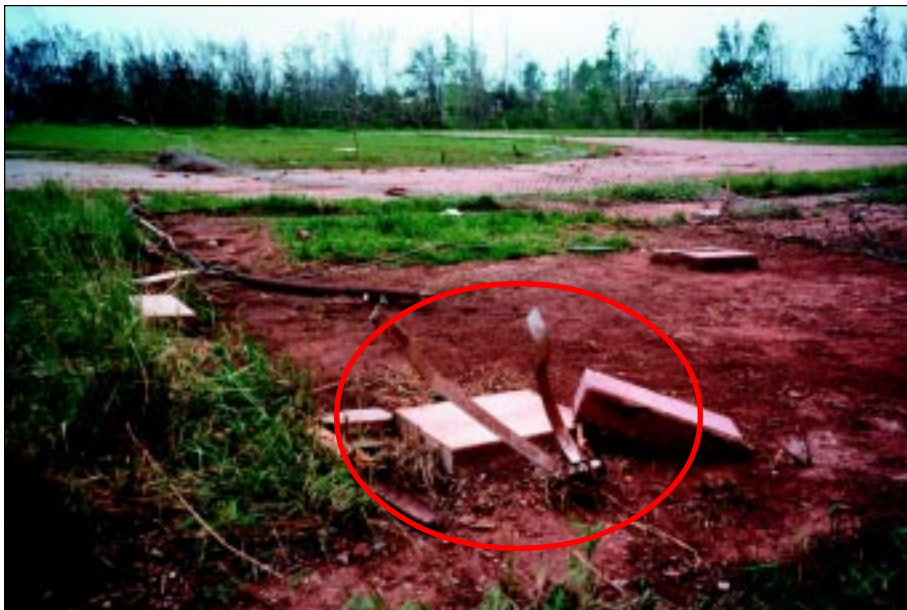
tornado vortex was approximately 300-400 ft away from this home. At the original site, vertical and diagonal straps remained attached to the ground anchor, but had failed about 2 to 3 ft from the anchors (Figure 4-48). The first anchors had been fastened about 12-ft from the east end. Both the number of anchor straps and tensile capacity of the straps were inadequate to resist wind uplift forces (Figure 4-49).

FIGURE 4-48: Failed straps at the anchorage of a manufactured home in Bridge Creek, Oklahoma. This site was 300-400 feet from a violent tornado vortex.

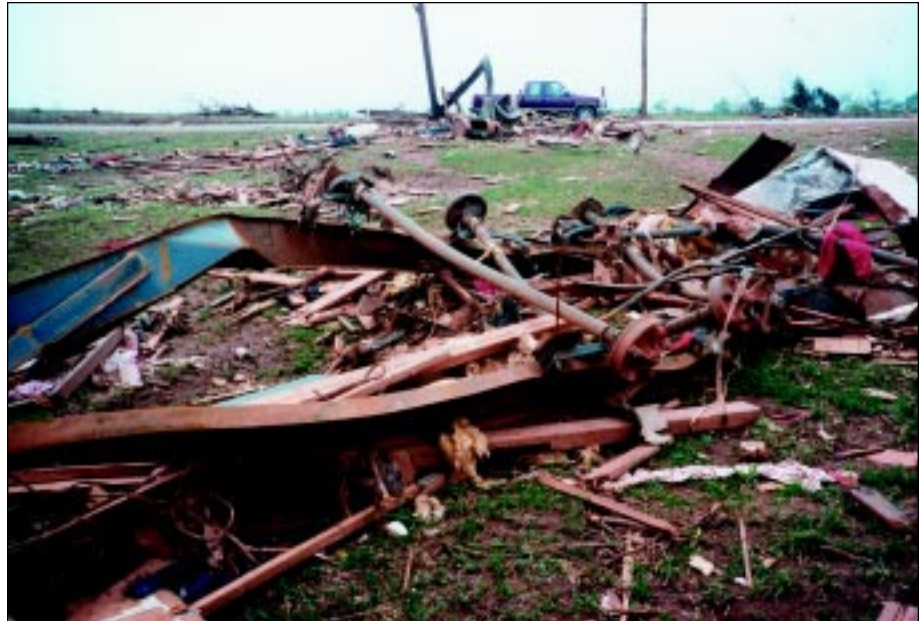
FIGURE 4-49: Strap anchoring failure most likely led to the displacement of this chassis, Bridge Creek, Oklahoma.

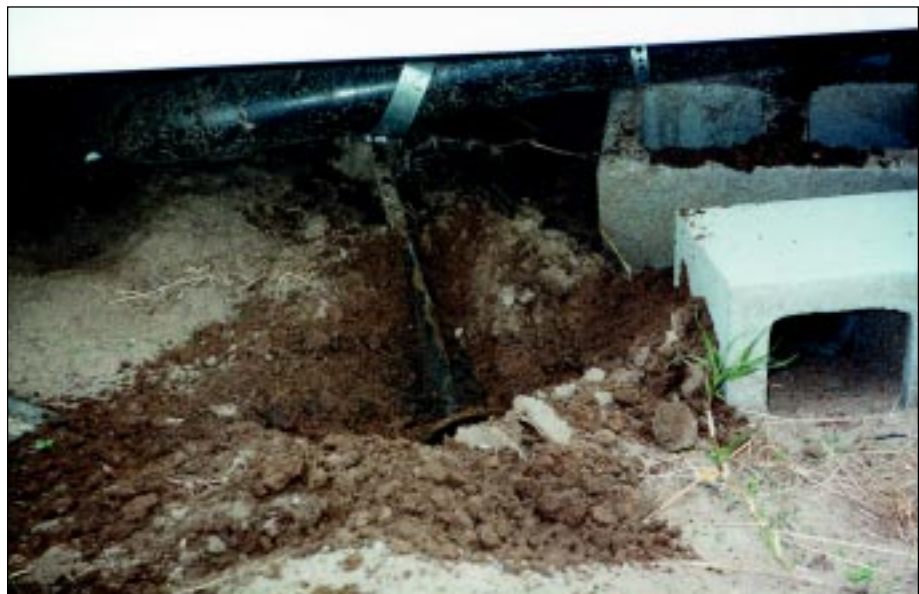
FIGURE 4-50: Ground anchor of manufactured home pulled from soil. This home in Wichita, Kansas, was located within the inflow area of a strong tornado.

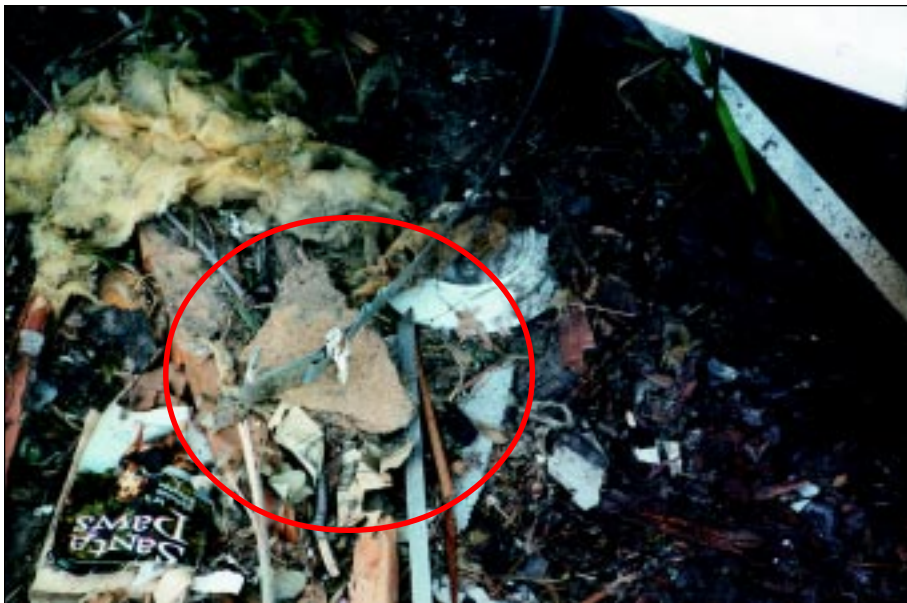
ment of the unit. Anchor depth into the loose sandy soil did not appear to be adequate to resist wind uplift and overturning forces (Figures 4-51 and 4-52) generated by a strong tornado whose vortex passed nearby, but did not directly strike the homes.

FIGURE 4-52: Strap torn off from chassis of manufactured home. This home in Wichita, Kansas, was located within the inflow area of a strong tornado.

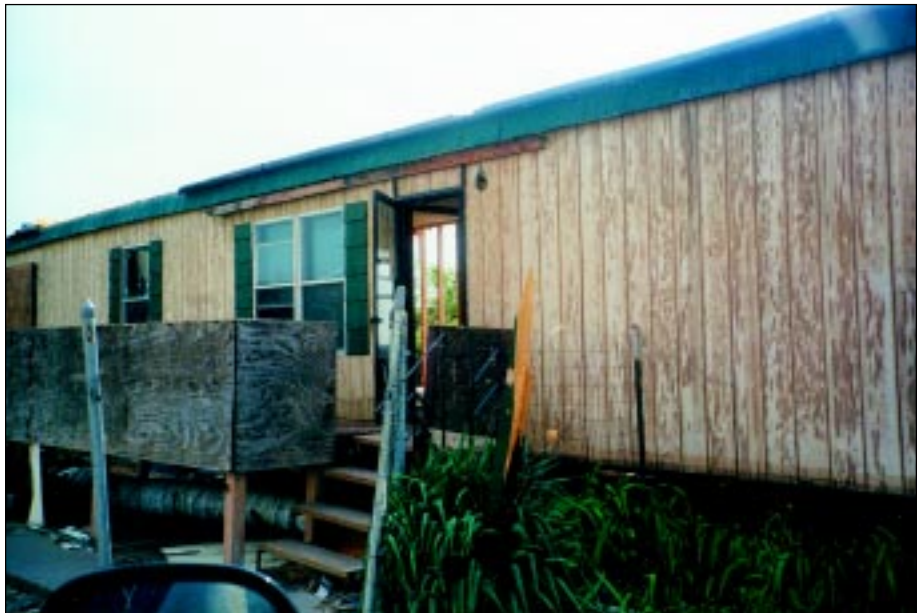
Several manufactured homes lost plywood roof sheathing and roof trusses, and some only lost asphalt roof shingles. Fastening of the roof sheathing and roofing materials was inadequate to resist wind uplift (Figures 4-53 and 4-54) from inflow winds of a strong tornado.

FIGURE 4-54: *Damage to a manufactured home located on the periphery of a strong tornado, Wichita, Kansas.*

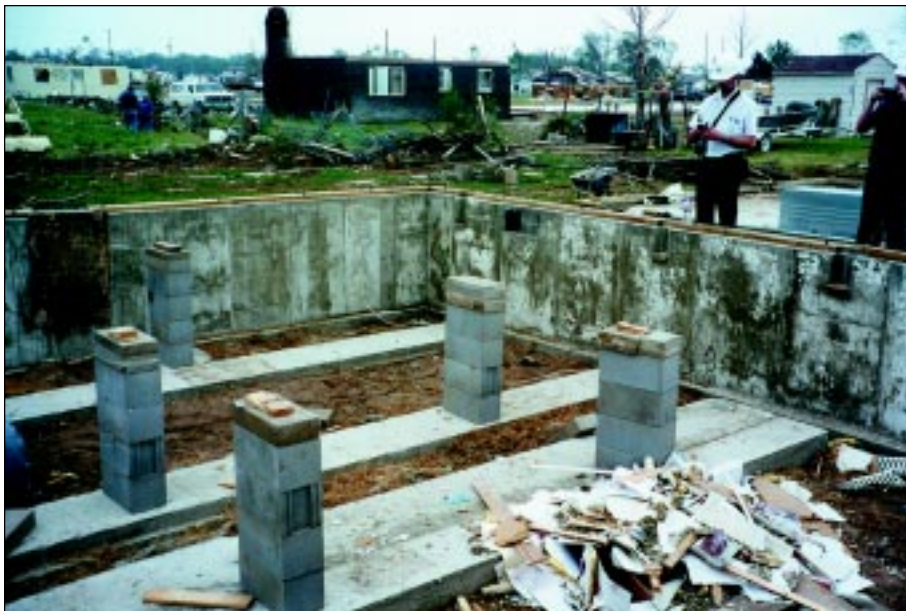
FIGURE 4-55: *Lack of bolts or positive connectors present between the chassis and foundation of a double-wide manufactured house, Haysville, Kansas. The floor framing of the house was still resting on the foundation after the tornado passed.*

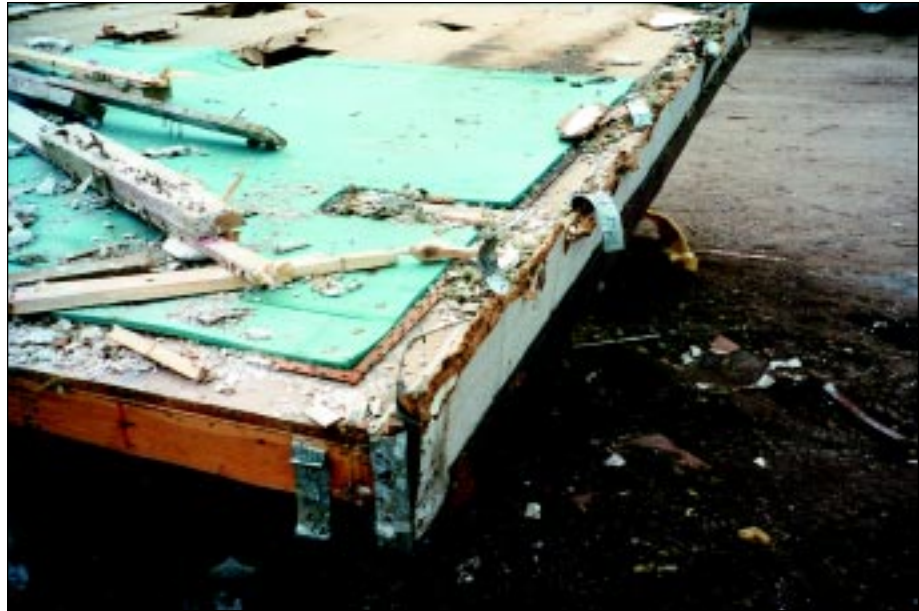
FIGURE 4-56: A close-up of the manufactured home floor and chassis after it was removed by a contractor from the permanent foundation in Figure 4-55.

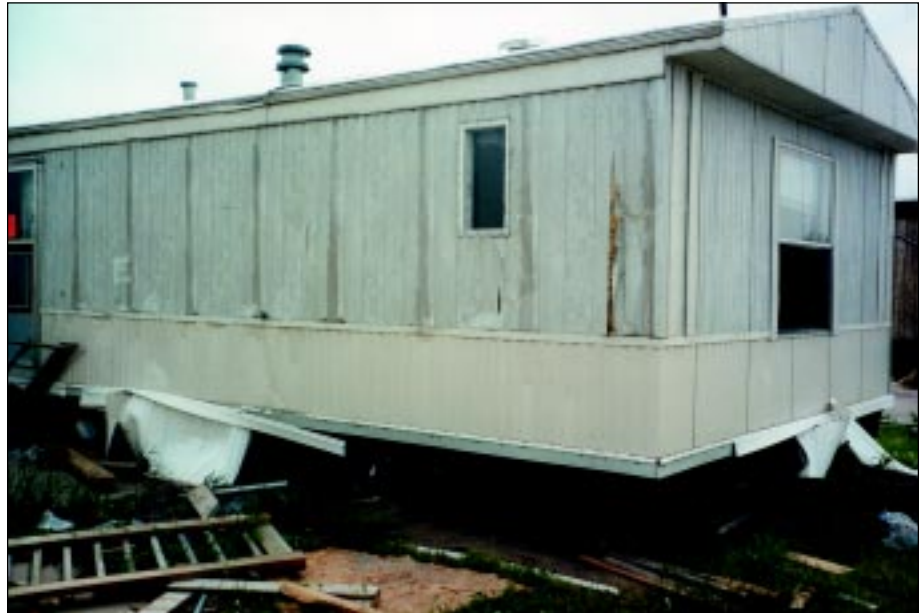
Several double-wide manufactured housing units in Haysville and Wichita, Kansas, partially survived high wind forces. However, ground anchors were pulled out of the soil, or they were bent over, loosening tie-down straps. Homes shifted laterally from wind forces and fell off un-reinforced and ungrouted CMU block piers. In some cases, tie-down straps with metal clips for attachment to chassis beams were loose and lying on the ground (Figures 4-57 through 4-60).

FIGURE 4-57: This manufactured home laterally shifted from wind force generated along the periphery of a violent tornado, Haysville, Kansas.

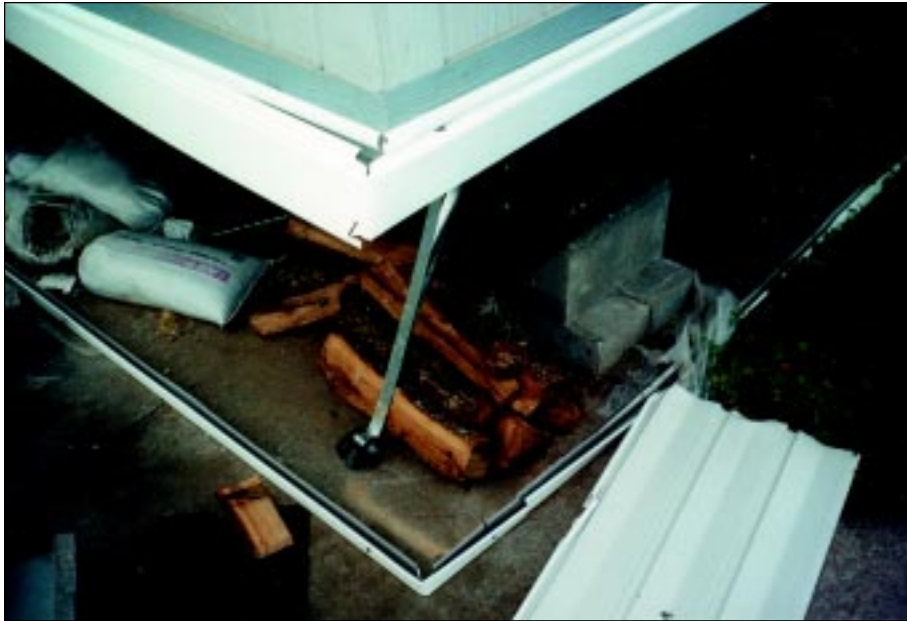
FIGURE 4-58: View of anchor strap and attachment indicating lateral shifting of a manufactured home, Haysville, Kansas. This home was located along the periphery of a violent tornado.
